Visual Pest Inspection Report

15 Glenhaven St, Kedron

31/03/2025.

VISUAL TIMBER PEST INSPECTION REPORT as per AS4349.3-2010

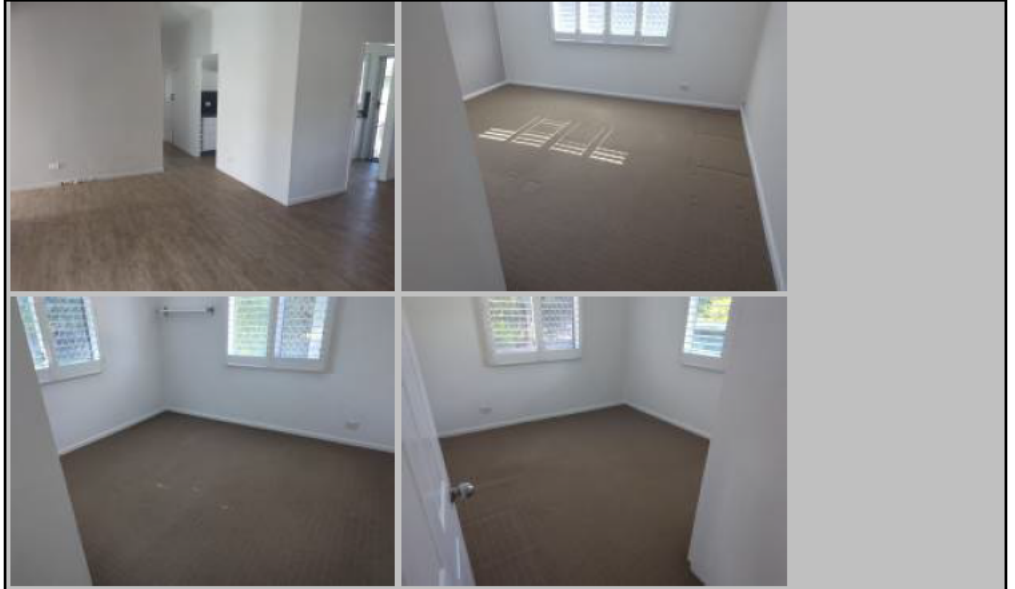
Inspection Restrictions

Floor coverings and furnishings are present and restricted inspection within this area, furnishings are but no limited to non-removable items such as, joinery and cabinets, wardrobes, curtains and blinds ect.

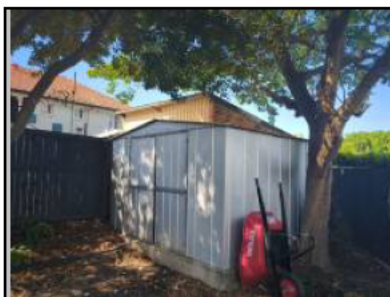
Description of Outbuilding

A metal garden shed:

To the rear of the property.
