# Earthquake Claims and Insurance Information

Property Address: 2/85 Trafalgar St, St Albans

**Information request – CLM/2010/086160 - 2/85 Trafalgar Street, Saint Albans, Christchurch 8014**

# Geotechnical Investigation Report Units 1 and 2, 85 Trafalgar Street, St. Albans

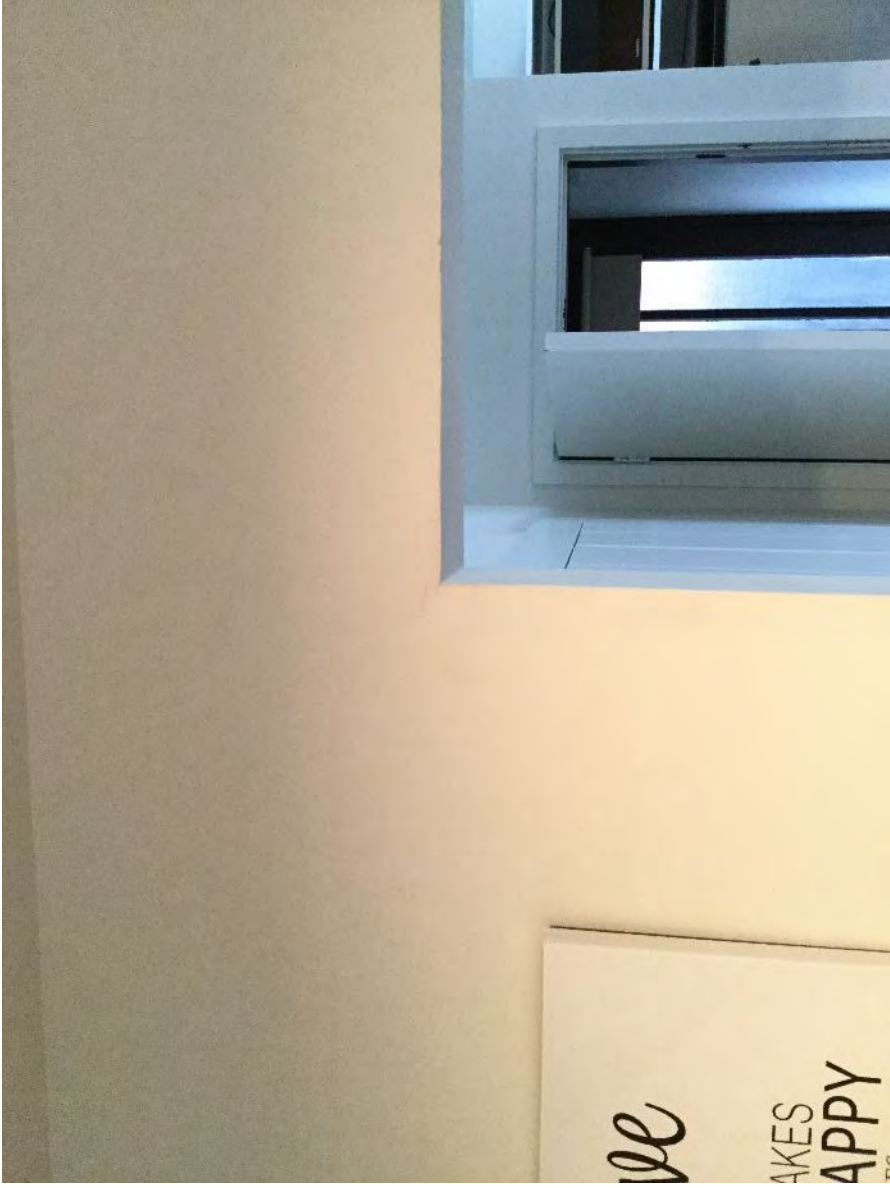
1 (7)

Water damage from shower – Not Kaikoura event damage

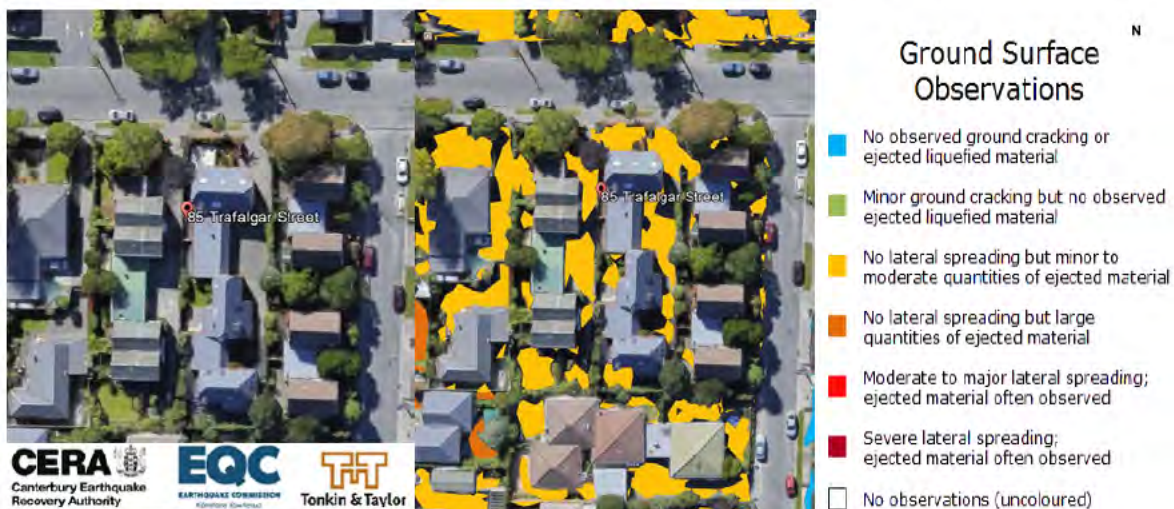
Photo 3. EQC liquefaction and lateral spreading observations obtained from Canterbury Geotechnical Database show “No observations (uncoloured)” following the September 2010 and “No lateral spreading but minor to moderate quantities of ejected material” following the February 2011 earthquake events.

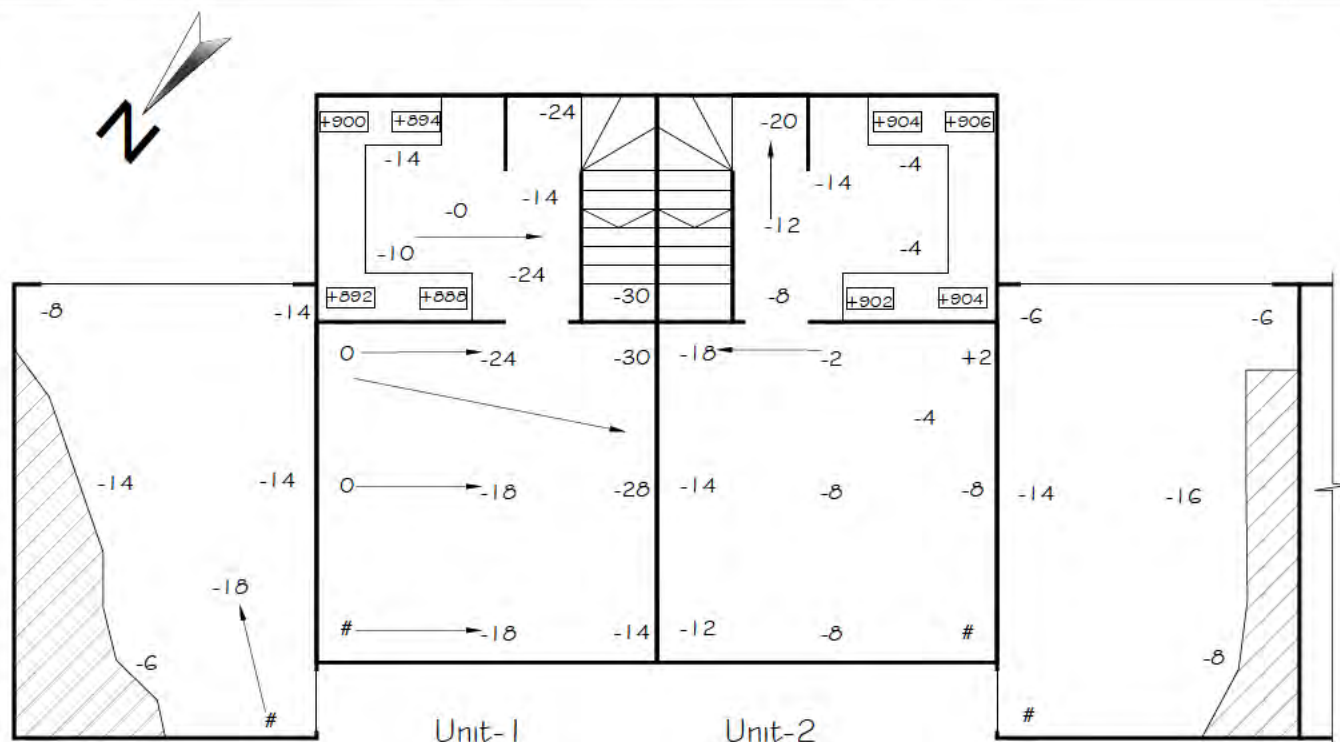
**SK1**

### FLOOR LEVEL SURVEY PLAN (NTS) (SEPARATE DATUM)

Garage Floor Unit 1 : 18mm (-18, 00)

Garage Floor Unit 2 : 16mm (-16, 00)

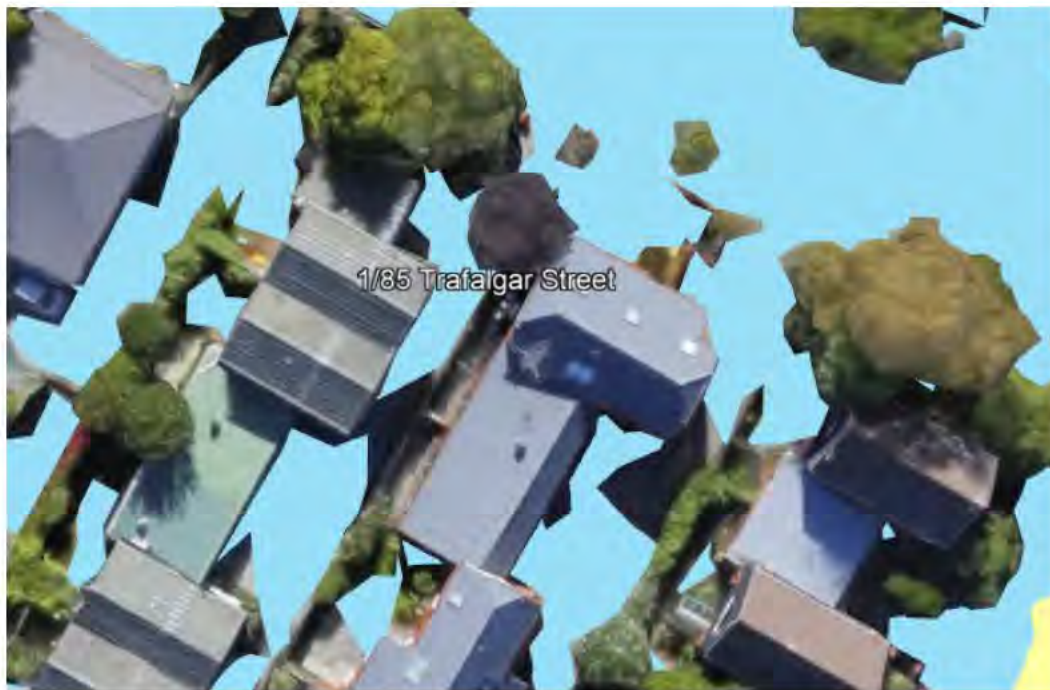
Figure 2. MBIE Technical Category Maps

The site is currently mapped as "Green Zone, Technical Category 3, blue" as defined by the Ministry of Business, Innovation and Employment (MBIE) Residential Technical Categories. This indicates that moderate to significant land damage from liquefaction is possible in future large earthquakes.

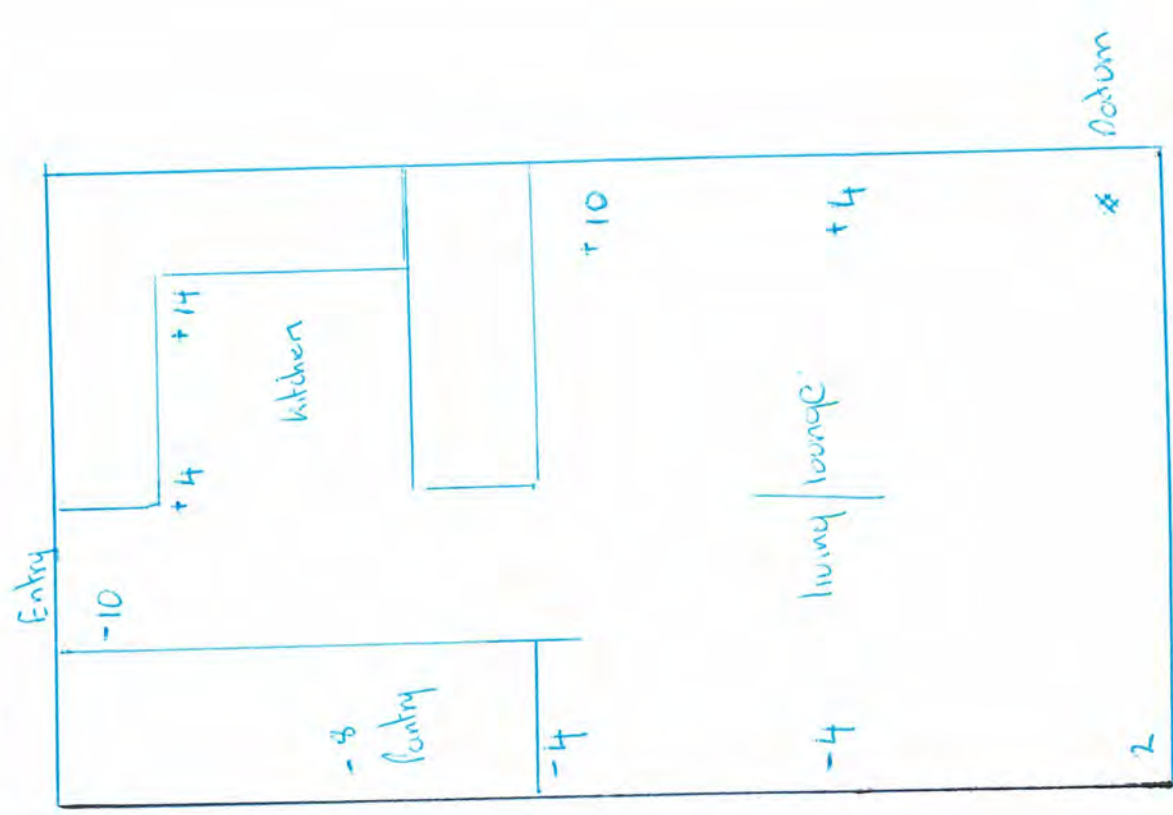
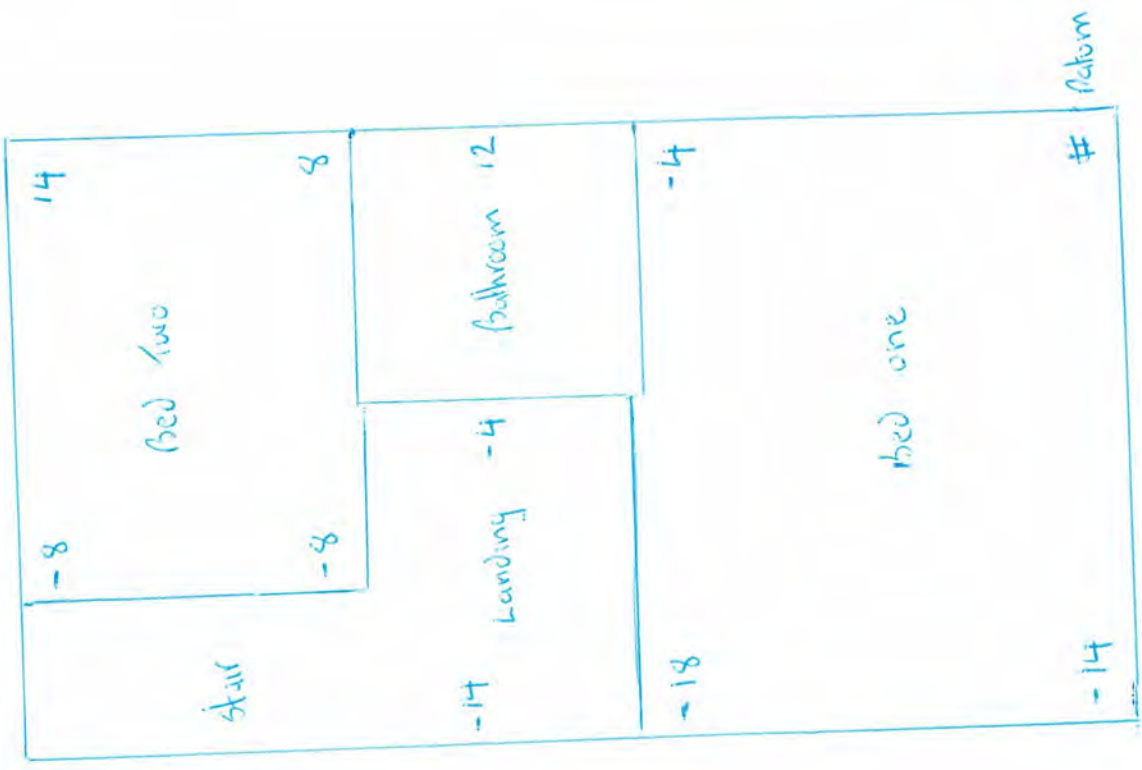
Date 3/1/20 2/85 Trafalgar St.

levels taken using 2.8 level

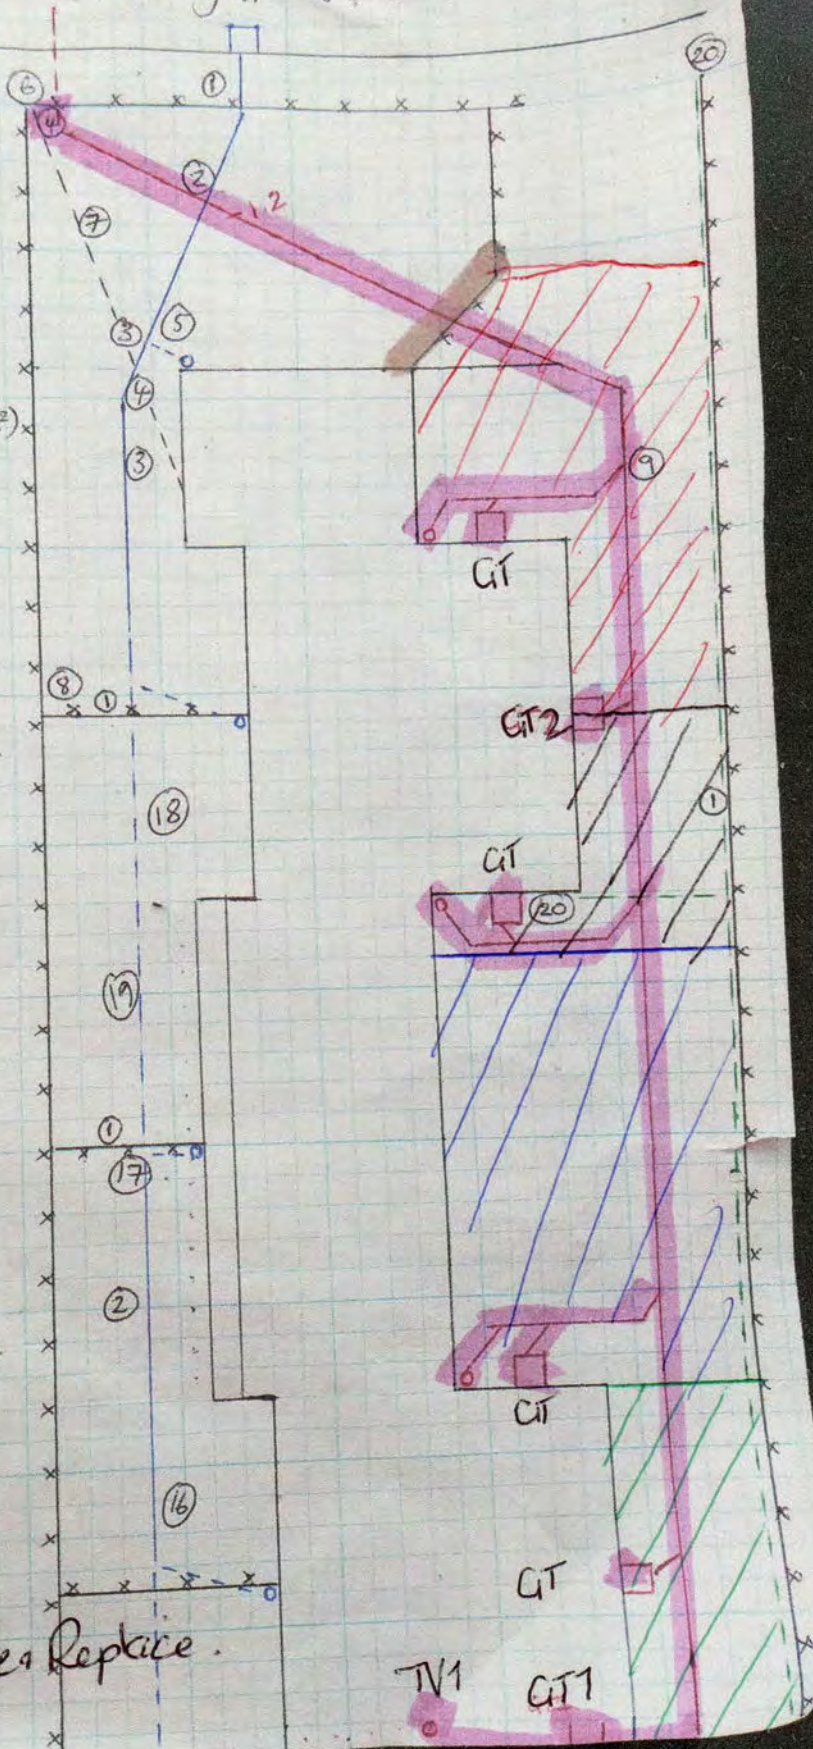
/// Drive 30m<sup>2</sup>. 100% Unit 4  
 /// Drive 60m<sup>2</sup> 50% 4 + 3.

/// Drive 35m<sup>2</sup> 33% 4, 3, 2  
 /// Drive 65m<sup>2</sup> 25% 4, 3, 2, 1

SS Repair

Fence-Remove &amp; Replace.
