All Building Inspections Limited

Building Report

11 Harry Shaw Way
Raumati South

*This report has been updated as recommendations from the initial inspection have been implemented.

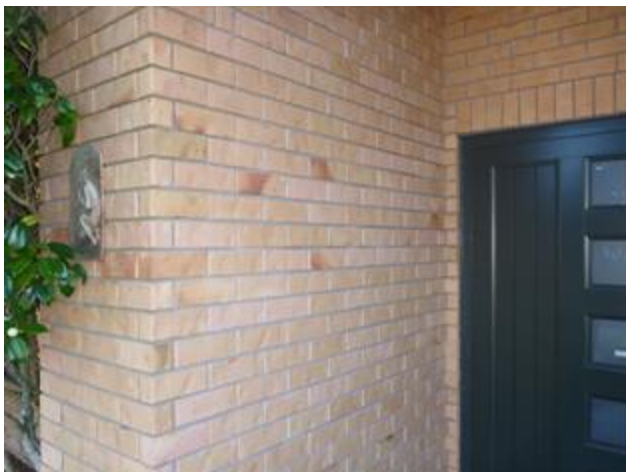
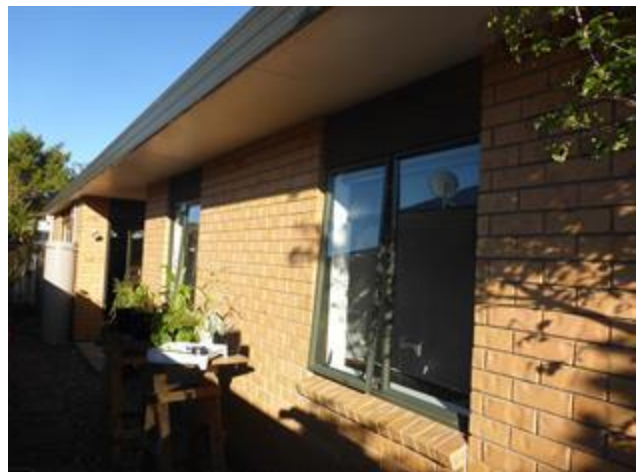
Toilet window sill

No gaps or cracks were detected in the exterior walls of the brick but the mortar to the toilet windowsill has aged with repair and a new mortar recommended as part of the dwelling's maintenance planning.

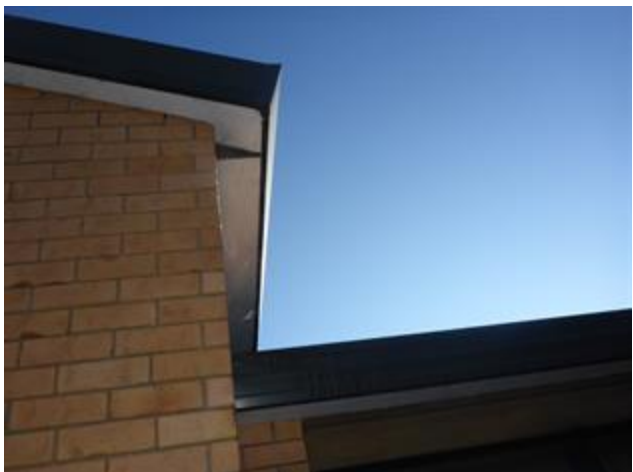
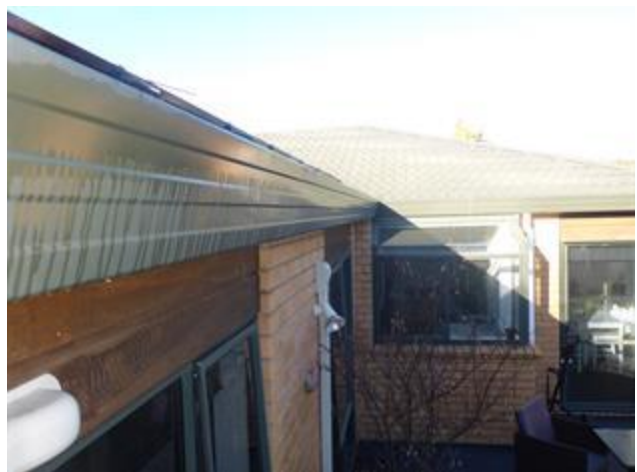
The cladding was in good condition. Cement board's maintenance requirement is to ensure a good level of paint finish to protect and seal the cladding and the paint finish was of a good standard.

The cladding appeared in good condition. At the first sign of surface and cut edge corrosion, the affected areas can be cleaned down, spot primed and re-painted with appropriate paint.

Dirt/ grime buildup can shorten the life of the cladding material. As part of the maintenance of the dwelling, I recommend washing down sealed cladding, windows and frames regularly. As with the fascia, particular attention should be paid to the areas that do not get rain washed such as under the eaves and at the top of garage doors. A soft brush and a low-pressure hose are recommended and not a high-pressure water blaster.

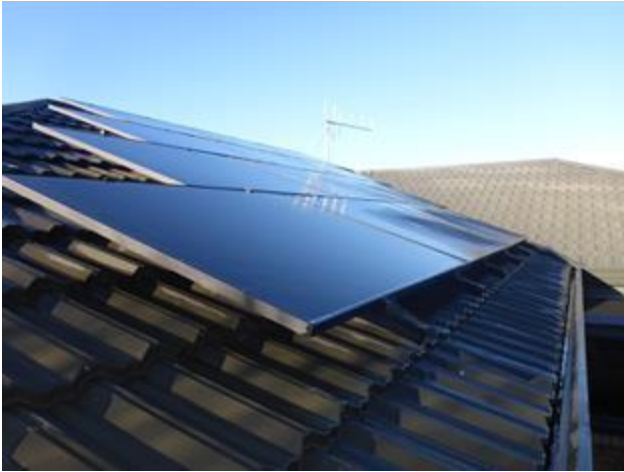
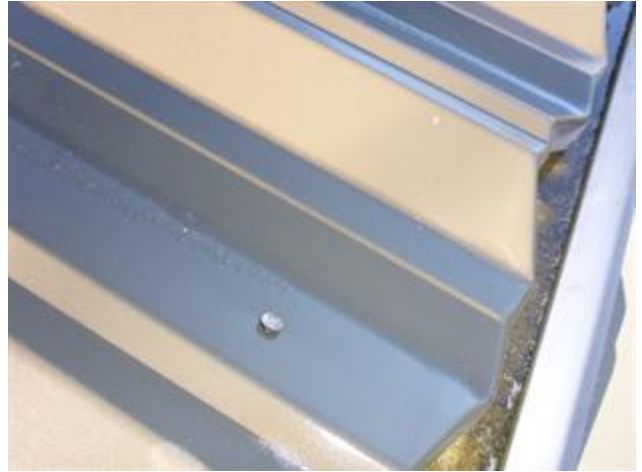
Lower run

The tiles of the lower run above the spouting have been fixed through the tops of the tiles without rubber washers. This would have been compliant at the time of construction but does not meet today's standards as this can allow moisture ingress issues.

I recommend that the roofing material have further appraisal by a licensed roofer to give you advice on the degree of fastener replacement, washer upgrades and potential costs.

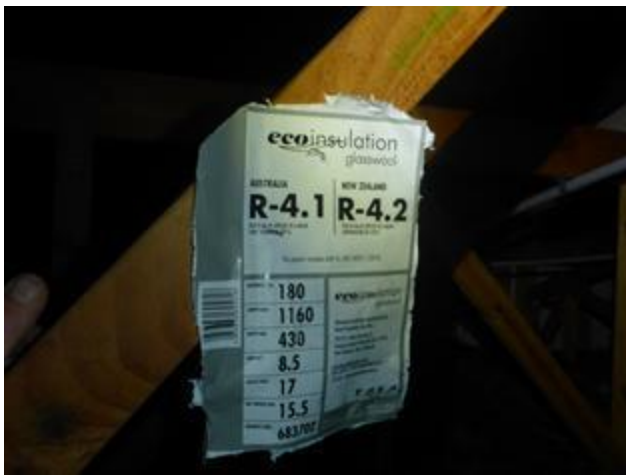
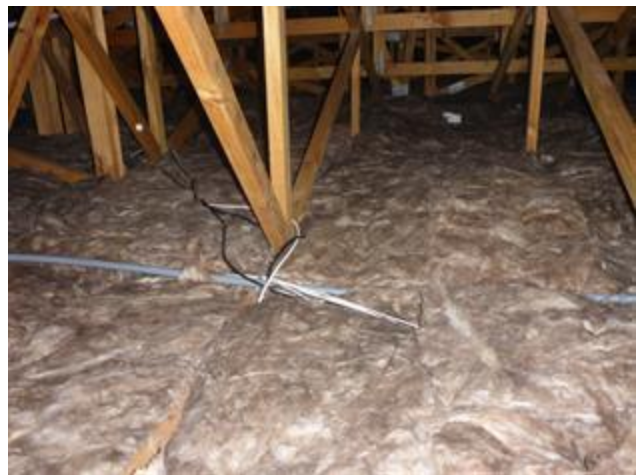
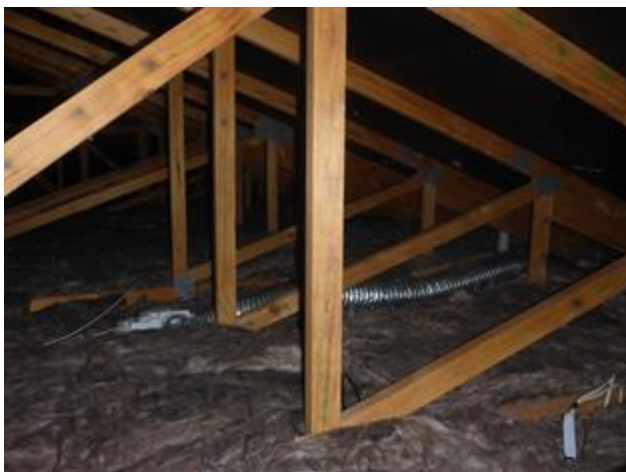
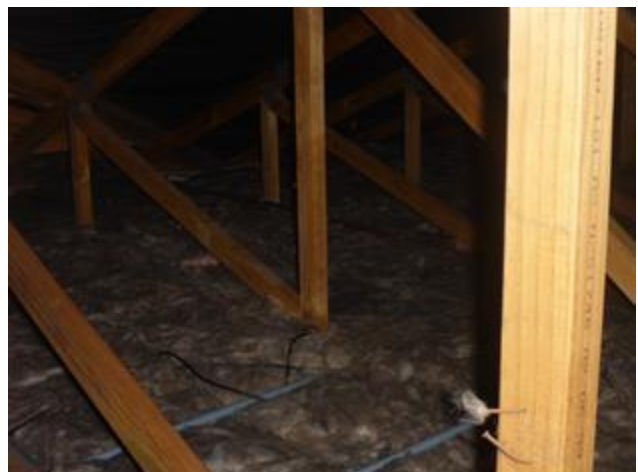
Earthwool ceiling insulation was installed throughout the roof space over a layer of insul-fluf. The manufacturer states that Earth wool is rot-proof, odourless, does not sustain vermin and does not encourage the growth of mould, fungi or bacteria.

It is also recommended that insulation is fitted snugly between framing without gaps, tucks or folds but not compressed or packed tightly around electrical wiring.

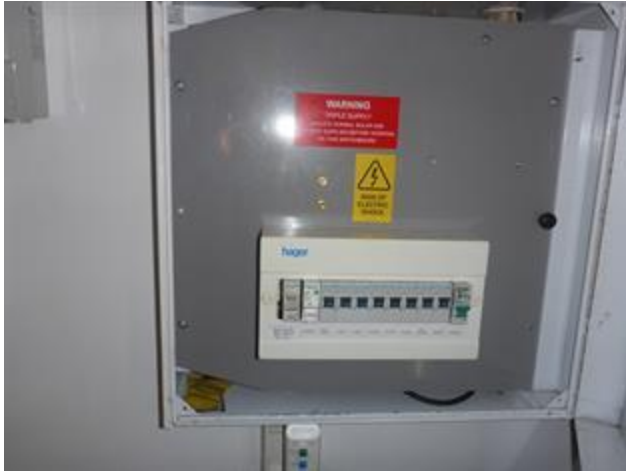
Circuit Board

The electrical system consists of an internal circuit board located in the garage with the meter located in the garage and viewed from the exterior.

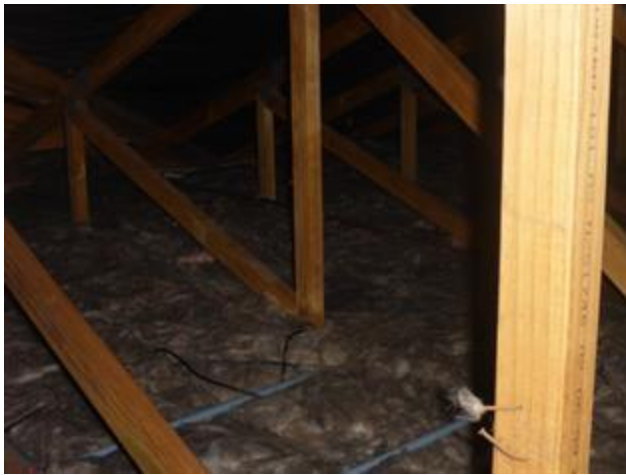
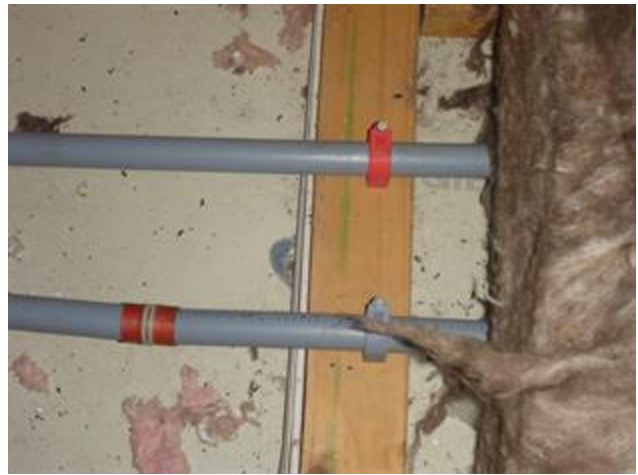
Some copper water piping was also present and supplying the hot water cylinder.

Where the plumbing was visible, there were no indications of any issues to report.

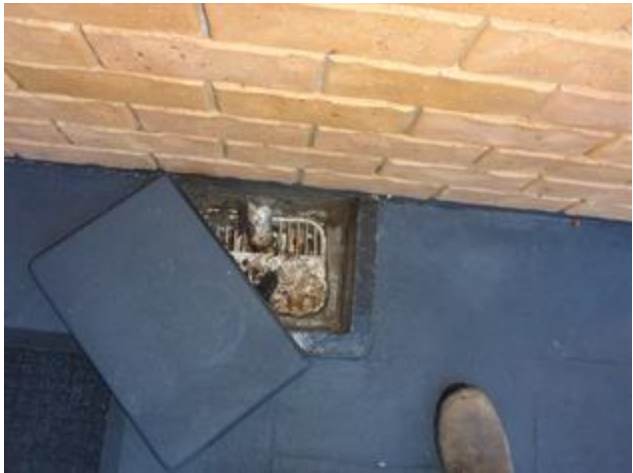
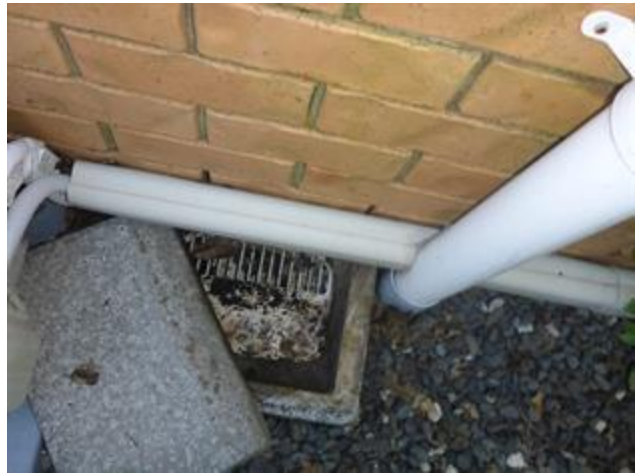
The gully traps appeared clear and clean at the time of inspection.
