Exemption from building consent

Project Address
1-2/85 Trafalgar Street, Saint Albans

PROJECT : STRUCTURAL REPAIR ASSESSMENT

REVIEW OF EXISTING STRUCTURAL ENGINEERS' REPORT – UNITS 1 & 2 / 85 TRAFALGAR STREET, SAINT ALBANS, CHRISTCHURCH.

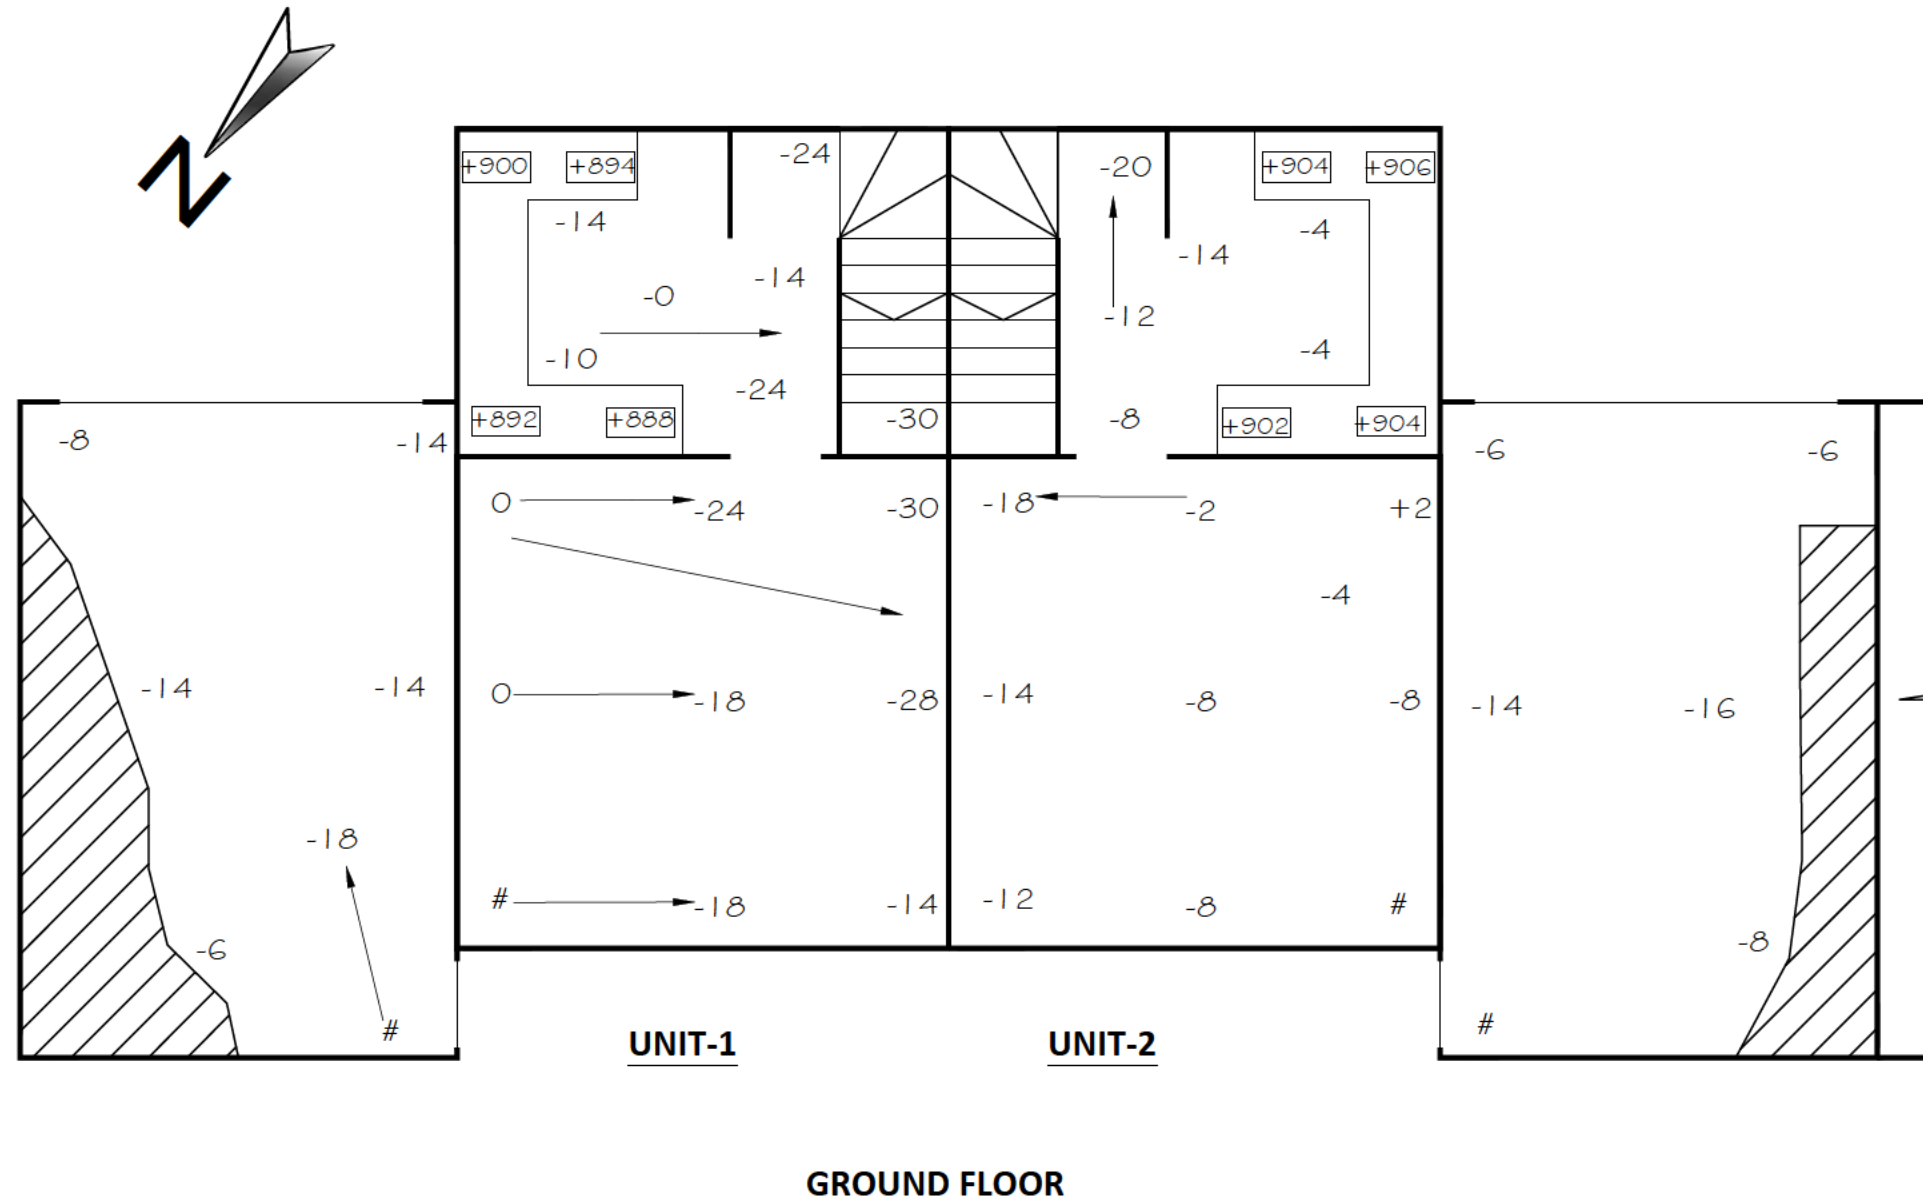
FLOOR LEVEL SURVEY PLAN BY OTHERS (NTS)

- 1) FLOOR LEVEL BY OTHERS
- 2) DATUM DENOTED AS "#".
- 3) THE FLOOR SLOPE EXCEEDED 1/200 TOLERANCE DENOTED AS " " (INDICATIVE ONLY).
- 4) FLOOR LEVEL DIFFERENCES BETWEEN THE HIGHEST AND LOWEST POINTS ARE:
 - GROUND FLOOR UNIT 1: 30 MM (-30, 00)
 - GROUND FLOOR UNIT 2: 20 MM (-20, 00)
 - GARAGE FLOOR UNIT 1: 18 MM (-18, 00)
 - GARAGE FLOOR UNIT 2: 16 MM (-16, 00)

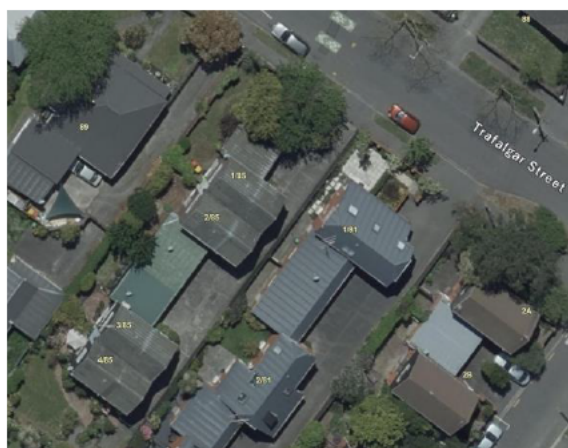
Photo 1. 85 Trafalgar Street, Saint Albans, Christchurch.

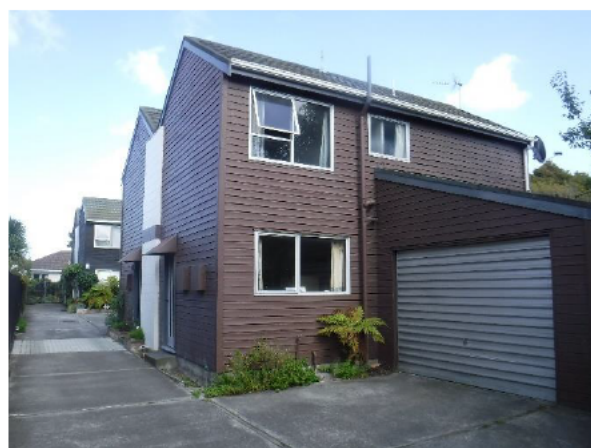
Photo 2. Elevation view of the flats from the southeast corner of the property.

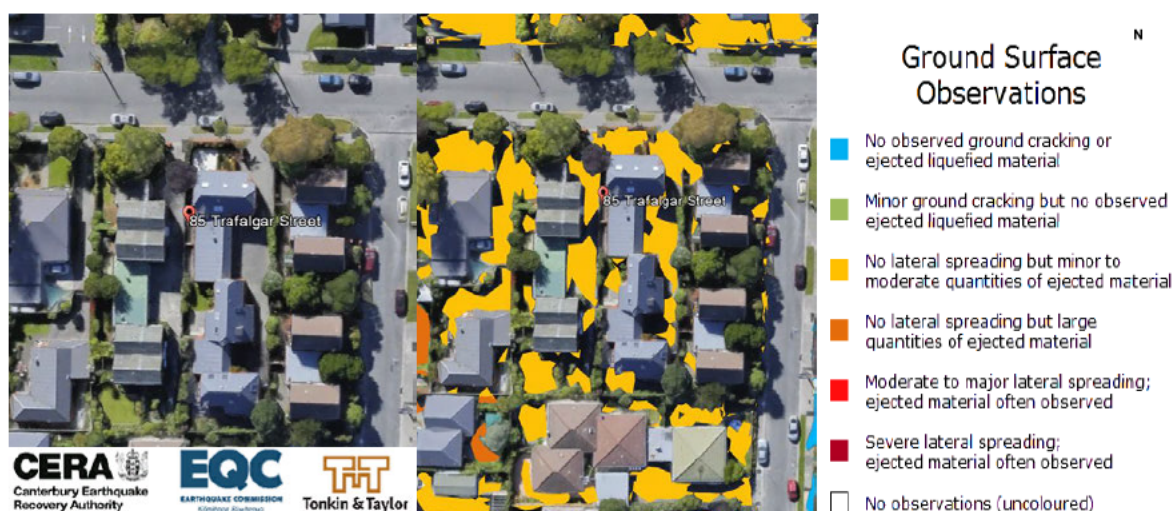
Photo 3. EQC liquefaction and lateral spreading observations obtained from Canterbury Geotechnical Database show “No observations (uncoloured)” following the September 2010 and “No lateral spreading but minor to moderate quantities of ejected material” following the February 2011 earthquake events.
