2025 | COMPREHENSIVE WEATHERTIGHTNESS REPORT H/V

42 Harry Shaw Way
Paraparaumu, Wellington 5032

JULY 9, 2025

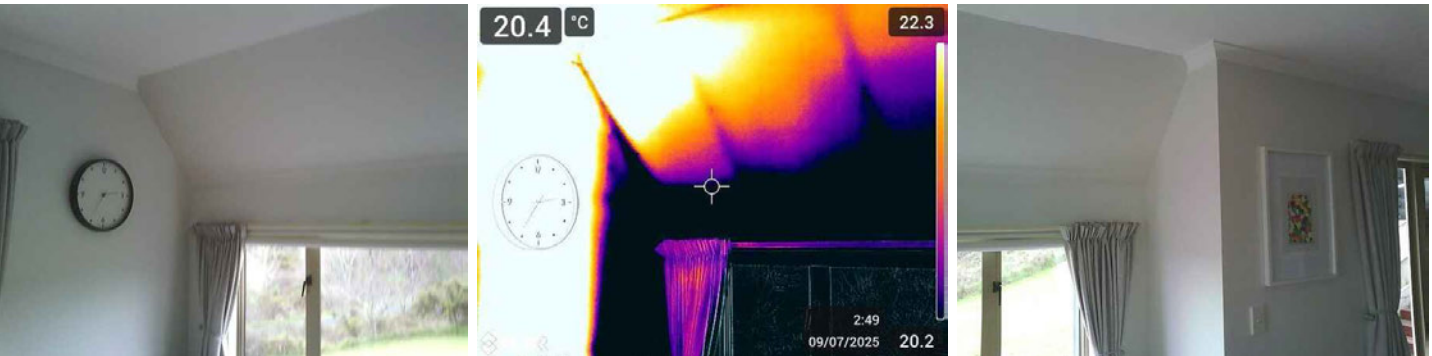
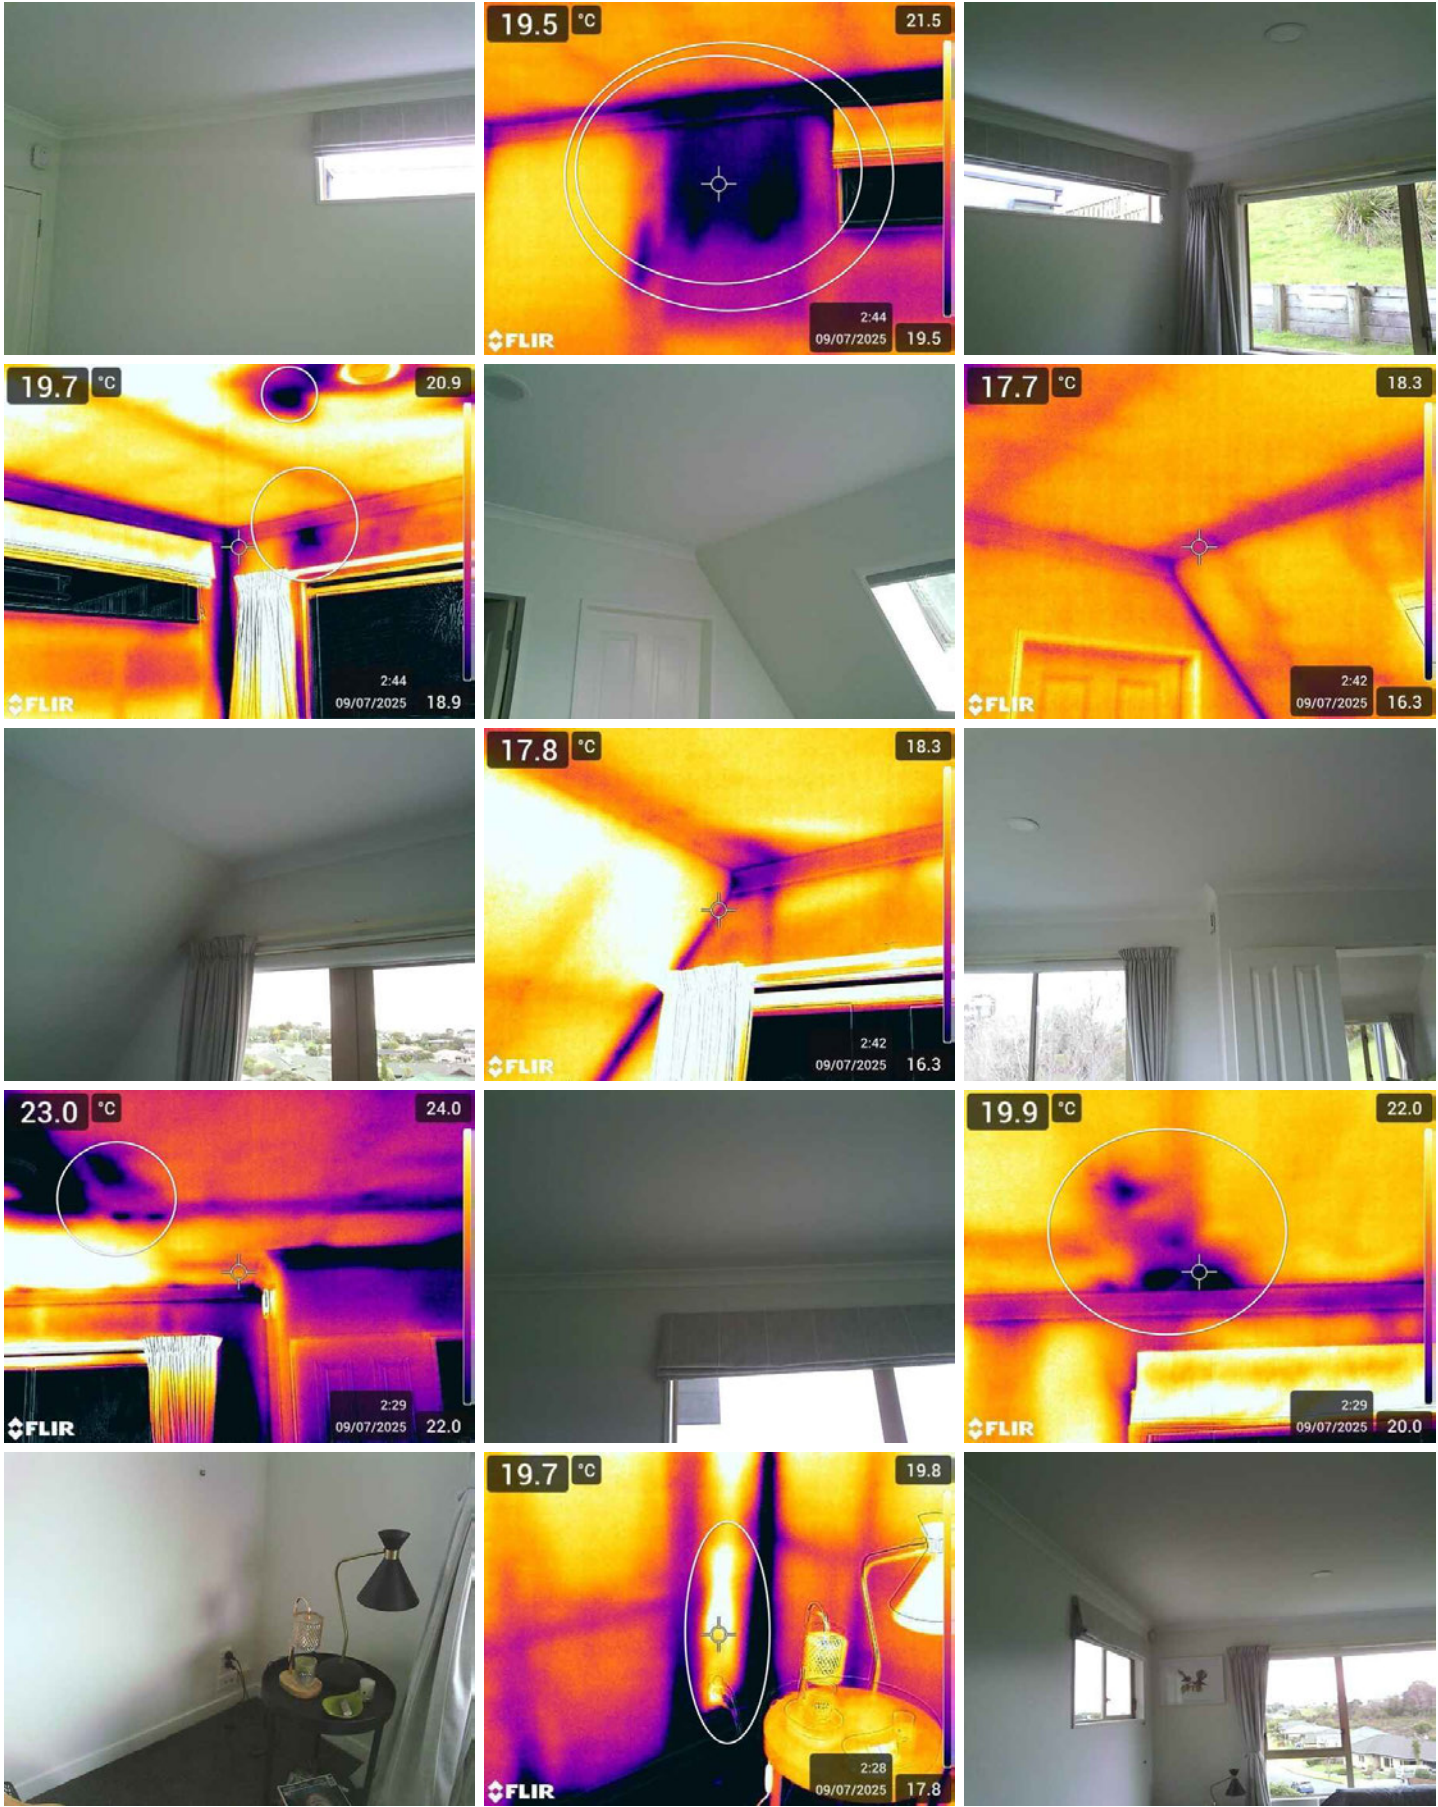
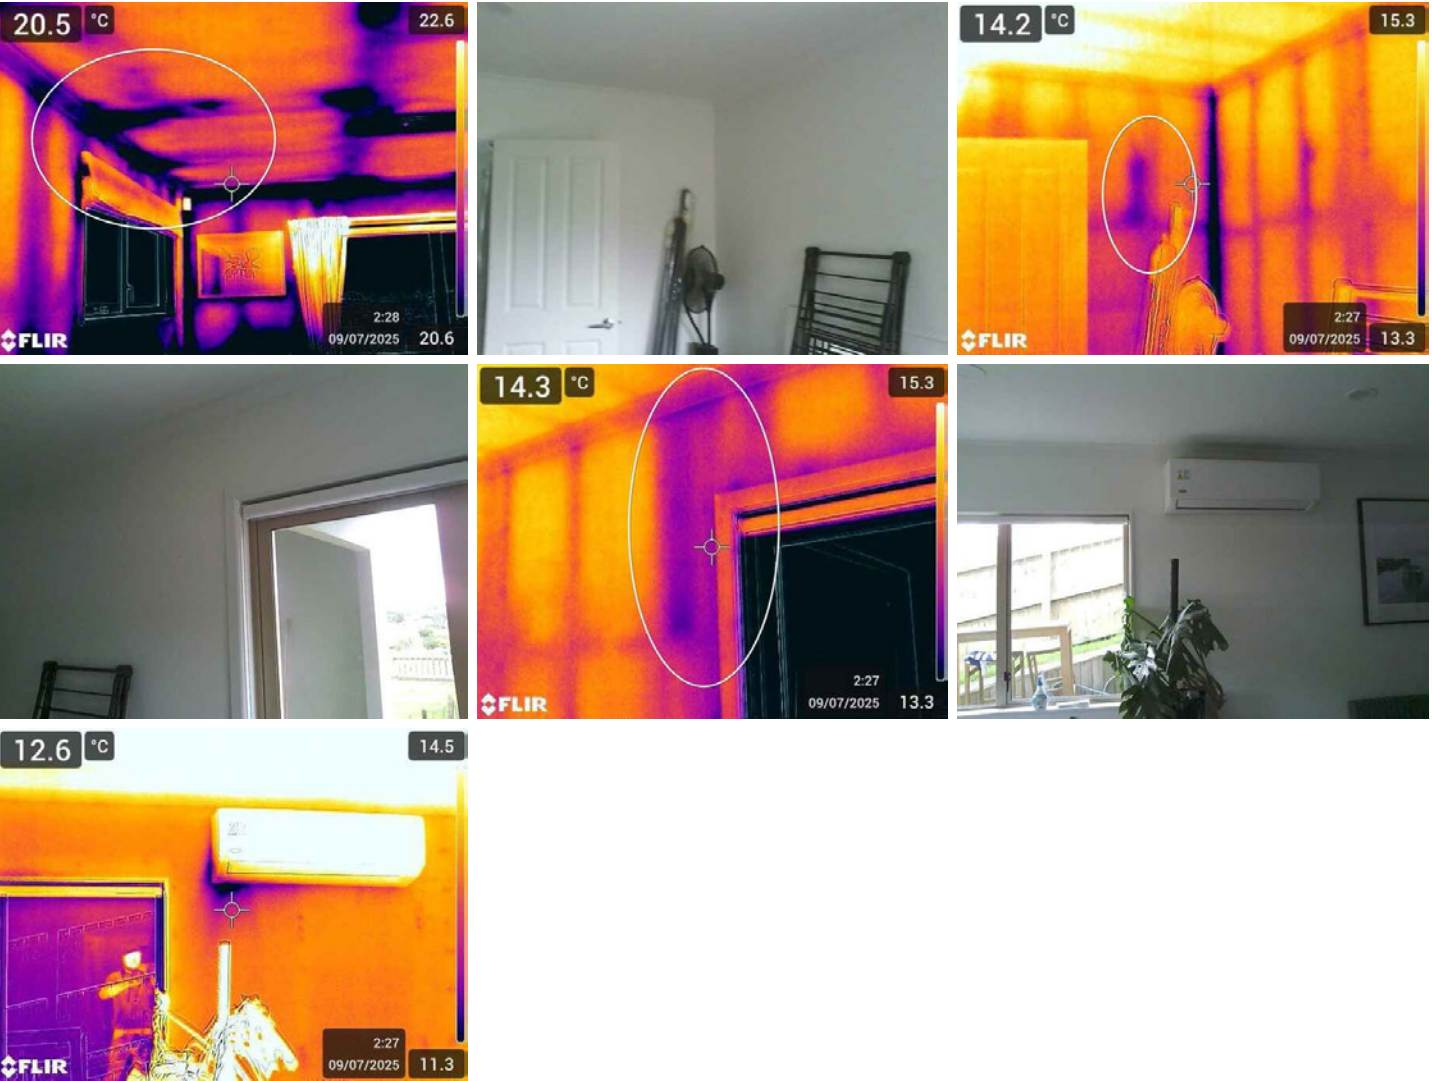
3.1.2 INTERIOR INSPECTION RESULTS AND SUMMARY
THERMAL IMAGING T560 DOCUMENTATION

- Moisture may, or may not have been detected with definitive certainty in all theses particular areas of observation. However, these areas were indicating a moderate to major temperature differential through the FLIR T560 Thermal imager and/or visual signs of moisture ingress/damage may also have been observed.
- The areas marked with a white CIRCLE have been investigated further via invasive measures.
- All areas have now been cleared for current moisture ingress.
- These areas must still be monitored moving forward.

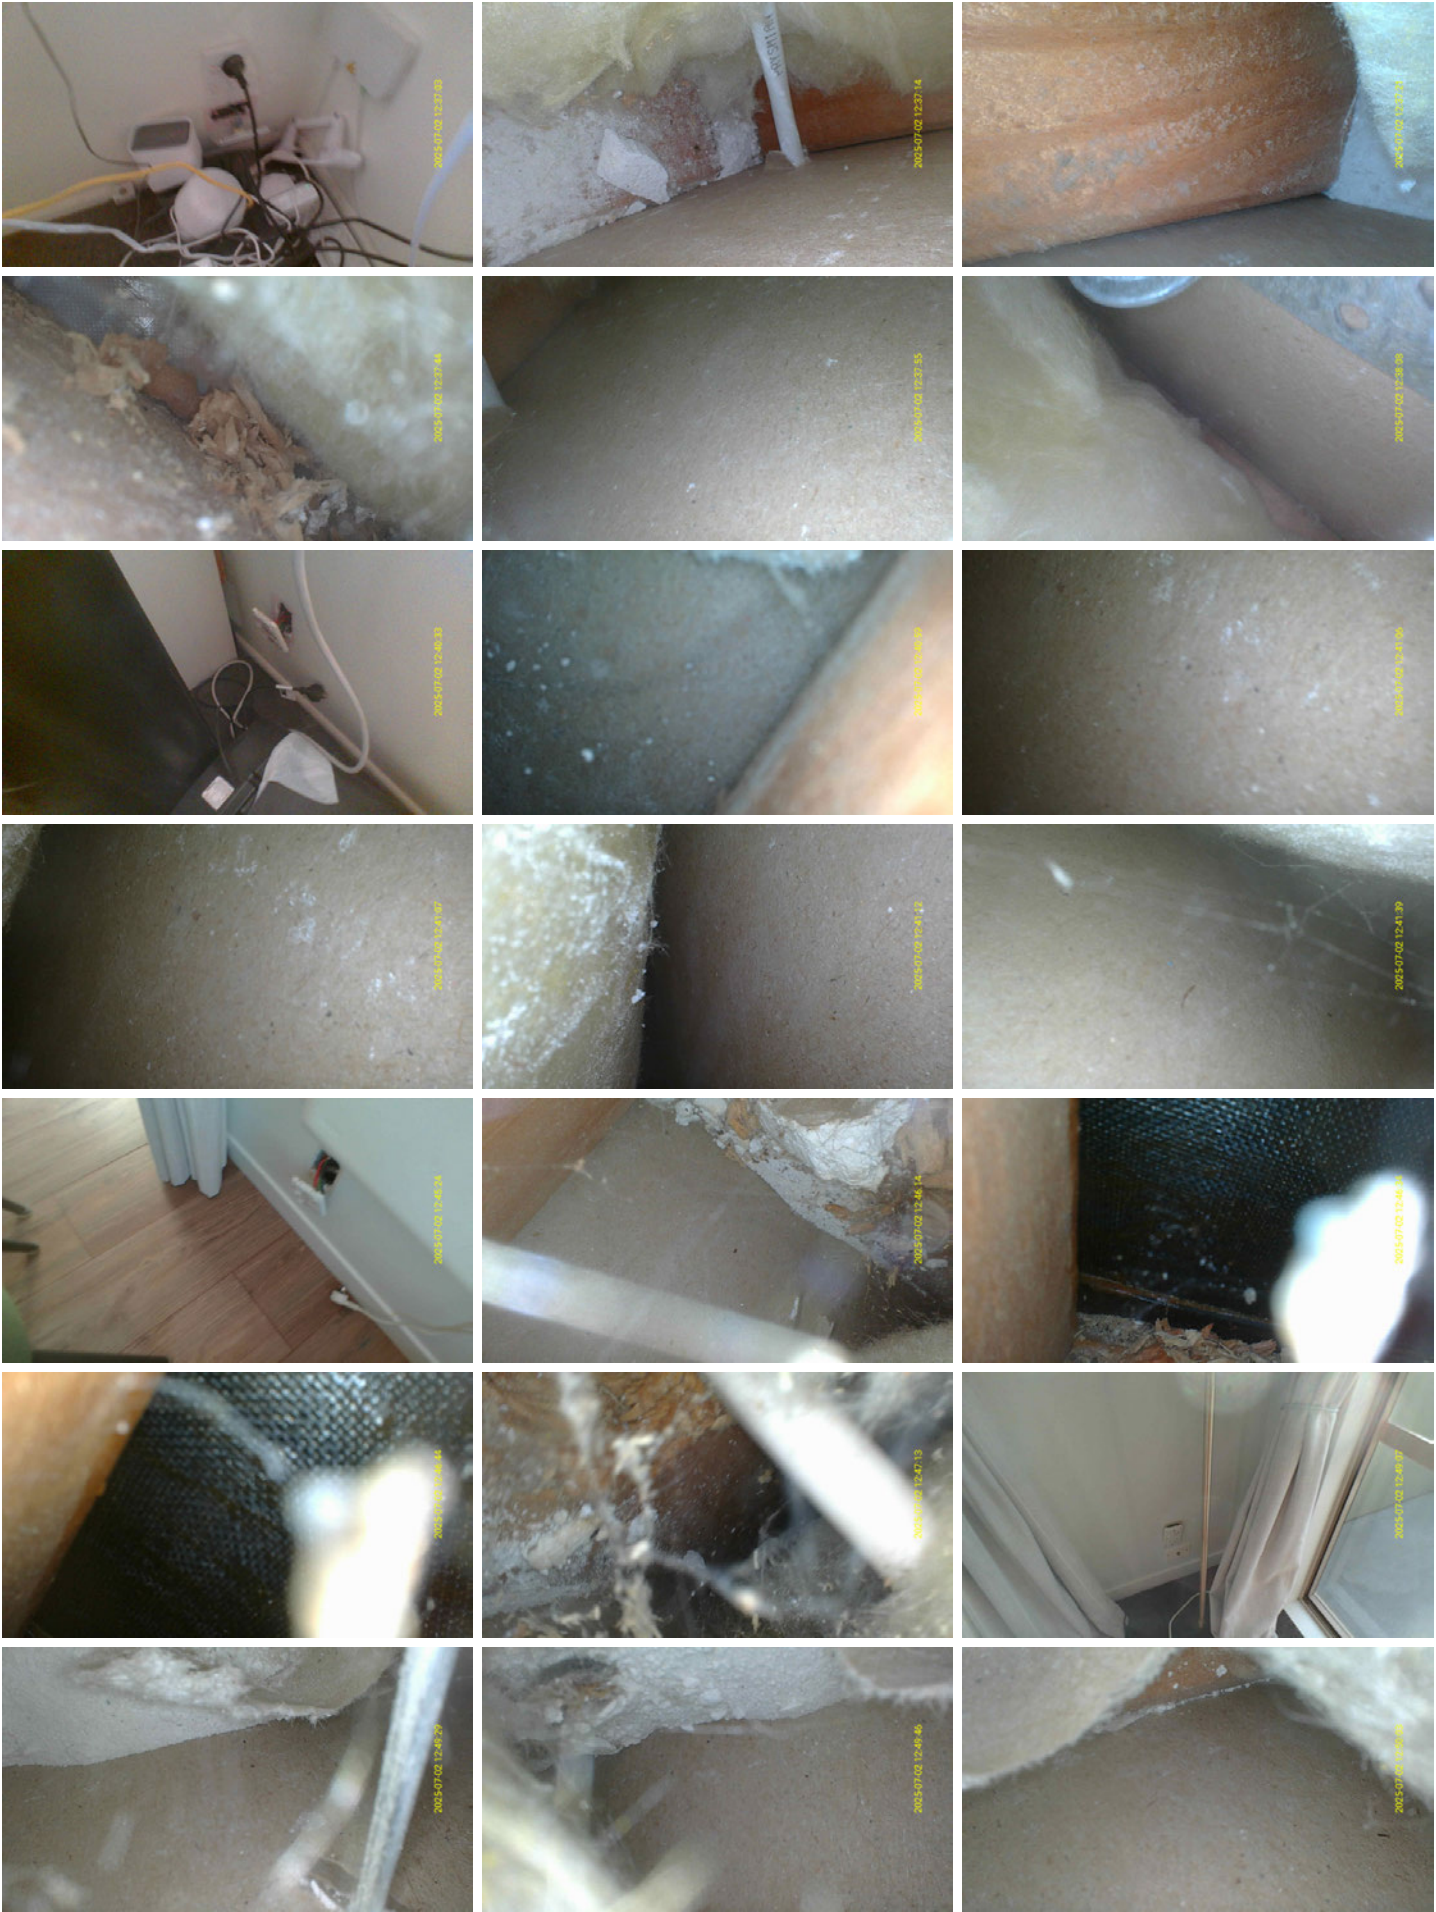
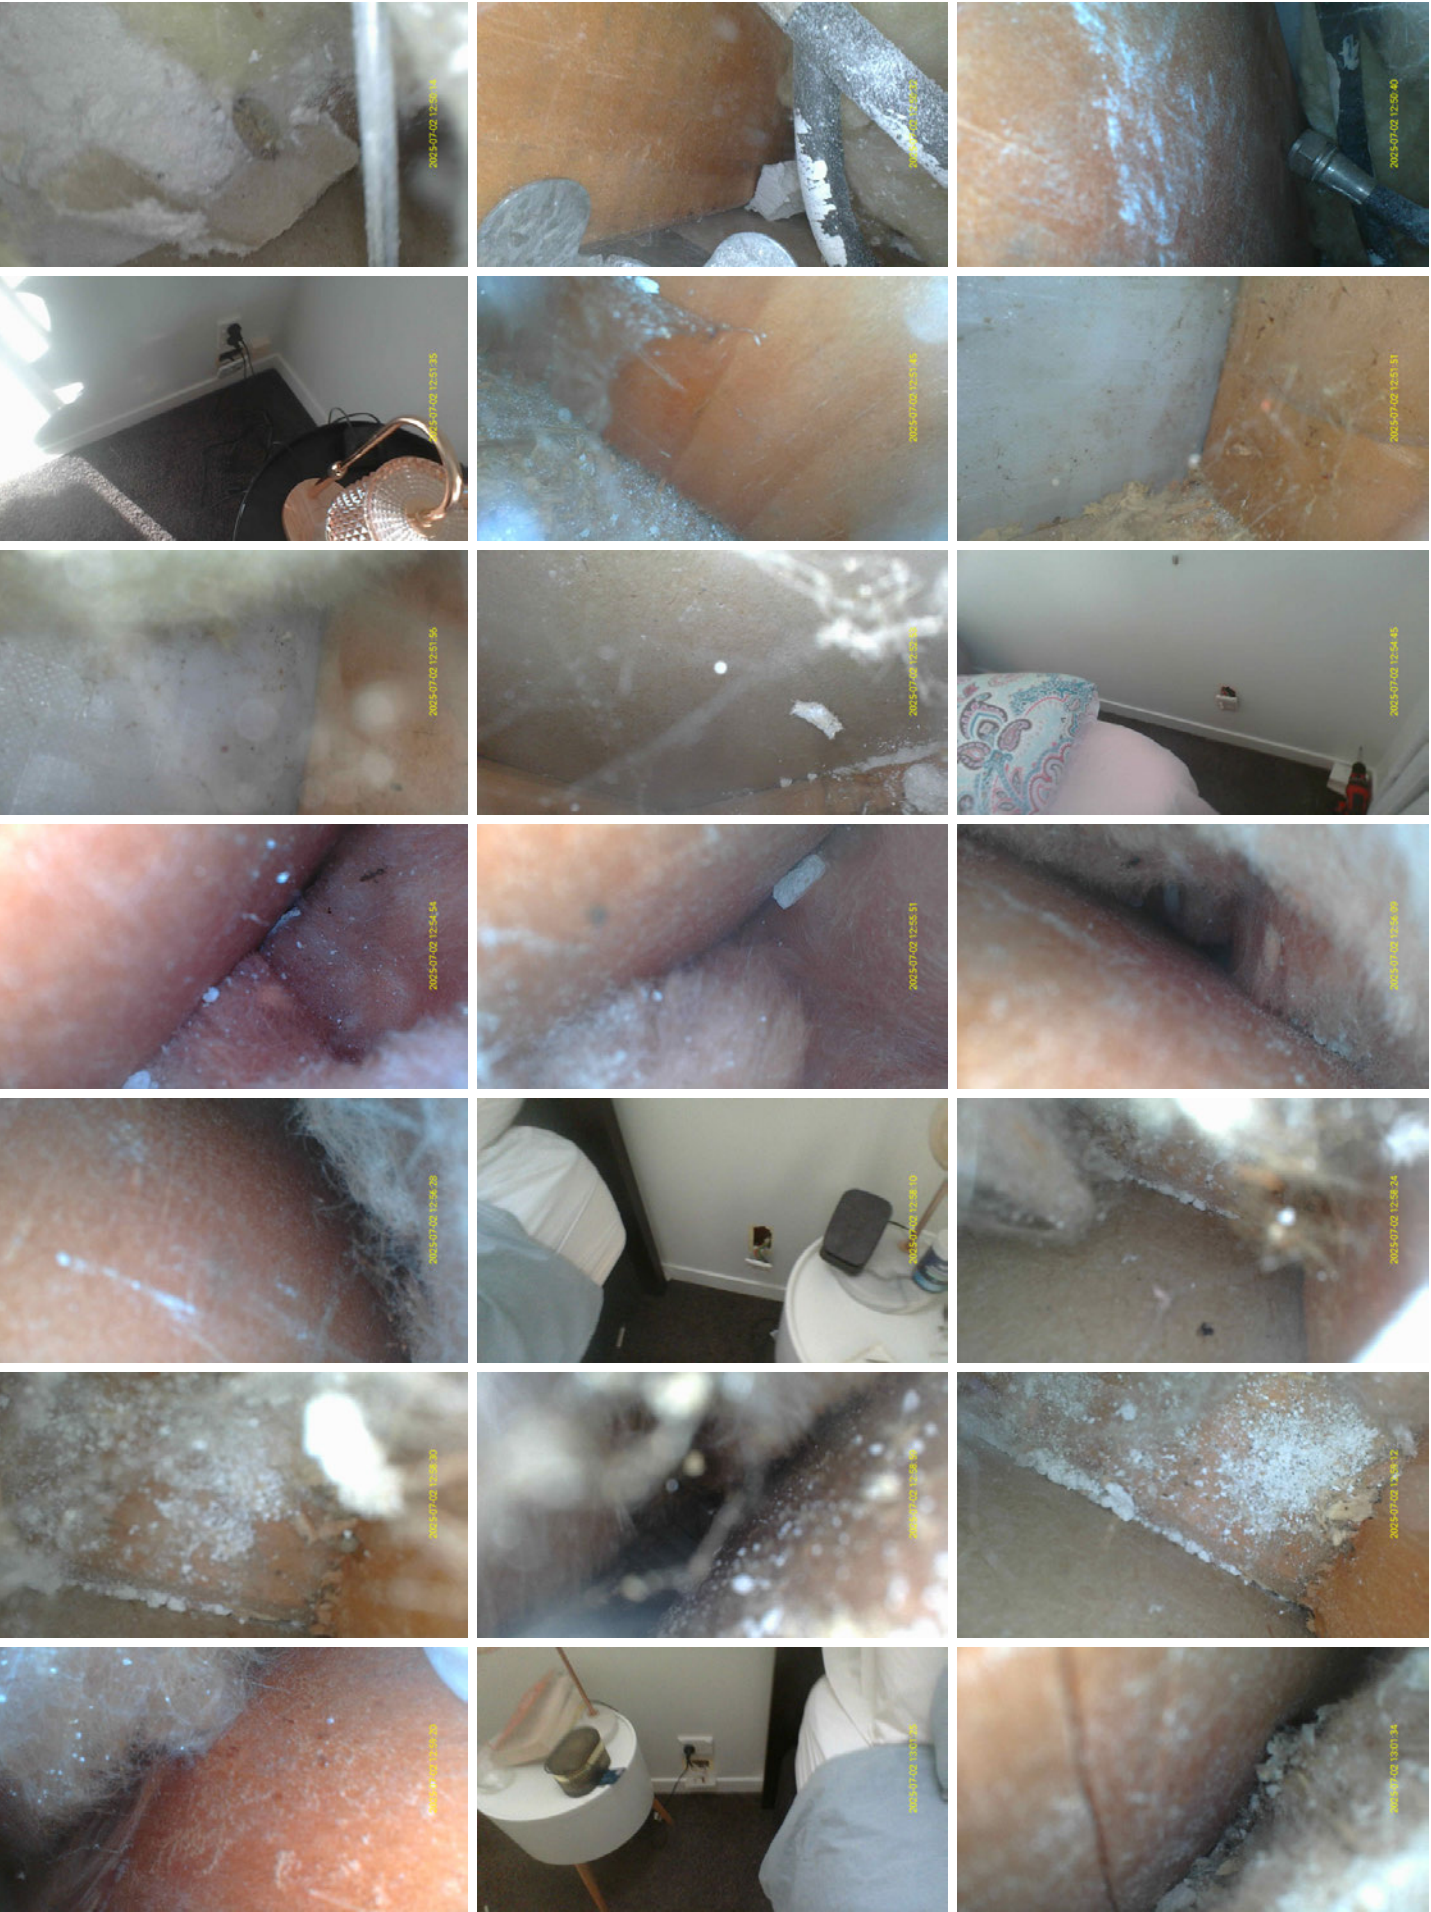
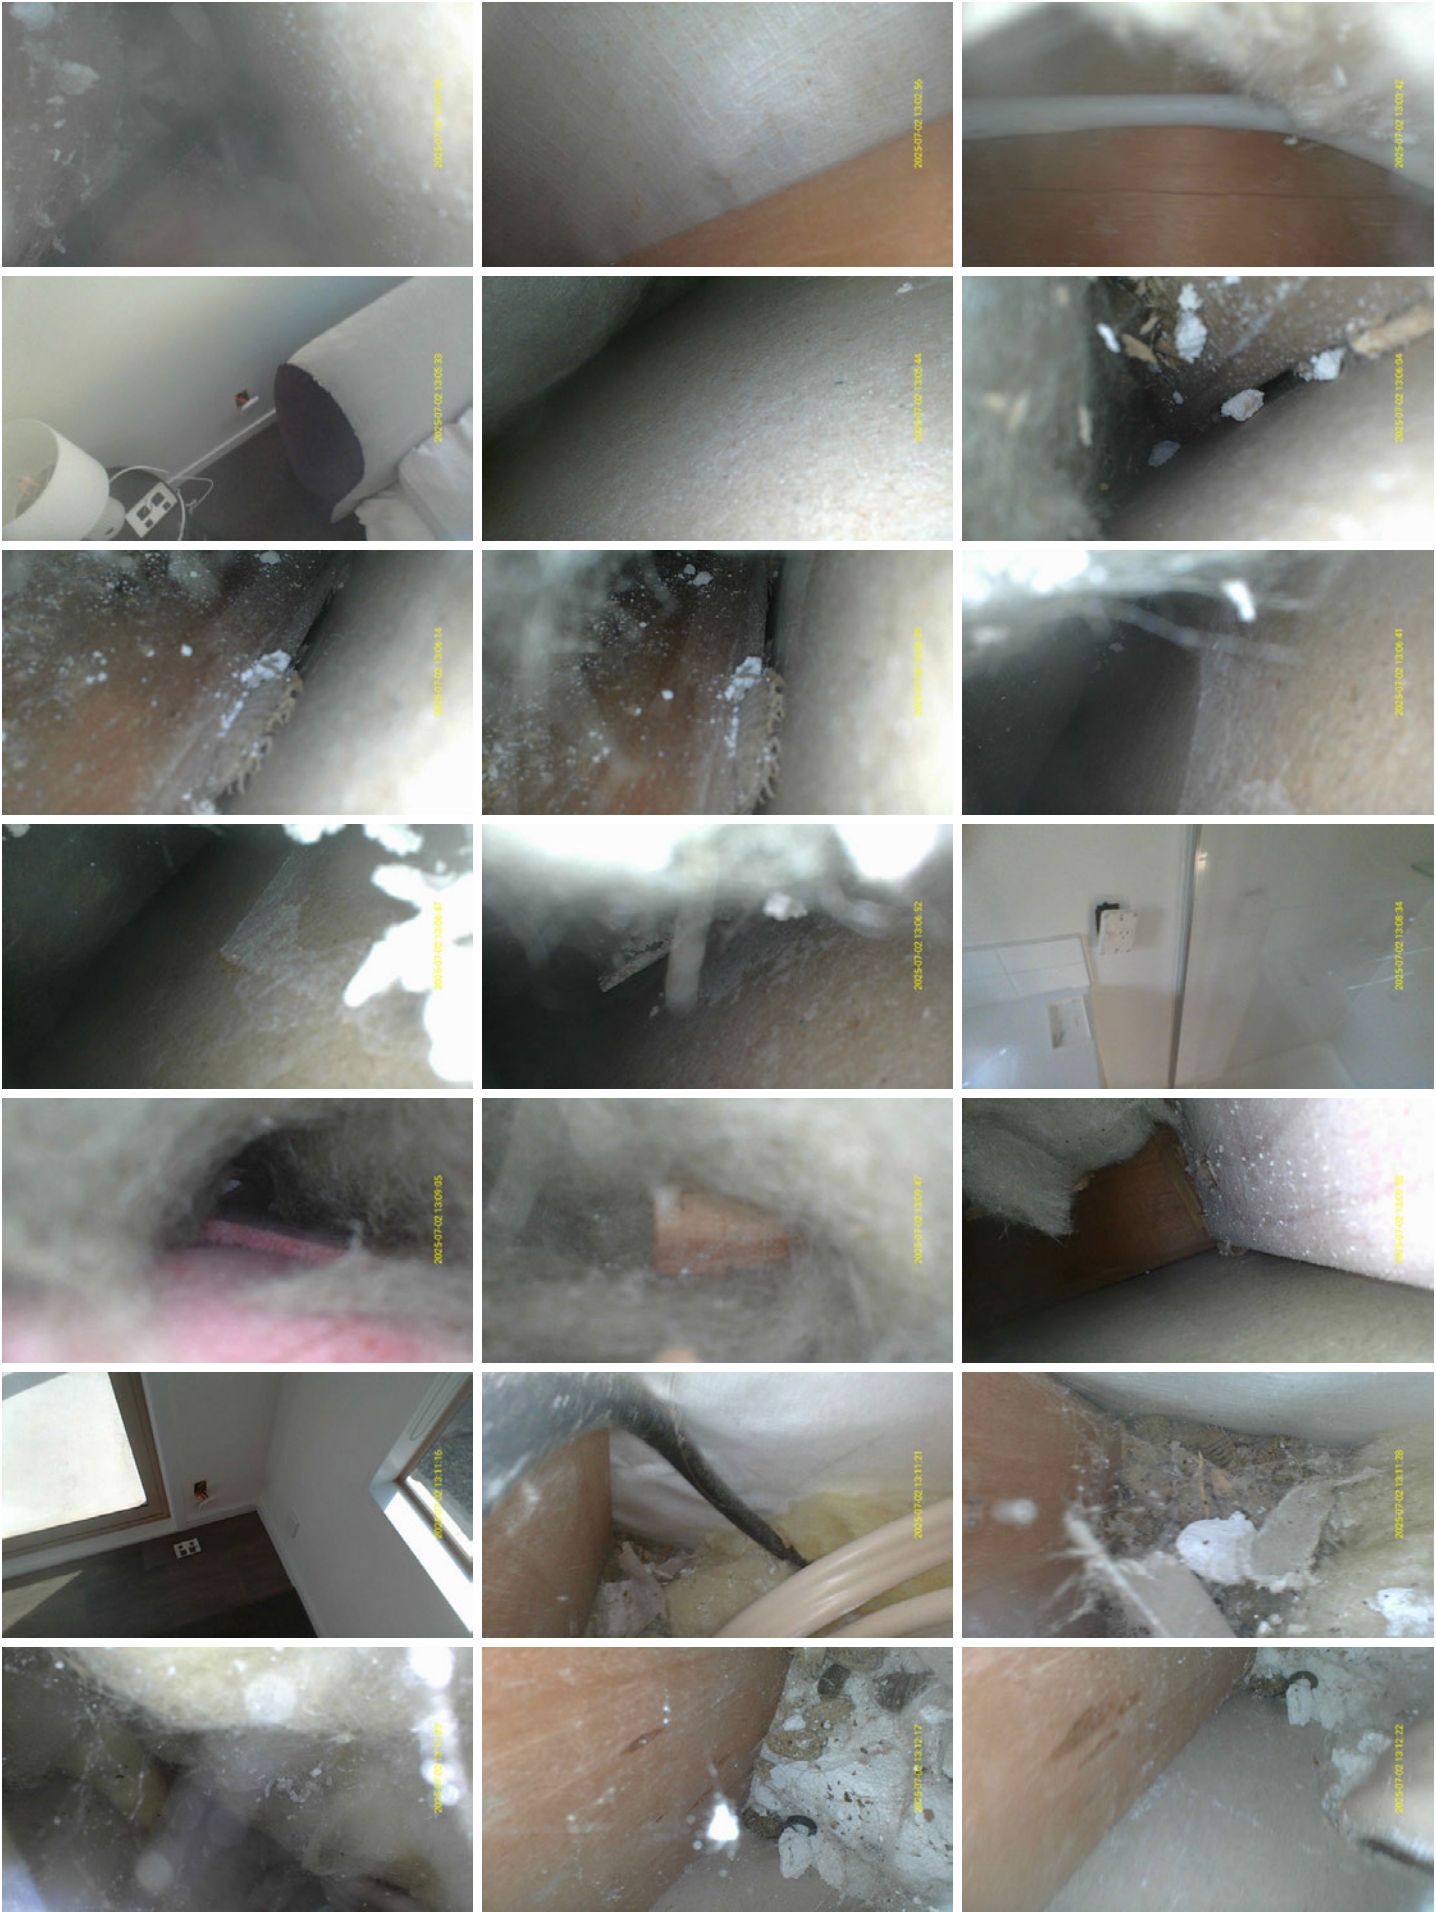
3.1.3 INTERIOR INSPECTION RESULTS AND SUMMARY
ENDOSCOPIC CAMERA DOCUMENTATION

- We use the endoscopic camera to gauge the condition of the timber framing within the wall cavities.
- The bottom plates showed only minor tea staining in one or more sections, with no indication of ever reaching full fiber saturation. The rest of the wall frames inspected showed only the expected age-related defects for a building of this age.

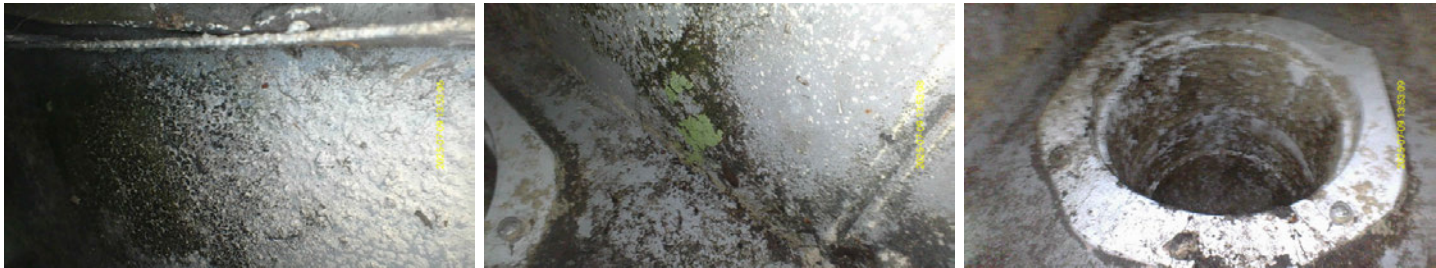
Inside gutter at rear of house

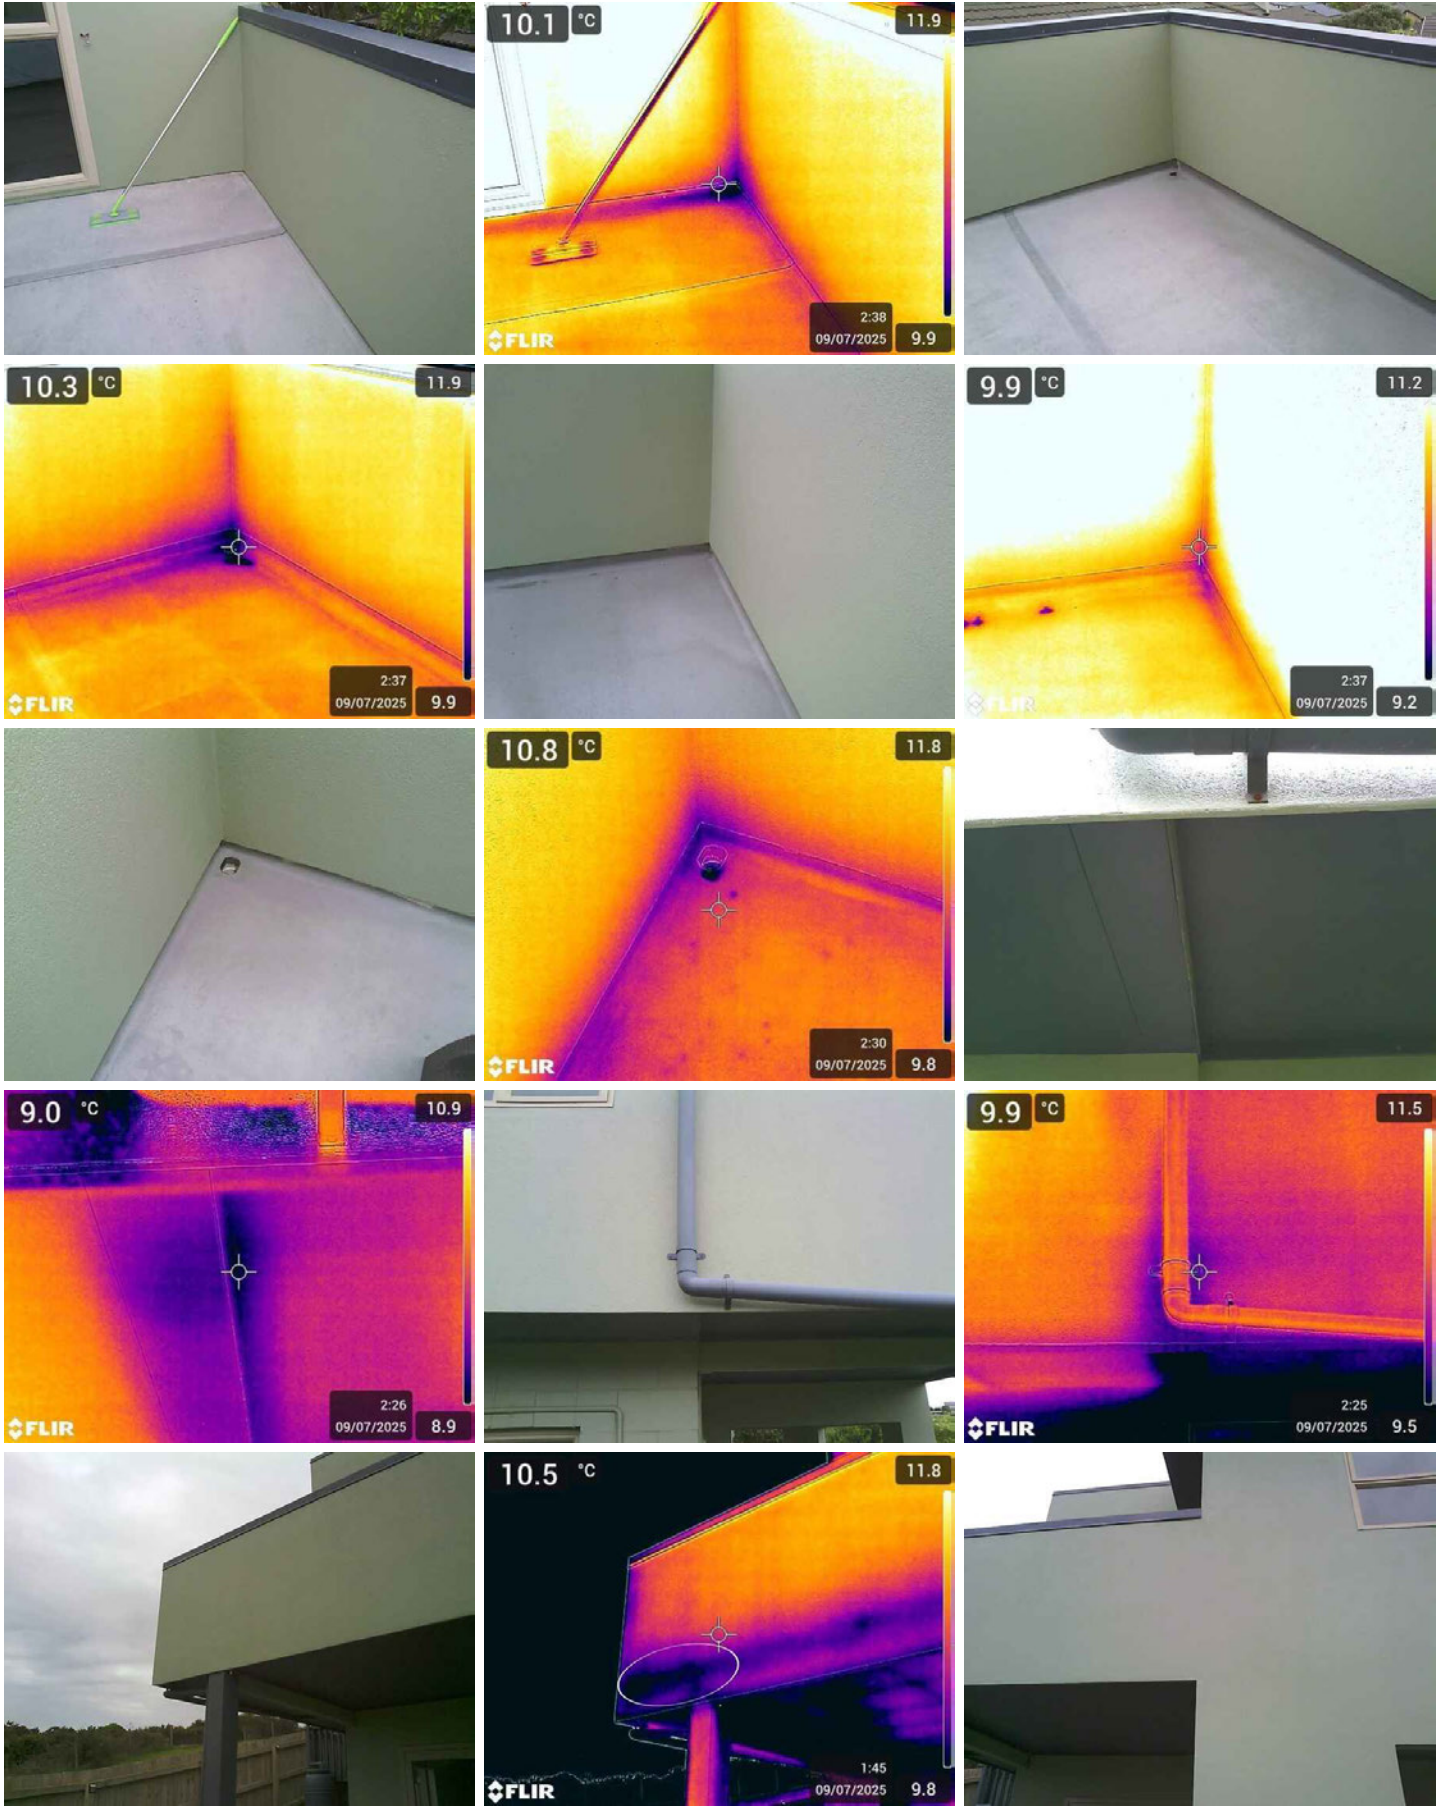
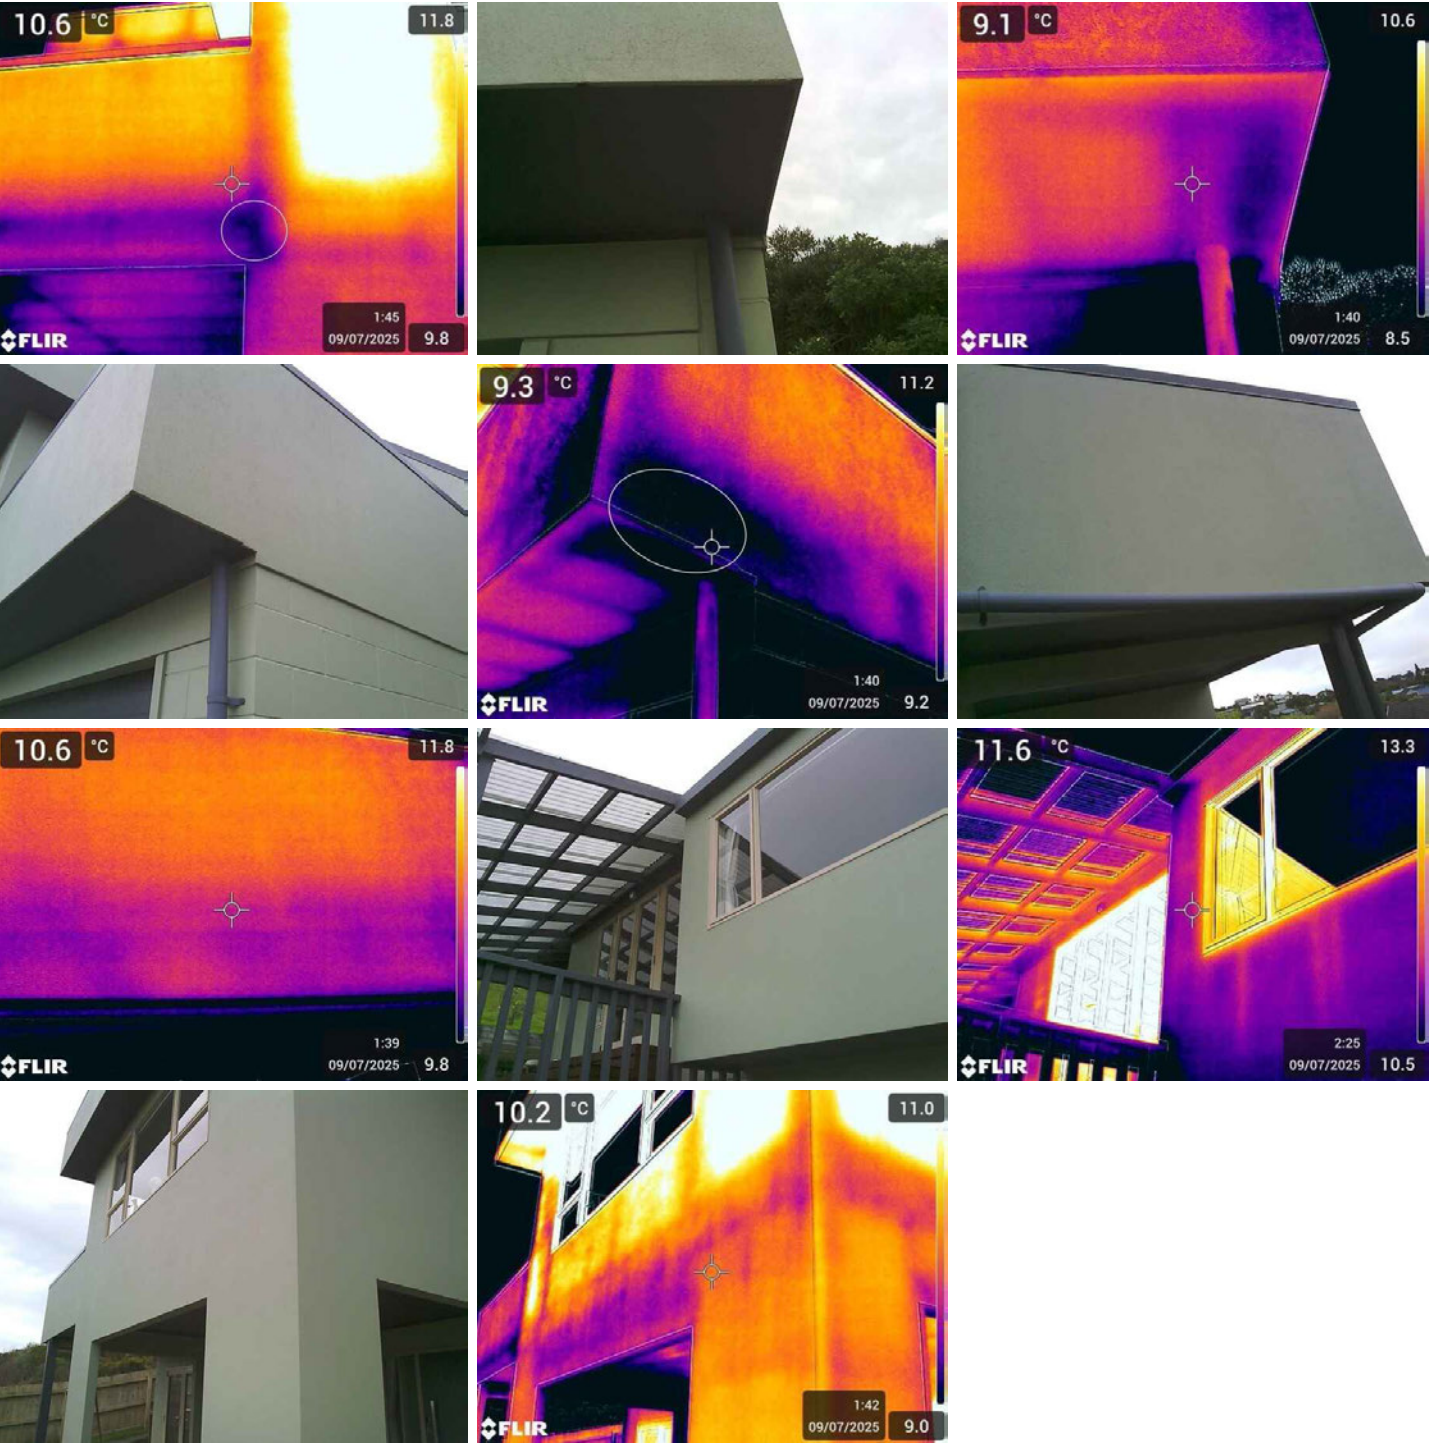
4.1.3 EXTERIOR INSPECTION RESULTS AND SUMMARY

- The areas marked with a white circle were investigated further via invasive measures.
- All areas have now been cleared for current moisture ingress.
- These areas must still be monitored moving forward.

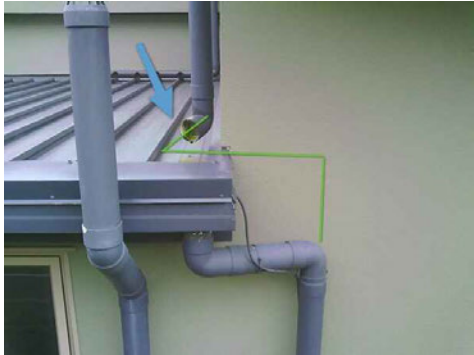
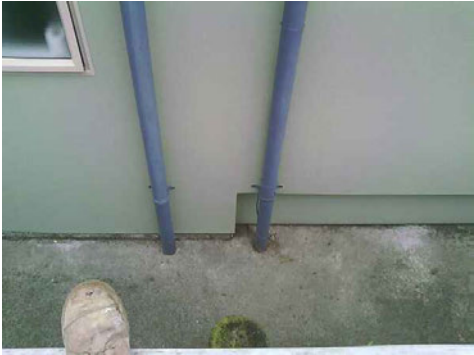
Modification to downpipe has now been made

Modification to downpipe has now been made
