## Building and Timber Pest Inspection Report

Inspection Date: Tue, 2 Sep 2025

Property Address: 40A Shields St, Redcliffe QLD 4020,  
Australia

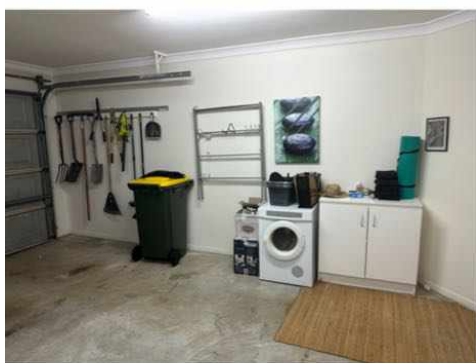
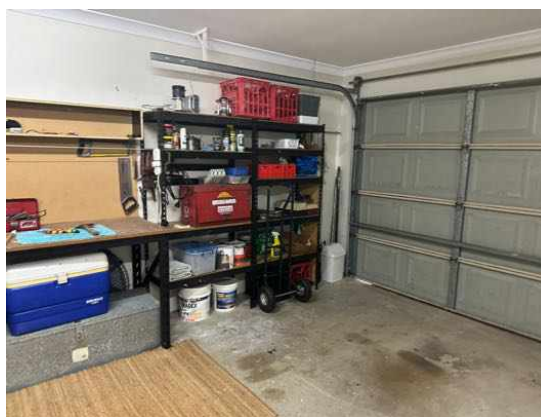
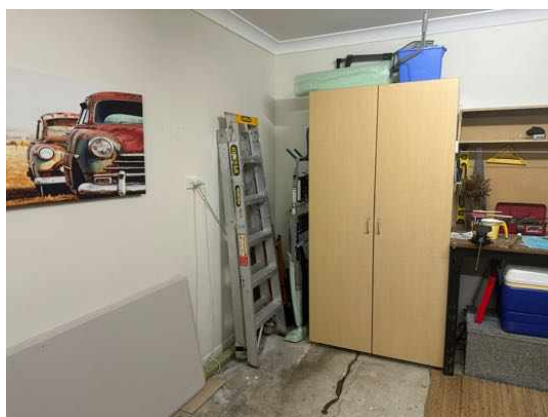
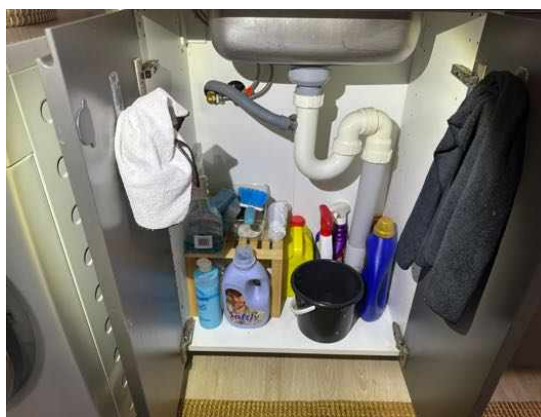
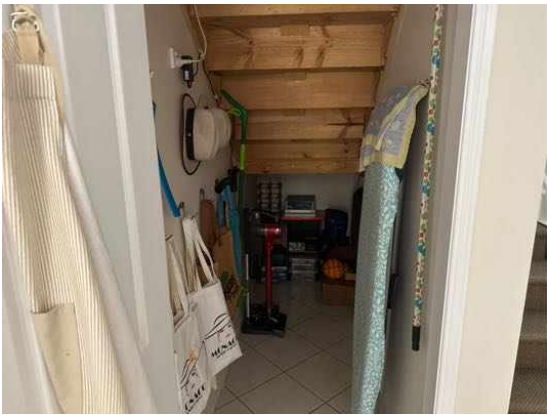
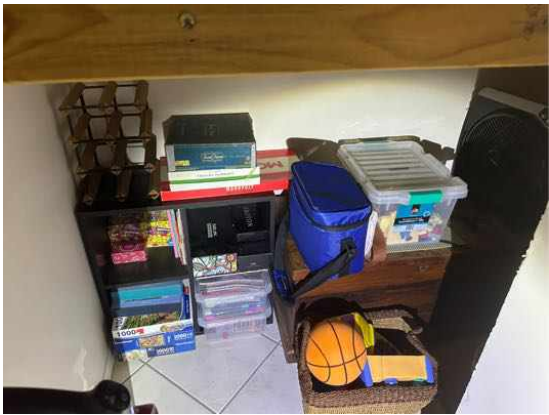
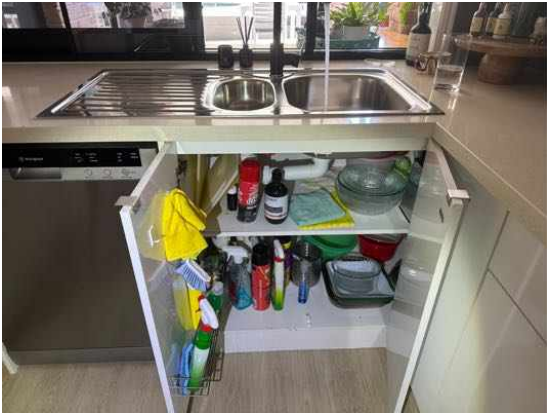
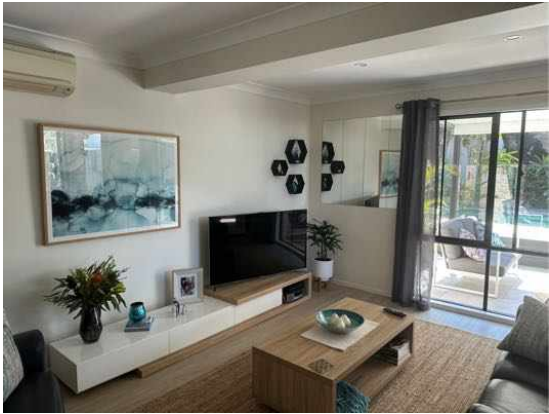
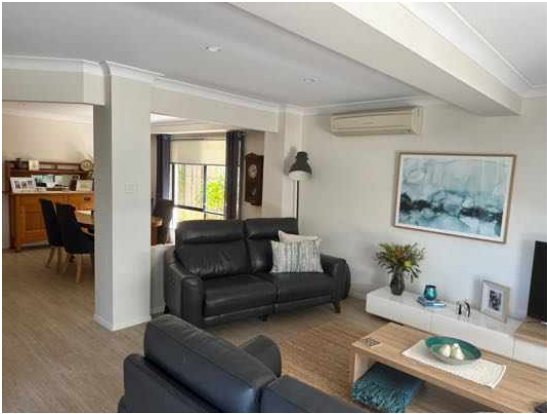
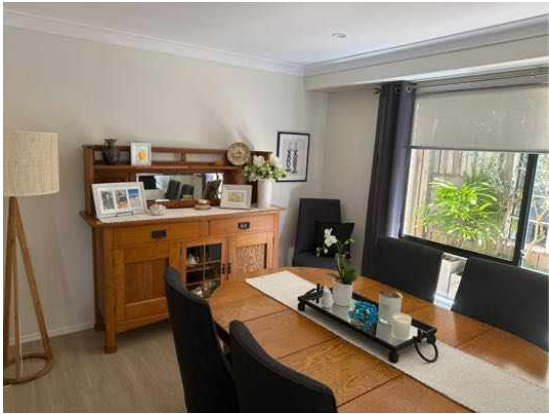
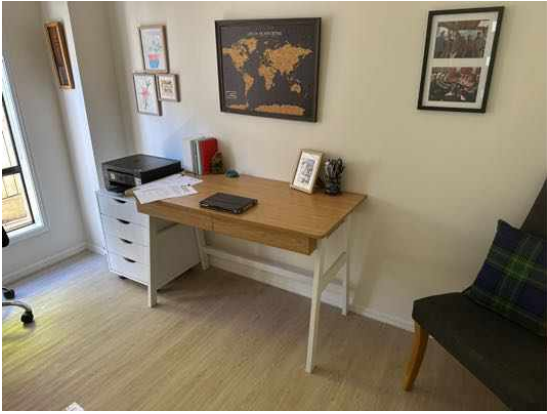
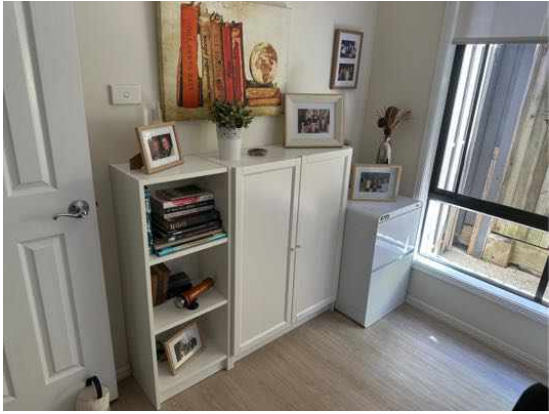
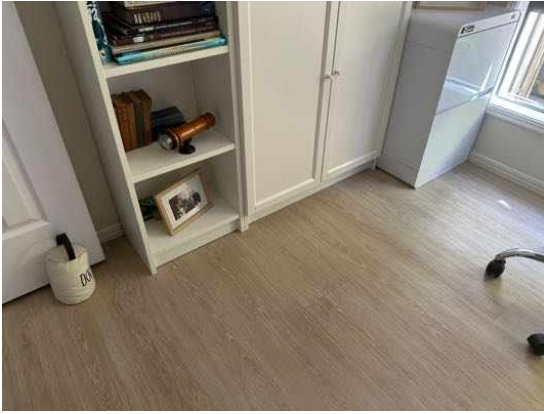
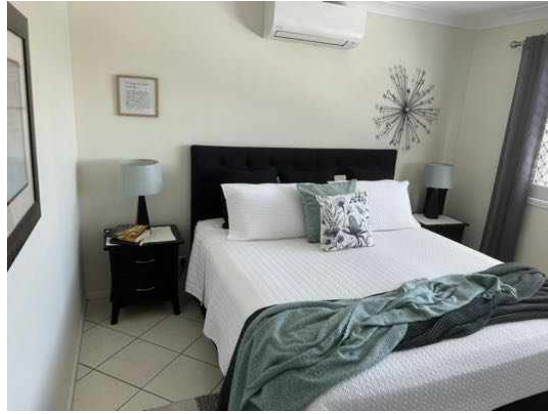
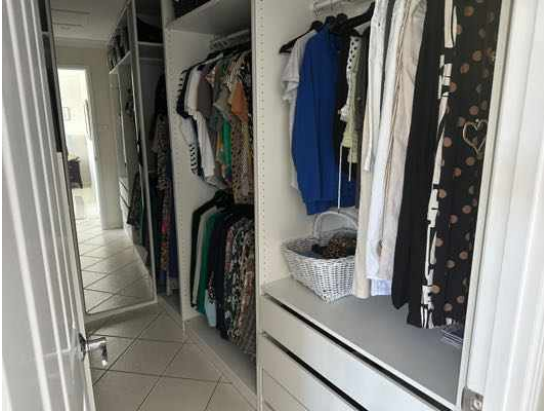
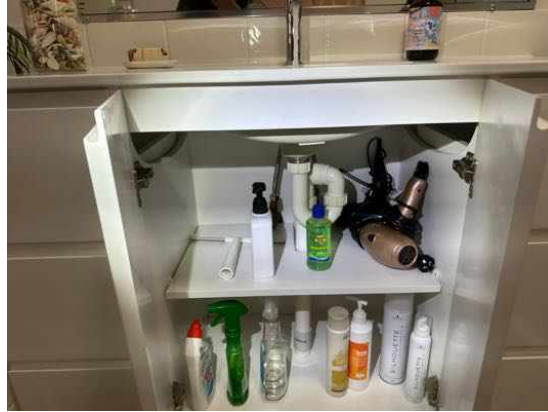
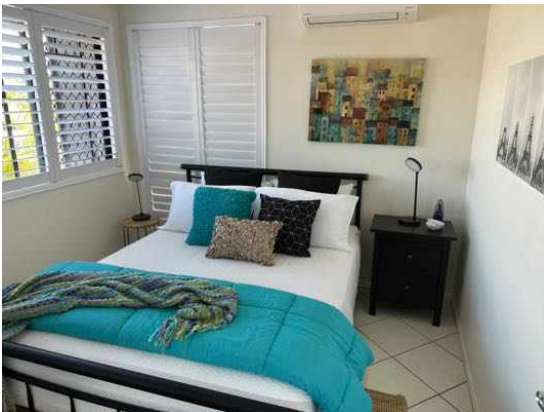
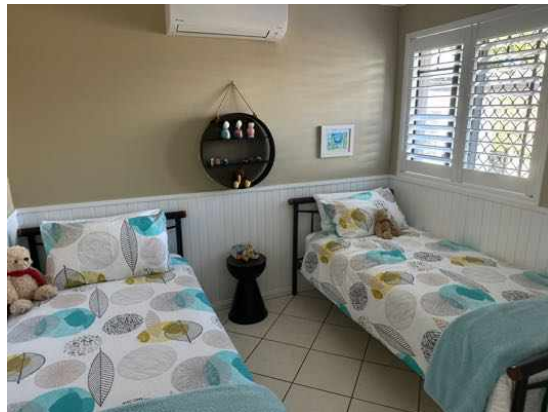
Building: Main Building  
 Location: All Internal Areas  
 Finding: Additional Photos - Obstructions and Limitations  
 Information: These photographs are an indication of the obstructions and limitations which impeded full inspection of the property at the time of inspection. These obstructions can hide an array of defects and should be removed to allow full inspection to be carried out. A re-inspection is recommended once the areas are made accessible.

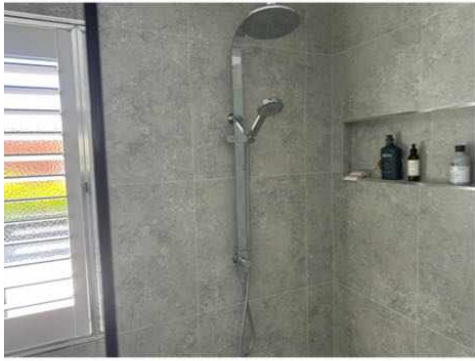
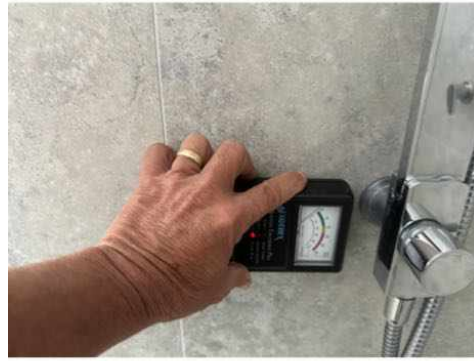
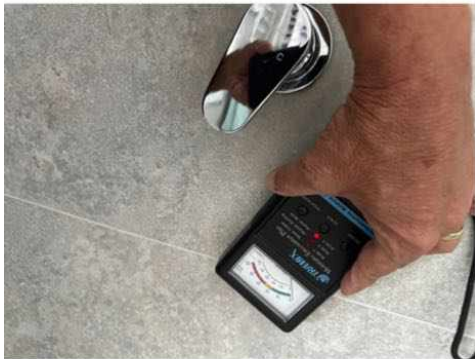
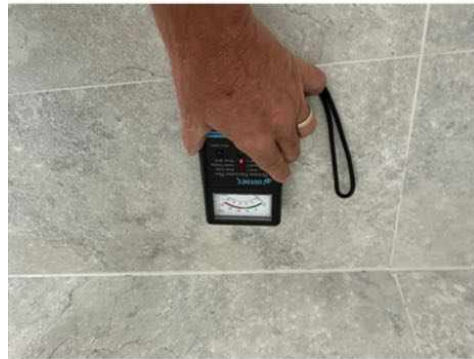
| Finding: | Additional Photos |
| Information: | Additional photos are provided for your general reference. No moisture detected. |

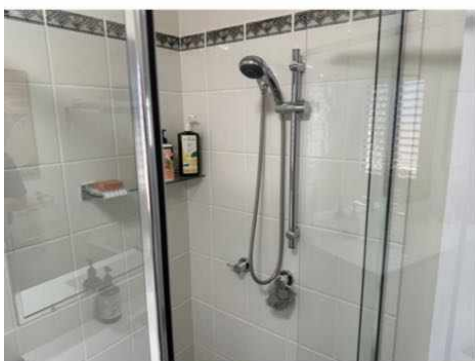
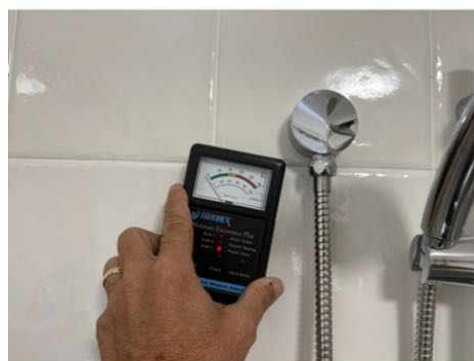
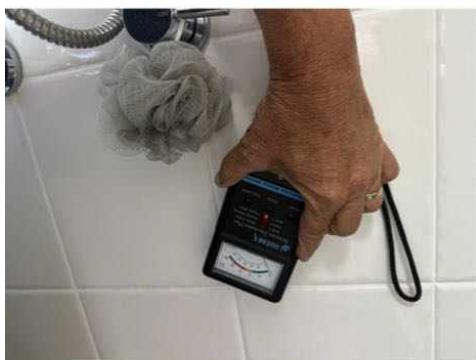
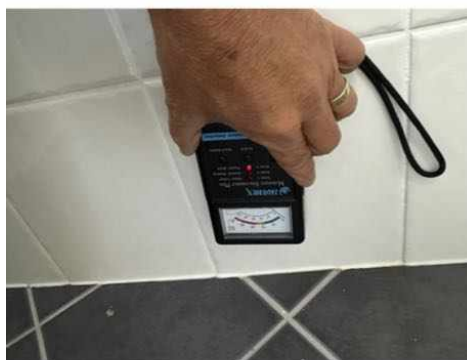
Building: Main Building  
Location: Bathroom  
Finding: Additional Photos  
Information: Additional photos are provided for your general reference. No moisture detected.
