EQC CLAIM DOCUMENTATION

EQR Property Overview Report

70 Landsdowne Terrace, Cashmere Structural Report

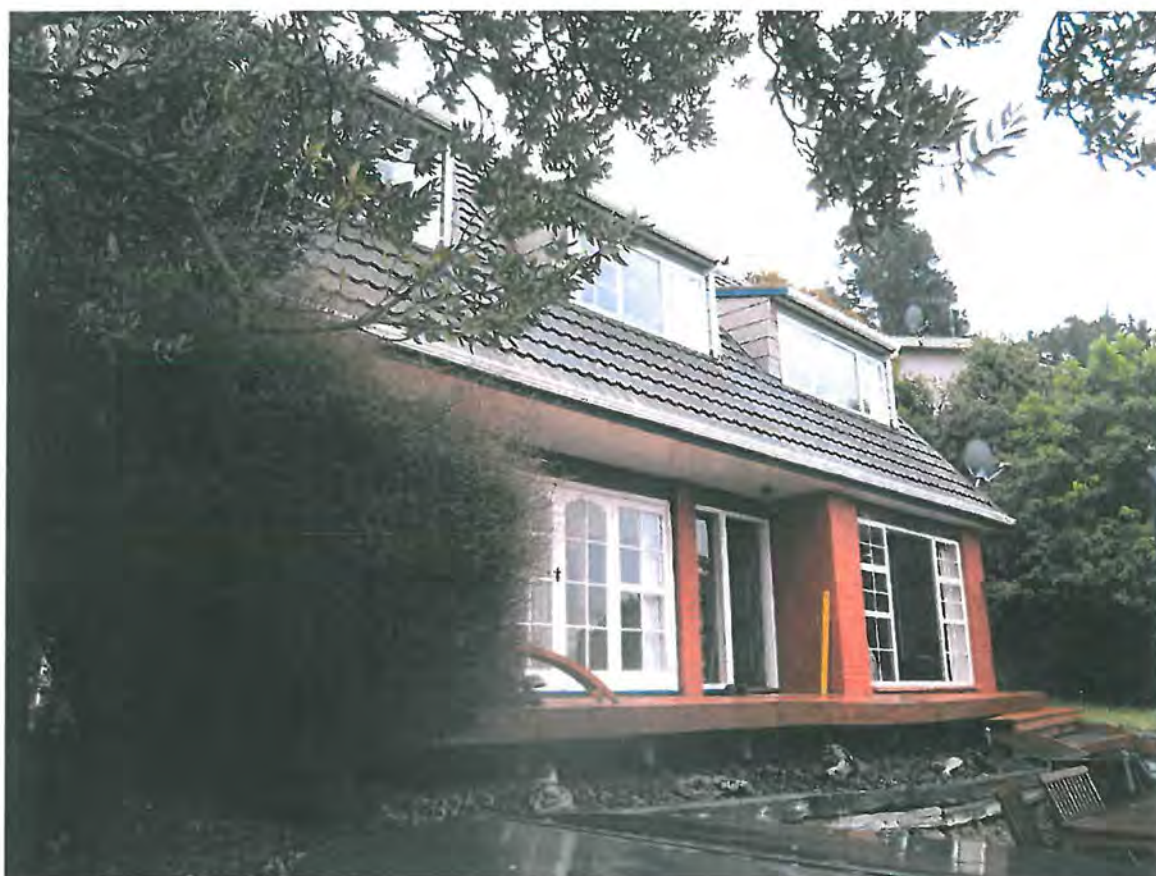
Year of Construction (approx)	1961-1980	
Number of Storeys	2	
Foundation Type(s)	Type C	
Wall Cladding	Heavy	Brick
Roof Cladding	Light	Decramastic Tile
Floor Area (approx)	150m ²
