Presale Building Report.

15 Pitoitoi Street, Otaihanga, Paraparaumu 5036

Date: 16/08/25

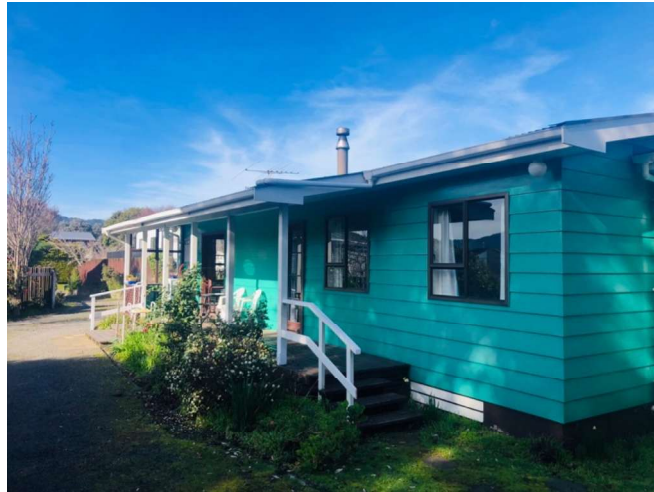
The property is a single-level, timber framed dwelling, constructed in 1985, built on concrete spread footing foundations and concrete piles, consisting of 3 bedrooms, 1 bathroom. The property is well built to the methods at the time of construction, with no visual signs of any structural issues.
