## Building Report

57 Matai Road

Paraparaumu

| <b>Type of inspection:</b> | Building Inspection |

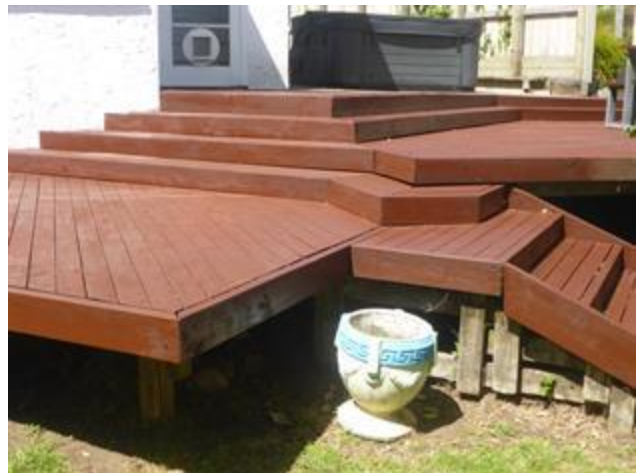
Decking

The decking was in reasonable condition with a recent stain finish applied.

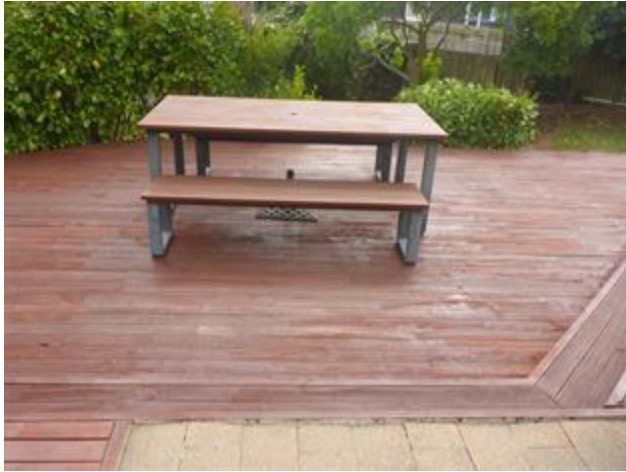
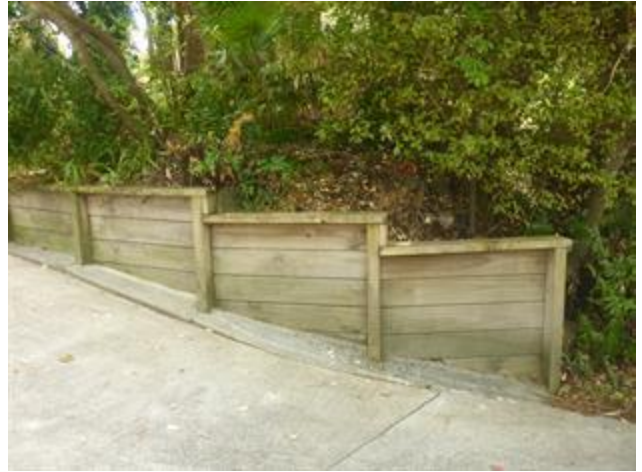
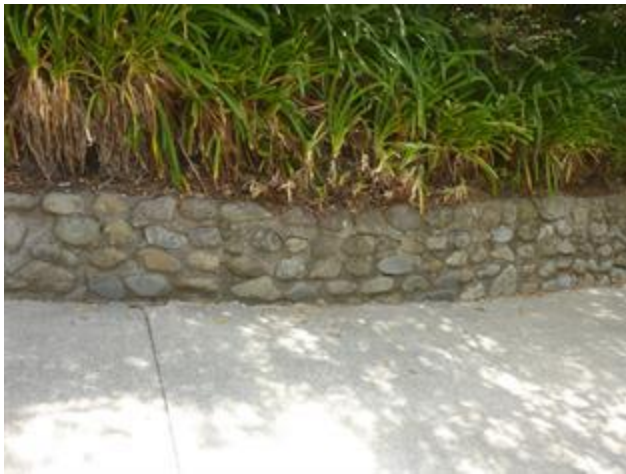
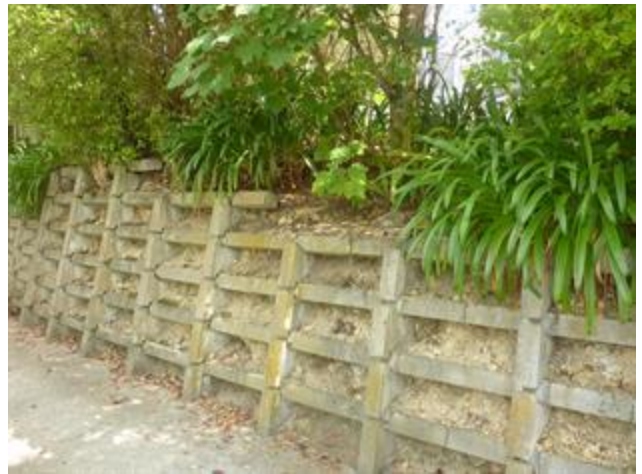
Front of the property

The property has numerous retaining walls in place, the majority appeared in good condition with no evidence of movement or subsidence except the wall to the front of the dwelling that has a small area that would benefit from repair to ensure stability.

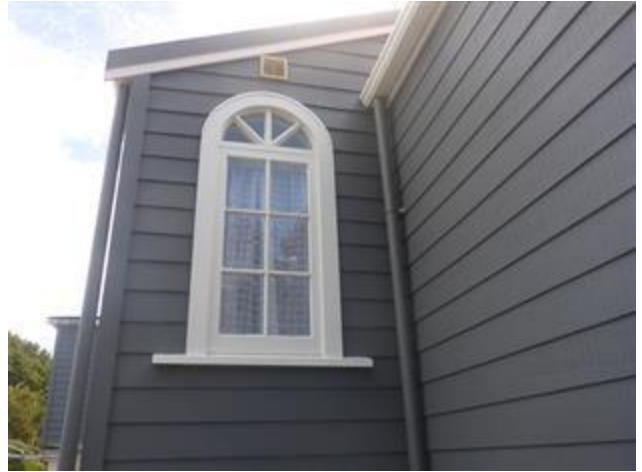
Some window hinges were showing signs of corrosion. I recommend removing the corroded hinges from the windows to be cleaned and oiled or replaced with brass or stainless-steel hinges if existing hinges cannot be cleaned and re-installed.

Hinge corrosion

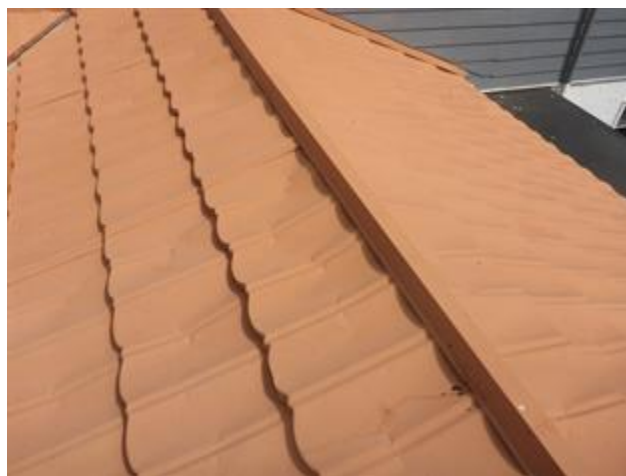
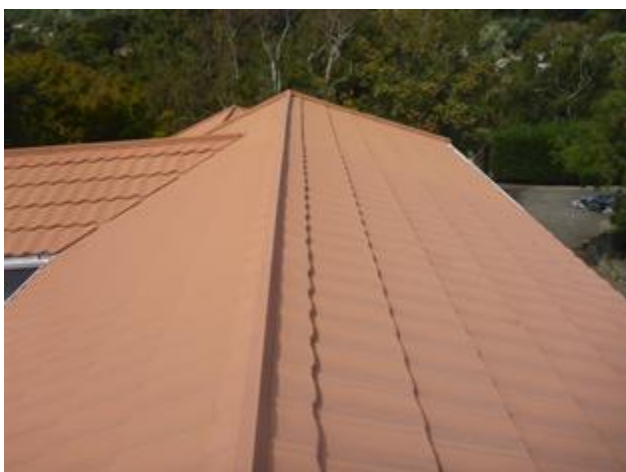
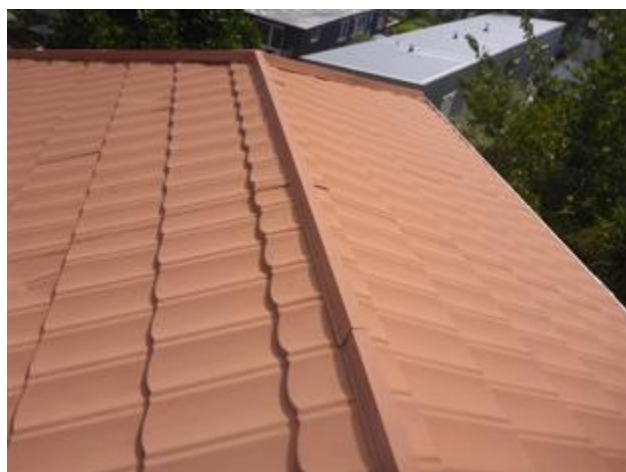
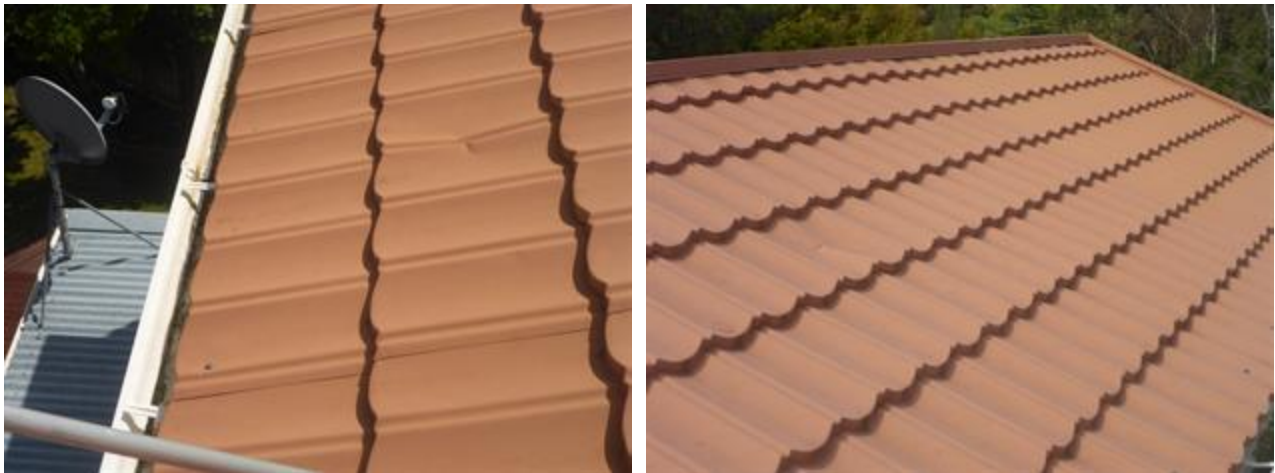
The majority of the colour tile roof cladding was in good condition however foot traffic over the roof has led to noticeable dents across small areas of its surface. These dents can compromise the integrity and performance of the roofing system. Not only can these dents reduce the roof's lifespan, but they can also be the direct cause of leaks and accelerated deterioration. The dented tiles could be replaced as part of the dwelling's maintenance planning.

Dented tiles

I recommend that the roofing material have further appraisal by a licensed roofer to give you advice on the degree of tile repair and potential costs.

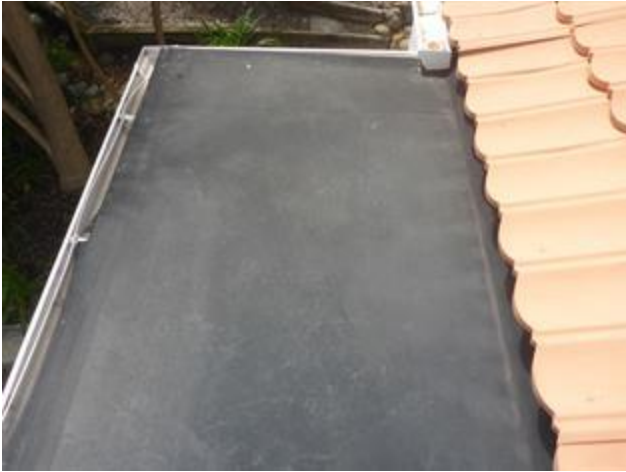
The roofs although around the twenty-year mark appeared well sealed with no signs of pitting or deterioration and the substrates appeared solid when walked on.

Butynol membranes

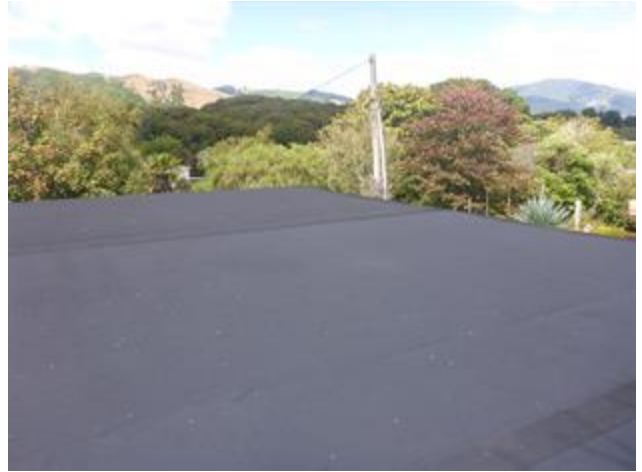
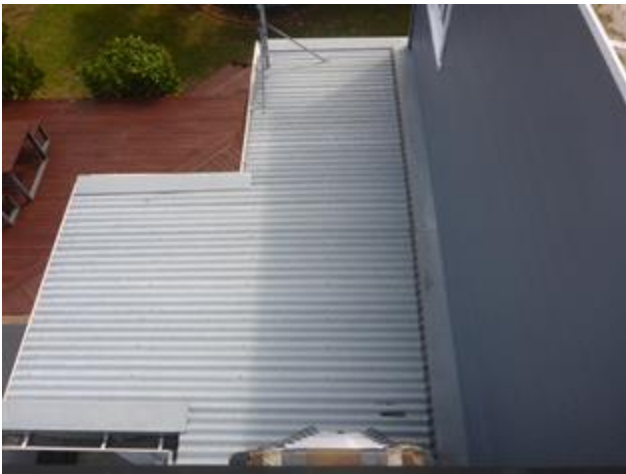
Galvanised

Painting this roof is recommended as part of the maintenance planning. Maintaining a good level of paint finish will ensure the maximum life of the materials can be achieved. Painting is also beneficial in forming a seal around the screw fixings and joins.

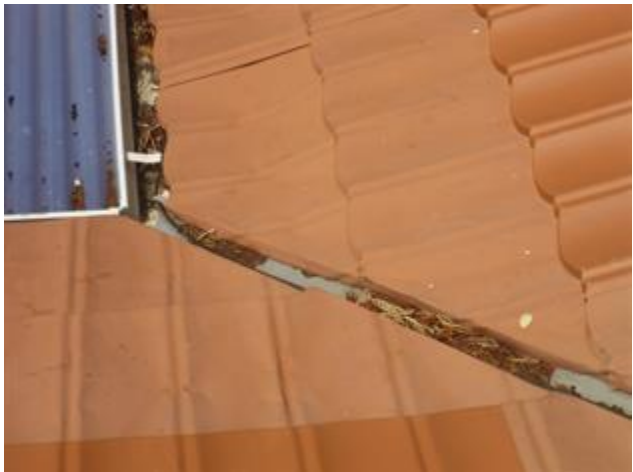
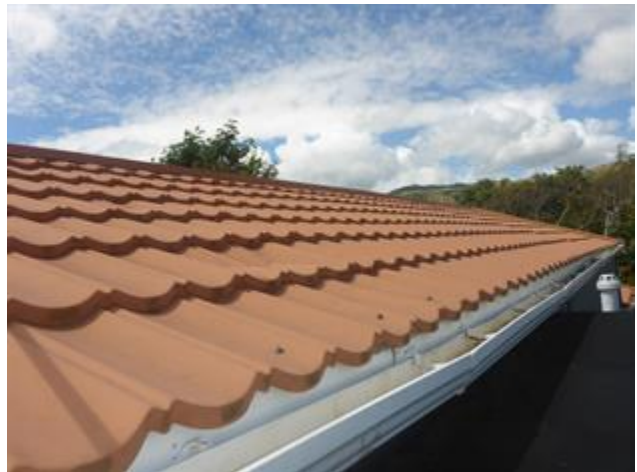
The spouting appeared in good condition with the correct fall to the downpipes.

There were small amounts of debris in areas of the spouting and this needs to be removed to prevent moisture build up, which can lead to moisture ingress to the interior.

To clean out your spouting, disconnect the downpipe and hose out the debris. If disconnecting the downpipe is impractical, you can block it off with a tennis ball wrapped in an old sock before hosing. Afterwards, remove the ball, hose again and check the downpipe for any blockages or leaks.

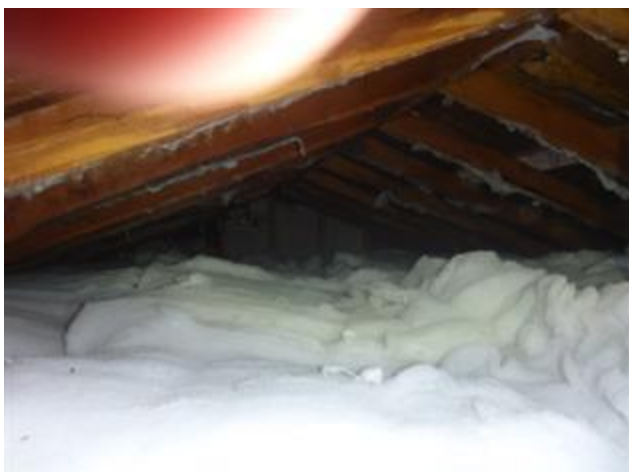
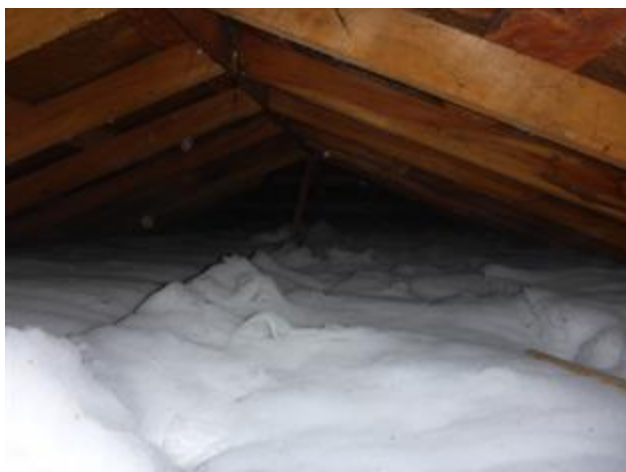
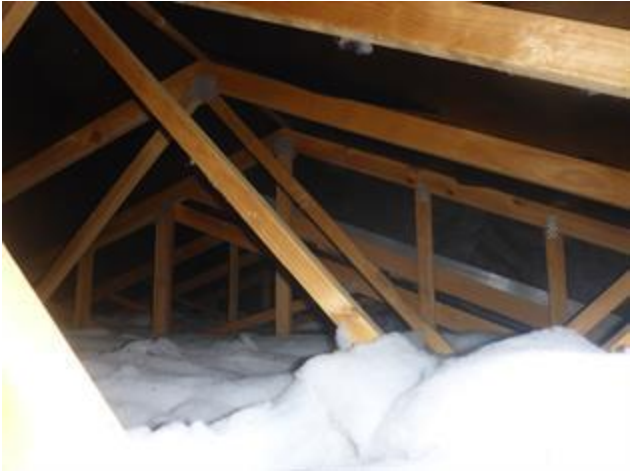
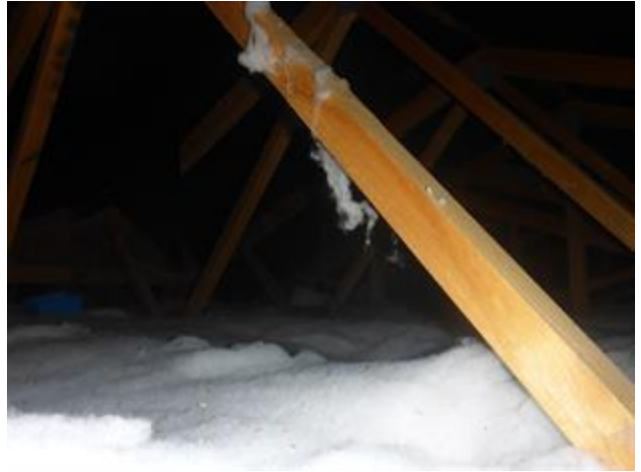
Dropped insulation

It is also recommended that insulation is fitted snugly between framing without gaps, tucks or folds but not compressed or packed tightly around electrical wiring.

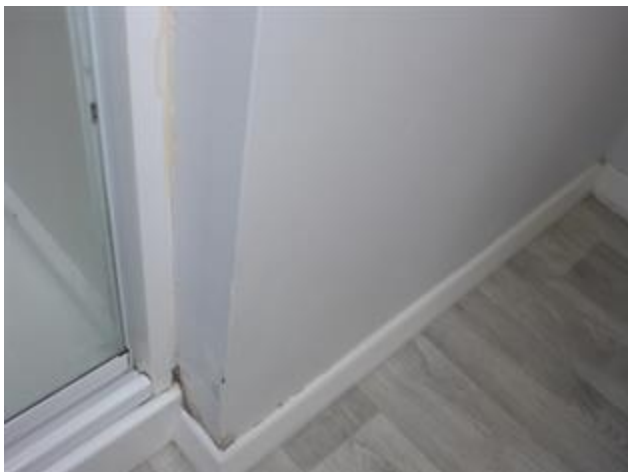
All moisture readings were within acceptable parameters except to the right side of the end bathroom shower enclosure.

High moisture levels

I suggest first removing the skirting to assess the wall lining to ensure there are no further indications of moisture issues. If further indications are present a small piece of wall lining could then be removed to determine the extent of the moisture damage.

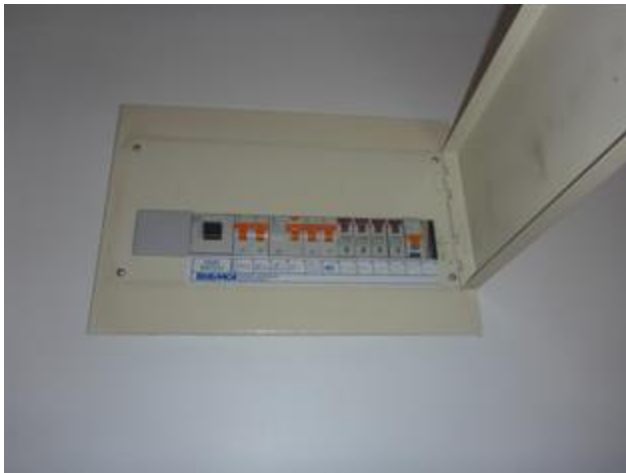
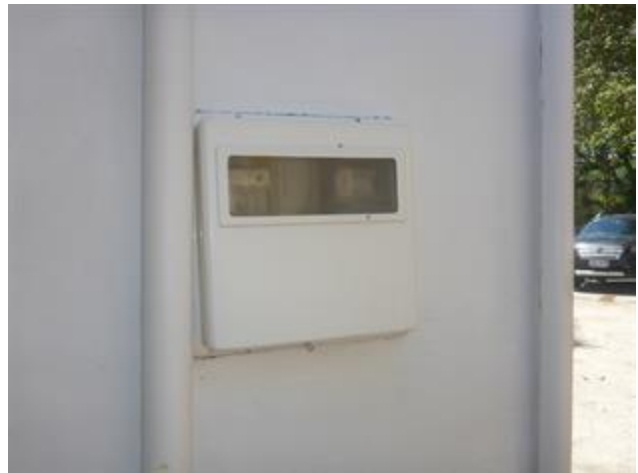
The electrical system consists of an internal circuit board located in the hall with an external meter.

All the fuses were modern circuit breakers.

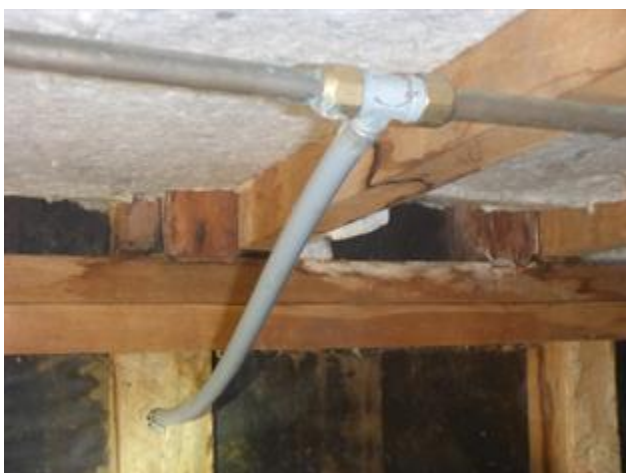
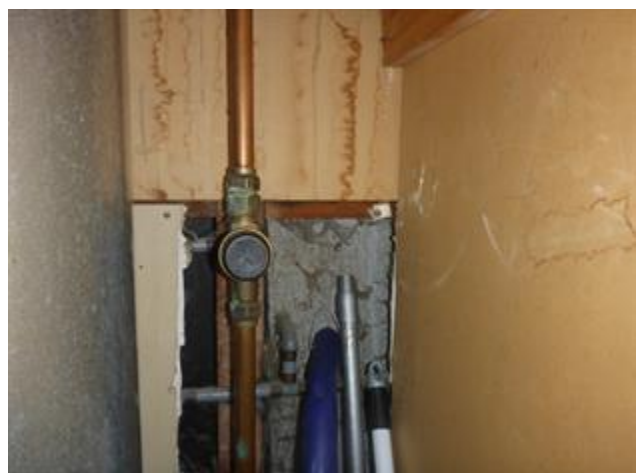
The water piping sighted was a mixture of products, most of the piping was Polybutylene (grey plastic) which is an industry standard product. Some copper water piping was also present and supplying the hot water cylinder.

Where the plumbing was visible, there were no indications of any issues to report.

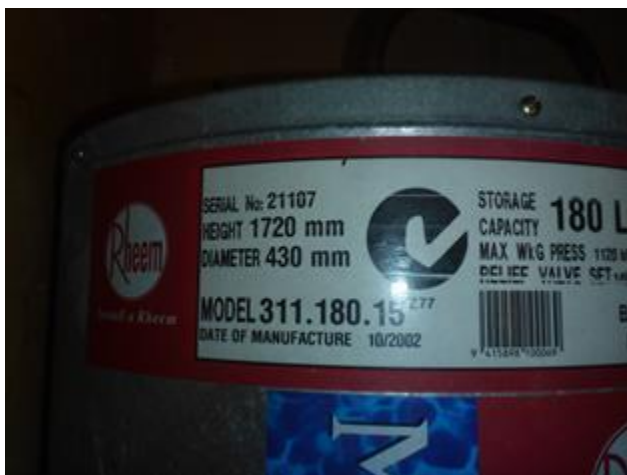
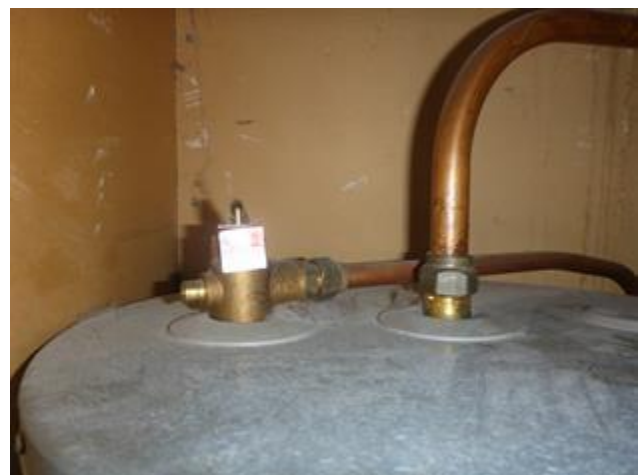
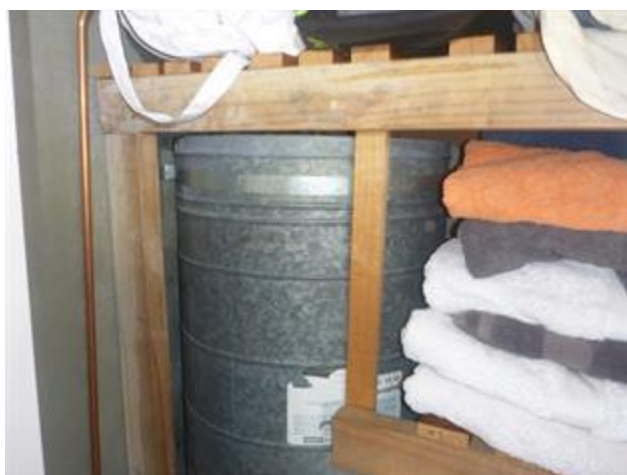
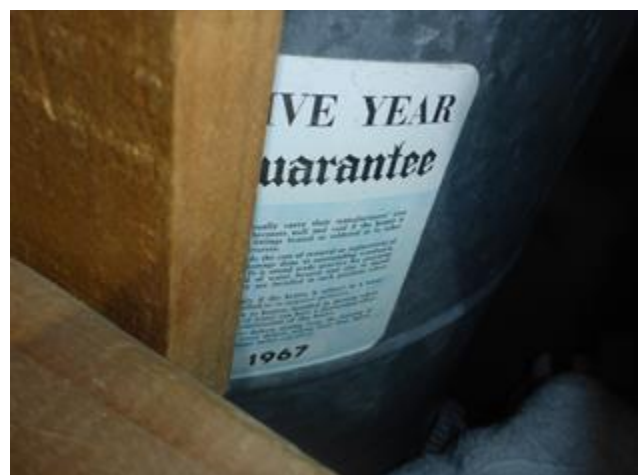
The hot water supply to the dwelling is via a 180 litre Rheem mains pressure electric cylinder manufactured 10/2002. The cylinder is located in a laundry cupboard.

The hot water supply to the upstairs bathrooms is via a 180 litre low pressure hot water cylinder manufactured 1967.

Located on the top of the cylinder is a valve to relieve pressure in the hot water cylinder. It is recommended that the relief valve be checked for adequate performance or replaced at intervals not exceeding 5 years, or more frequently in areas where there is a high incidence of water deposits and that the valve easing gear be operated at least every six months.

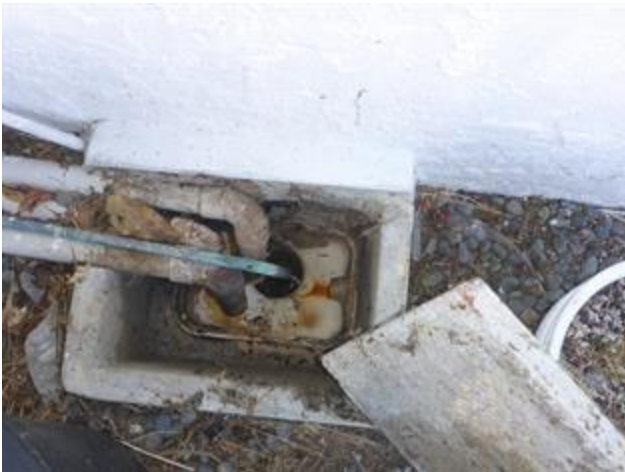
The visible gully trap appeared clear and clean at the time of inspection.
