Inspection Report

Ausispec

20 Harward Street, The Gap, Queensland, 4061

Report/Agreement # 240725054013322
Inspection Date: 24 July 2025
Inspection Time: 03:00 pm

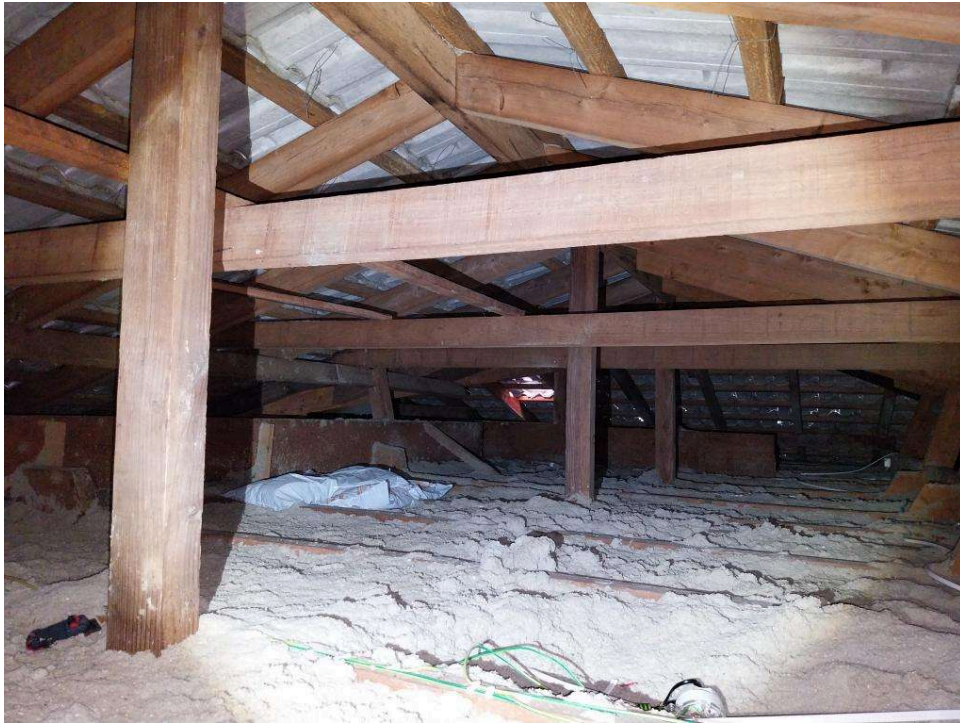
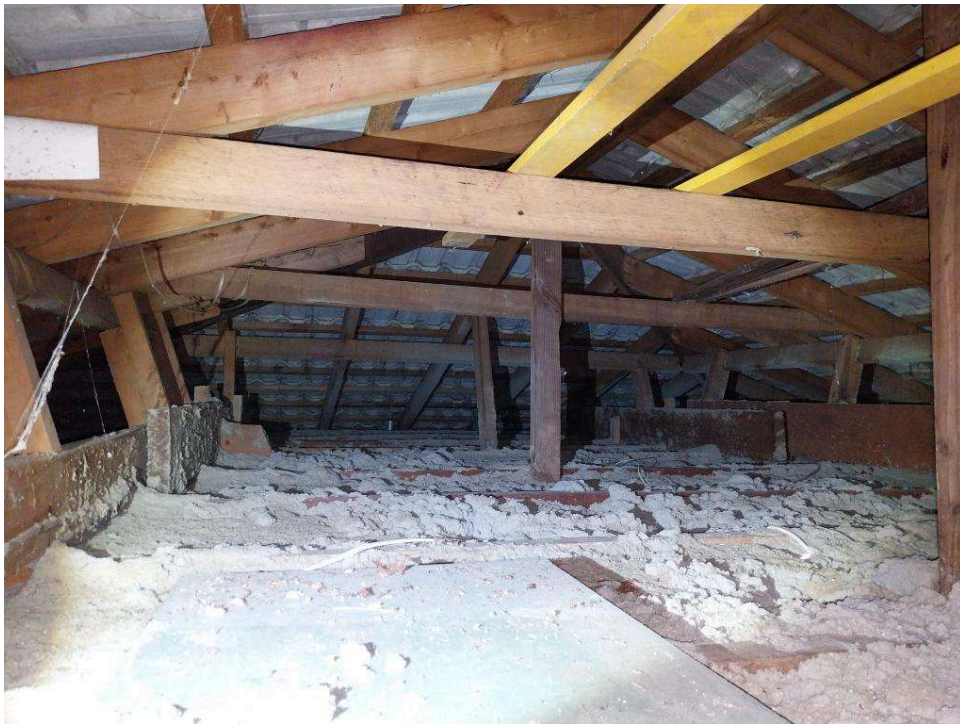
The roof-framing members were inspected for indications of structural failure due to sub-standard construction methods, mechanical damage, or adverse deterioration. Non-compliant construction methods may also be reported if the inspector believes in his opinion that such defective construction exists. Please refer to section 2B of the Terms And Conditions section of this report.

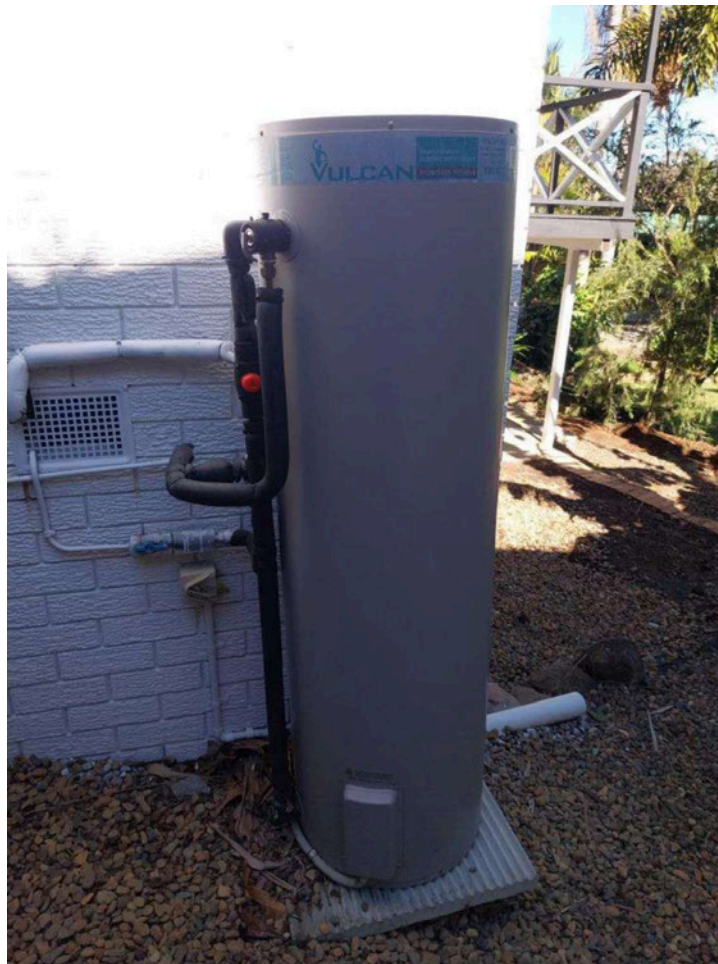
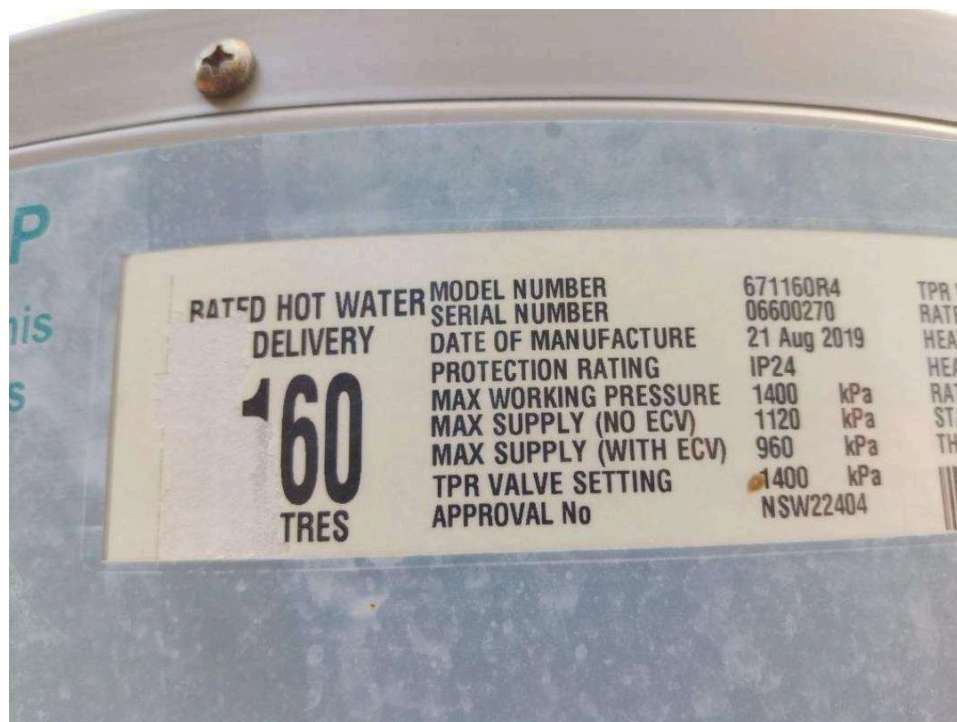
Electric heat transfer system

ACCEPTABLE

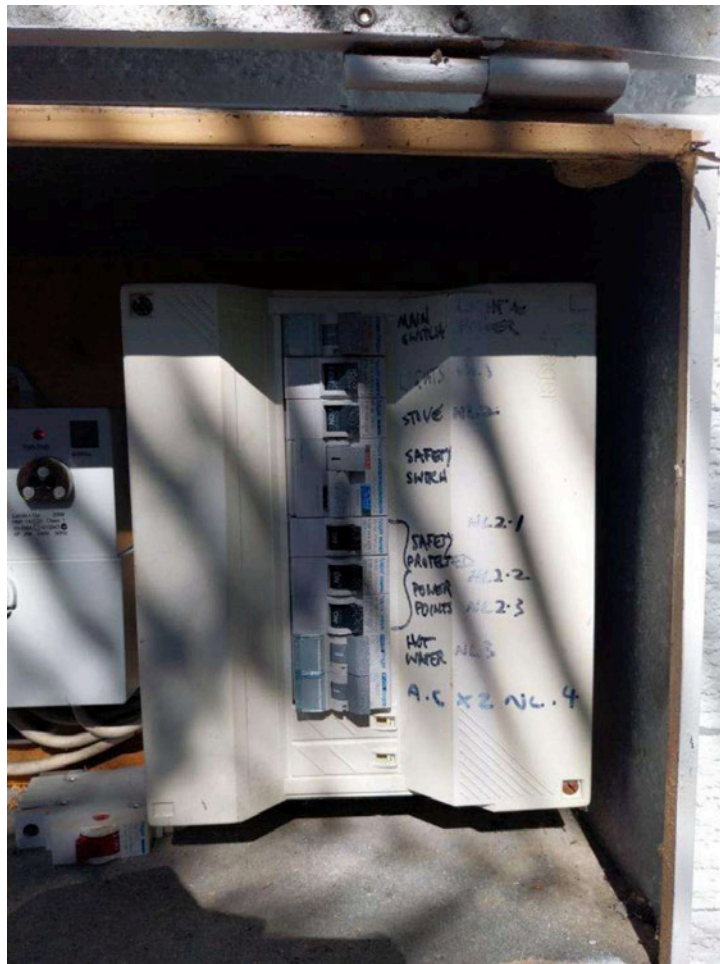
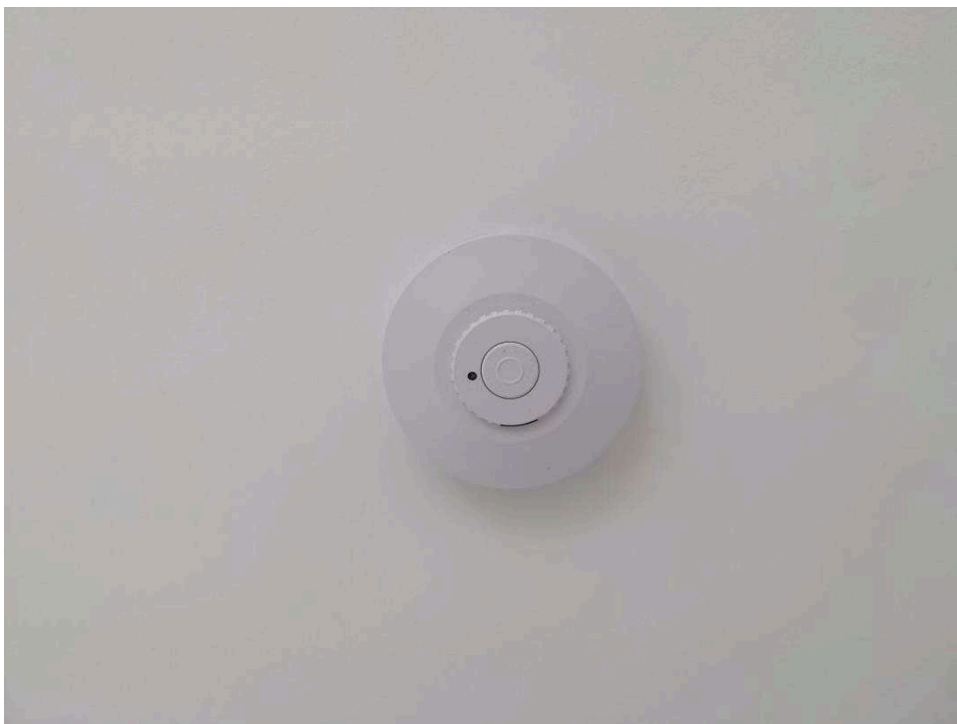
ACCEPTABLE

In regards to the status of any existing smoke detection system, it is strongly recommended that an independent specialist be engaged to assess and advise if the current system is adequate or requires upgrading. This report strongly recommends that any existing system be upgraded to the current compliant regulations in place at the time of inspection.
