## BUILDING INSPECTION REPORT

## 41 Parnwell Street, Burwood

17/09/2025

Property Inspected by Adam Brownie 027 914 9087  
Adam@inspectedresidential.co.nz Qualified builder and  
Licensed Building Practitioner  
National Certificate in Carpentry  
This inspection was carried out in accordance with  
NZS4306:2005

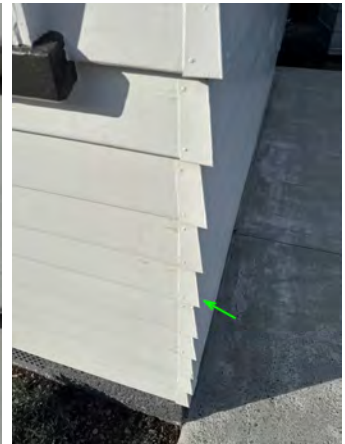
Metal corner soakers have been fitted to some corners. These help protect the weatherboard ends from moisture damage.

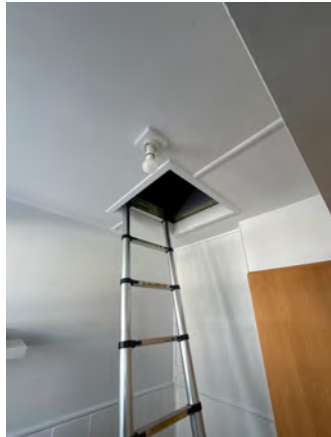
Remove debris brought in by pests and consider pest proofing where possible.

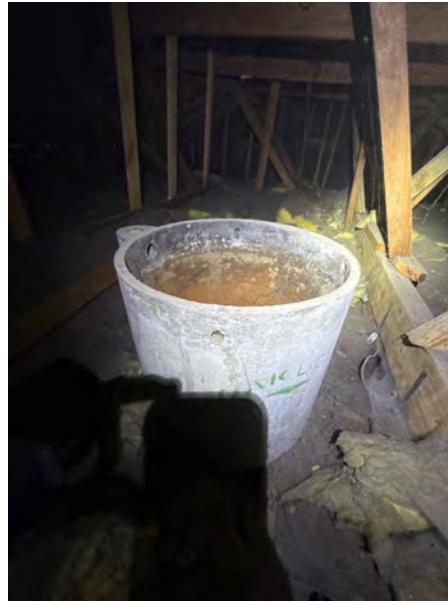
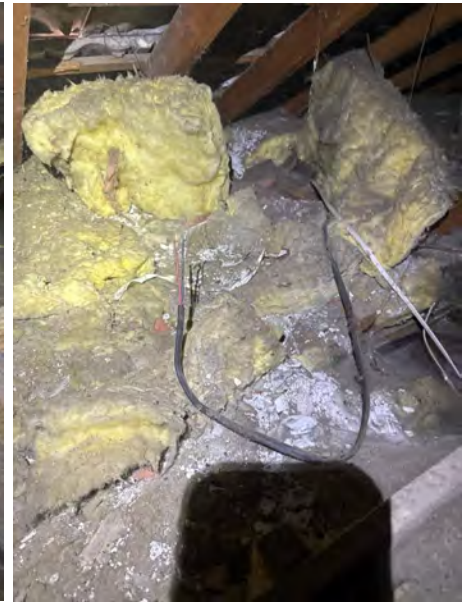
Old exposed wiring. Have an electrician check if this is obsolete.

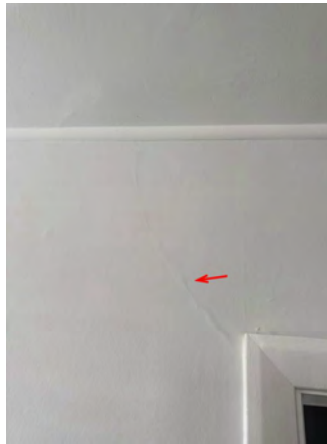
Crack under wallpaper.

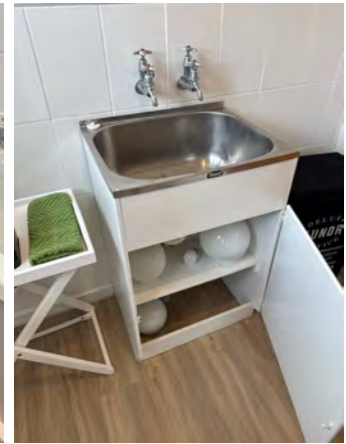
Tub cabinet is quite flimsy and should be strengthened.
