# Independent Builders Report

Total Home Inspection Services Porirua City Ltd

Fri 21 Feb 2025

**21 Matai Rd, Raumati South, Paraparaumu, 5032, New Zealand**

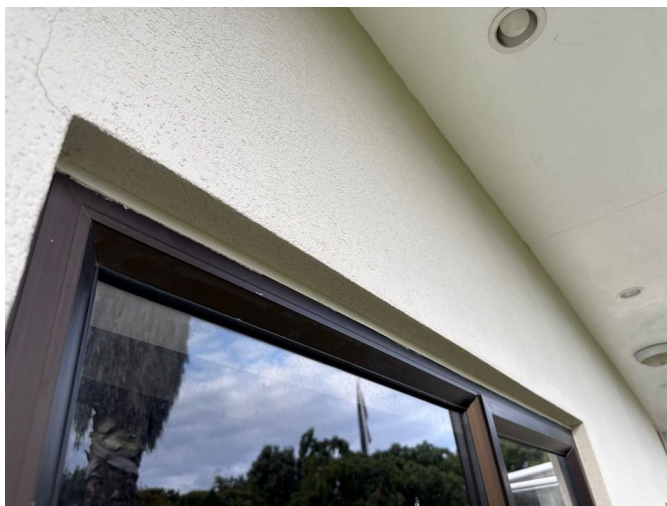
The polystyrene cladding was installed at an unknown time and was possibly installed over the original fibre cement cladding. The owner disclosed that there is no council record of this cladding addition. Note the owner has a warranty for the cladding from 2007.

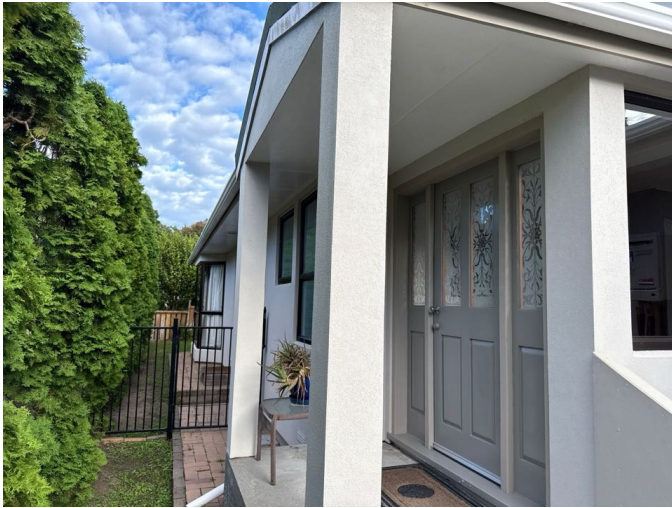
Roof supports are solid and secure

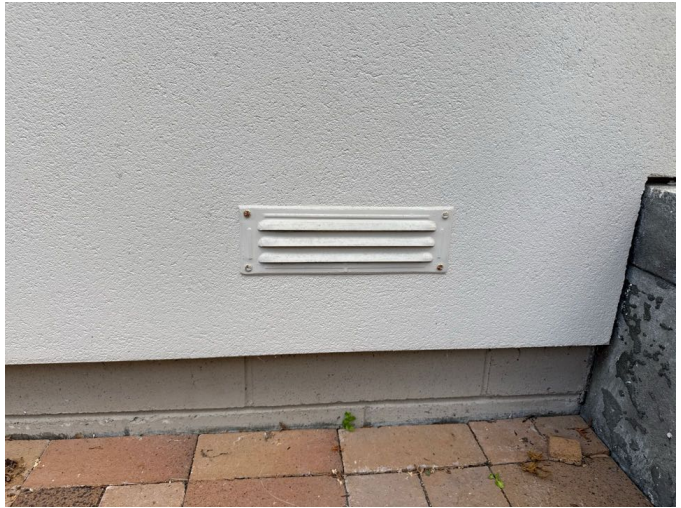
Sub floor vents installed in some areas

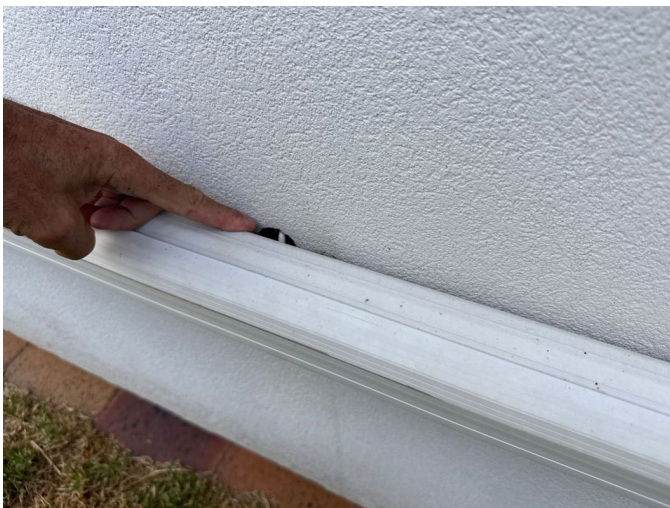
This hole in the cladding is a high weather tightness risk. Water proofing improvements are required.

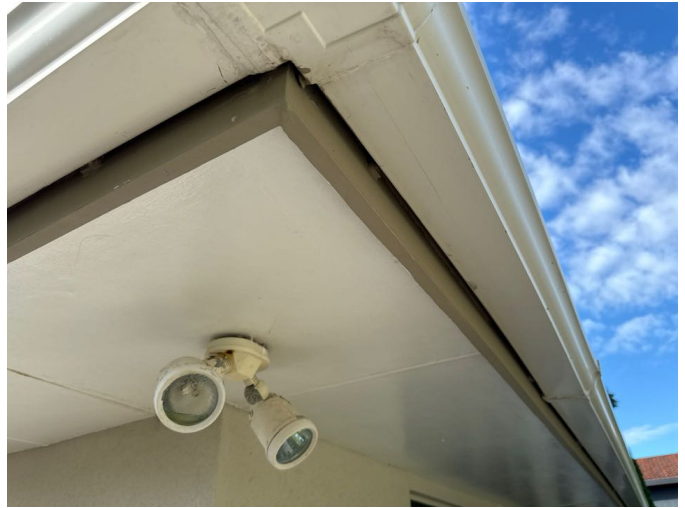
Average paint quality to the timber fascia, barge boards and fibre cement soffit linings

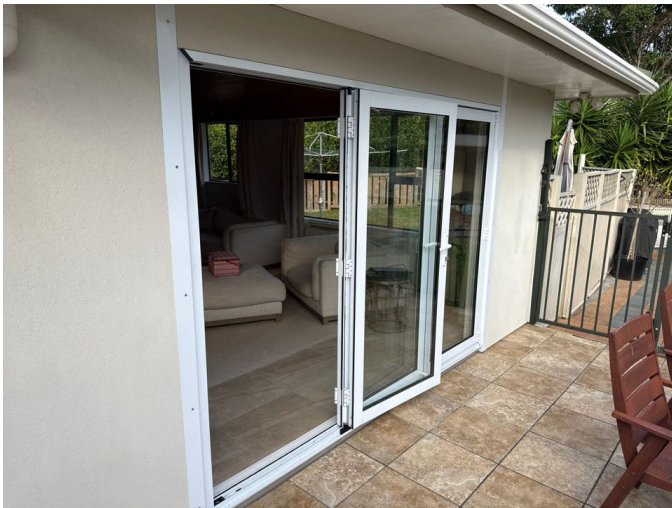
A double glazed aluminium bifold door unit has been installed by the patio. The unit appears to be effectively flashed and is in good condition.

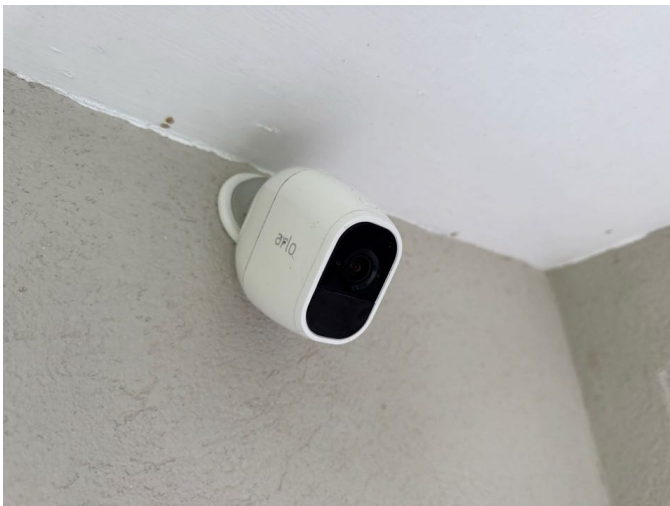
Security camera system installed. Untested.

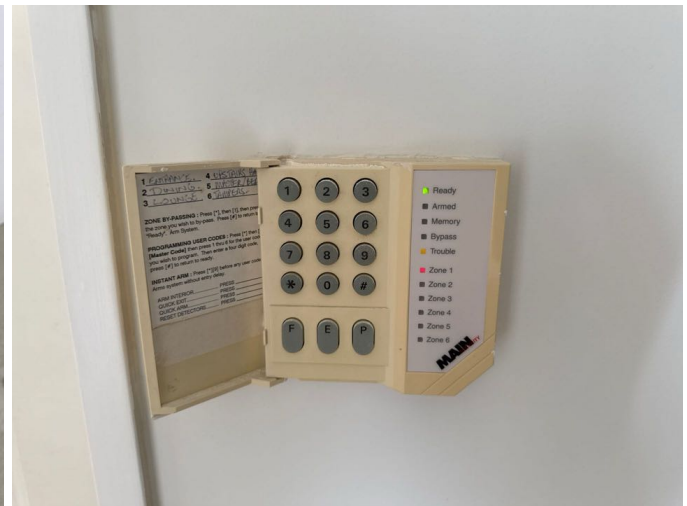
Security control panel installed by the garage

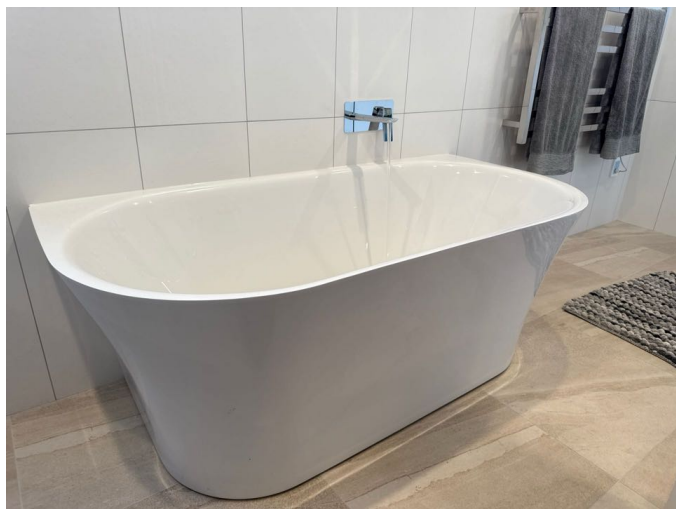
The back of the bath is well sealed. The tap is functioning well.

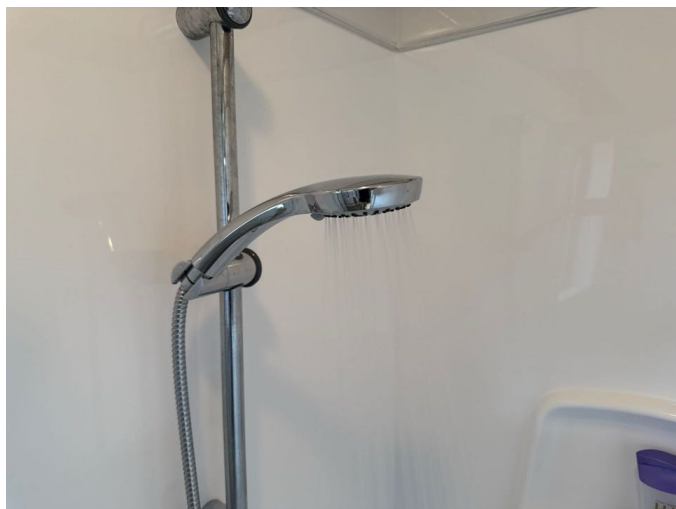
Good water pressure noted

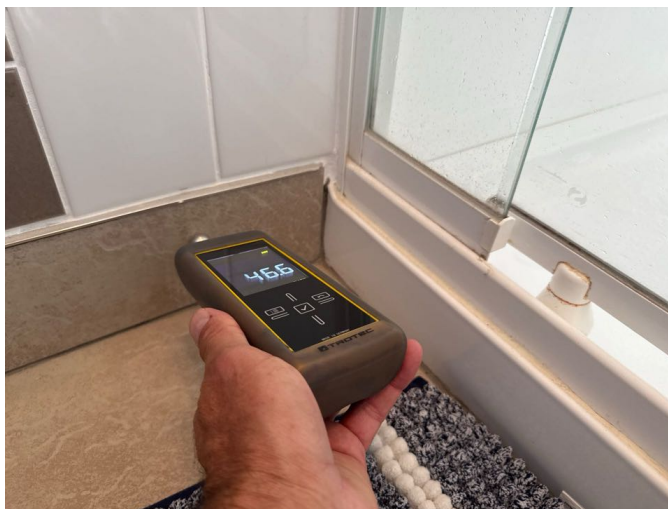
The common fail areas of the shower were checked for elevated moisture. Moisture levels were within the normal range.

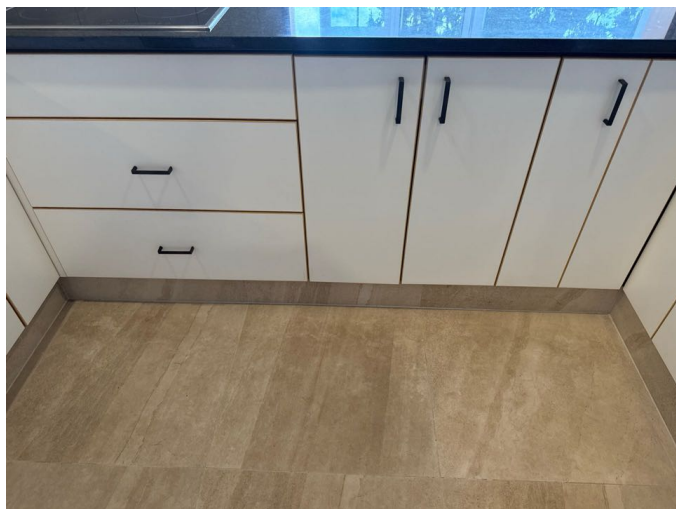
The kitchen cabinetry and tile floor are in good condition

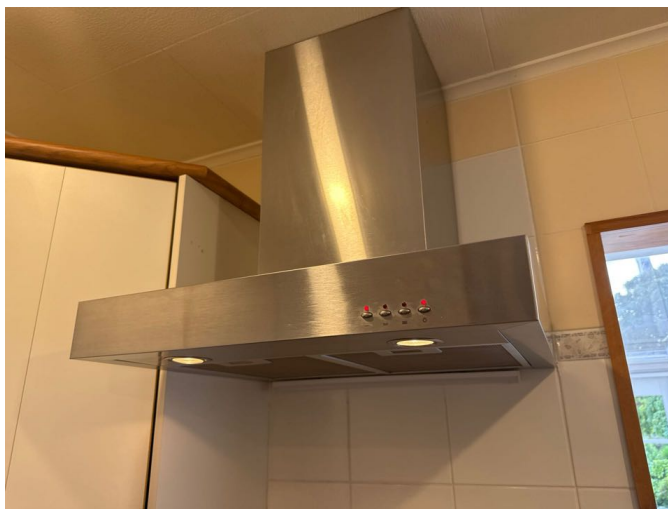
The range hood extraction unit is functioning

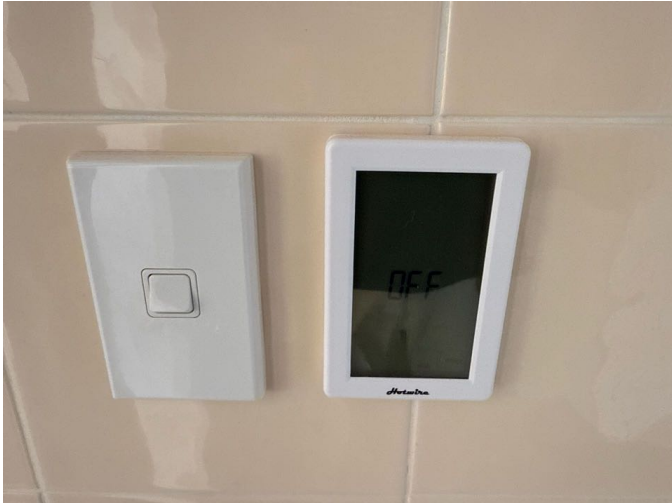
Under tile heating to the kitchen. Untested.

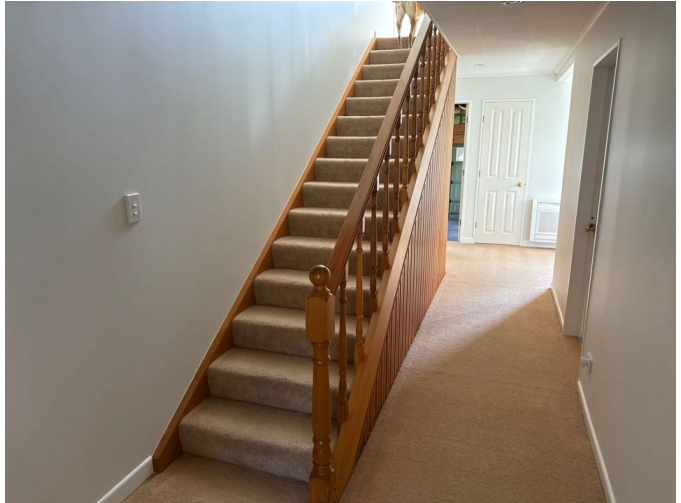
The timber stairs and balustrade are solid and secure

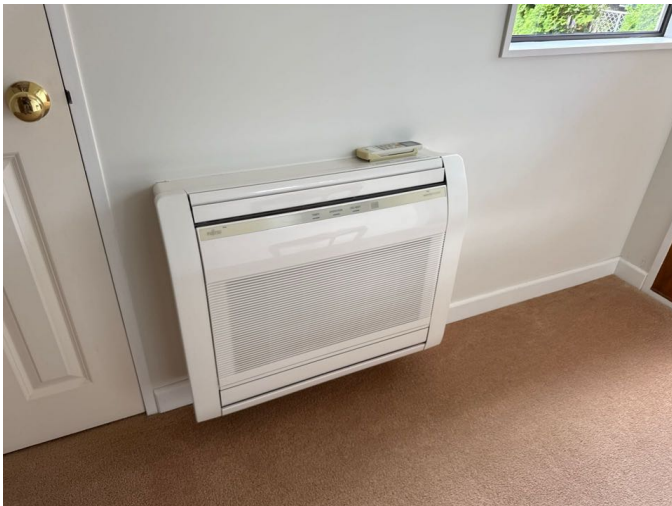
Heatpump to the east end of the hallway by the entrance. Untested.
