## BUILDING INSPECTION REPORT

## Building Inspection Report

51 Wayside Avenue, Burnside

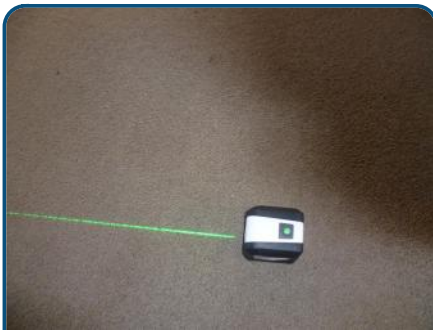
Laser floor tec used, green laser should be 45mm above floor
