All Building Inspections Limited

Building Report

14 Allen Road
Raumati Beach

Building Consultant:	Ian Hall, NZIBI
Present for inspection:	Ian Hall / Carol Saxton
Weather at time of inspection:	Fine 29-Oct-2025
Date/s of inspection:	26-Sep-2025
Type of inspection:	Building Inspection
Name of property inspected:	14 Allen Road Raumati Beach
Report prepared for:	Carol Saxton

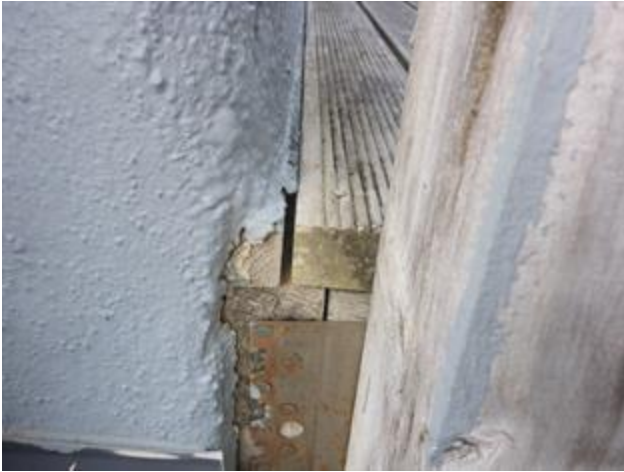
The decking is fastened to the dwelling with direct fixing through the cladding without a flashing in place. Moisture retention between the bearer and the cladding can become an issue with this construction and a flashing would direct moisture away from the cladding and bearer.

Decking direct fixed

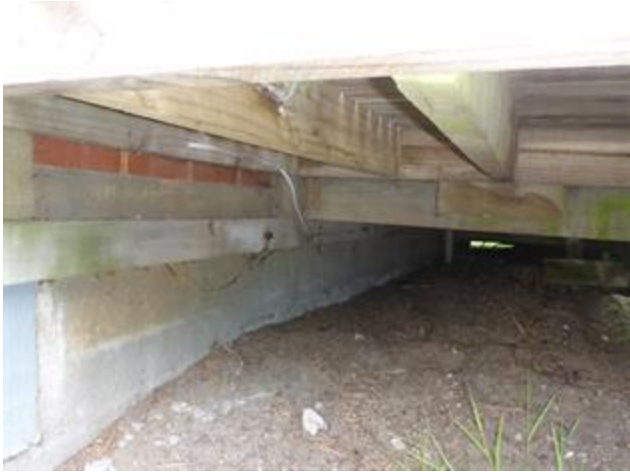
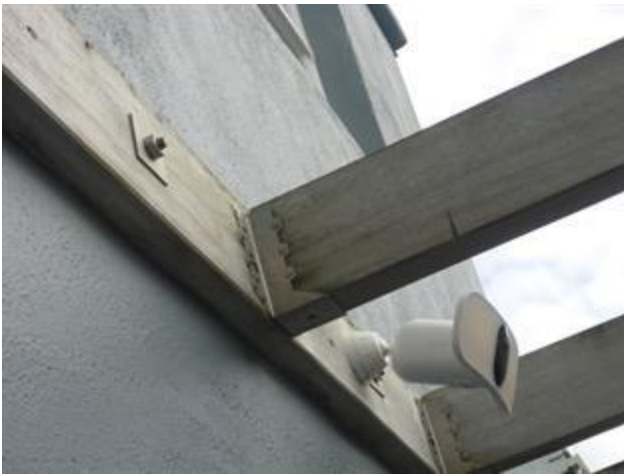
Moisture retention between the decking and the cladding can become an issue as the decking is in contact with the cladding. Creating a 12mm clearance between the two materials could be considered

Decking in contact

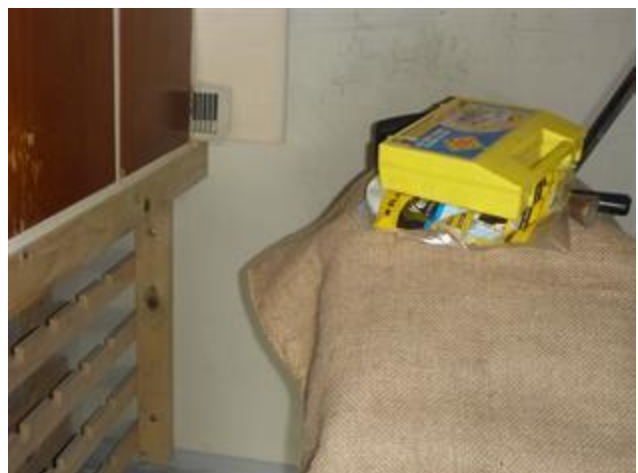
Garage interior

The rear of the garage is below the ground surface and reliant on the moisture barrier that is not visible as the barrier is covered. The interior of the garage to the rear and sides where below the ground surface appeared dry with no visible indications of moisture ingress.

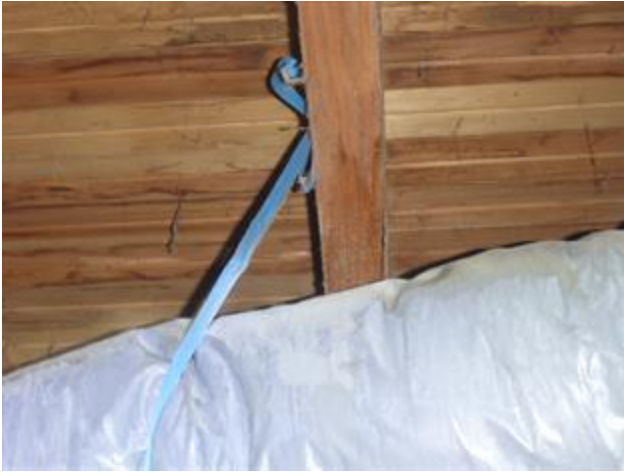
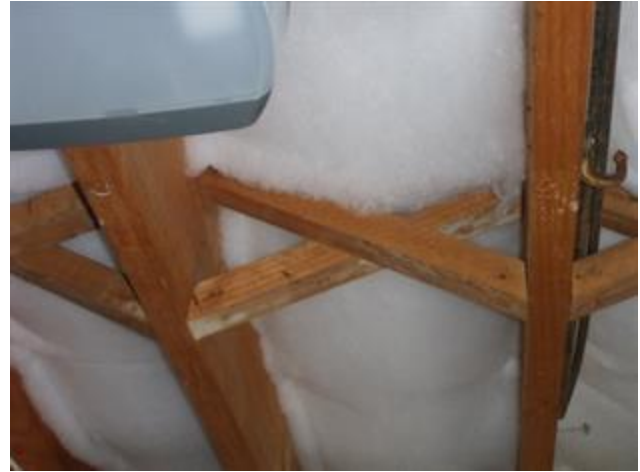
Garage insulation

The rest of the dwelling is still to have insulation installed. I recommend that the option of fitting some sort of under floor insulation be explored as part of the maintenance of the dwelling and to reduce the costs of heating.

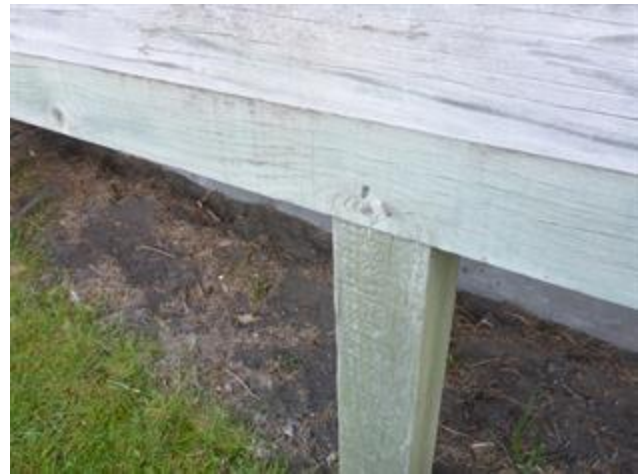
Additional fasteners are recommended with an additional support to the bearer junction to the front where the bearer is currently cantilevered.

Additional support to bearer join

***Update 29/10/25 Additional fasteners have been fitted.**

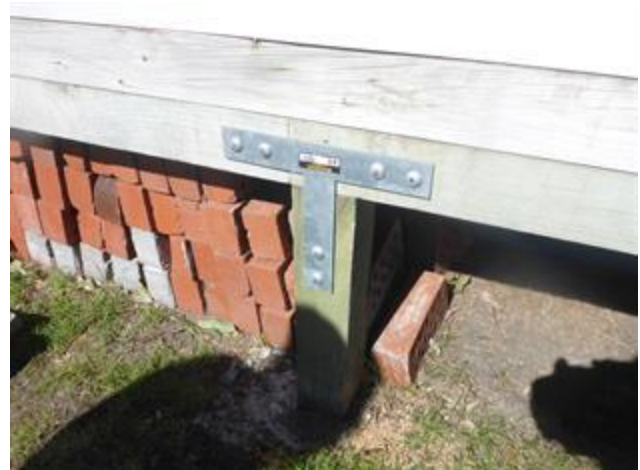
***Update 29/10/25 fasteners fitted**

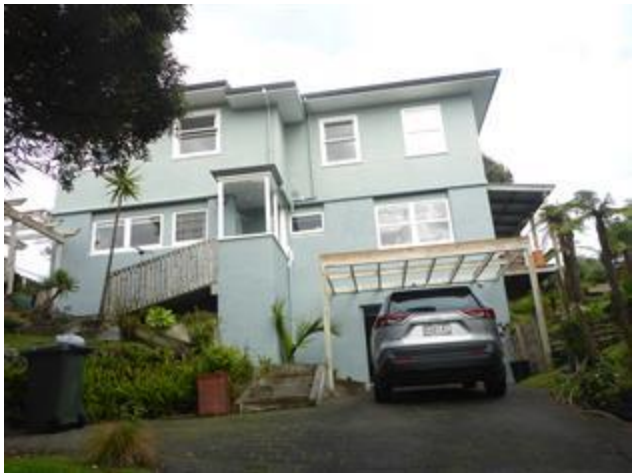
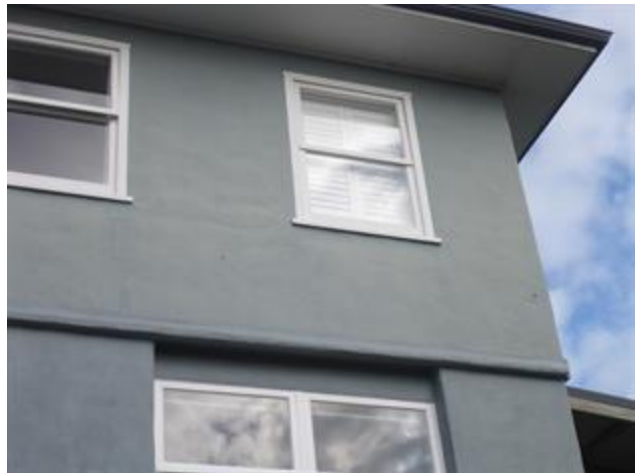
Scaffolding bolts were noted to the sides of the dwelling. These are no longer recommended due to health and safety requirements and as the bolts are a penetration that can allow moisture ingress. Sealing the penetrations is recommended after the bolts have been removed.

Scaffold bolts penetrations

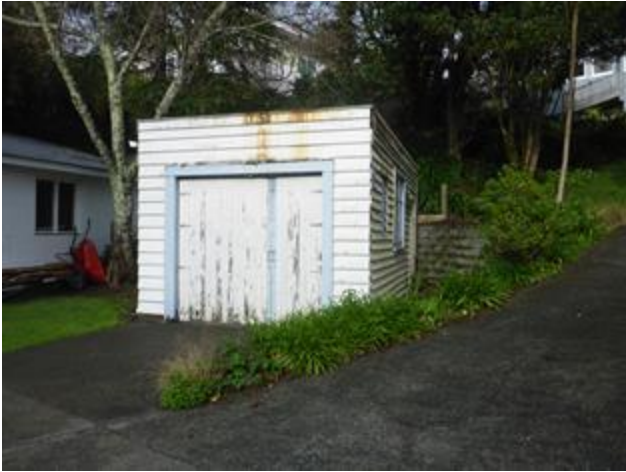
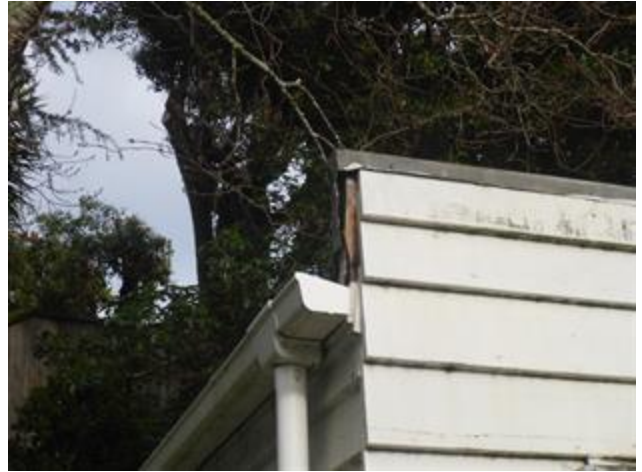
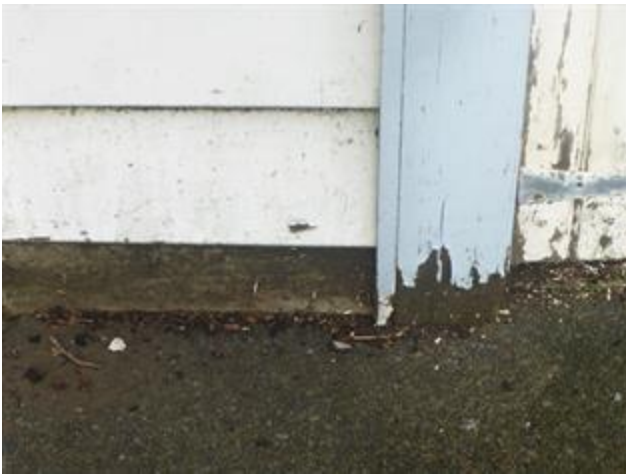
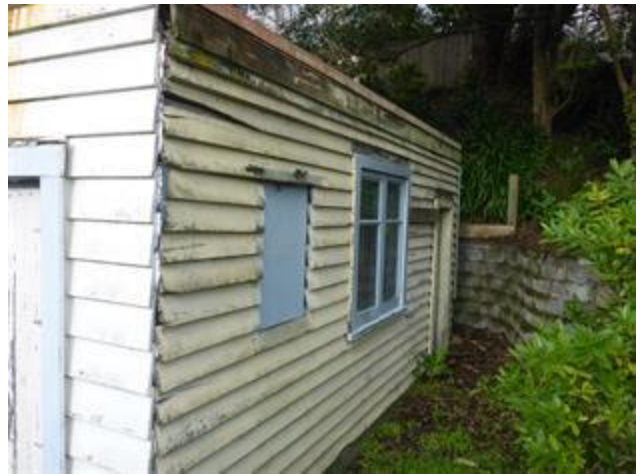
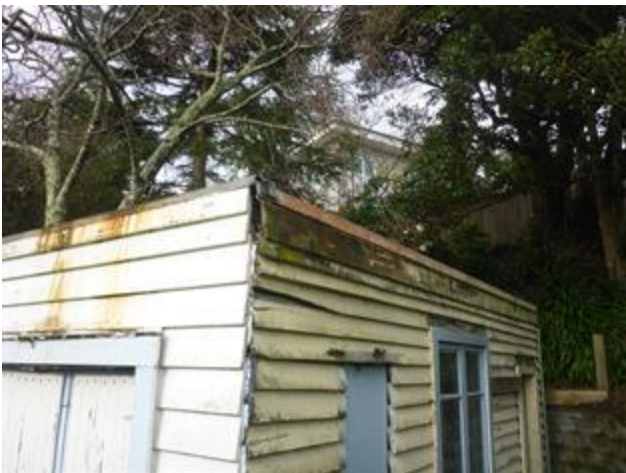
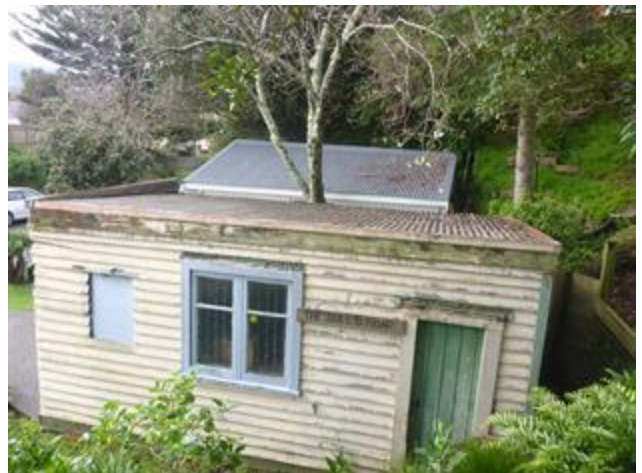
The roadside garage is past its prime with several areas of decay sighted. Significant repair or removal is recommended dependent on requirements of the owners.

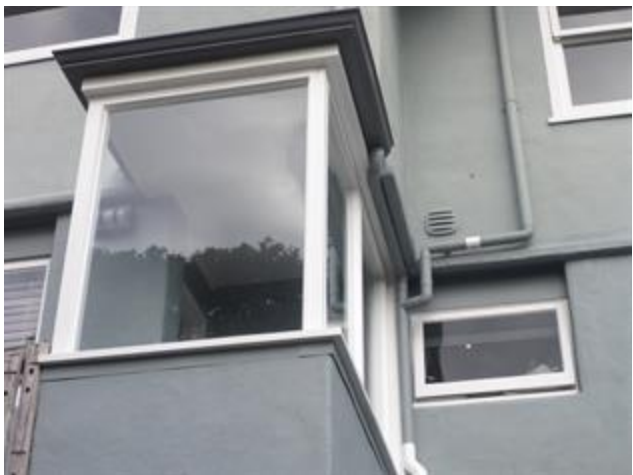
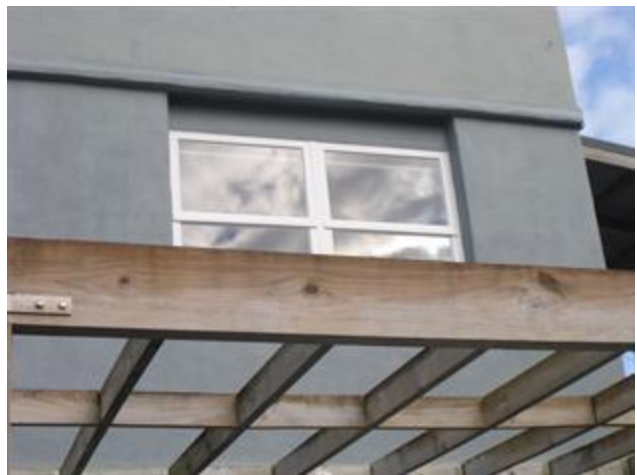
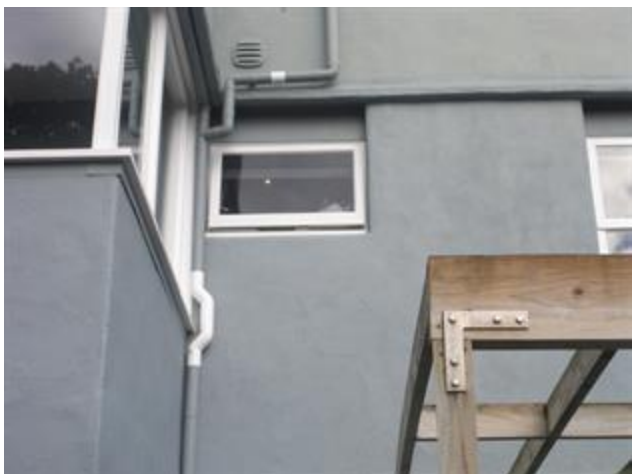
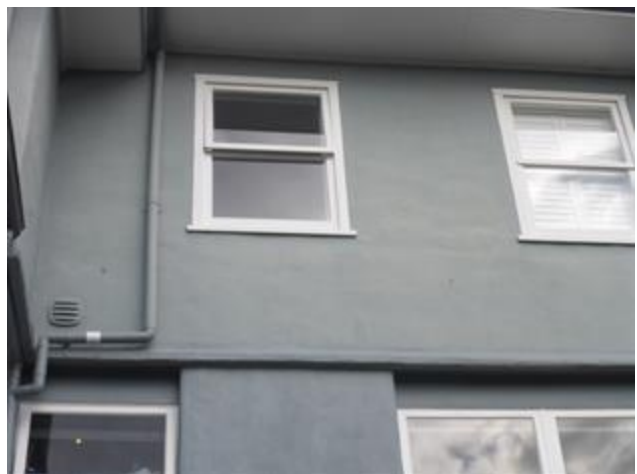
The paint finish has started to age to areas of the window joinery.

Several window hinges were showing signs of corrosion. I recommend removing the corroded hinges from the windows to be cleaned and oiled or replaced with brass or stainless-steel hinges if existing hinges cannot be cleaned and re-installed.

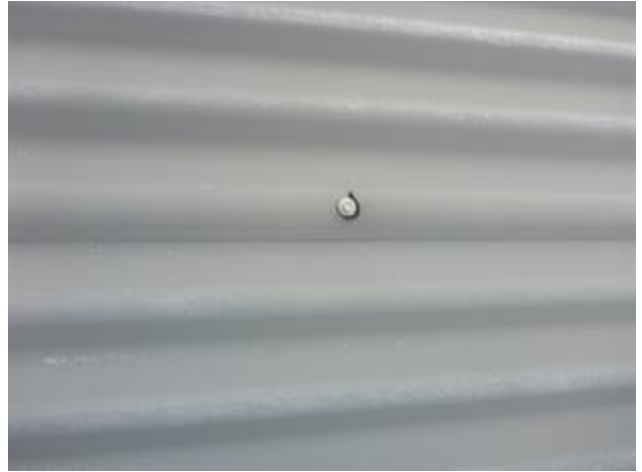
Distorted washers

There were several overtightened screws and distorted rubber washers that require replacement as the damaged washers are unable to perform their function of preventing water ingress.

I recommend that all fasteners showing signs of deterioration be replaced with compatible fasteners to prevent progressive damage. If there is oxidation to areas below the fasteners the deterioration will have to be removed before new fasteners are fitted.

***Update 29/10/25 A roofing contractor has replaced all corroded fasteners and distorted washers.**

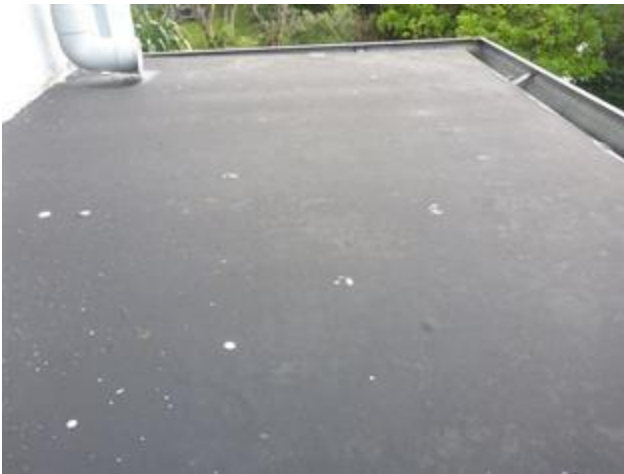
There was a small area of butynol above the front door covered area that was aged and several pin hole pricks were noted. Butynol roofing membrane is a synthetic rubber waterproofing membrane designed for use on roofs and decks. The product is installed as a single layer system.

I recommend that the roofing material have further appraisal by a licensed roofer to give advice on the degree of fastener replacement, butynol upgrades and costs.

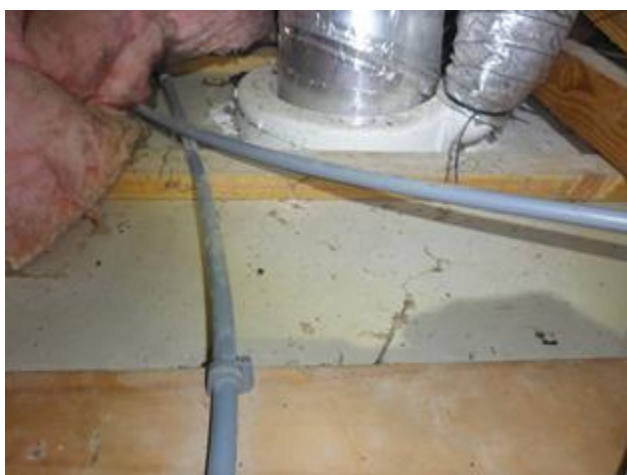
Insulation gap

There was a small area identified in the attic space where the insulation could be fitted better. To gain maximum benefit from the insulation it needs to cover like a blanket as any gaps will cause heat loss. Filling the gaps would benefit the dwelling and the occupants.

It is also recommended that insulation is fitted snugly between framing without gaps, tucks or folds but not compressed or packed tightly around electrical wiring.

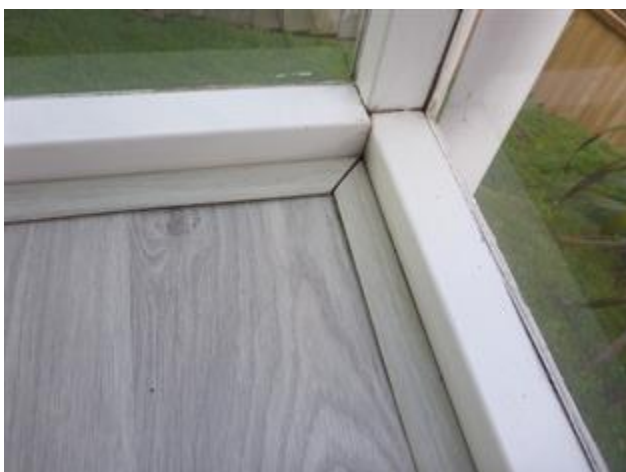
High moisture levels

All moisture readings were within acceptable parameters except to the floor lining to the southwestern corner of the conservatory. As moisture retention can lead to decay, I recommend further invasive appraisal of the area showing high moisture levels.

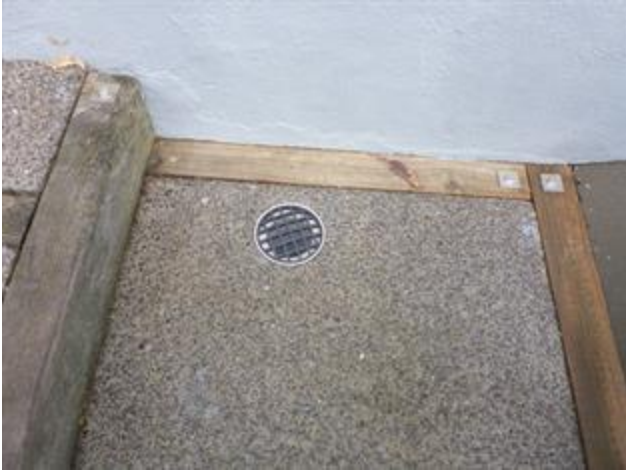
The gully traps appeared clear and clean at the time of inspection.

Gully traps are designed to relieve blocked drain sewerage externally, as they are the lowest discharge point, they also prevent drainage smells from escaping.
