# EARTHQUAKE RECOVERY (EQR) DOCUMENTATION

# EQR Property Overview Report

## Assessment of Property at 63 TAUWI CRESCENT, HEI HEI, CHRISTCHURCH 8042 on 14/03/2012

**EQC Repair works 63 Tauwi Crescent, Hei Hei**  
**Claim No: 2010/015493**

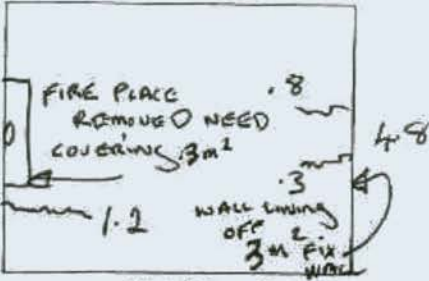
| <p>Lounge 3.4</p> | <p>Dining Room</p> | <p>Kitchen 3.5</p> |

| Trd No. | Trade Description | Trade % | Cost/m2 | Trade Total |
|---|---|---|---|---|
| 11 | Lounge: Reline damaged ceiling with 13mm GIBboard, stop, paint, square stop and electrical \$1,736.00 | | | |

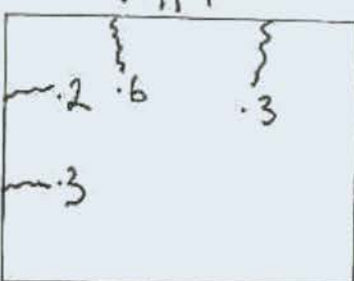
| Trd No. | Trade Description | Trade % | Cost/m2 | Trade Total |
|---|---|---|---|---|
| 12 | Kitchen/Dining/Rear Entry: Reline damaged ceiling with 13mm GIBboard, stop, paint, square stop and electrical \$2,107.00 | | | |
