**SUBJECT: STRUCTURAL INSPECTIONS AND SIGN-OFF FOR REPAIR / RE-LEVEL TO EXISTING RESIDENTIAL BUILDING AT 38 VIVIAN STREET, BURWOOD, CHRISTCHURCH 8083.**

## STRUCTURAL REPAIR ASSESSMENT

Project Number 24338

38 Vivian Street, Burwood, Christchurch 8083

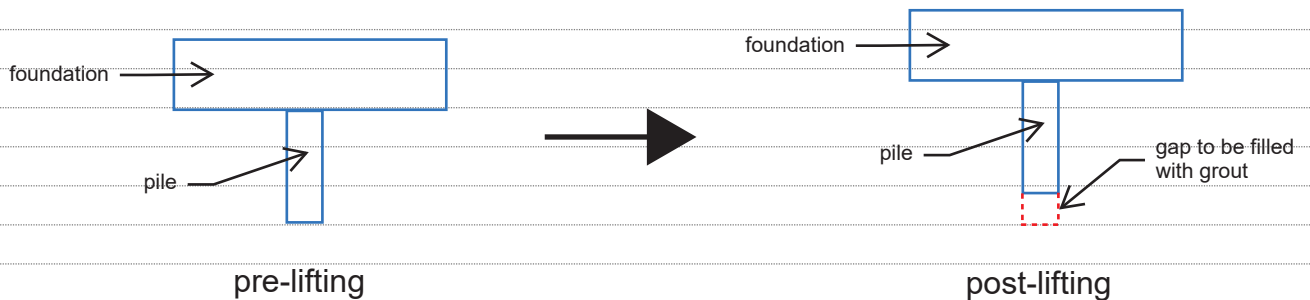
- Excavation for re-levelling pad carried out as per plan.
- Min. 750x750mm footing size measured on site.
- Min. 400mm below NGL excavated depth measured on site.
- Max. 2500crs pad spacing measured on site.
- Min. 150kPa UBC achieved on site at all tested locations.
- 2 layer of SE62 mesh observed on site.
- Any intermediate pile (between jacking pads) bottom to be filled with grout post lifting.

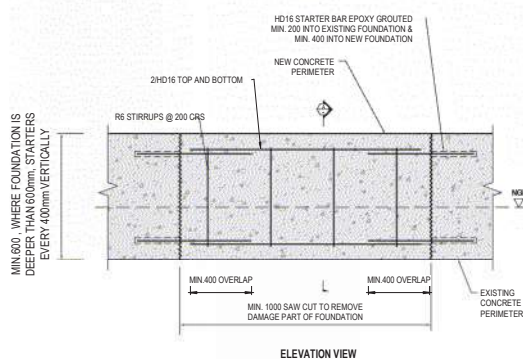
2 PARTIAL FOUNDATION REPLACEMENT DETAIL  
SCALE A1 1:10 / A3 1:20

8) Foundation replacement, existing bar to retain, additional bar as per detail. **SEND PHOTOS TO ENGINEER FOR APPROVAL.**

**SITE VISIT ON 27-05-2025. OK.**
