BUILDING DETAILS

Property address: 74 Amyes Road, Hornby, Christchurch, 8042

Date of assessment: Tue, 18-Aug-20

Assessor name: Clinton Smither

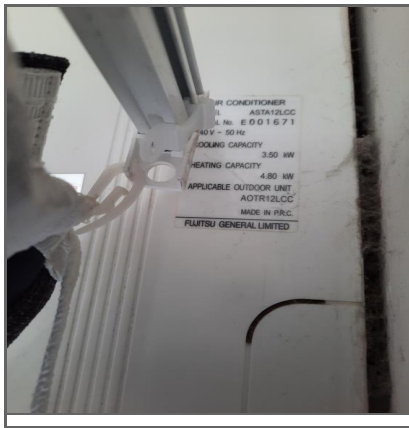
PRE-EXISTING FIXED HEATER

Heater compliant: Yes

Heater type: Heat pump

Heater make: Fujitsu ASTA12LCC

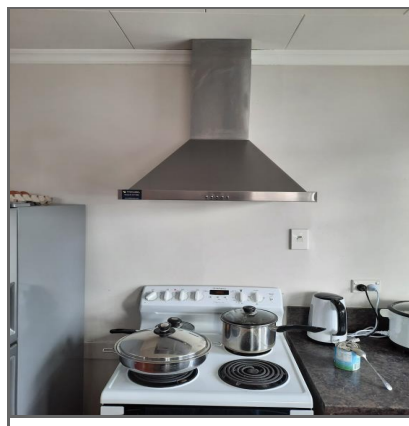
PRE-EXISTING EXTRACTION FAN

Location of extraction fan: Kitchen 1

Fan operational: Yes

Vents to the outdoors: Yes

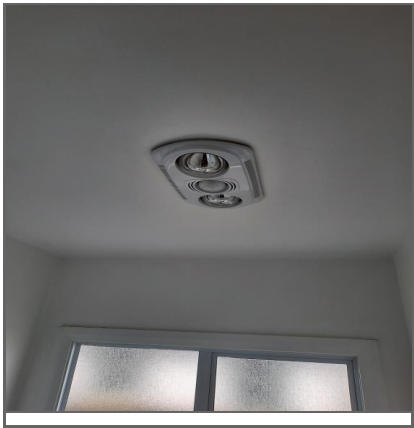
PRE-EXISTING EXTRACTION FAN

Location of extraction fan: Bathroom 1
Pre-existing extraction fan: Yes
Fan operational: Yes
Vents to the outdoors: Yes
Exhaust ducting diameter: 150mm
Property is exempt from HHS: No

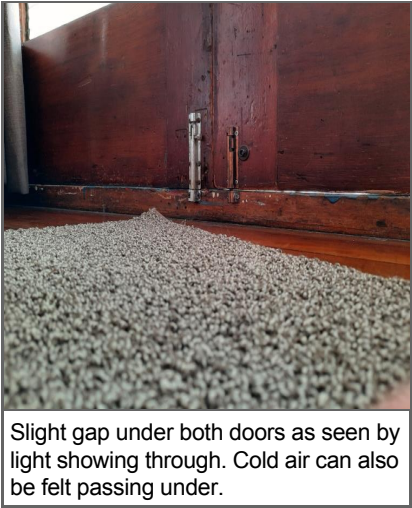
ADDITIONAL PHOTO

Location of door: Front door

Gaps or holes: Yes

Please comment further: 1 x French door weather seal. 2 x brush seals.

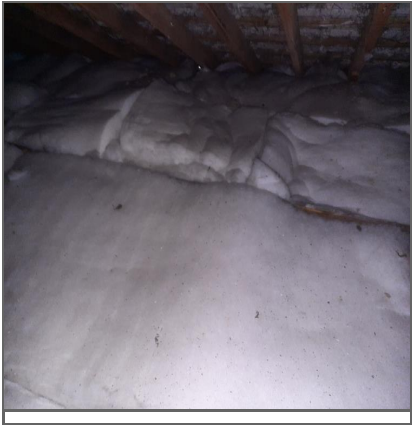
EXISTING INSULATION

Existing insulation type: Polyester
Existing r-value: R3.2
Condition of existing insulation: Good
Compliant with HHS: Yes
Property exemption from HHS: No
Internal wall: No
Ceiling size: N/A
Roofspace design: Rafter
Access to ceiling: Laundry
3 in 1 fan: 1
Un-ducted fan: 0
Chimneys: No
Downlights: 0

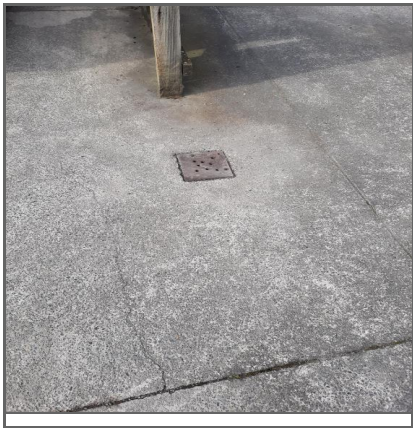
SURFACE WATER DRAINAGE

Comment further: Gutters around the property are sagging and do not present with the correct fall to the limited amount of down pipes at the property. The gutters are also in poor condition and a full re gutter will be quoted for.

Gutter on the left hand side of the property is disconnected and damaged.

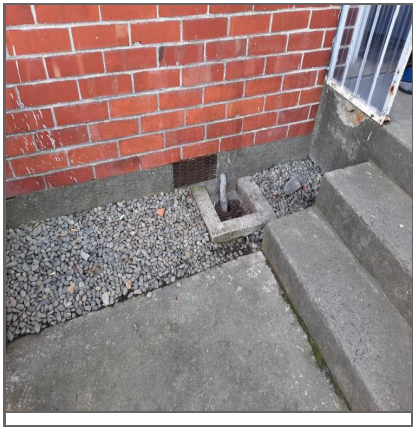
SUBFLOOR SPACE CONDITION

Sub-floor: leaks or flooding present: Dry
