CASH SETTLED CLAIM(S)

EARTHQUAKE COMMISSION

Statement of Claim Checklist

Situation of Loss: Flat 3/75 Ardour St
Merivale.

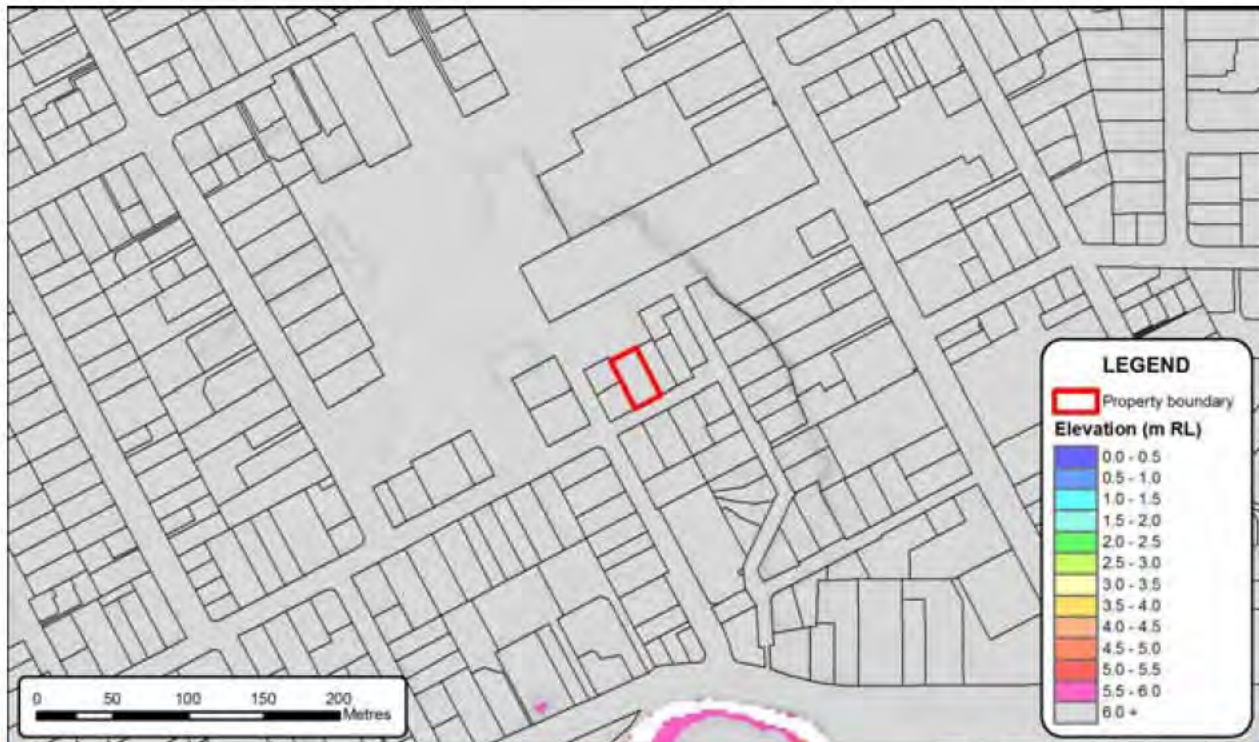
Map 4: Ground surface elevation post December 2011

Map 4 shows the ground elevation (i.e. the height of the land) following the Canterbury earthquake sequence. The ground surface elevation was measured using an aerial LiDAR survey (which involved scanning the ground surface

from an aircraft). This post-earthquake ground elevation survey is a key input into the modelling of the post-earthquake flood depth. Similar surveys were used as an input into the modelling of pre-earthquake flood depths.
