## BUILDING INSPECTION REPORT

## NZ Residential Property Inspection Report

Inspection Date: Thu, 13 Nov 2025

Property Address: 43 Tovey Street, New Brighton,  
Christchurch 8061, New Zealand

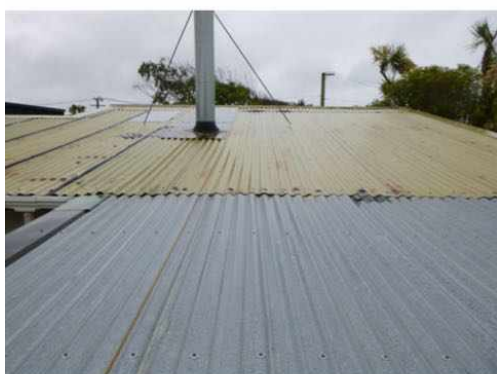
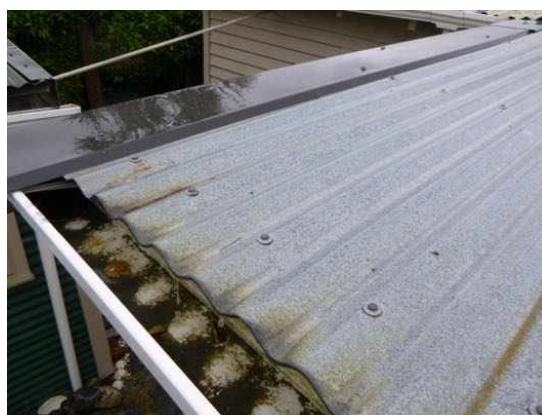
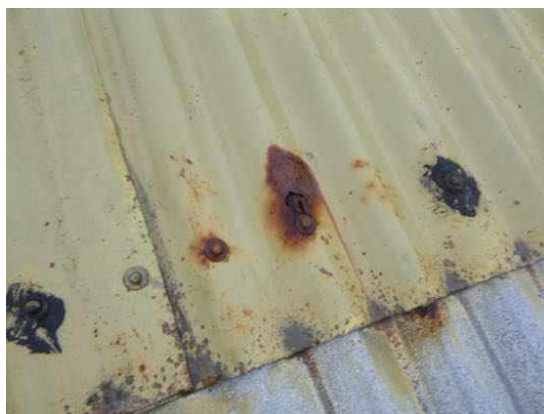
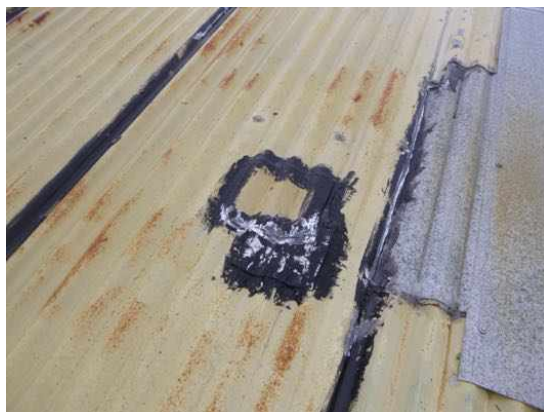
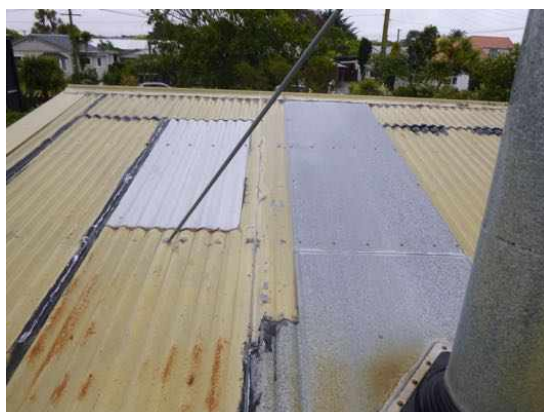
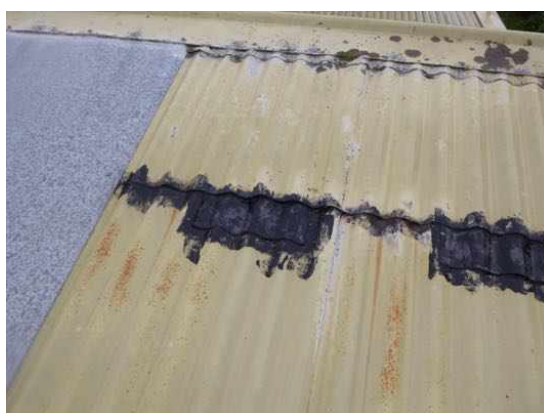
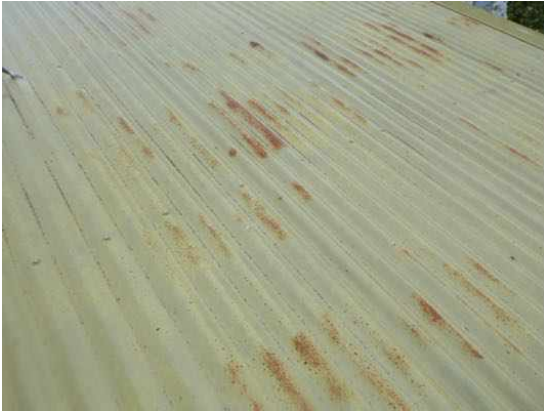
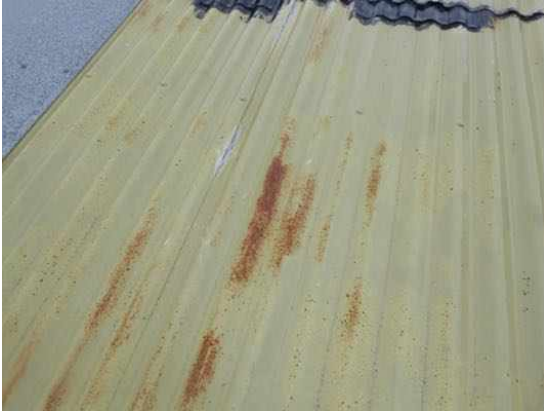
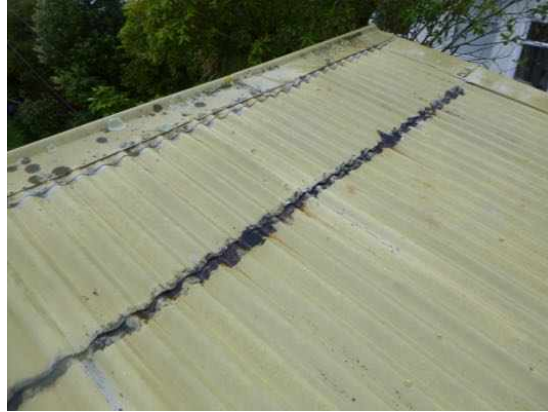
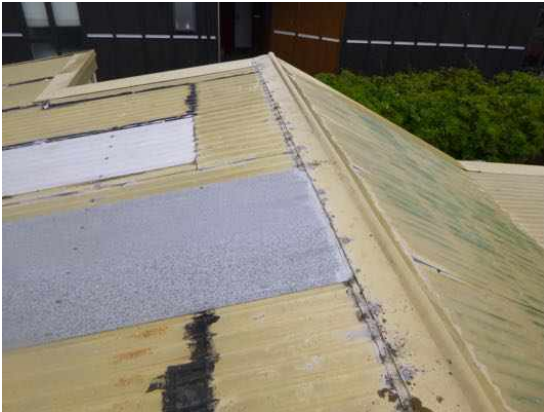
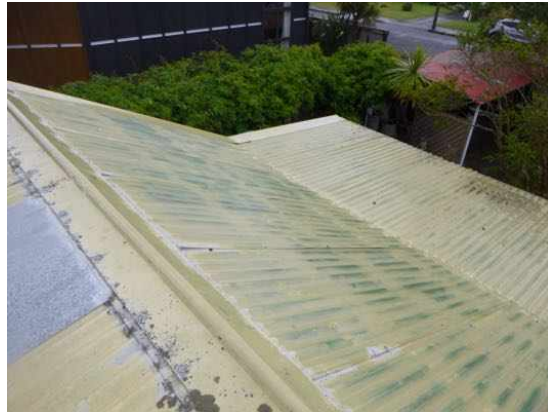
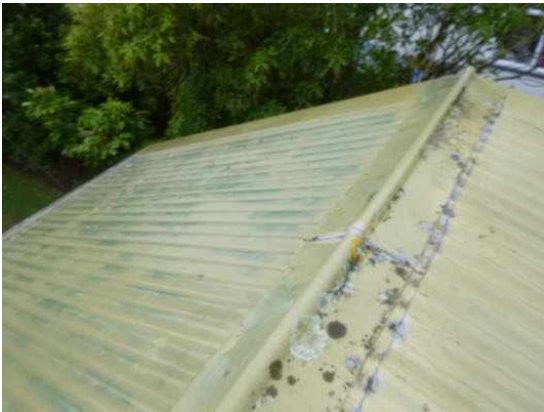
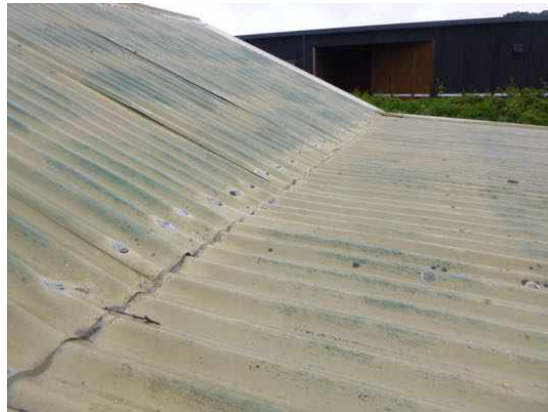
#### Defects 3.01

Building: Main Building  
Location: Roof Exterior  
Finding: Roofing - Condition  
Information: The visible corrugated roofing and flashings appeared in fair to poor condition for its age. All penetrations and flashings were installed and sealed adequately.

Evidence of surface rust to some sections was identified. Some patching and re-coating was evident. If left unmanaged, this could allow water ingress to the internal roofing structures, potentially leading to secondary damage of building elements. Accelerated deterioration of the roofing sheets and any associated building elements is also likely to occur. Replacement of the roofing should be considered. Failing this is advised that a professional painter be consulted to carry out works such as the application of rust-retardant surface protectors and roof paint, in the near future.

The roof is fastened down with roofing nails which can be prone to popping overtime. As general house maintenance, periodically check nails and replace any that may have popped with suitable roofing screws.

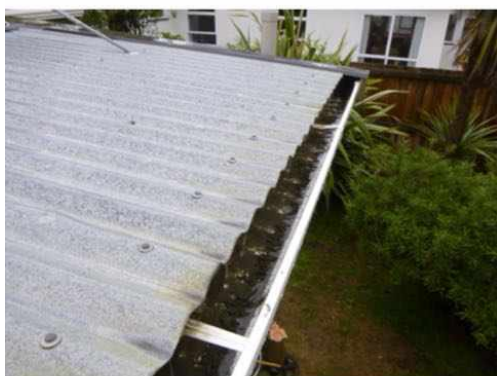
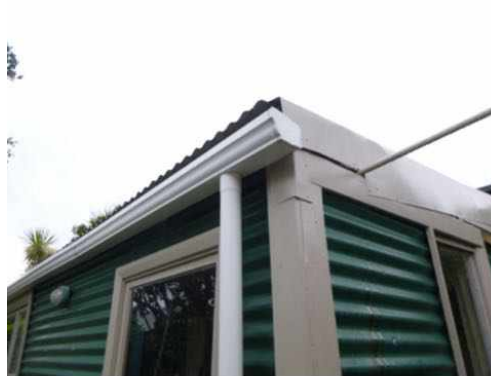
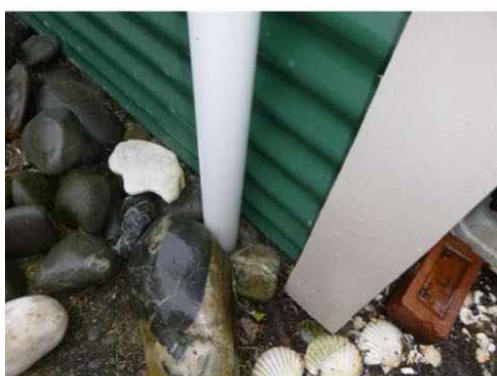
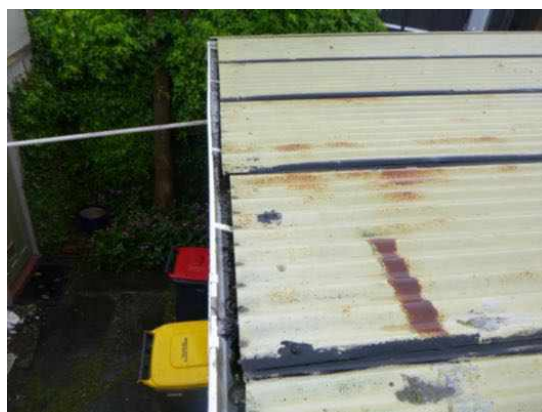
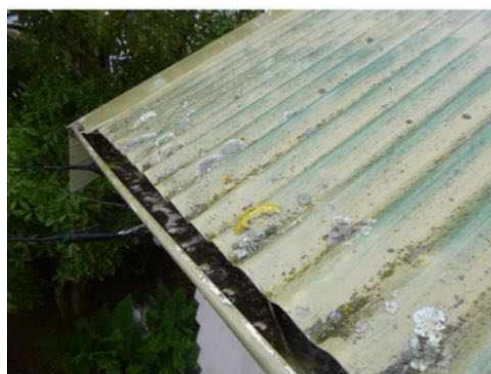
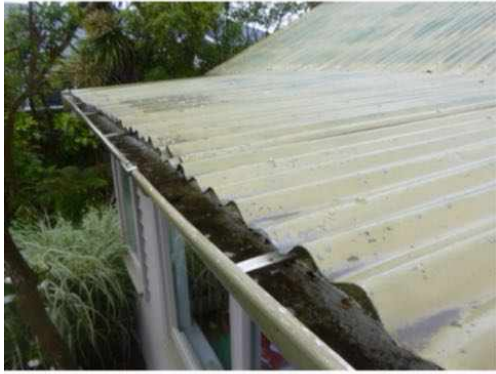
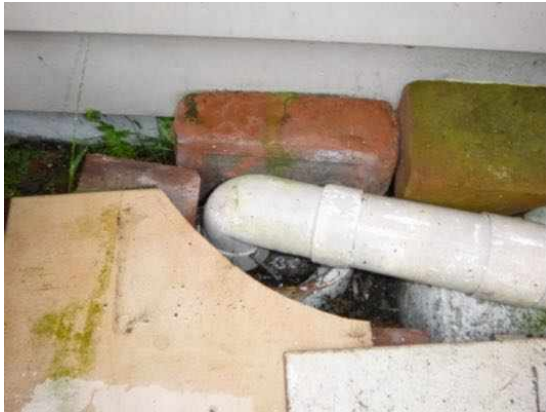
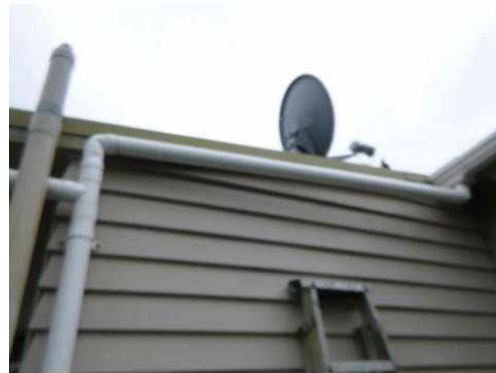
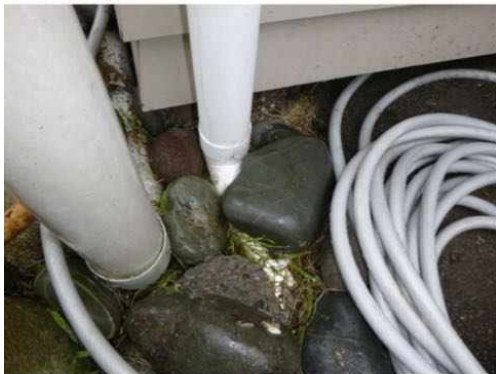
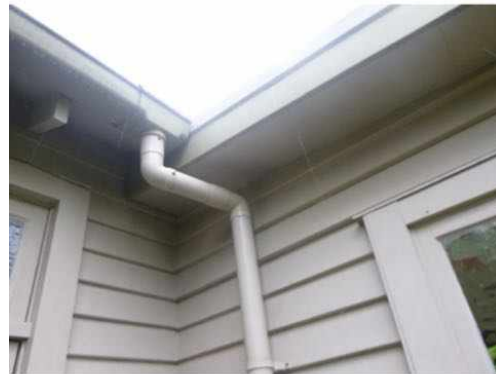
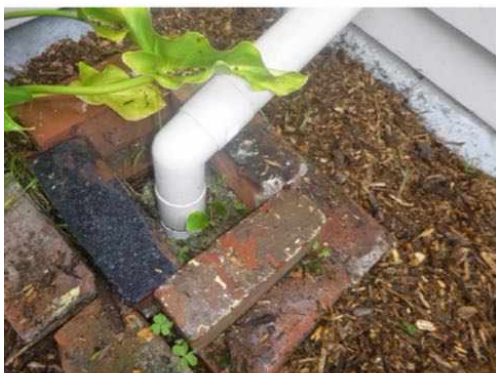
Defects 3.02

Finding: Gutters and downpipes - Condition

Information: The PVC gutters and downpipes around the property appeared to be in good condition, allowing good drainage to the downpipes. There does not appear to be any stormwater risers or connection the stormwater system.

Roof plumbing structures, such as guttering and downpipes should be free of all debris to prevent blockages. It is advised that gutters are checked by the homeowner or a general handy person as part of regular maintenance.

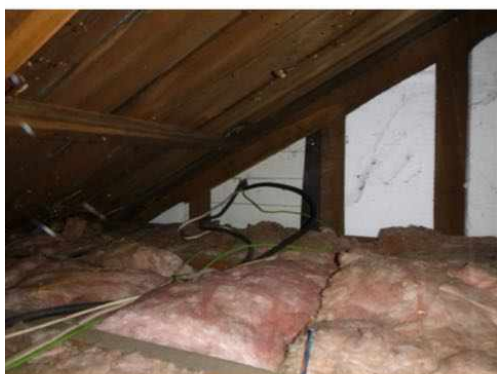
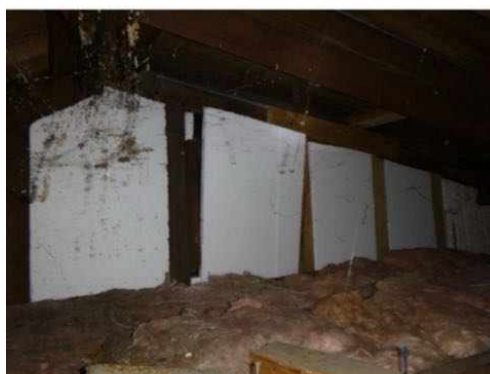
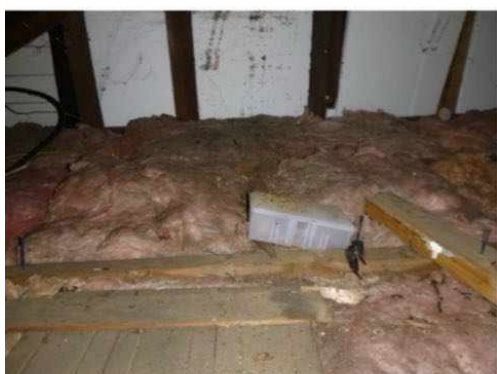
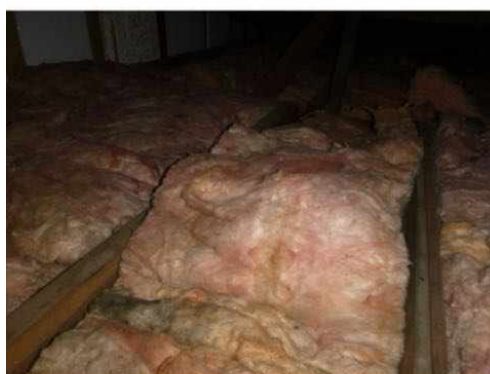
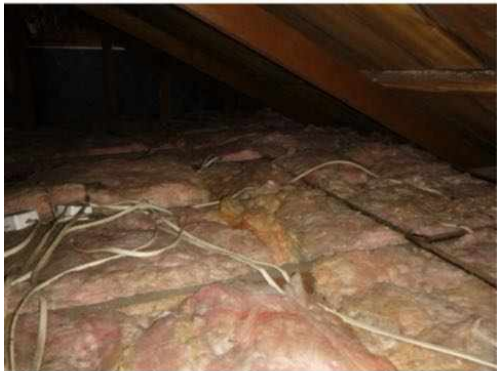
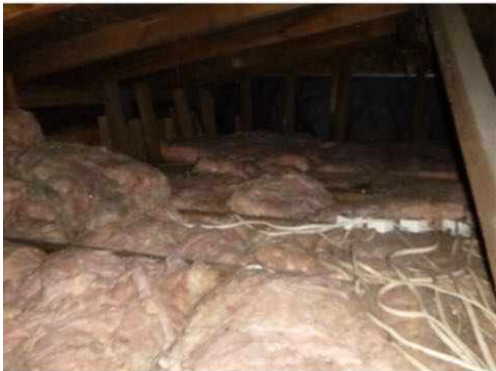
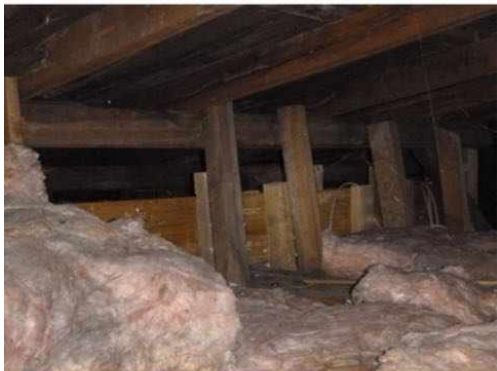
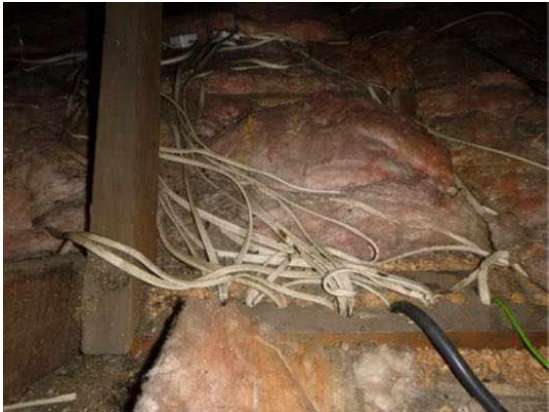
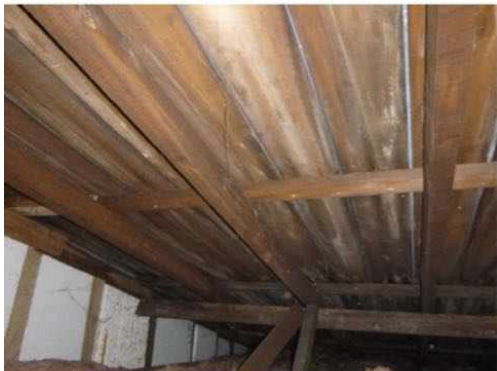
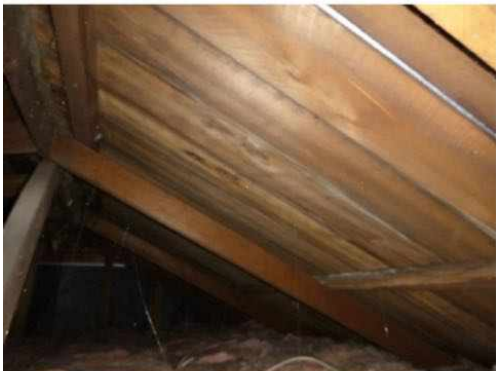
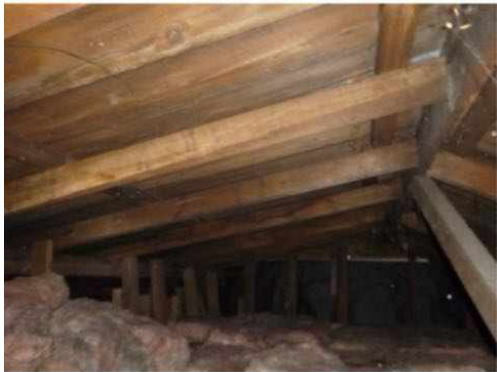
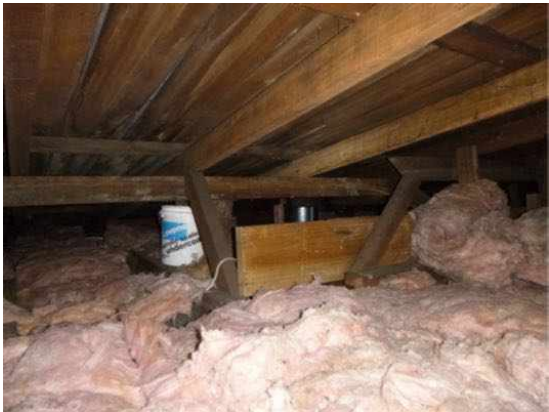
Defects 3.03

Building: Main Building  
Location: Roof Void  
Finding: Roof space - Condition  
Information: The roof space was in good order. This consists of pitched timber rafters and ridge boards with timber purlins and sarking underlay. No evidence of active or historic leaks was detected.

One timber purlin was found to be broken. This does not pose any structural issues.

The fibreglass Insulation has been installed to a good standard, with full coverage achieved. Not slumped or compressed. No obvious water damage observed.

The visible wiring was Modern TPS (Tough Plastic Sheath)

As on-going maintenance, all homes should be periodically checked for pests as they can cause damage to the construction material, plumbing, and electrical. There were signs of pests (rodents) found. There were no indications of borer in the roof space.

Structural modifications have been noted within the roof spaces, it is recommended that council records are checked to ensure compliance has been obtained.

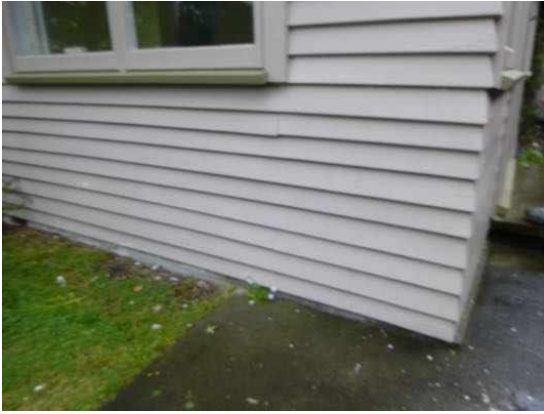
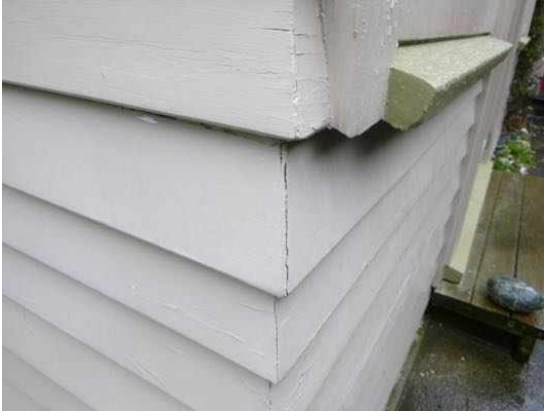
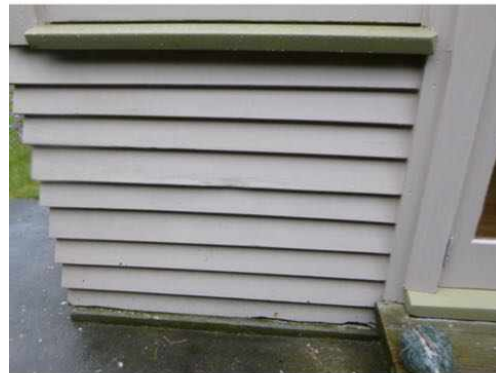
### Defects 3.04

| Information: | The exterior painted timber weatherboards were in fair condition overall. All windows and doors were flashed and sealed adequately. |

The paint finish was found to be deteriorating in some areas. Paint deterioration is generally classified as an appearance defect. However, the substandard appearance may also be indicative of poor surface preparation and substandard workmanship. A painting contractor should be appointed to perform necessary works to aid the appearance of the affected area and to ensure that the area is protected against further deterioration. Alternatively, the homeowner following manufacturer instructions may be able to provide this service.

I would recommend monitoring the weatherboard joints and junctions as this is where moisture issues are most likely to occur.

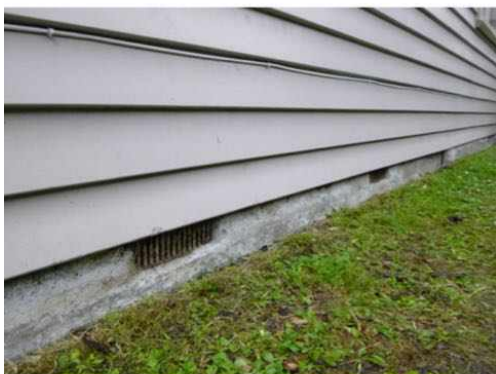
### Defects 3.05

Building: Main Building  
Location: All External Areas  
Finding: Foundation - Condition  
Information: There is no access to the subfloor due to the proximity of the framing to the ground. This is typical for the era of build. Good ventilation is maintained.

The concrete ring foundation visible showed no noticeable cracking.

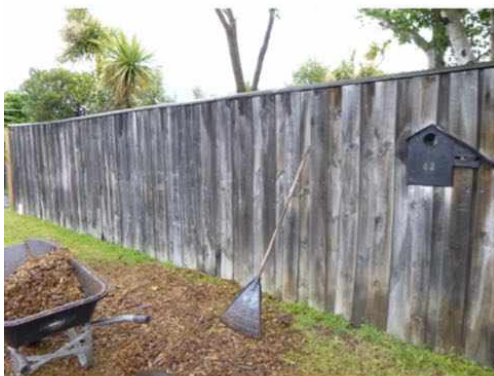
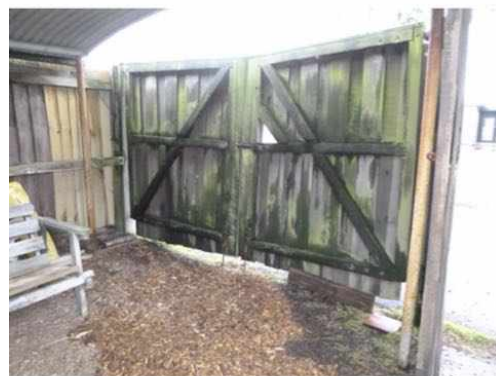
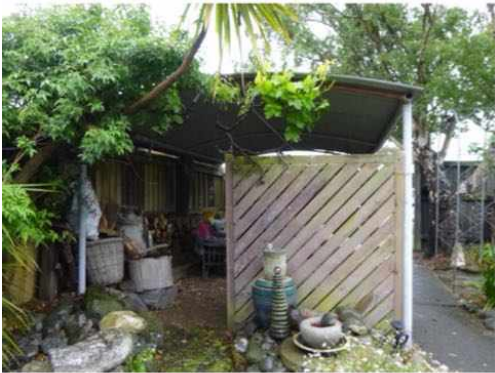
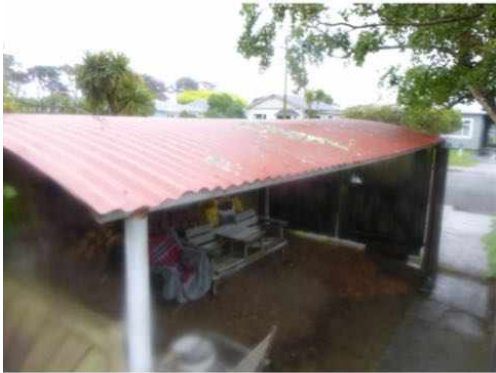
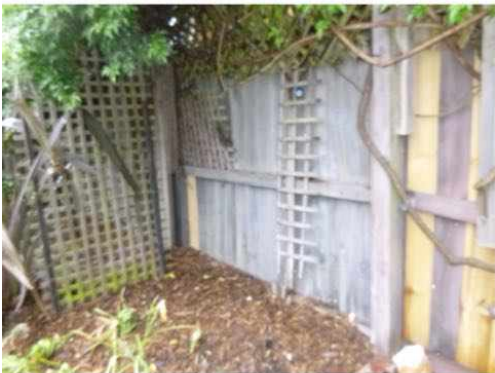
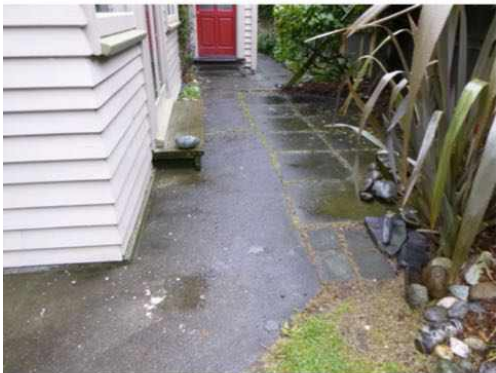
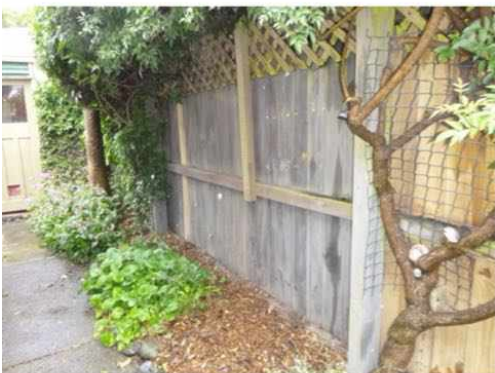
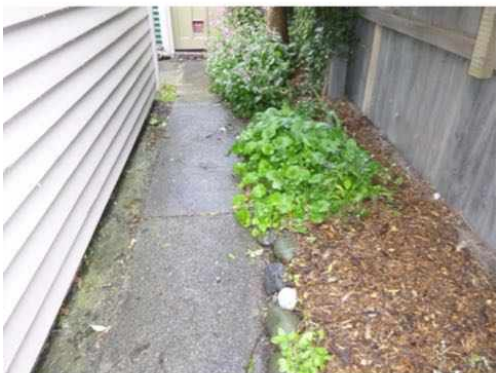
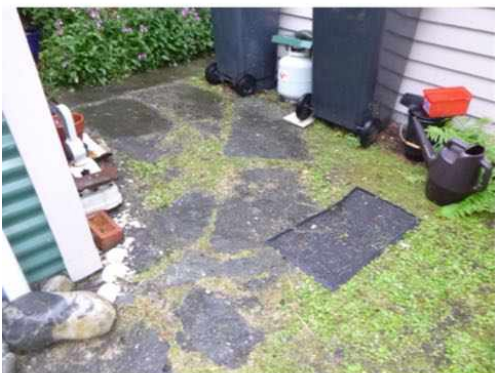
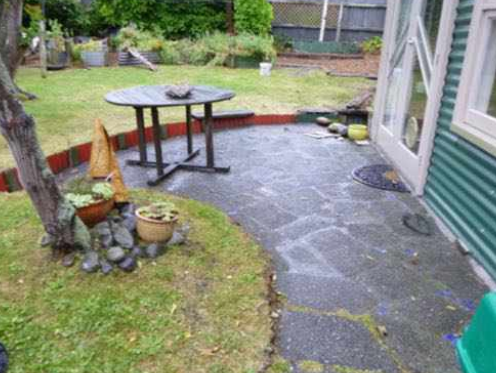
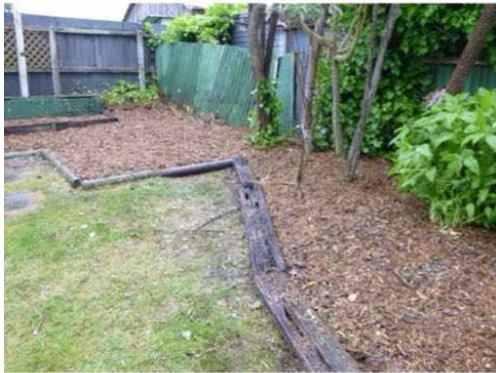
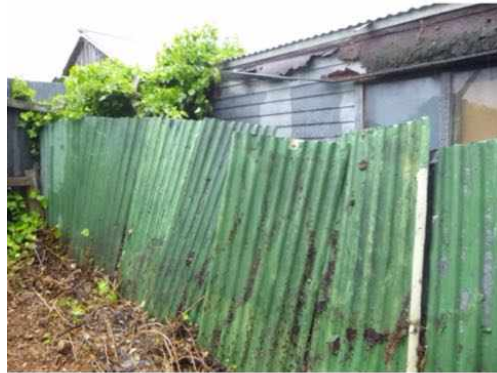
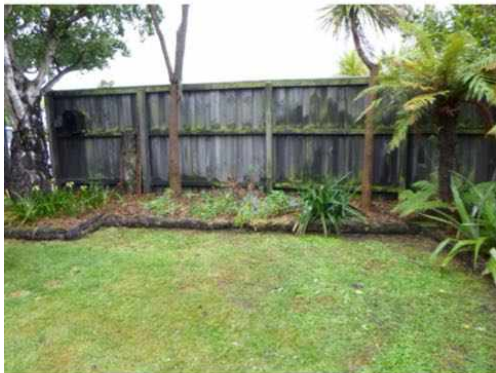
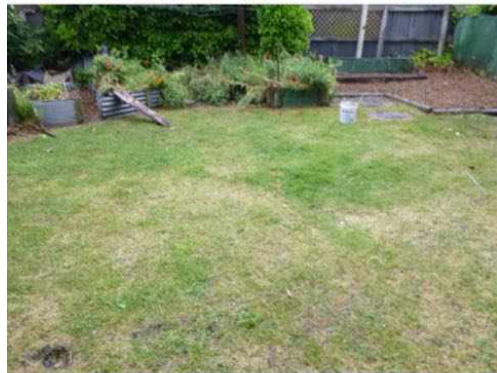
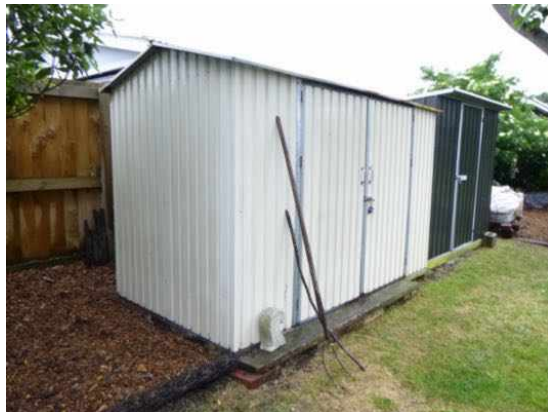
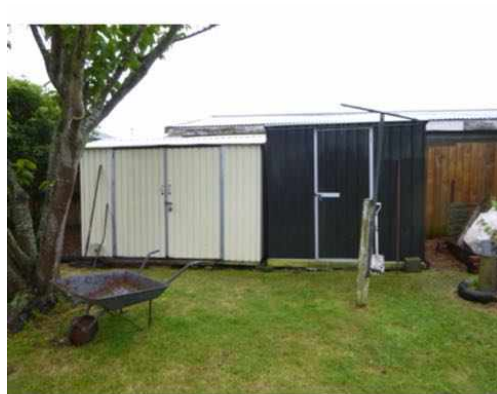
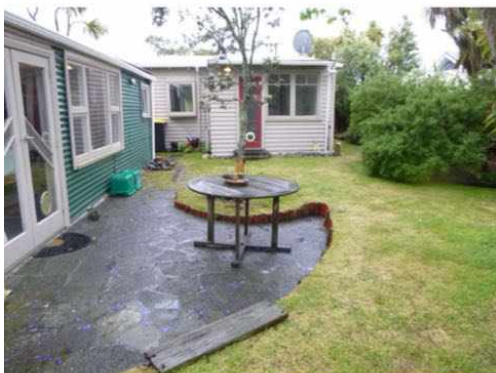
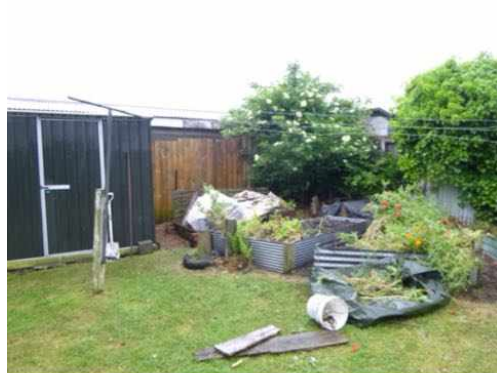
## Defects 3.06

Information: The timber fences/gates, sheds, clothesline and concrete/paved areas appeared to be in good condition for their age. The landscaping and lawn areas also appeared in good overall condition.

Typical age related deterioration to the timber fencing and cracking to the concrete areas was identified.

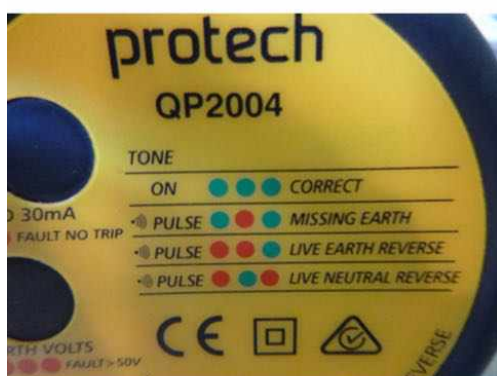
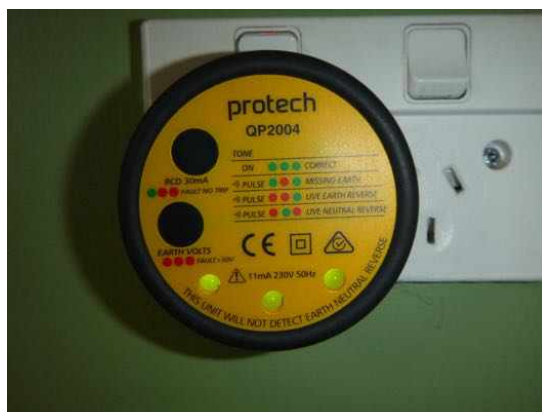
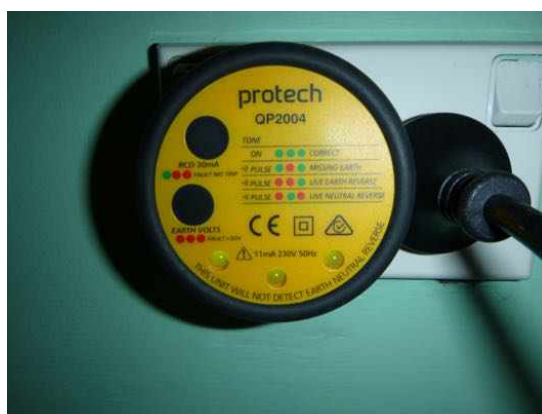
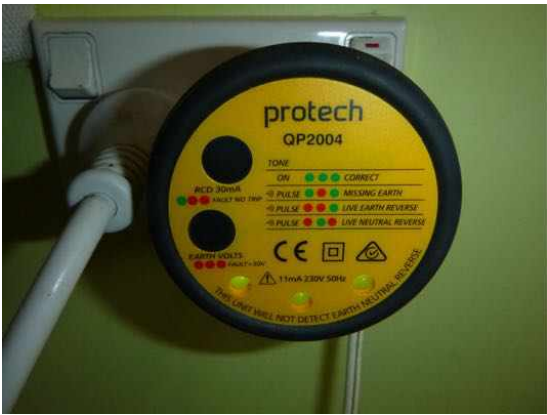
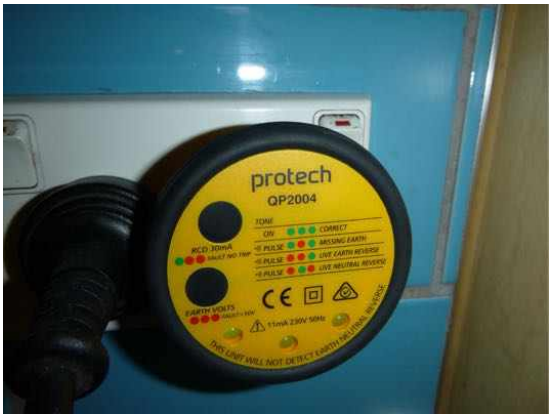
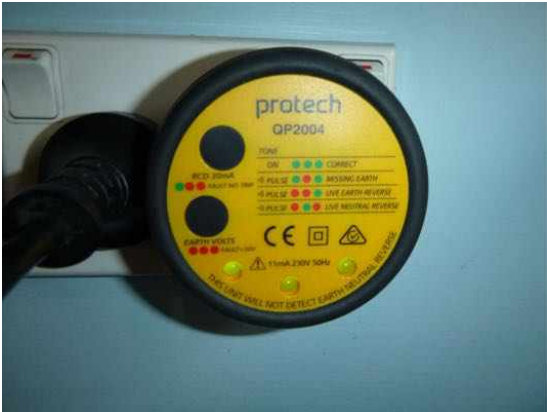
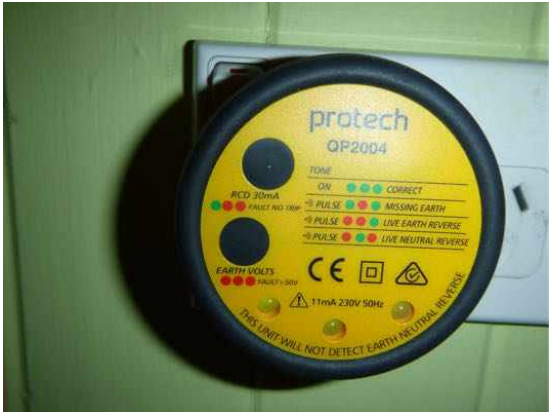
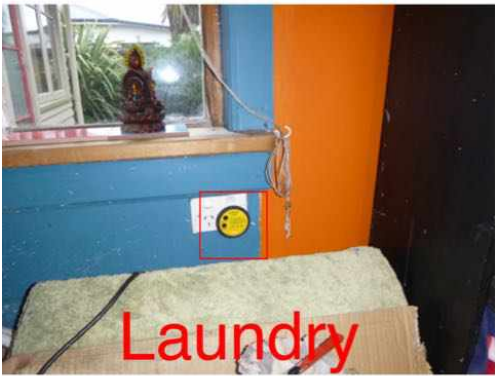
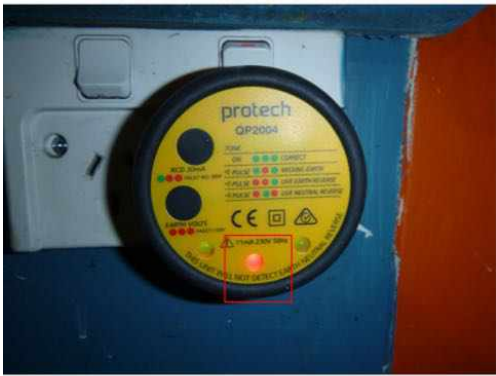
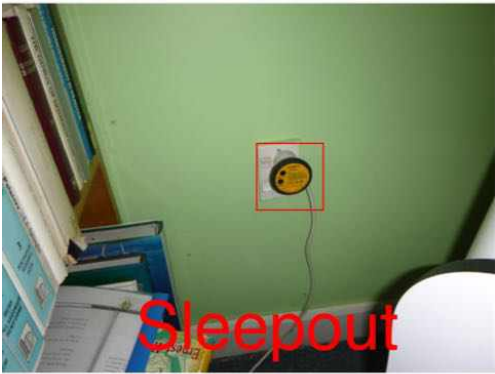
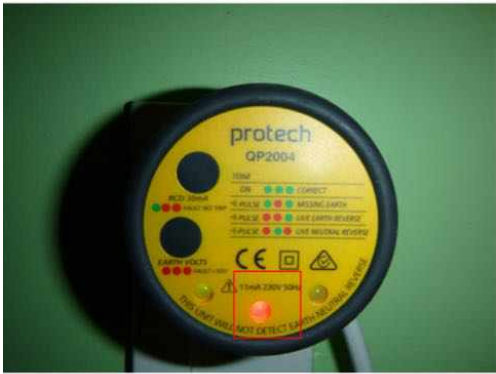
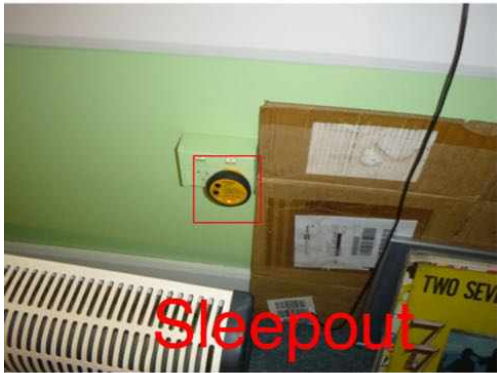
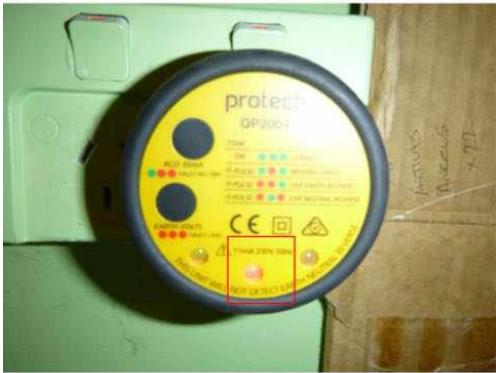
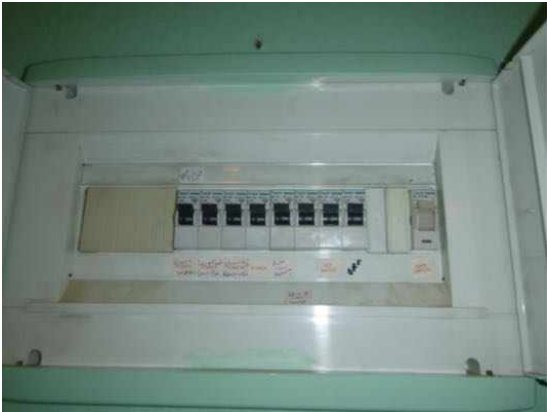
## Defects 3.07

One issue was found during the inspection. Polarity faults were found to a plug in the laundry and two plug in the sleepout. This may mean that the neutral wire is connected to where the hot wire should be, or it is missing the earth wire. This could result in a shock if the appliance is mishandled

A qualified electrician should be appointed to further investigate the fault

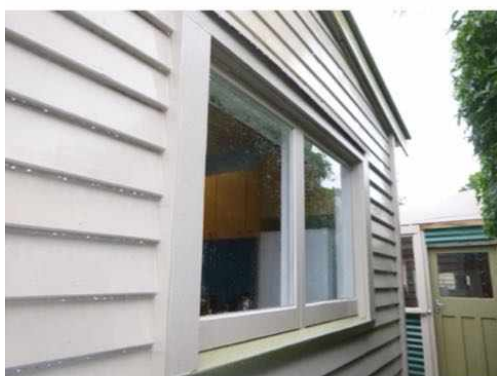
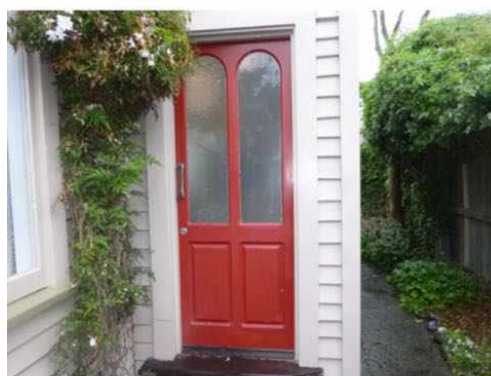
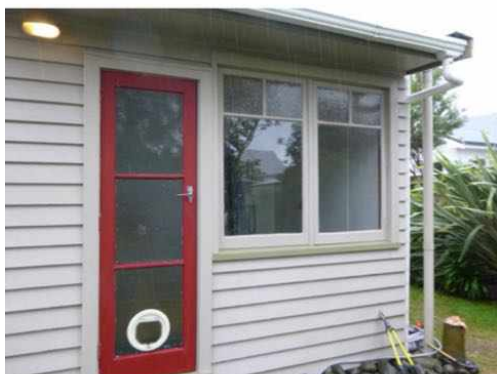
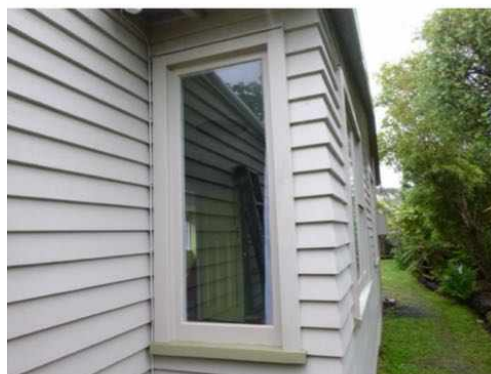
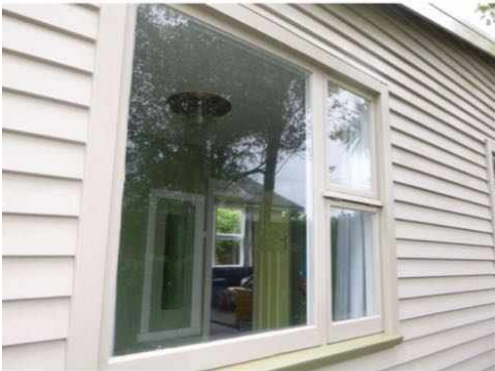
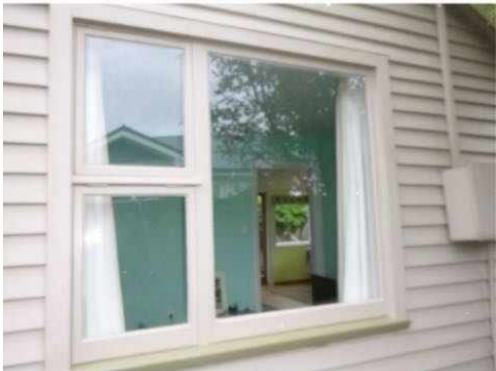
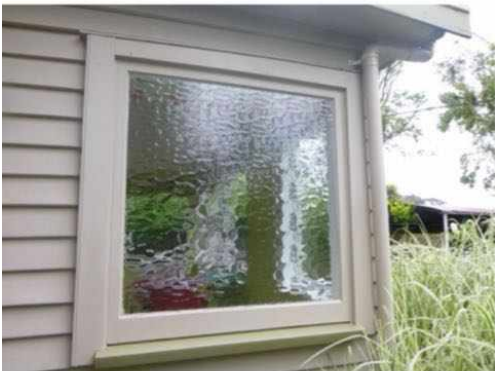
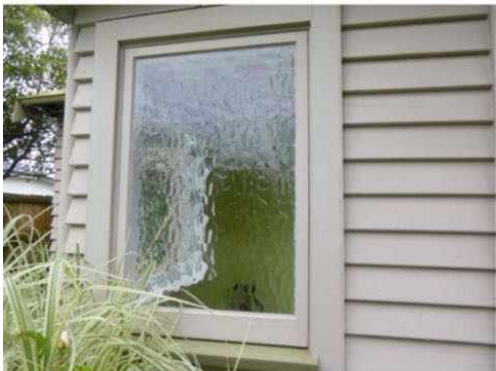
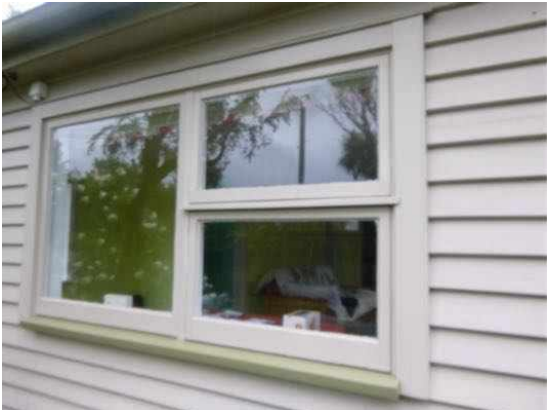
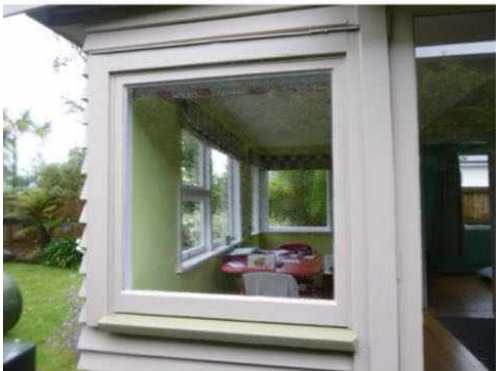
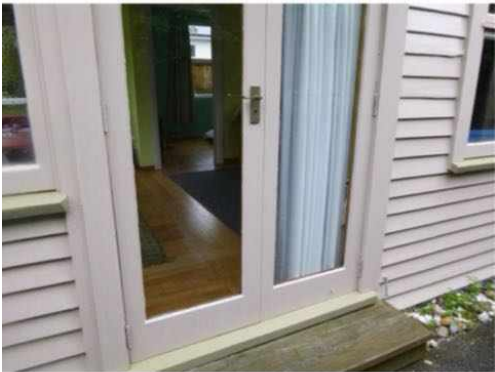
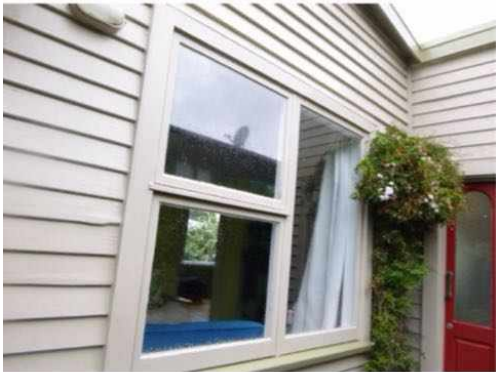
Building: Main Building  
Location: All External Areas  
Finding: Exterior Joinery - Condition  
Information: The exterior joinery is timber frame with single glazing, and timber reveals. All windows and doors were flashed and sealed adequately, and functional.

The timber frames appeared well-maintained and is in good condition for their age. There are minor noted defects that are typical to find on this style of construction.

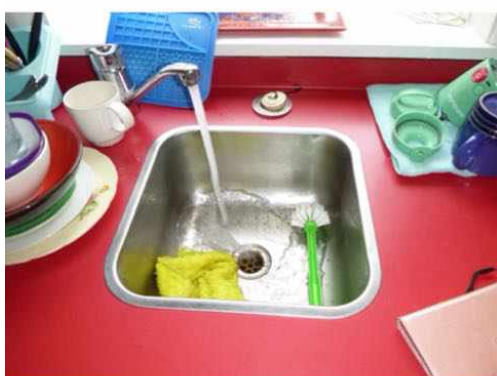
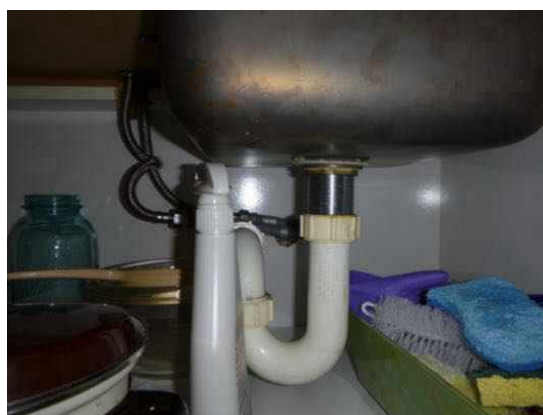
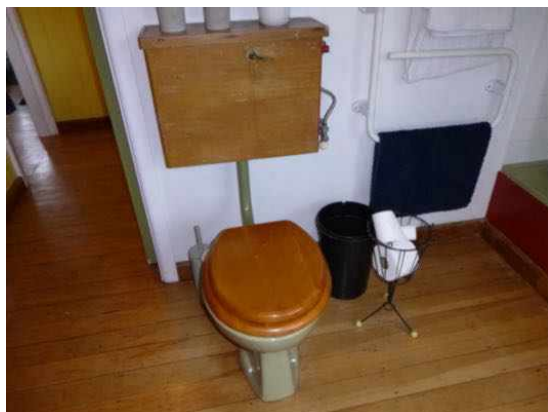
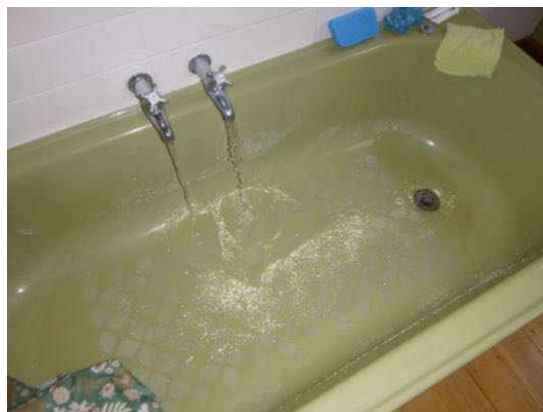
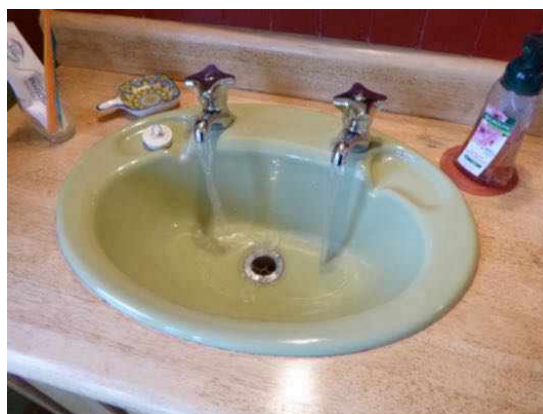
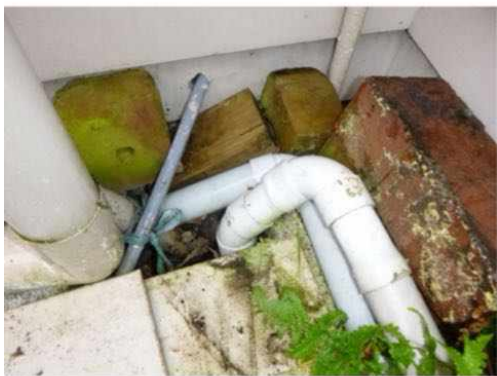
Building: Main Building  
Location: All Areas  
Finding: Plumbing items - Condition  
Information: All taps and the shower were run for a period of time and toilet flushed, it appears the water is running freely. The water pressure was good. The plumbing items appear to be in good condition where visible and tested.

The gully traps were checked and were clear, and are sufficient height off finished ground level. Covers are installed on traps to prevent debris getting into the grey water system

The water is heated via an electric hot water cylinder.

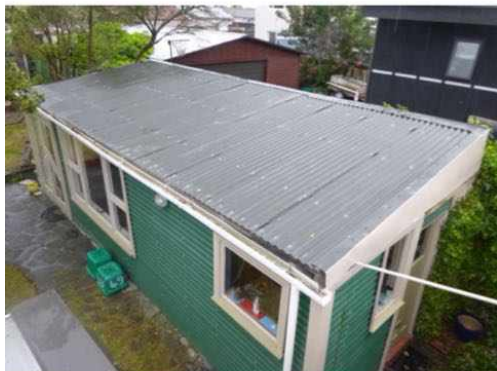
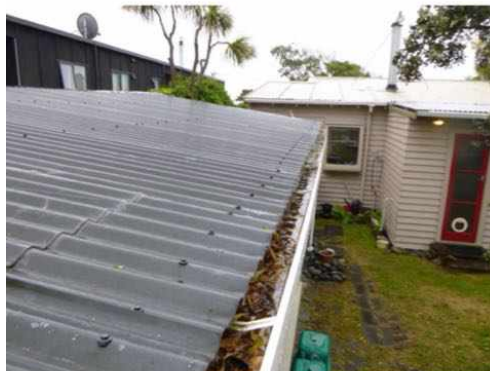
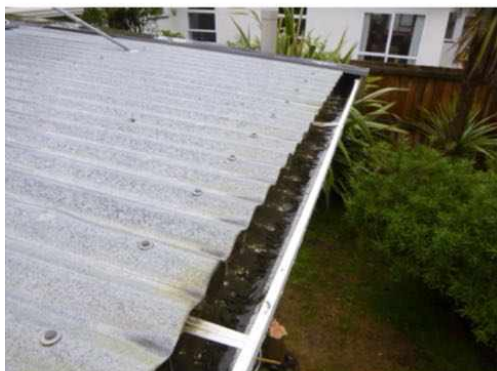
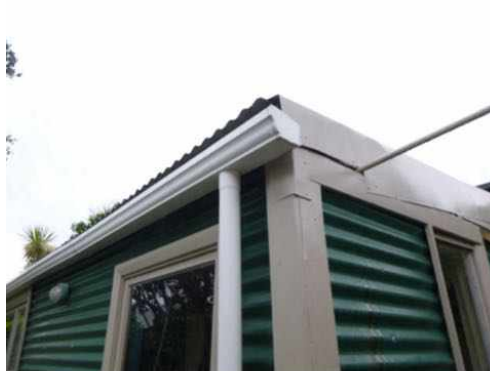
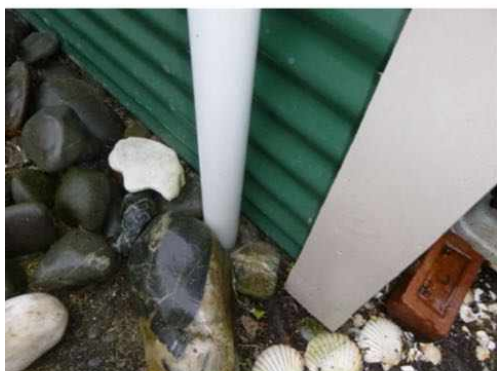
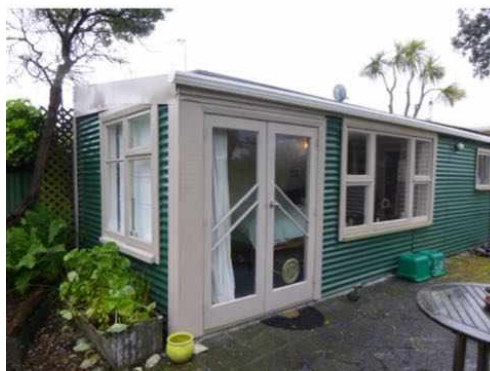
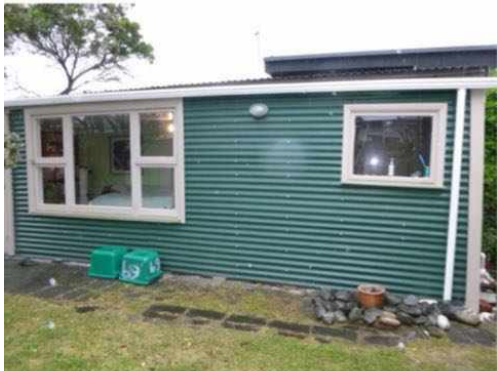
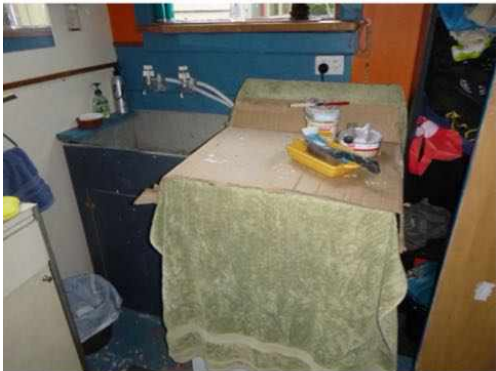
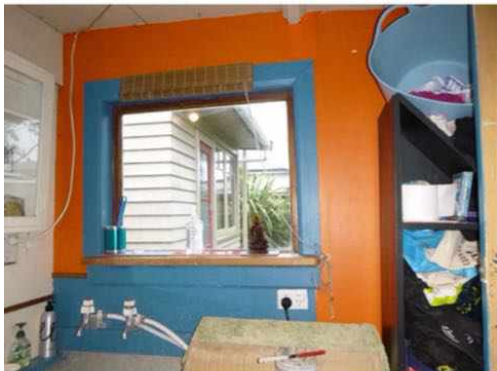
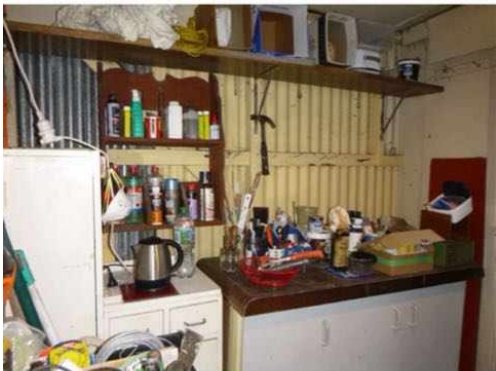
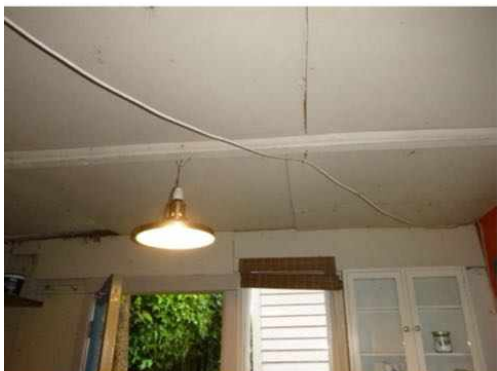
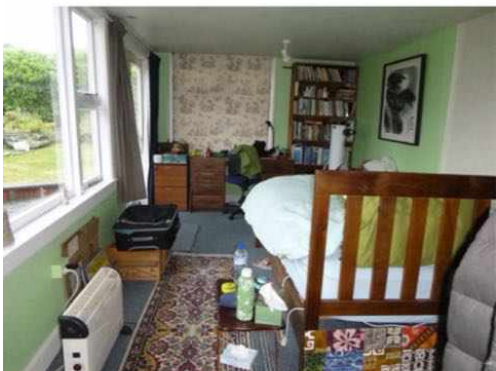
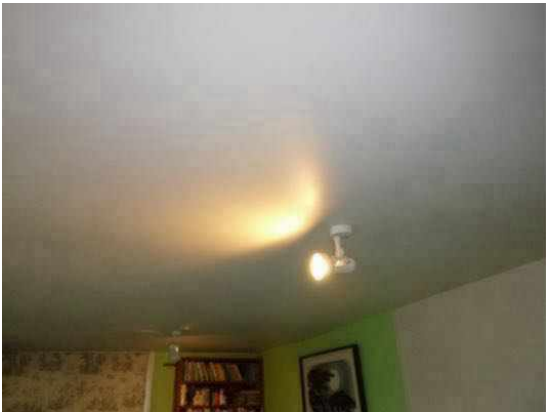
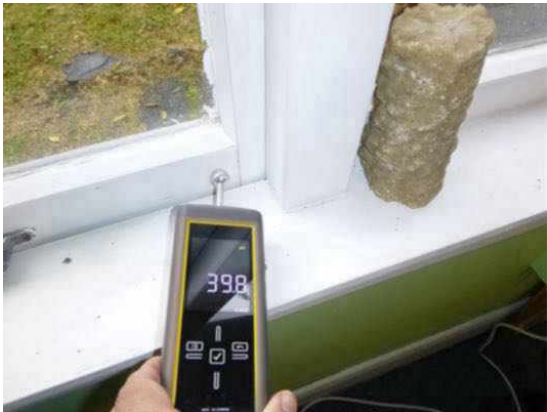
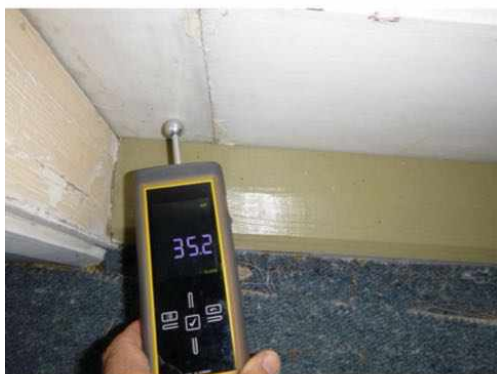
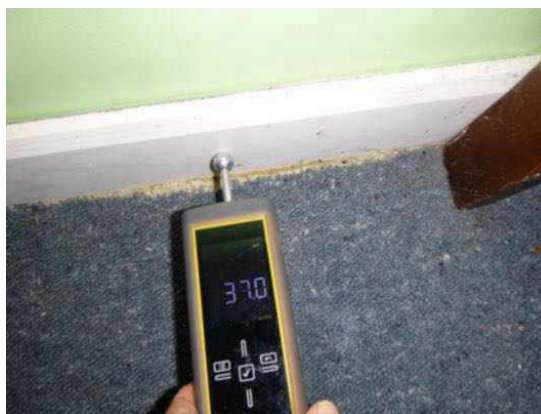
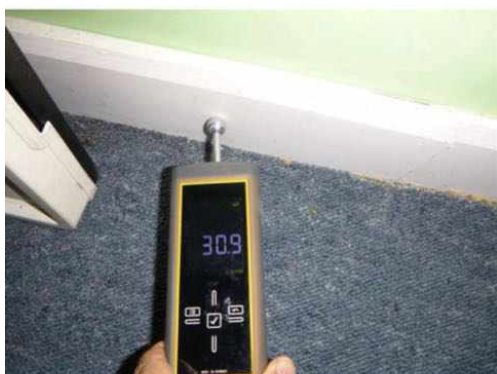
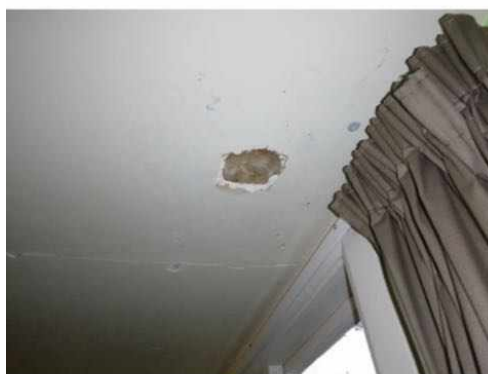
Building: Studio  
Location: All Areas  
Finding: Laundry/Studio - Condition  
Information: The detached building is timber framed construction with coated corrugated metal roofing. This sits on a concrete slab. The exterior cladding is horizontal corrugated iron.

This appeared in good overall condition and structurally sound.
