## BUILDING INSPECTION REPORT

## NZ Residential Property Inspection Report

Inspection Date: Thu, 13 Nov 2025

Property Address: 43 Tovey Street, New Brighton,  
Christchurch 8061, New Zealand

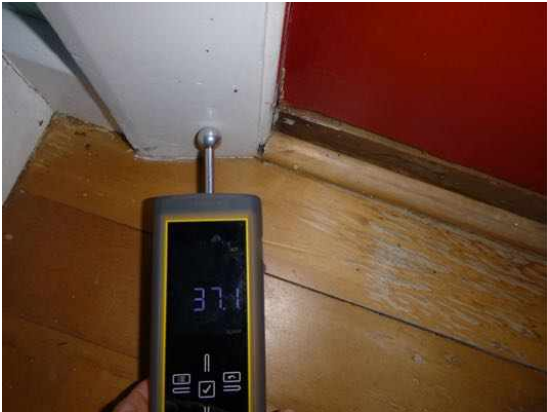
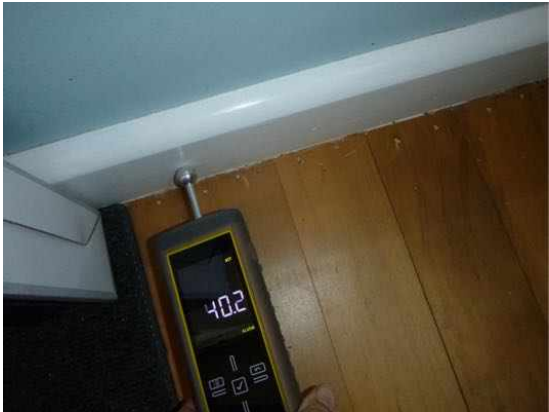
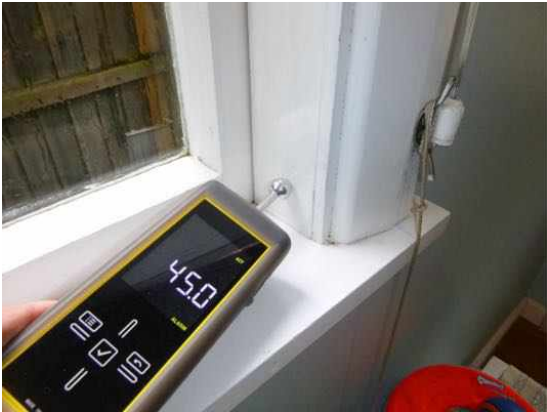
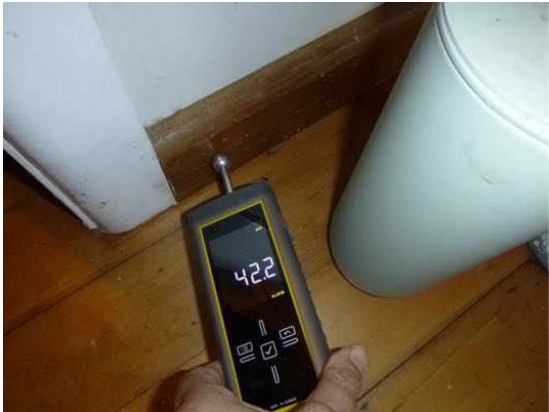
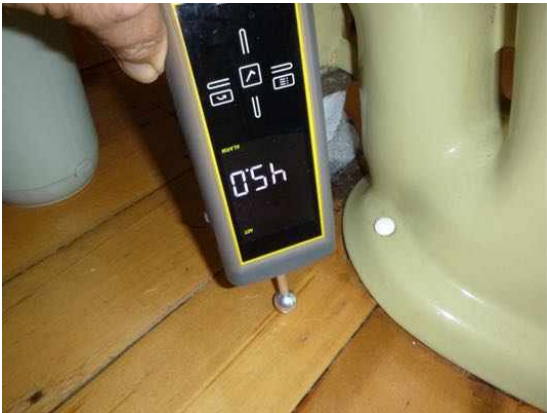
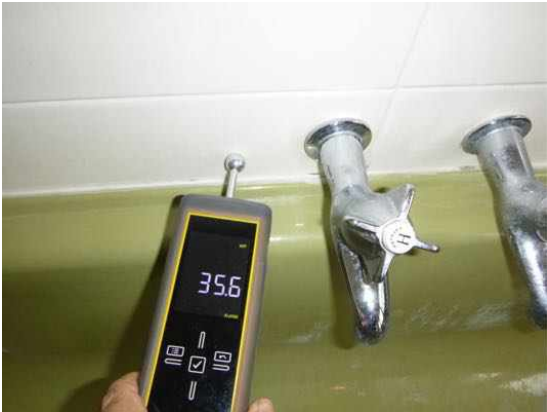
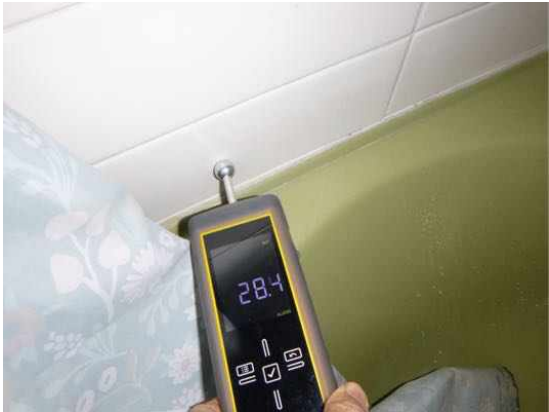
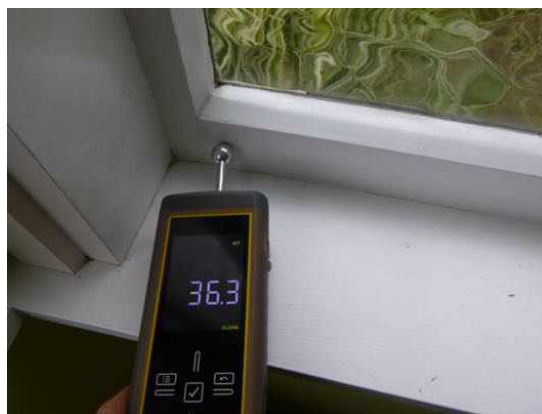
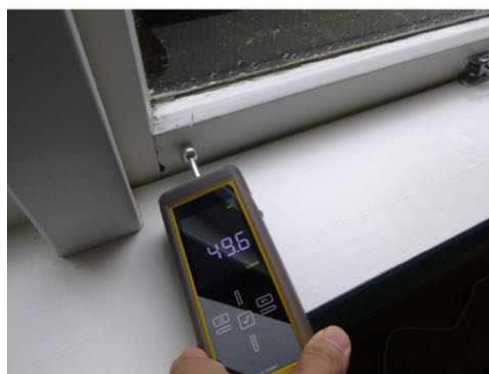
Building: Main Building  
 Location: All Areas  
 Finding: Moisture Readings  
 Information: Moisture readings were taken using a Trotec T660 capacitive non-invasive moisture meter. No indications of any elevated moisture levels were detected.

Moisture meter reading Guide: 0-50 = Dry, 50-80 = Damp, 80 Plus = Wet

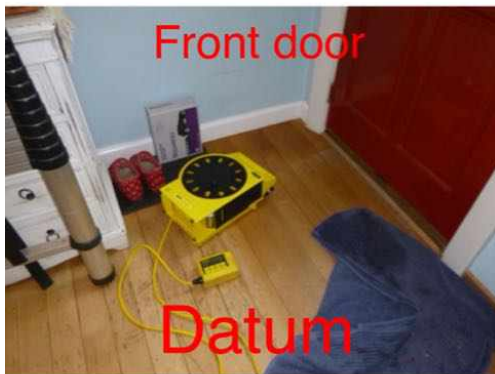
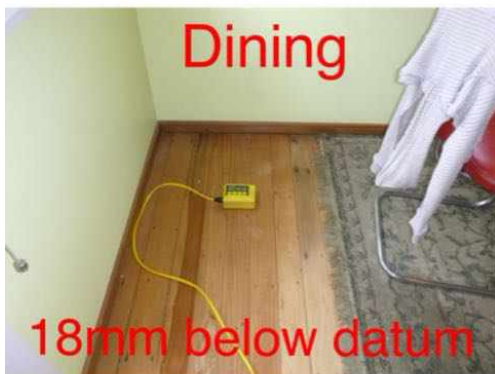
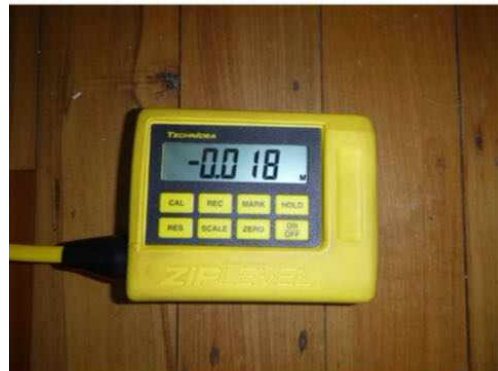
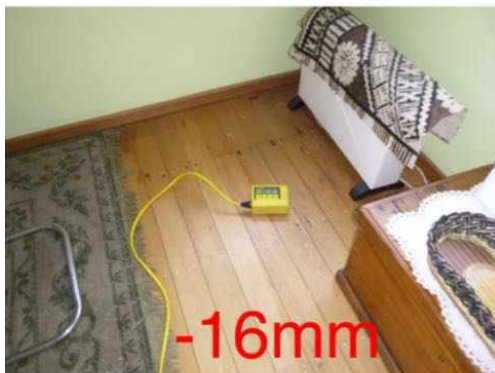
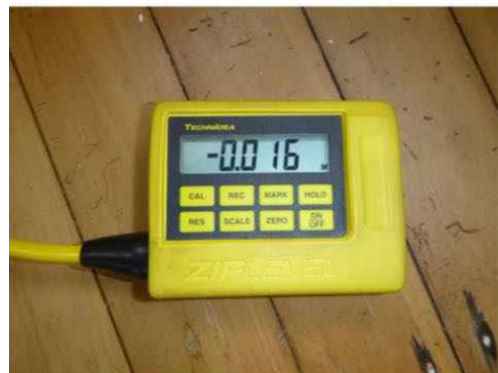
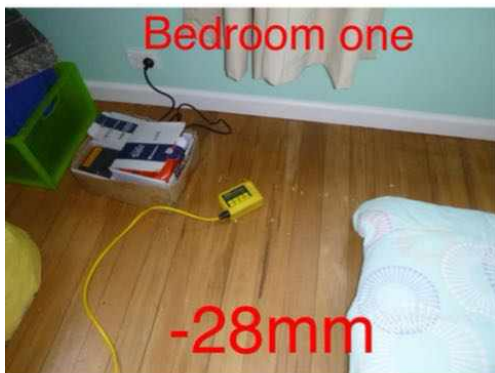
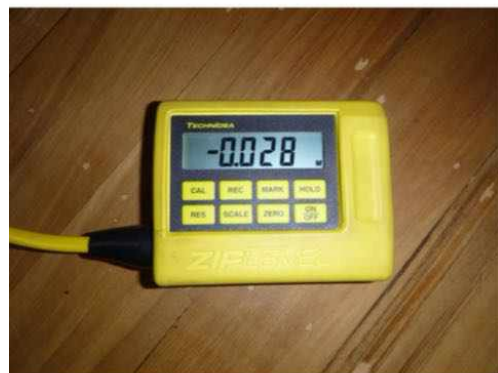
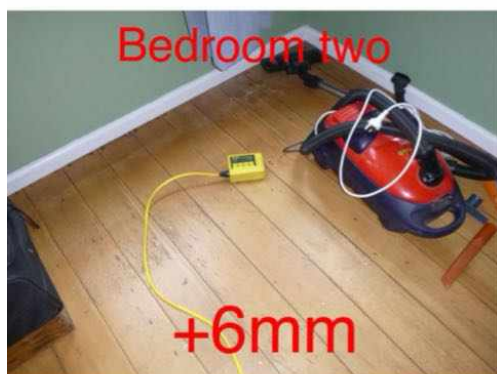
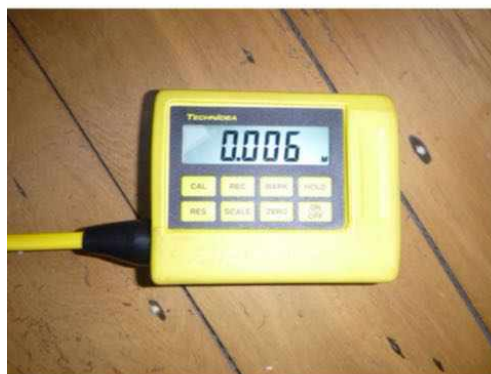
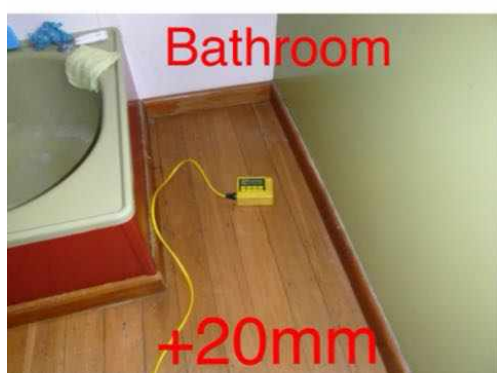
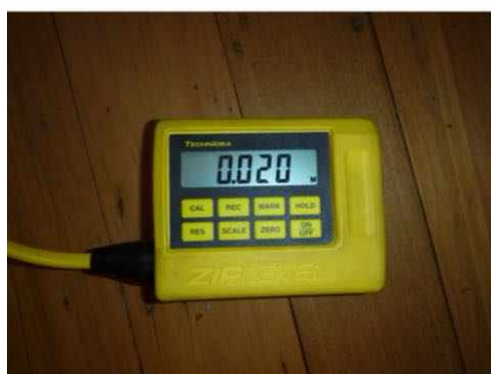
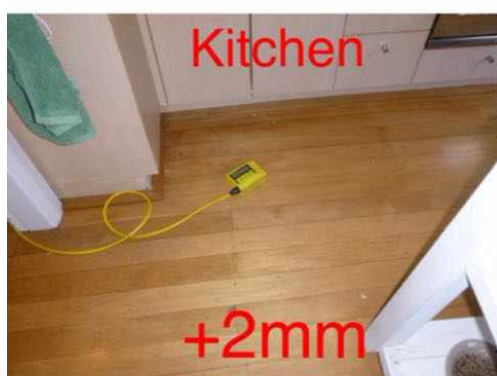
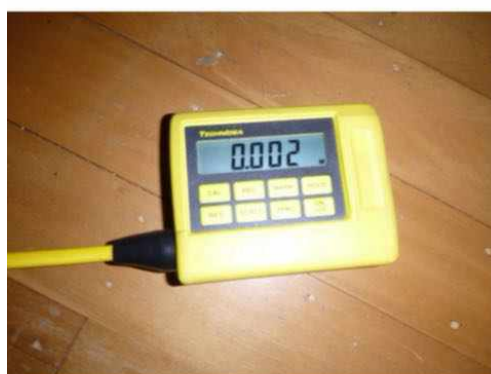
Building: Main Building  
 Location: All Areas  
 Finding: Floor - Levels  
 Information: Spot floor level readings were taken throughout the main floor areas of the dwelling where accessible. (JBI take into account floor covering thicknesses as needed throughout the dwelling)

This falls within the MBIE guidelines of 50mm over 10 metres.

All levels are within the MBIE guidelines over a short distance, being less than 0.5% or 10mm over 2 meters.

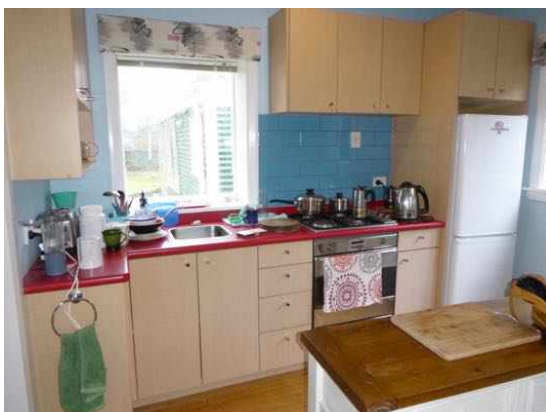
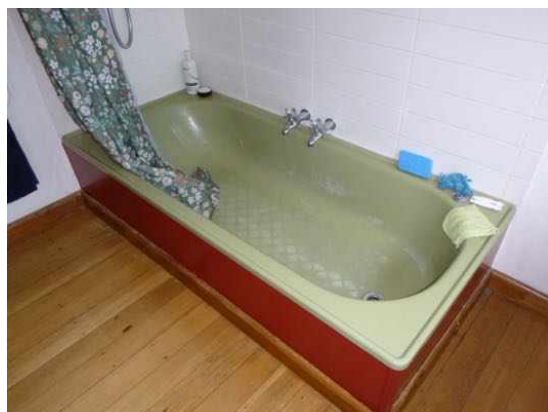
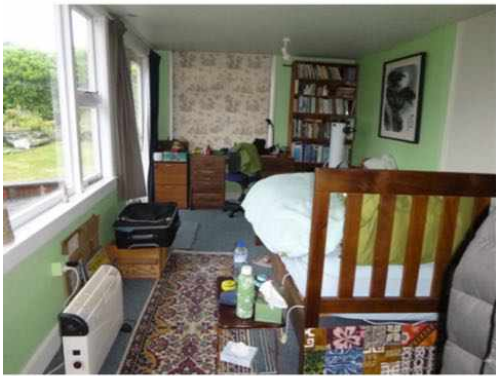
Building: Main Building  
 Location: All Areas  
 Finding: Additional Photos - Obstructions and Limitations  
 Information: These photographs are an indication of the obstructions and limitations which can impede a full inspection of the property at the time of inspection. These obstructions can hide an array of defects.

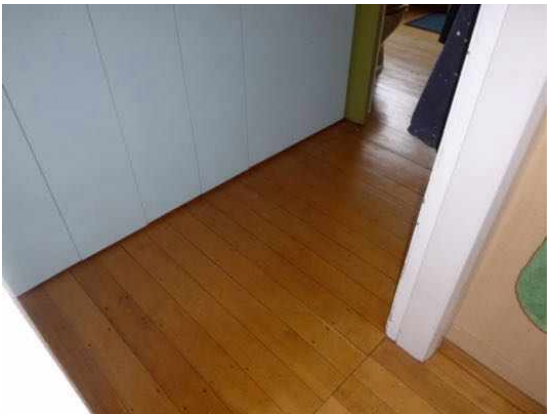
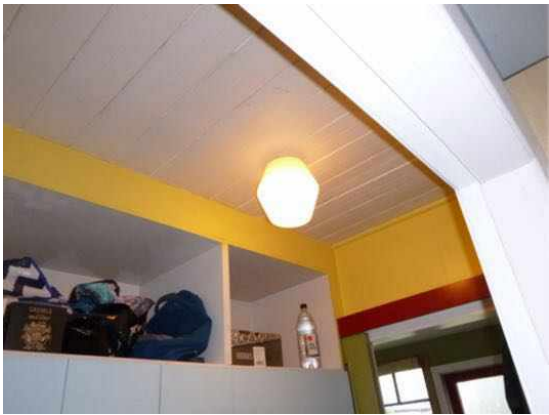
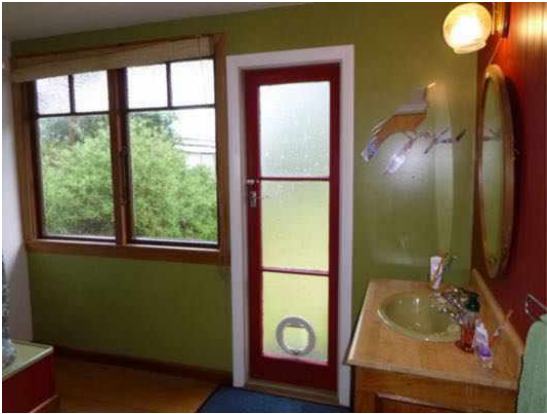
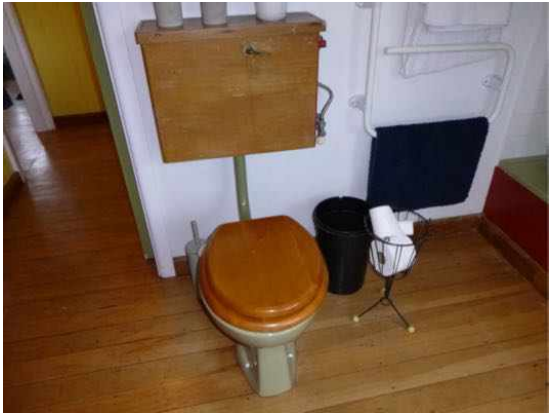
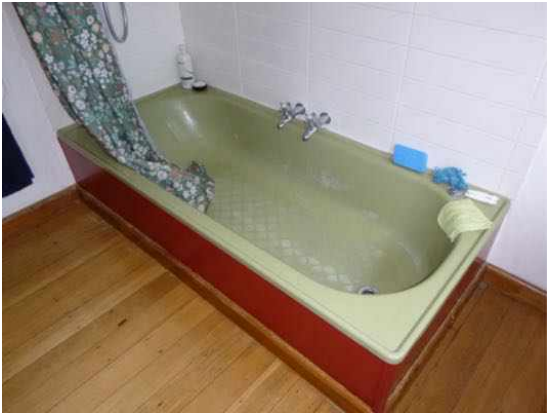
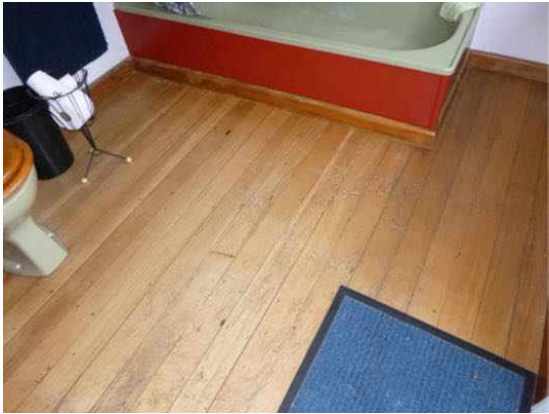
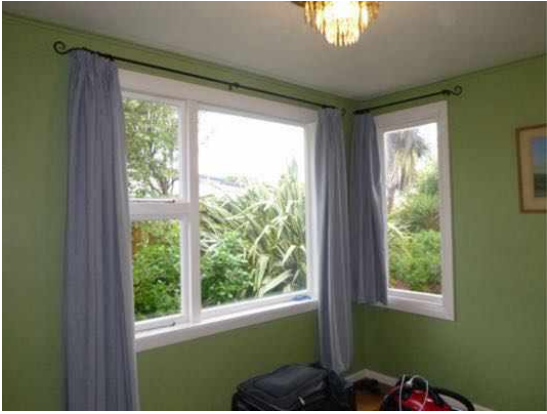
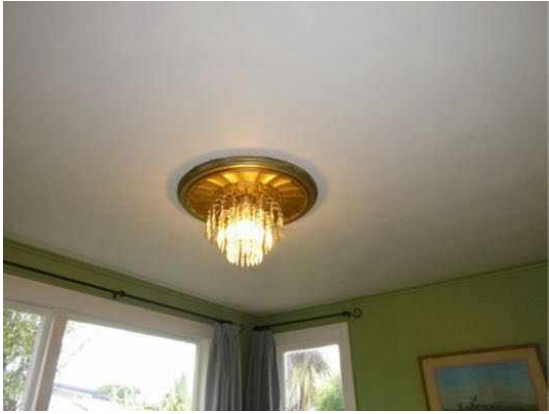
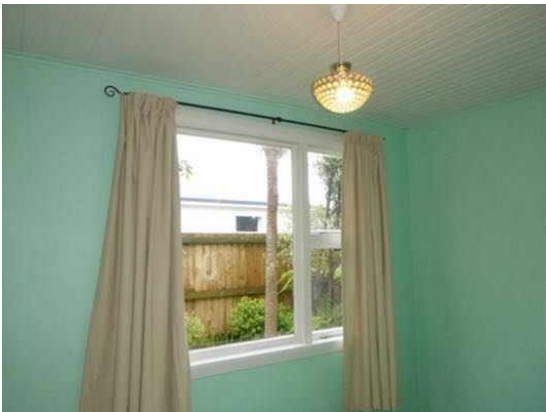
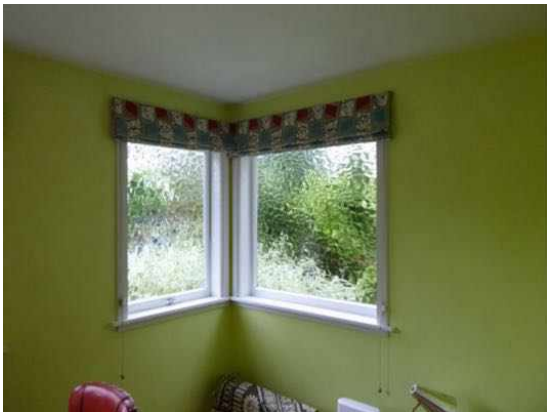
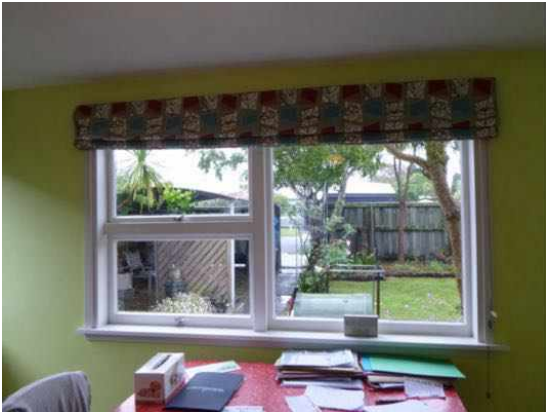
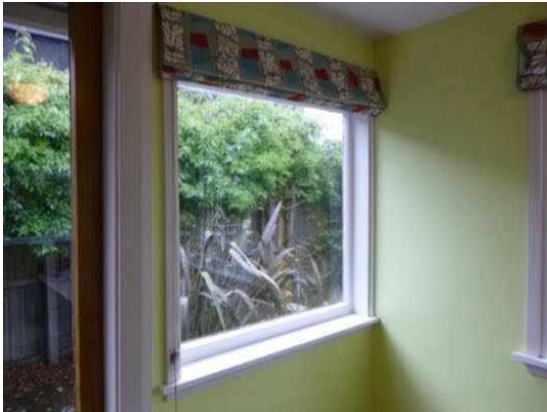
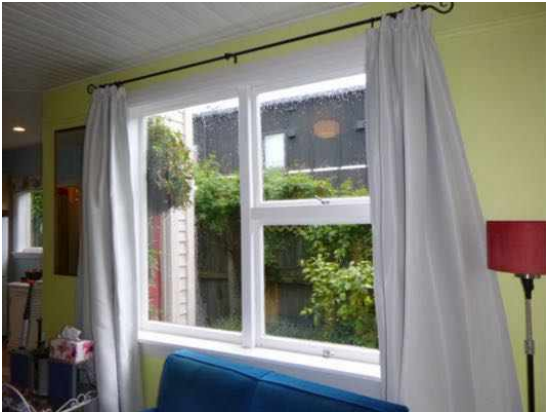
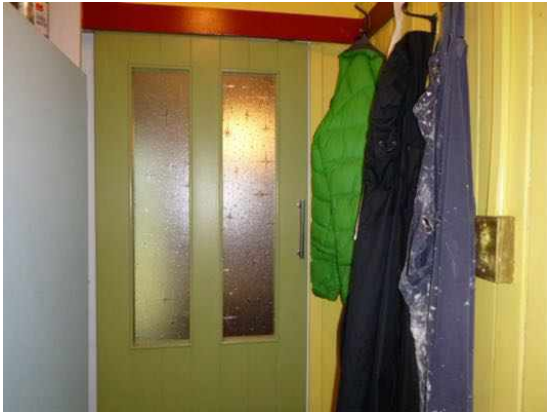
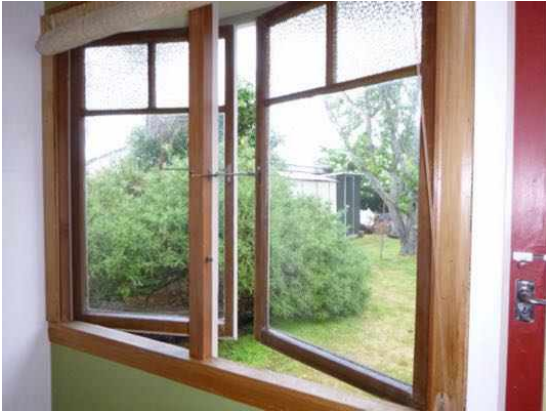
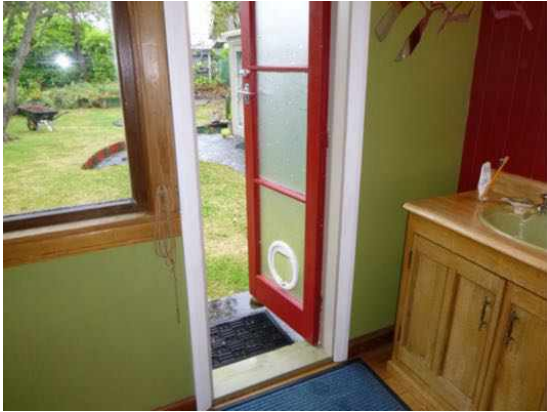
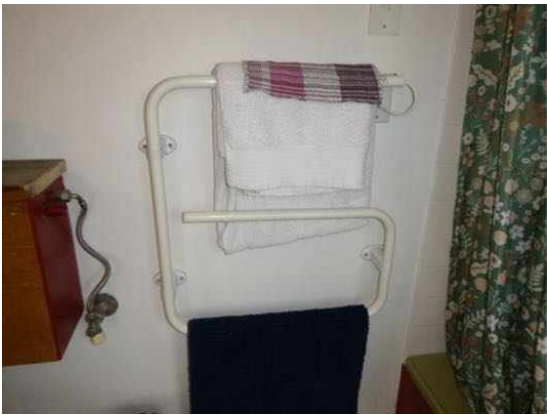
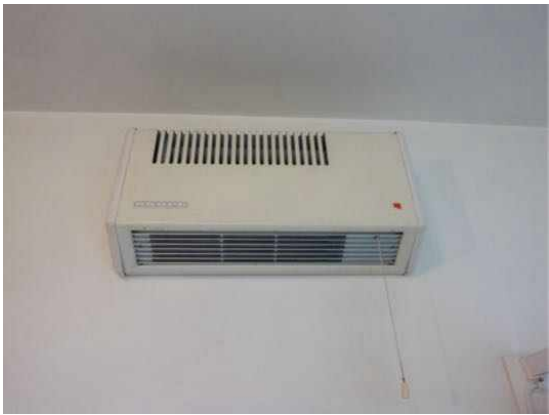
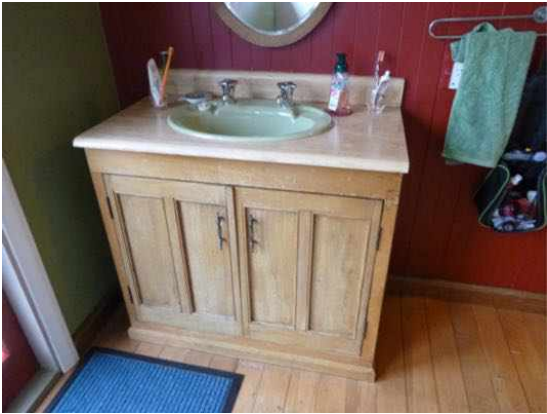
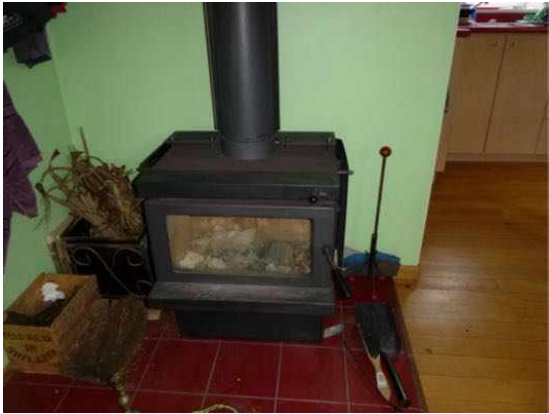
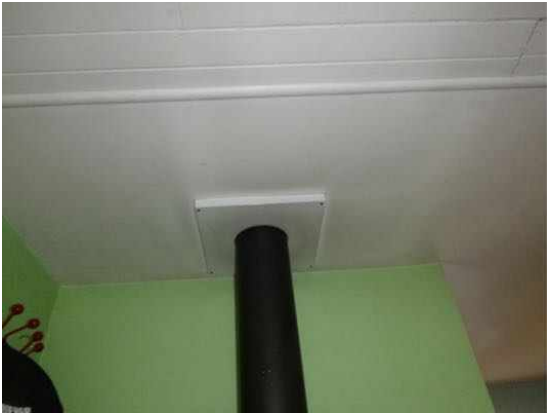
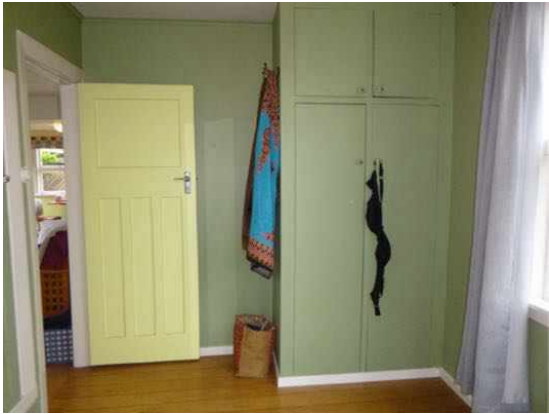
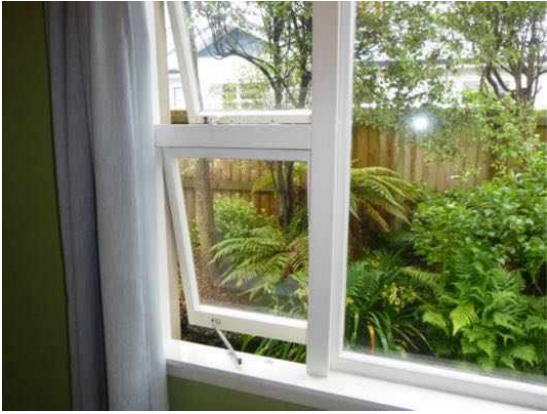
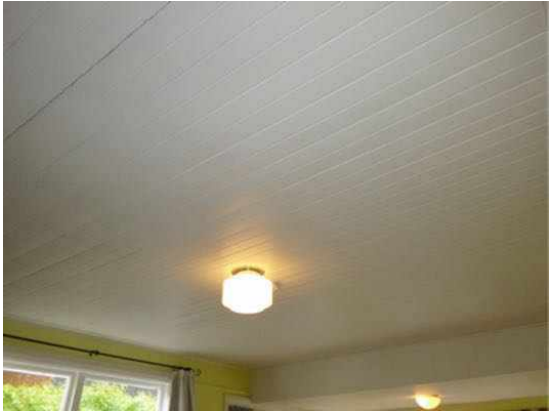
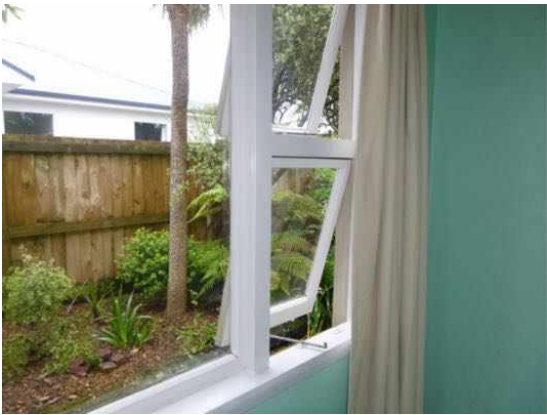
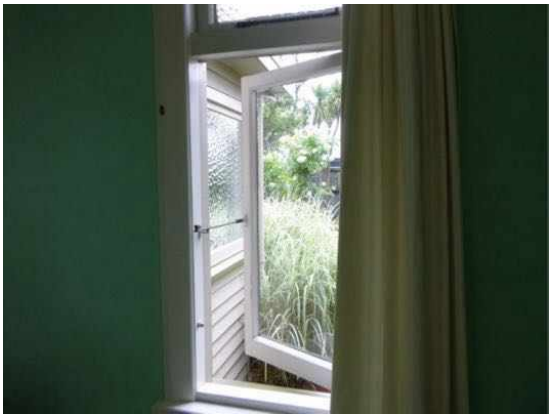
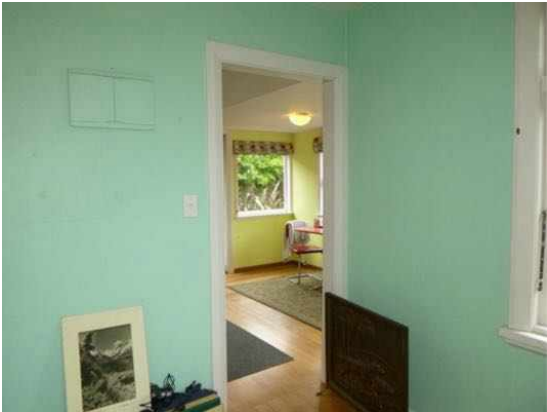
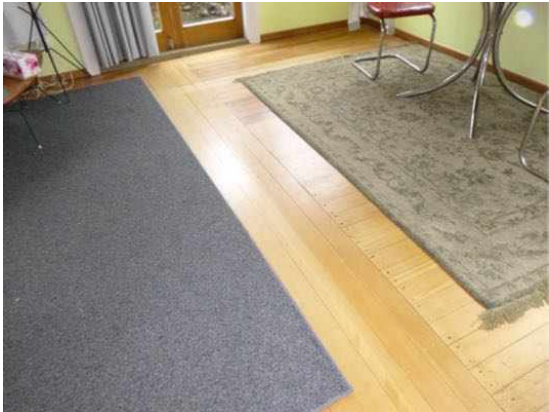
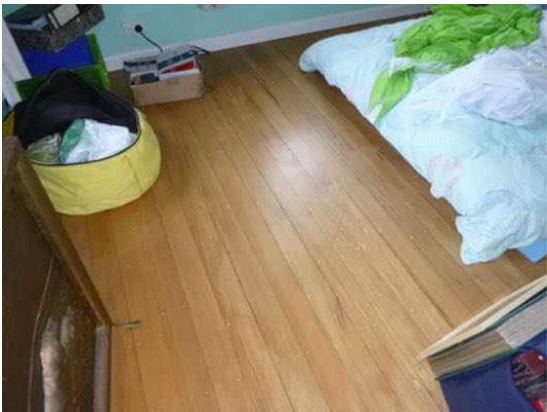
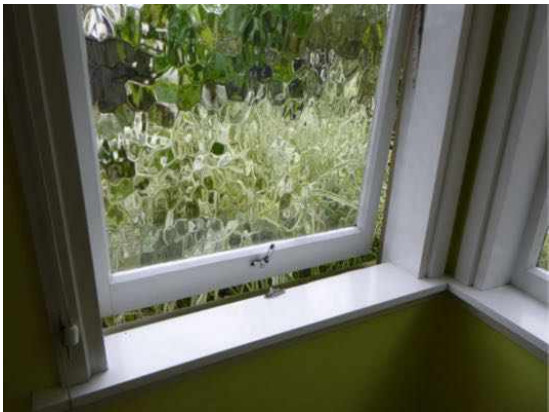
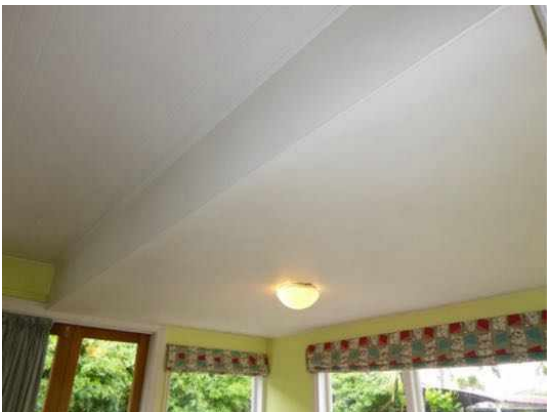
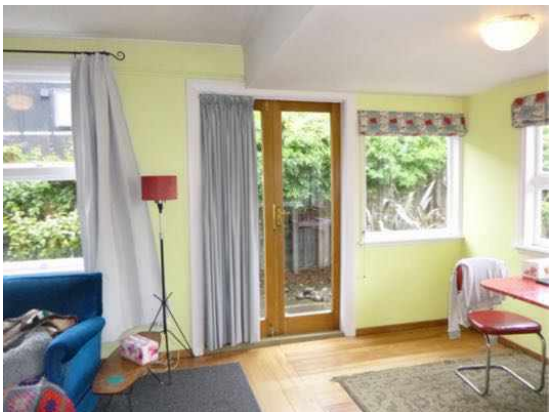
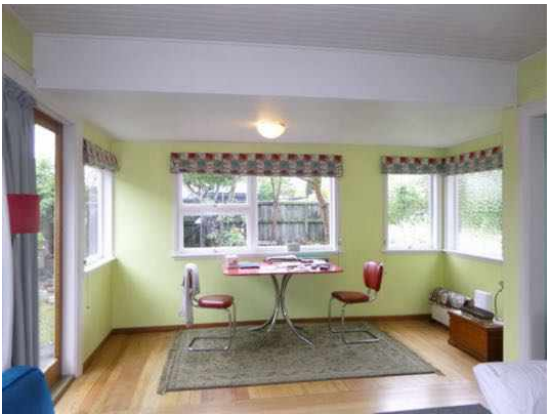
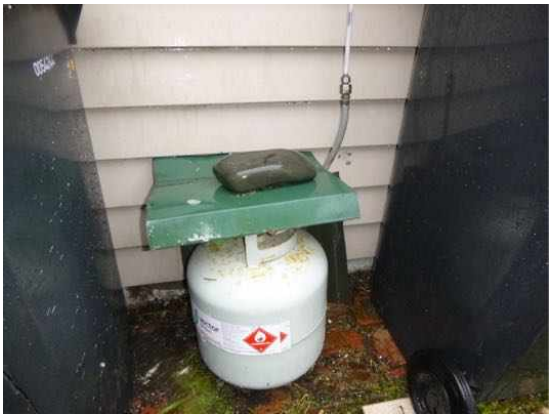
Building: Main Building  
Location: All Areas  
Finding: Additional Photos  
Information: Additional photos are provided for your general reference, and can be considered to be in good condition.
