EARTHQUAKE RECOVERY (EQR) DOCUMENTATION

Released under the Official Information Act 1982
EQR Property Overview Report

EQC Property ID	Property Address	Vulnerable?	Property F Status	Property Finalisation Indicator		
2010089178	15 WYCHWOOD CRESCENT, BISHOPDALE		F3 - Complete & Finalised	Some Finalisation has taken place		
Main Contractor:	CLOSED OUT-Hollyford Limited t/a Renovation Specialists ***** (S745)		Property F2'd By:	System Generated Finalisation	F2 Completed Date:	10-04-2015
Cont Managing Hub:	<UNALLOCATED>	Not Vulnerable	Property F3'd By:	System Generated Finalisation	F3 Completed Date:	10-04-2015

Address	15 WYCHWOOD CRESCENT, BISHOPDALE, CHRISTCHURCH, 8051	EQC Claim Number	CLM/2011/138670
Hazards	Nil	EQC Assessor (L,F)	Shanahan, Foss
Inspection Date	04-Nov-2011	Placard	No Sticker
Status	Current	EQC Estimator (L,F)	Thomas, Charles

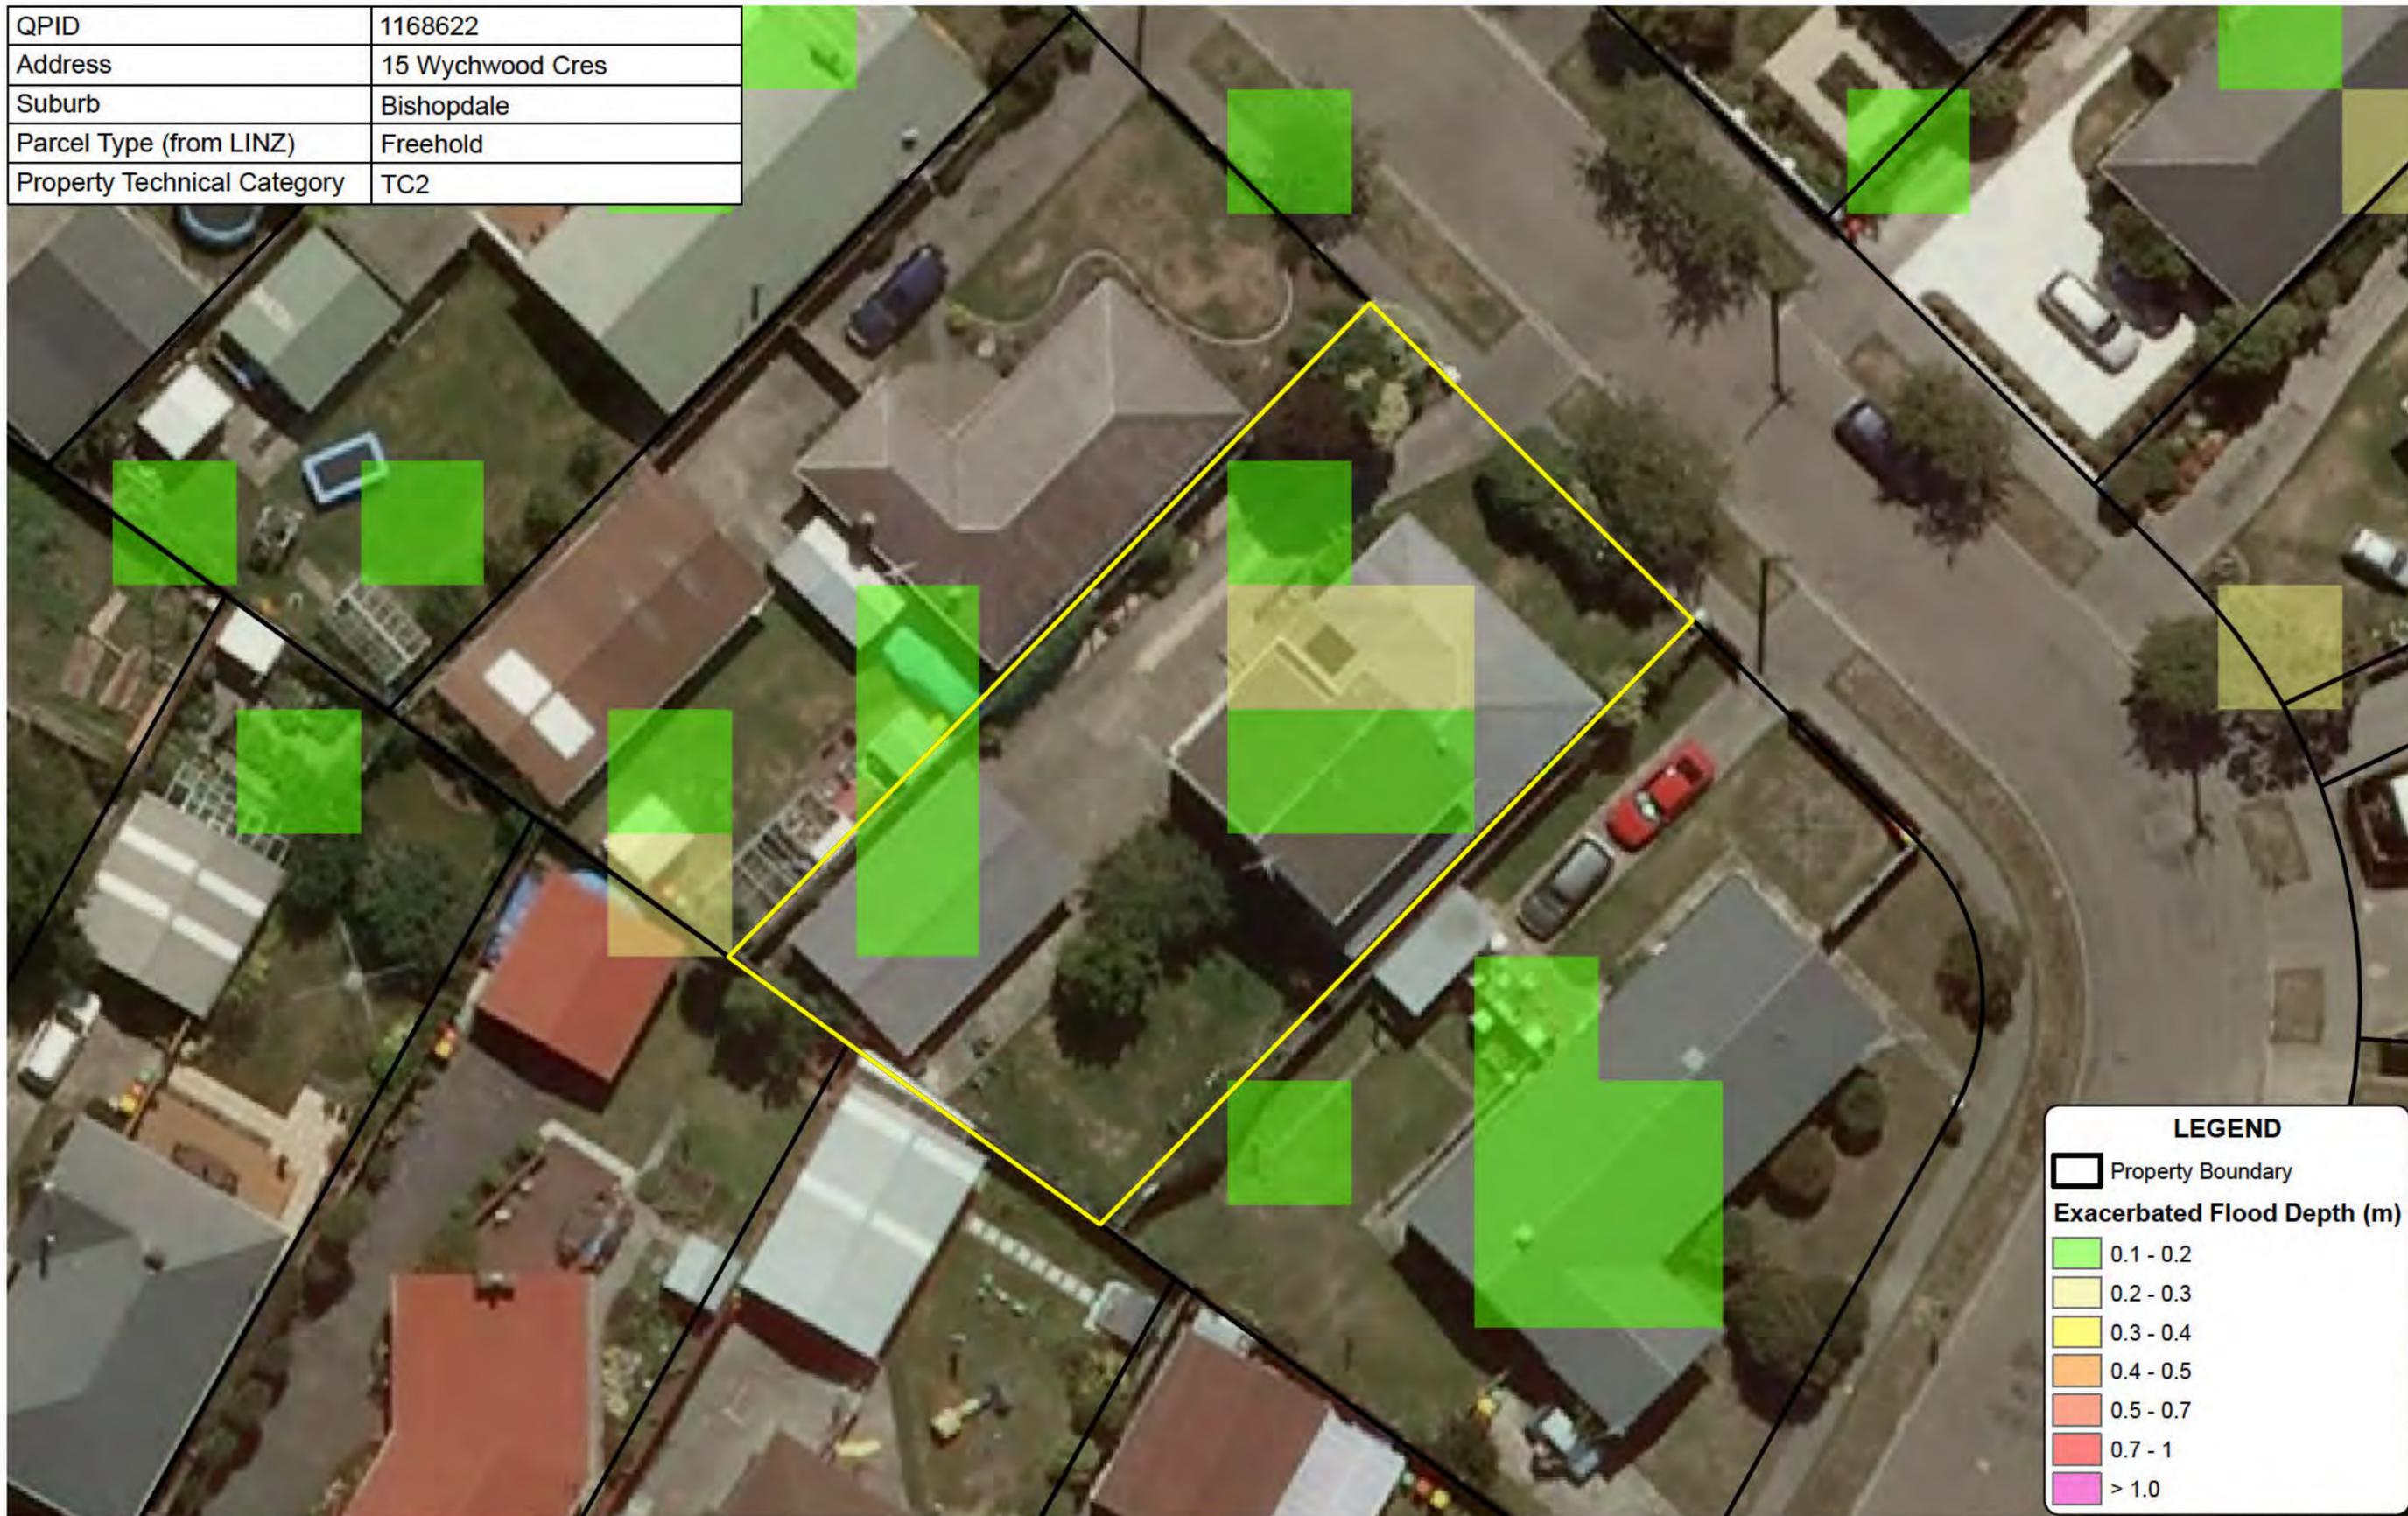
This engineering assessment identifies that the Property	DOES NOT have IFV land damage
--	-------------------------------

Threshold 1: Has the exacerbated flood depth on the residential land increased by 0.2m or more as a result of the Canterbury earthquake sequence?	No
Threshold 2: Has the exacerbated flood depth on the residential land increased by 0.1m or more as a result of a single earthquake event?	Yes
Threshold 3: Has the residential land suffered observable land damage as a result of the Canterbury earthquake sequence?	Yes
Have any exceptions to the three engineering thresholds been identified for the Property? EQC requires consideration of Event exception, Uplift exception and Land damage exception.	No
What is the finding of the site specific assessment?	
Land does not have IFV	
What is the finding of the final engineering review including consideration of the vulnerability of properties to higher frequency events and patterns of exacerbated flood depths of between 0.1m and 0.2m?	
Land does not have IFV

Map 1 shows exacerbated flood depth caused by the Canterbury earthquake sequence. The exacerbated flood depth is used as a measure of IFV. The exacerbated flood depth is defined as the increase in flood depth due to onsite land subsidence. This does not include changes in

flood depth that may have occurred due to off-site factors, such as changes to river heights, river banks, river beds and damage to stormwater infrastructure.
