## BUILDING INSPECTION REPORT

## **NZ Residential Property Inspection Report**

Inspection Date: Thu, 13 Nov 2025

Property Address: 43 Tovey Street, New Brighton,  
Christchurch 8061, New Zealand

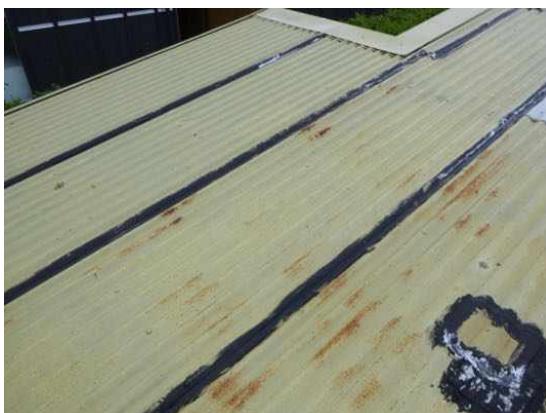
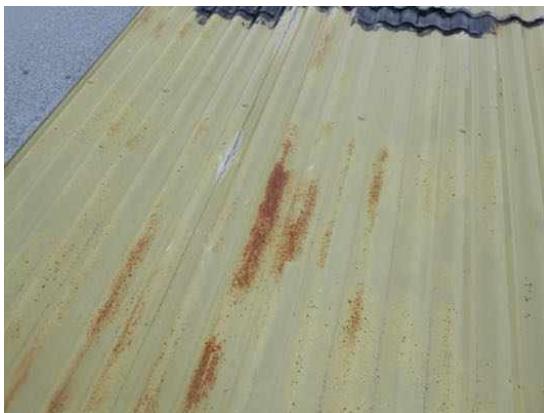
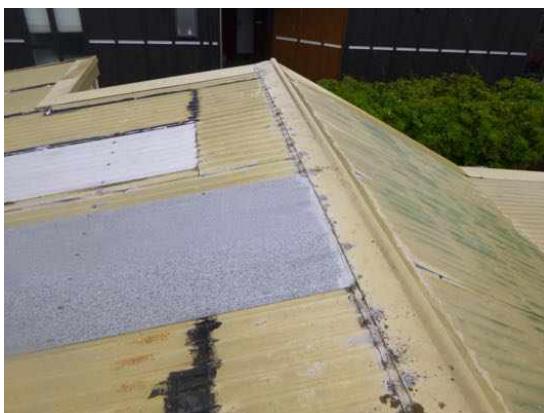
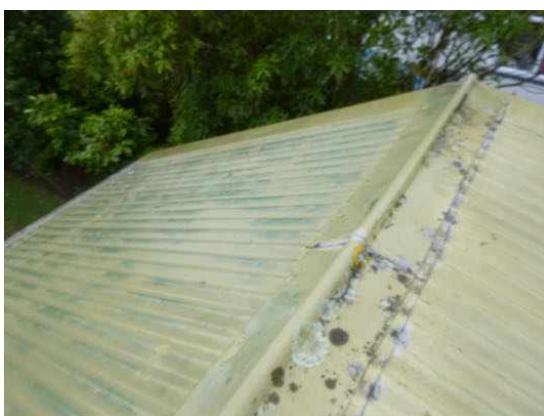
#### Defects 3.01

Finding: Roofing - Condition

Information: The visible corrugated roofing and flashings appeared in fair to poor condition for its age. All penetrations and flashings were installed and sealed adequately.

Evidence of surface rust to some sections was identified. Some patching and re-coating was evident. If left unmanaged, this could allow water ingress to the internal roofing structures, potentially leading to secondary damage of building elements.

Accelerated deterioration of the roofing sheets and any associated building elements is also likely to occur. Replacement or the roofing should be considered. Failing this is advised that a professional painter be consulted to carry out works such as the application of rust-retardant surface protectors and roof paint, in the near future.

The roof is fastened down with roofing nails which can be prone to popping overtime. As general house maintenance, periodically check nails and replace any that may have popped with suitable roofing screws.

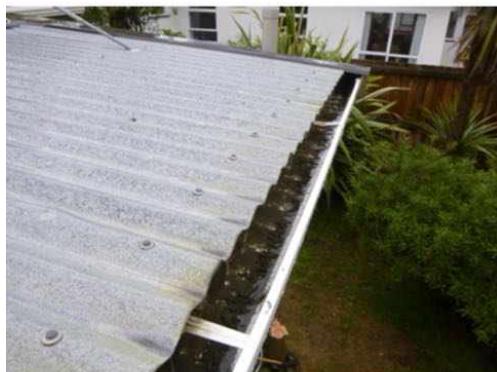
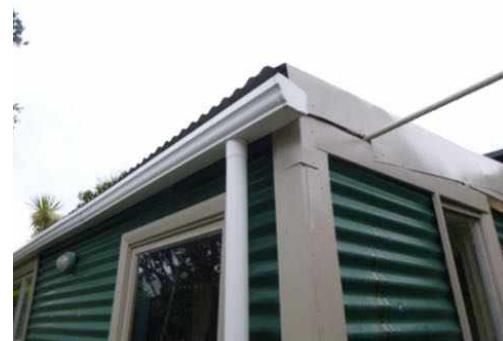
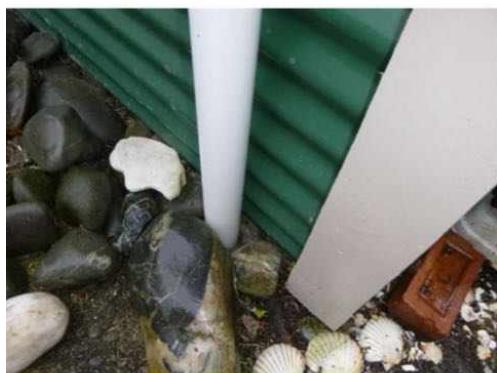
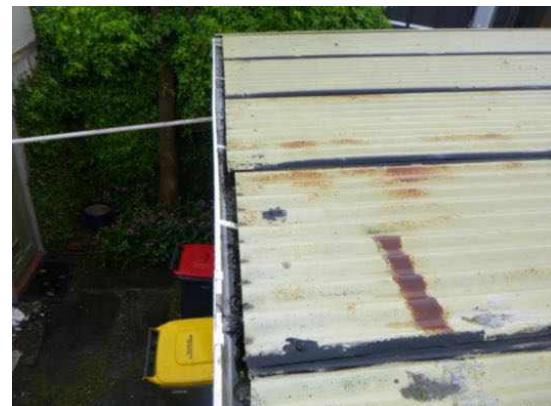
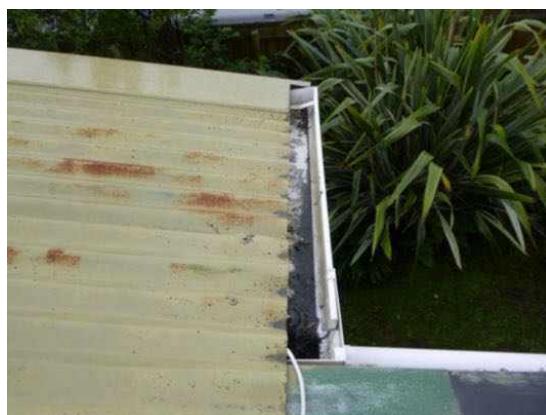
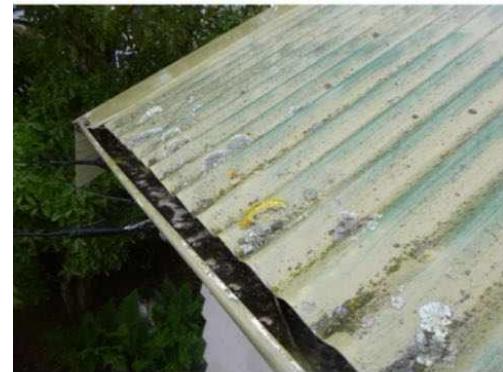
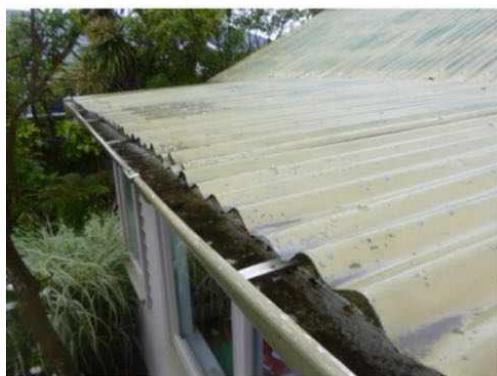
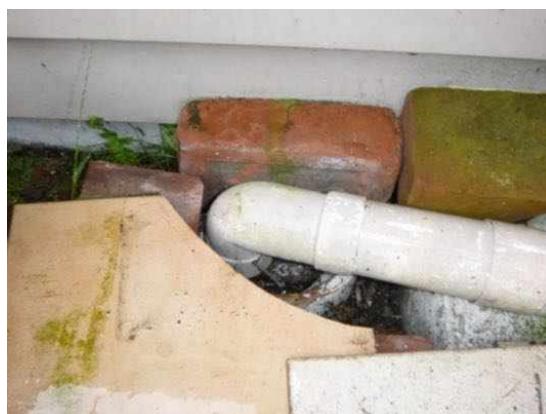
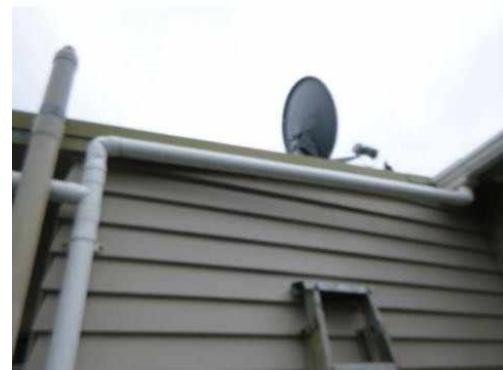
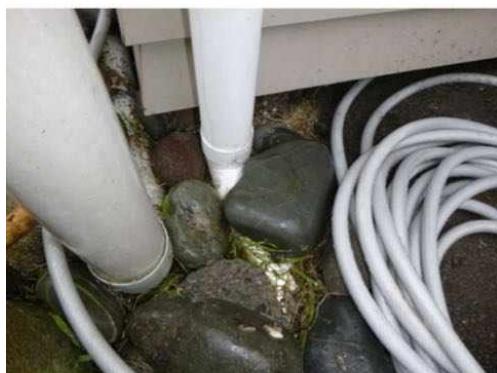
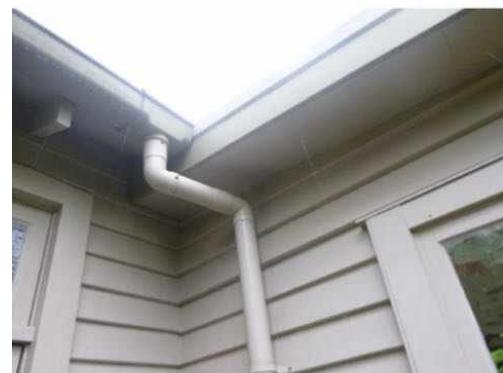
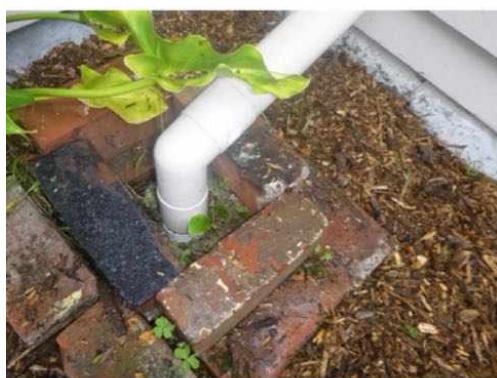
### Defects 3.02

Building: Main Building  
Location: Roof Exterior  
Finding: Gutters and downpipes - Condition  
Information: The PVC gutters and downpipes around the property appeared to be in good condition, allowing good drainage to the downpipes. There does not appear to be any stormwater risers or connection the stormwater system.

Roof plumbing structures, such as guttering and downpipes should be free of all debris to prevent blockages. It is advised that gutters are checked by the homeowner or a general handy person as part of regular maintenance.

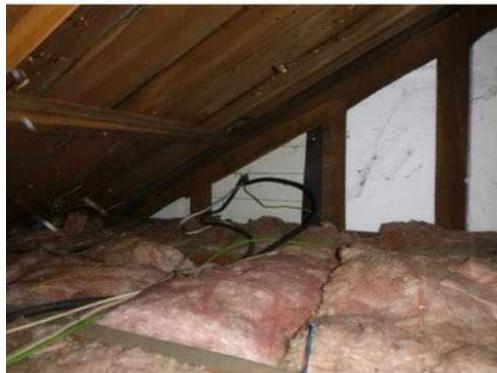
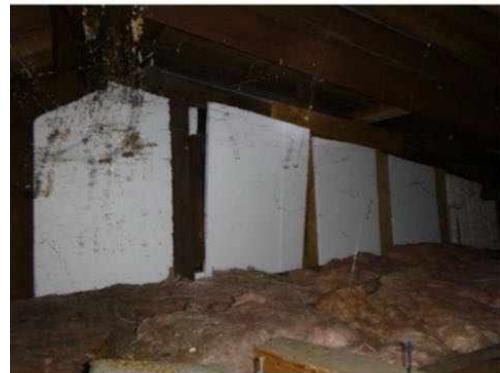
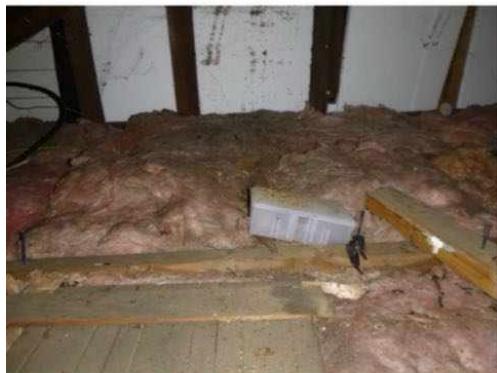
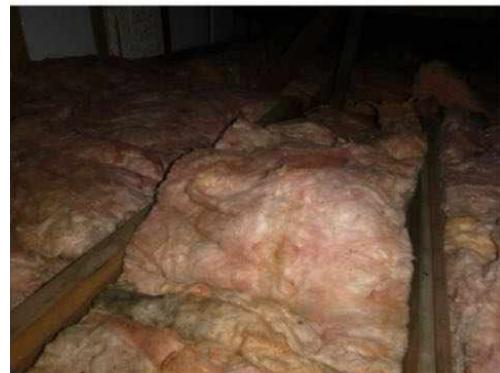
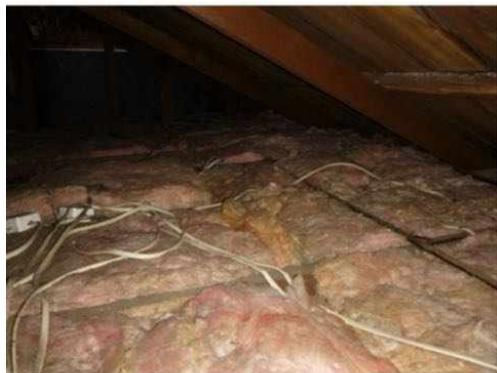
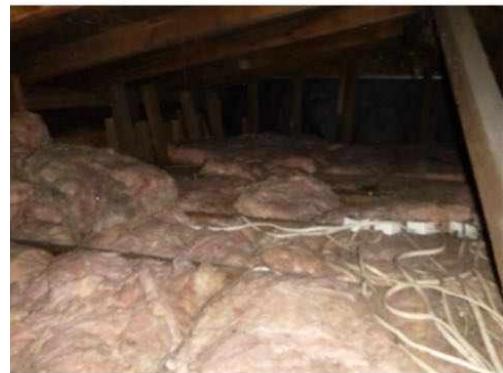
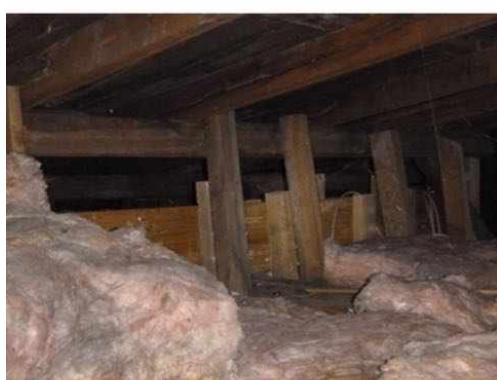
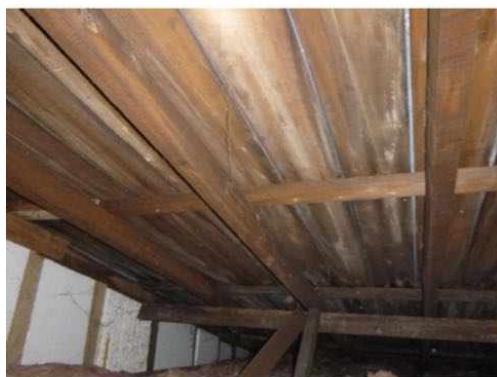
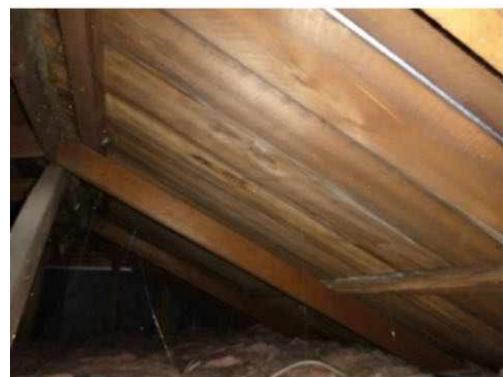
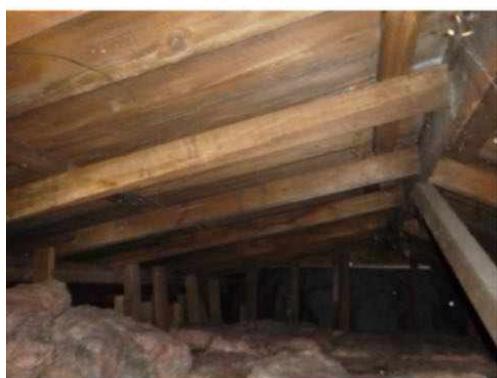
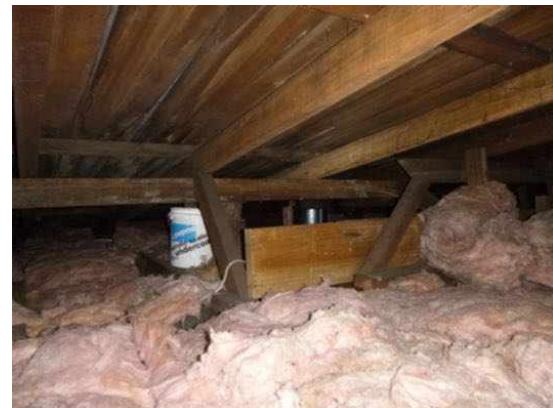
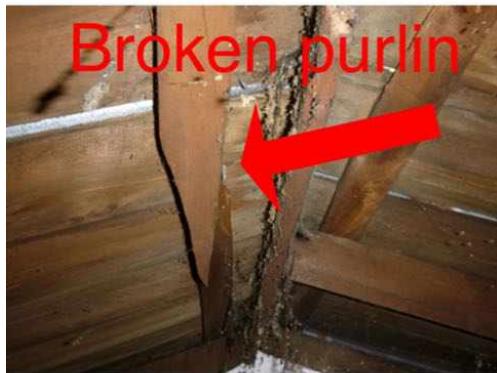
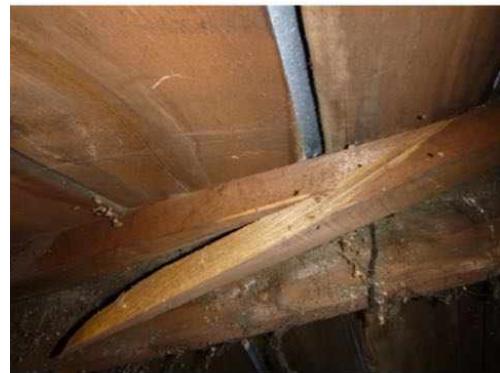
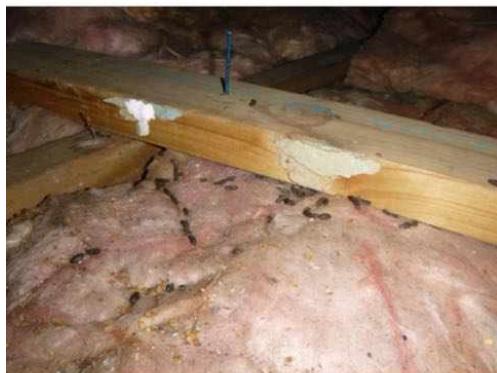
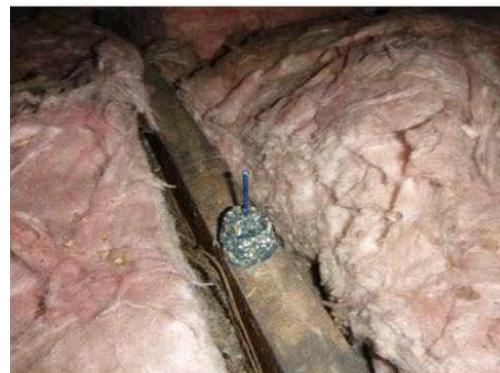
### Defects 3.03

Building: Main Building  
Location: Roof Void  
Finding: Roof space - Condition  
Information:

The roof space was in good order. This consists of pitched timber rafters and ridge boards with timber purlins and sarking underlay. No evidence of active or historic leaks was detected.

One timber purlin was found to be broken. This does not pose any structural issues.

Structural modifications have been noted within the roof spaces, it is recommended that council records are checked to ensure compliance has been obtained.

The fibreglass Insulation has been installed to a good standard, with full coverage achieved. Not slumped or compressed. No obvious water damage observed.

The visible wiring was Modern TPS (Tough Plastic Sheath)

As on-going maintenance, all homes should be periodically checked for pests as they can cause damage to the construction material, plumbing, and electrical. There were signs of pests (rodents) found. There were no indications of borer in the roof space.

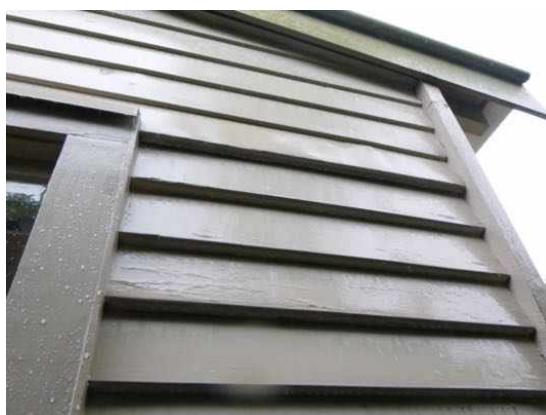
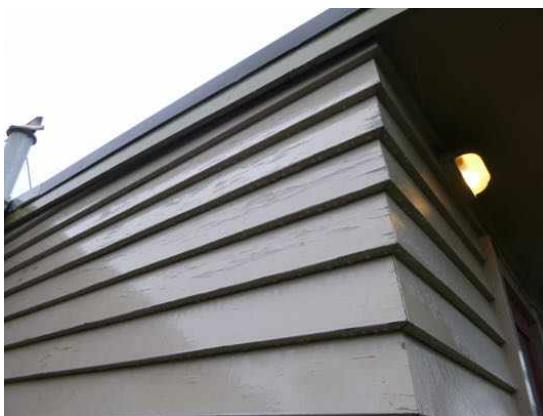
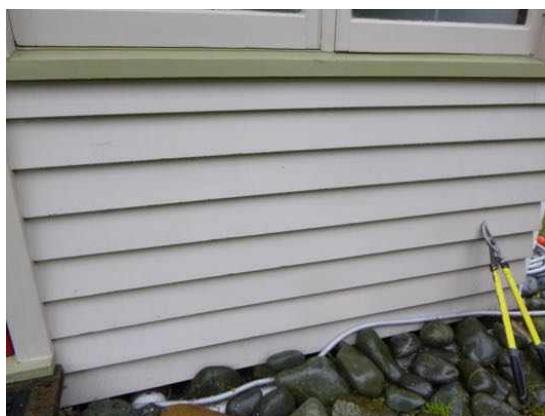
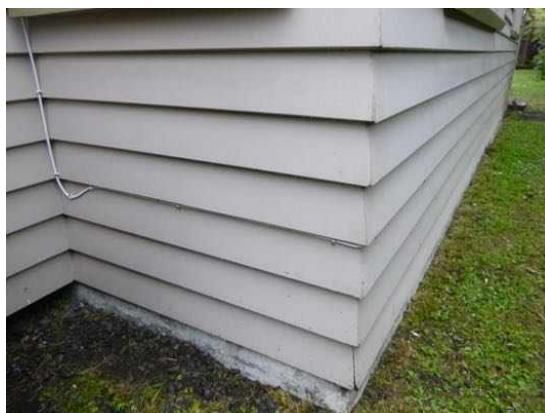
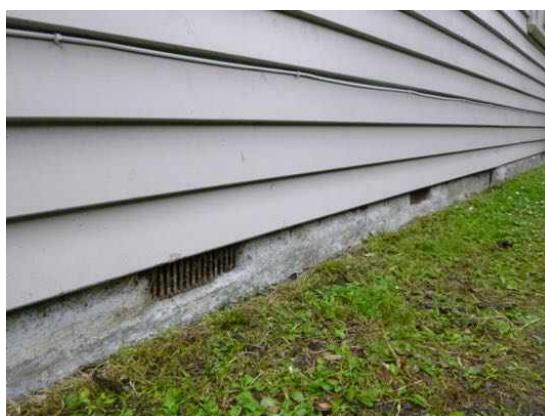
### Defects 3.04

Building:	Main Building
Location:	All External Areas
Finding:	Cladding - Condition
Information:	The exterior painted timber weatherboards were in fair condition overall. All windows and doors were flashed and sealed adequately.

The paint finish was found to be deteriorating in some areas. Paint deterioration is generally classified as an appearance defect. However, the substandard appearance may also be indicative of poor surface preparation and substandard workmanship. A painting contractor should be appointed to perform necessary works to aid the appearance of the affected area and to ensure that the area is protected against further deterioration. Alternatively, the homeowner following manufacturer instructions may be able to provide this service.

I would recommend monitoring the weatherboard joints and junctions as this is where moisture issues are most likely to occur.

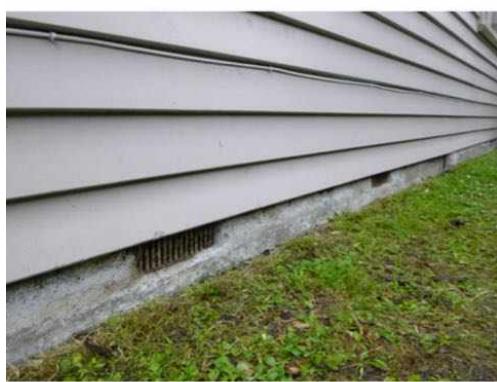
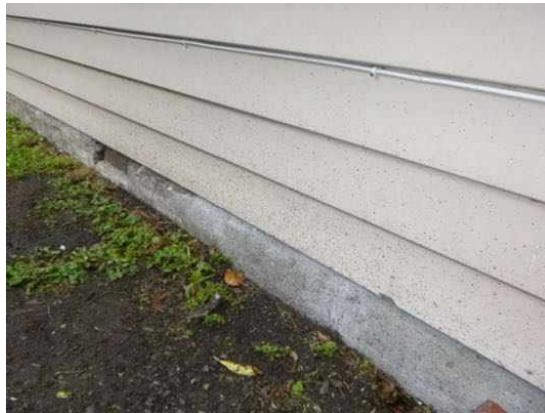
### Defects 3.05

Building: Main Building  
Location: All External Areas  
Finding: Foundation - Condition  
Information: There is no access to the subfloor due to the proximity of the framing to the ground. This is typical for the era of build. Good ventilation is maintained.

The concrete ring foundation visible showed no noticeable cracking.

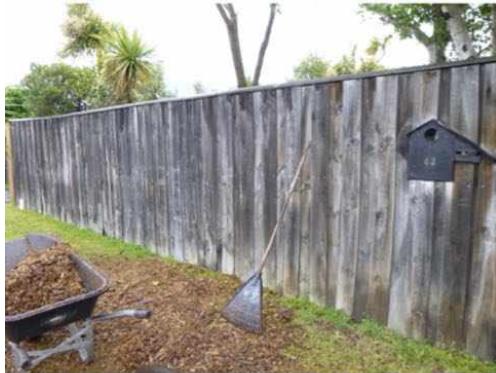
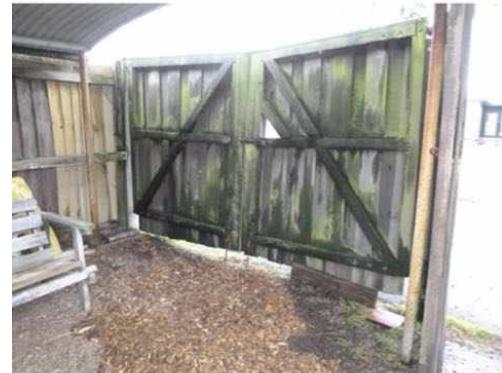
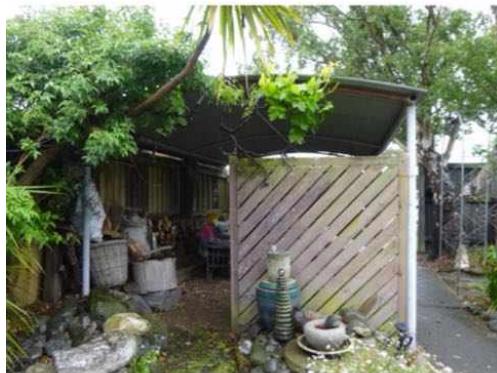
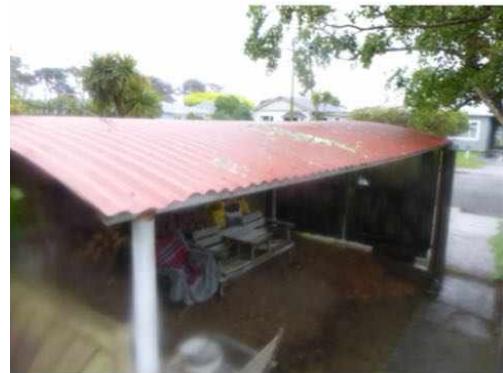
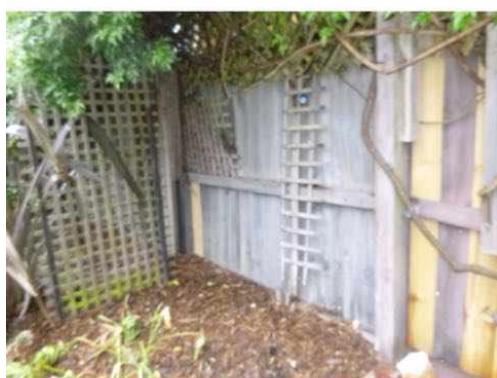
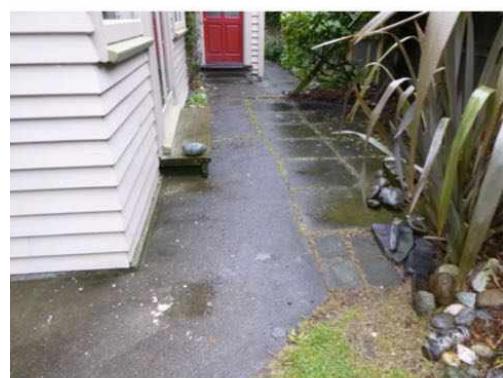
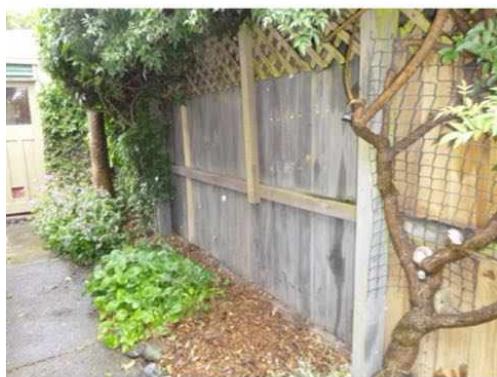
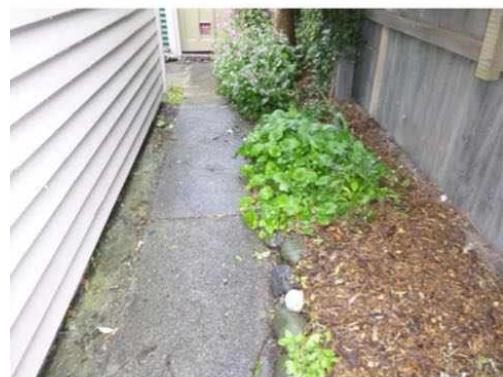
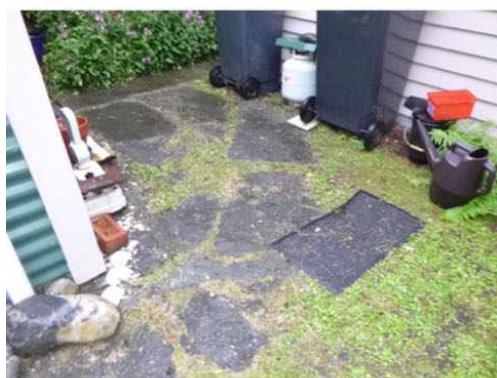
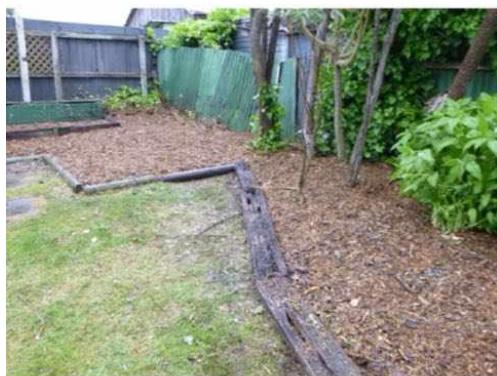
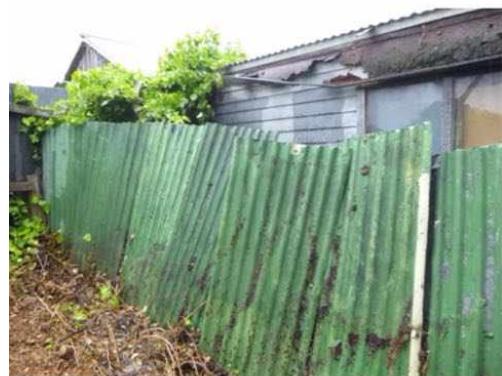
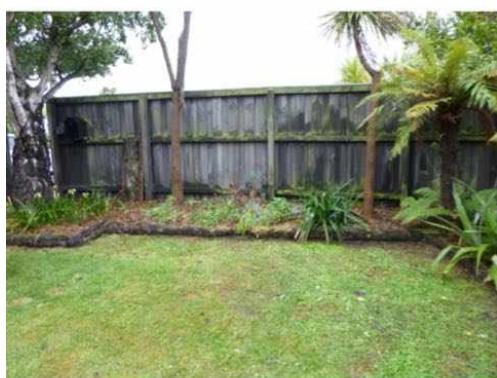
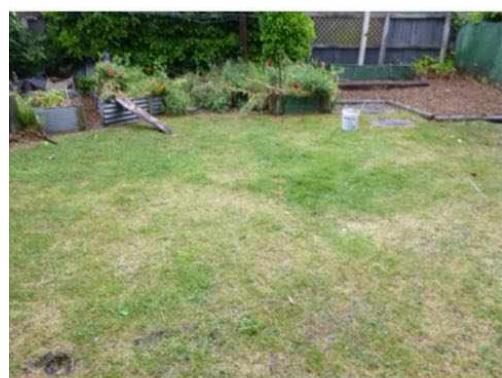
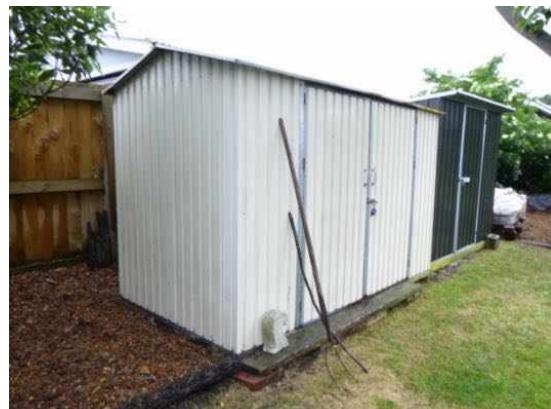
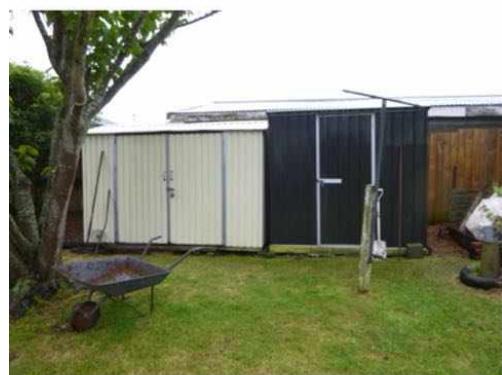
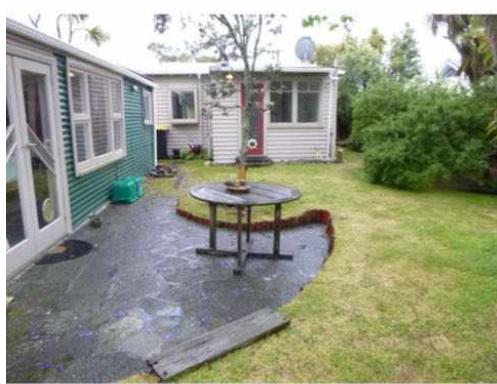
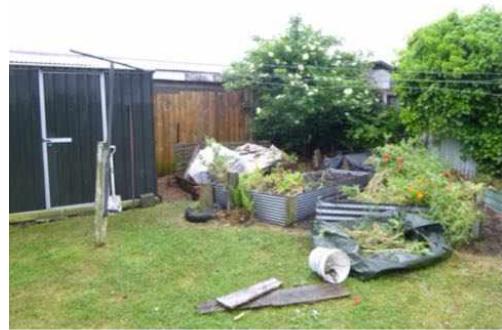
### Defects 3.06

Building: Yard  
Location: All Areas  
Finding: Yard - Landscaping  
Information: The timber fences/gates, sheds, clothesline and concrete/paved areas appeared to be in good condition for their age. The landscaping and lawn areas also appeared in good overall condition.

Typical age related deterioration to the timber fencing and cracking to the concrete areas was identified.

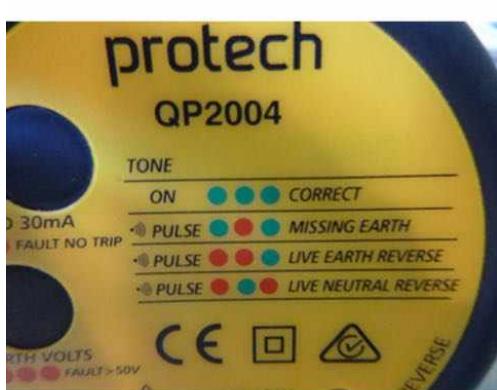
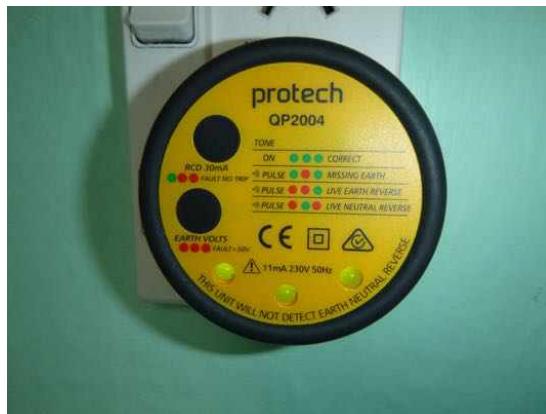
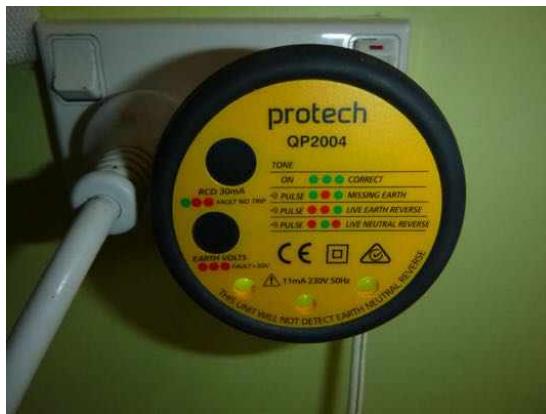
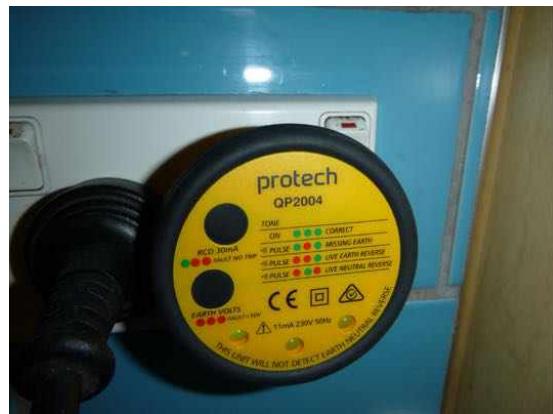
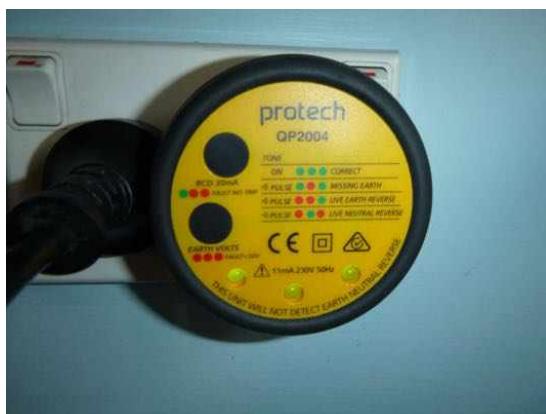
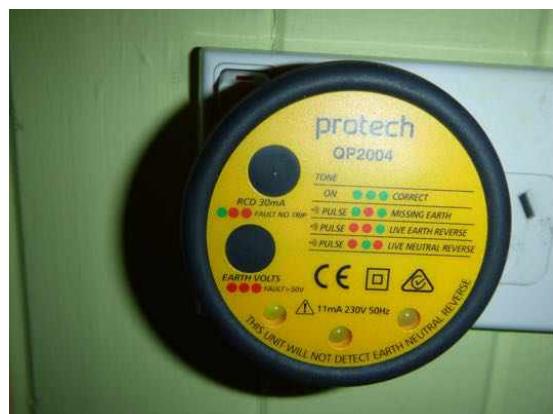
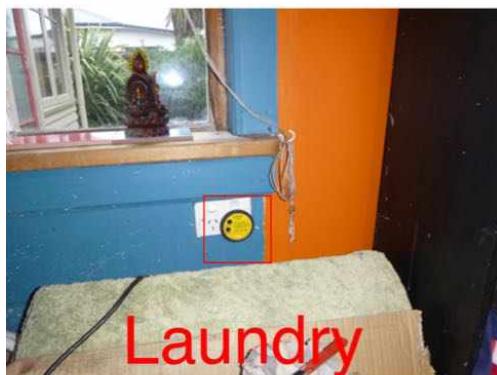
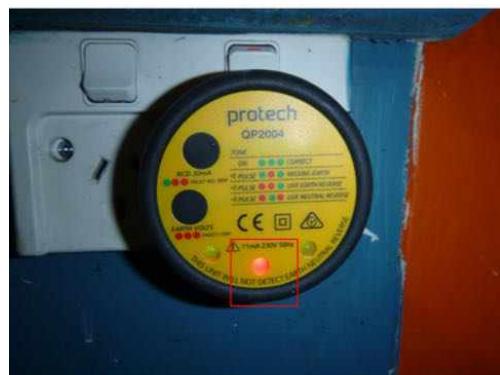
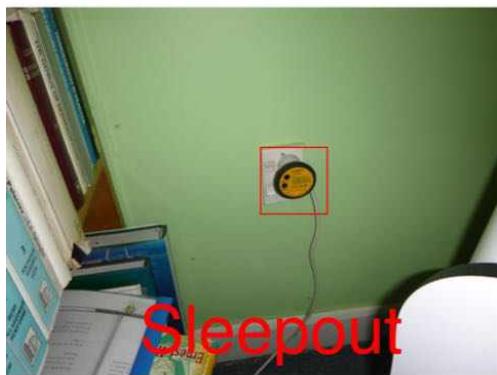
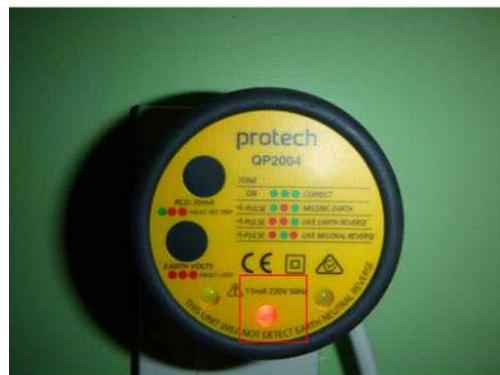
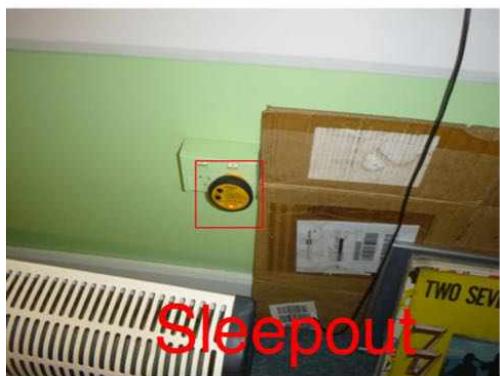
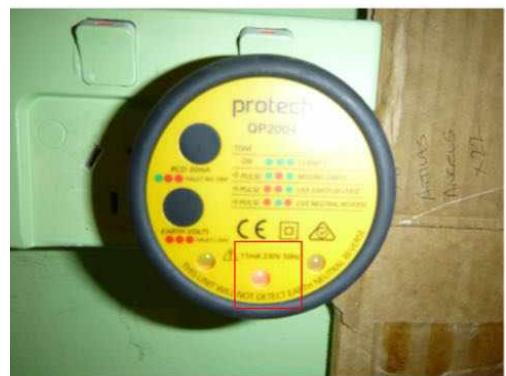
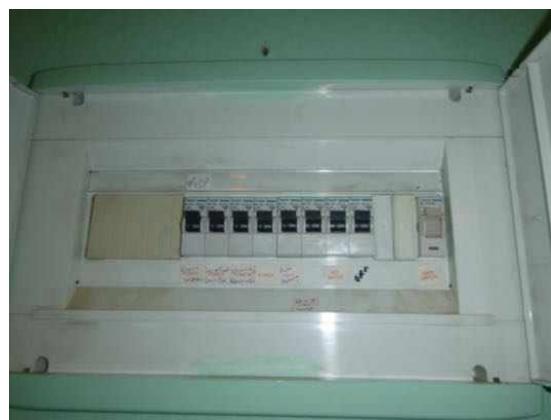
### Defects 3.07

One issue was found during the inspection. Polarity faults were found to a plug in the laundry and two plug in the sleepout. This may mean that the neutral wire is connected to where the hot wire should be, or it is missing the earth wire. This could result in a shock if the appliance is mishandled

A qualified electrician should be appointed to further investigate the fault

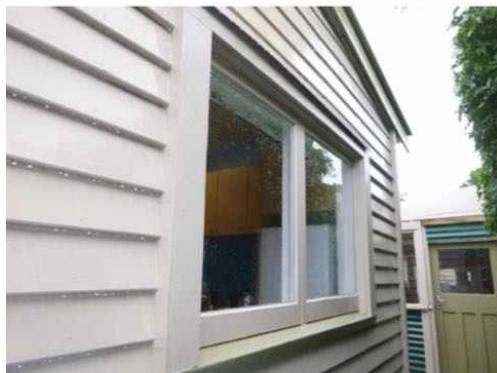
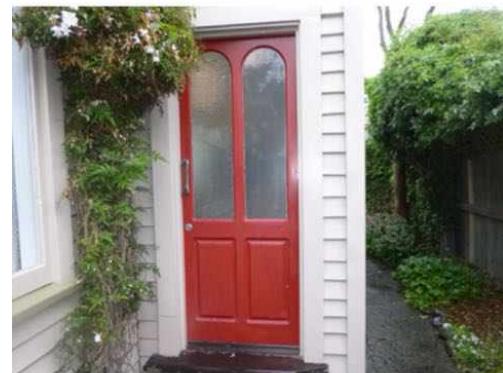
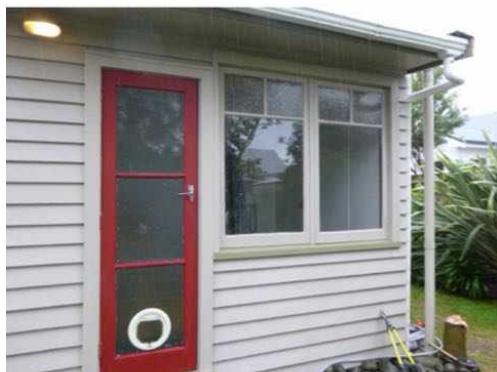
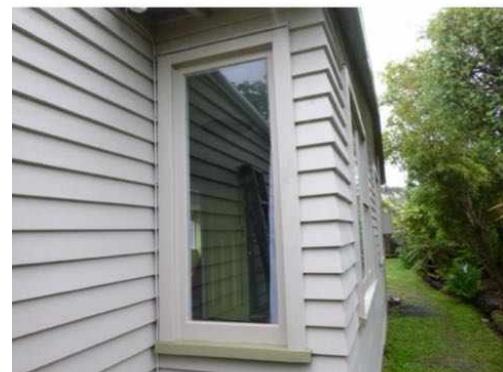
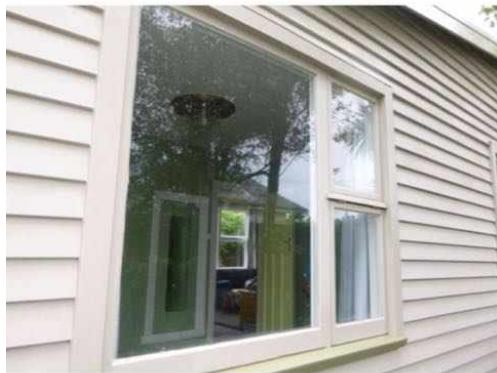
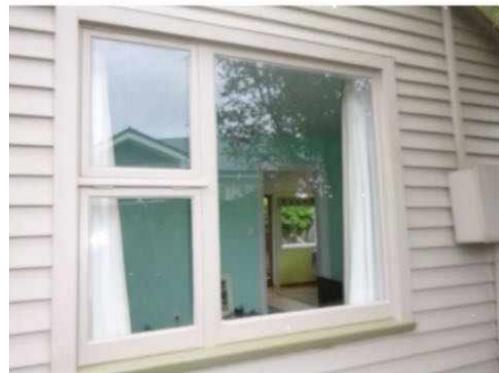
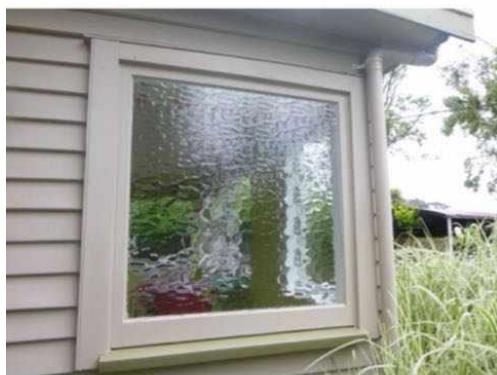
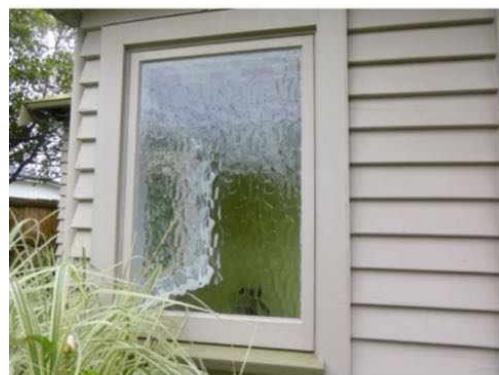
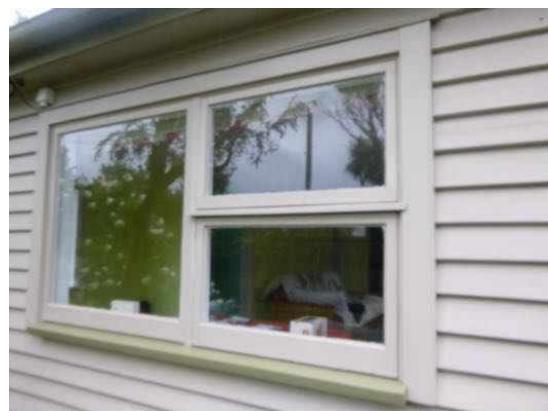
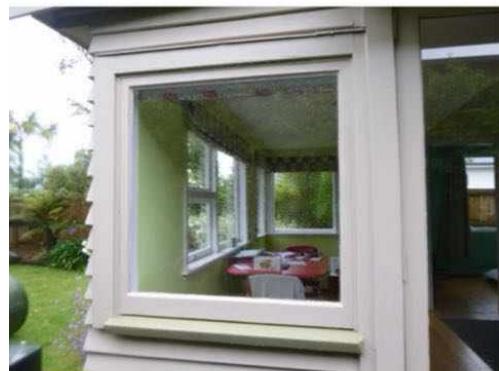
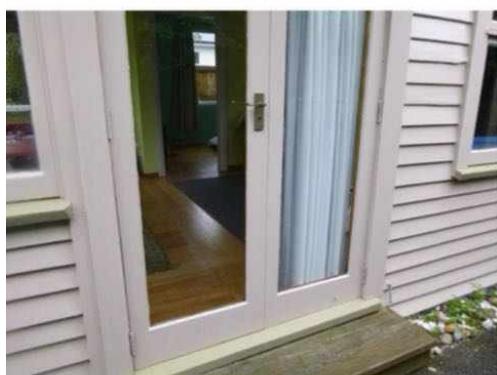
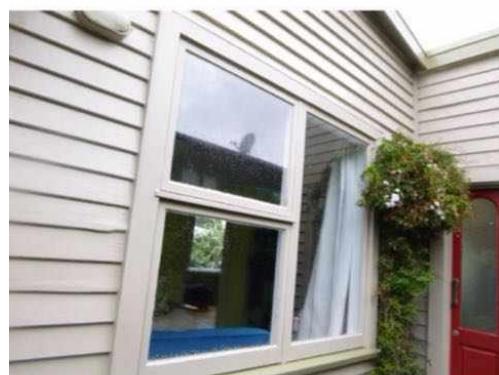
Building: Main Building  
Location: All External Areas  
Finding: Exterior Joinery - Condition  
Information: The exterior joinery is timber frame with single glazing, and timber reveals. All windows and doors were flashed and sealed adequately, and functional.

The timber frames appeared well-maintained and is in good condition for their age. There are minor noted defects that are typical to find on this style of construction.

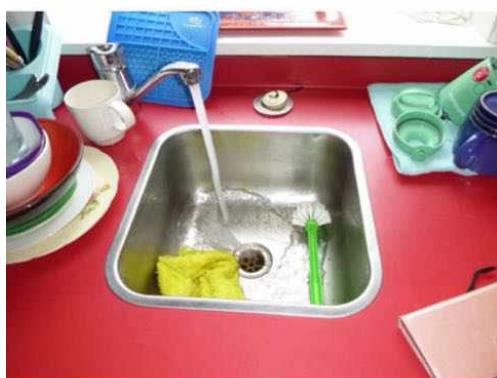
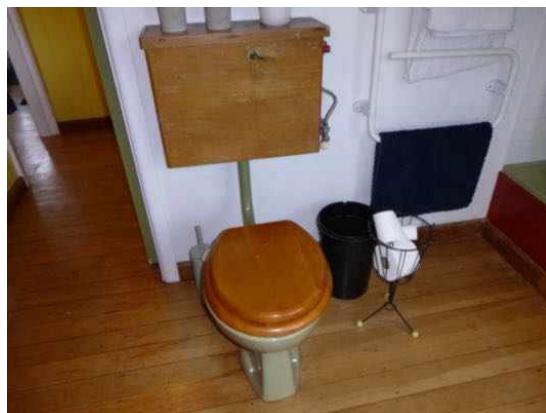
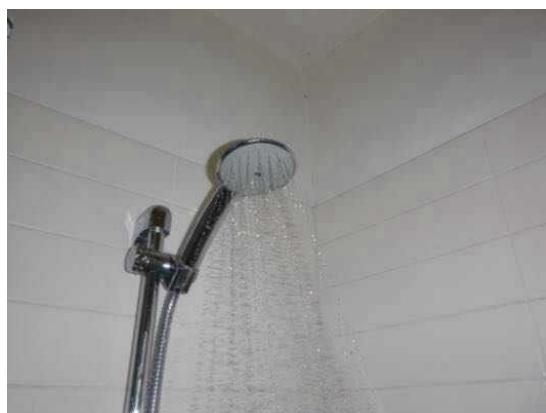
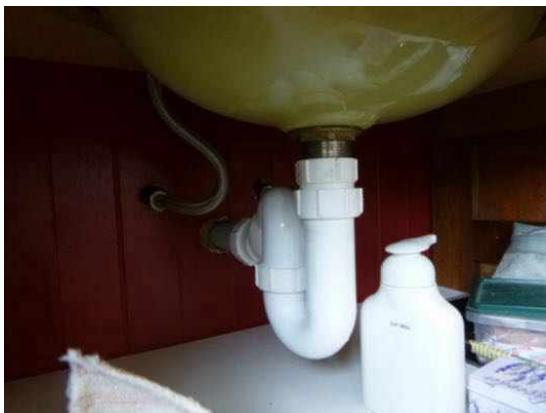
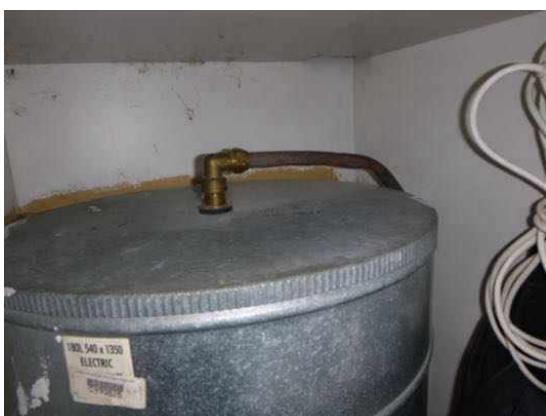
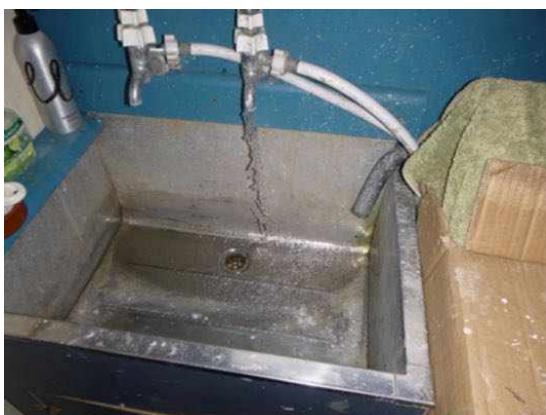
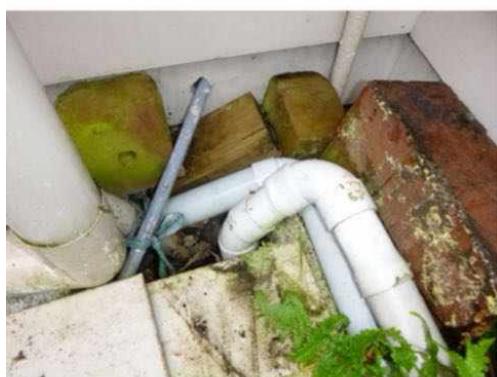
Building: Main Building  
Location: All Areas  
Finding: Plumbing items - Condition  
Information: All taps and the shower were run for a period of time and toilet flushed, it appears the water is running freely. The water pressure was good. The plumbing items appear to be in good condition where visible and tested.

The gully traps were checked and were clear, and are sufficient height off finished ground level. Covers are installed on traps to prevent debris getting into the grey water system

The water is heated via an electric hot water cylinder.

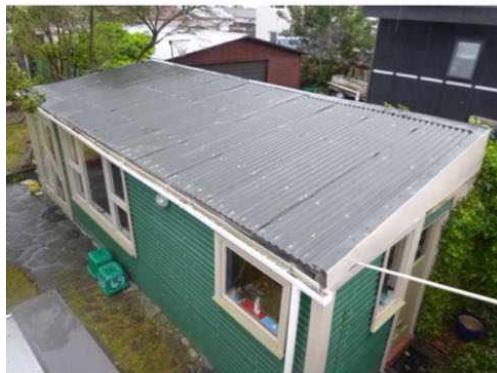
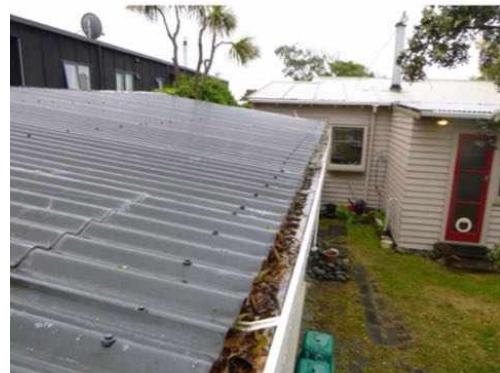
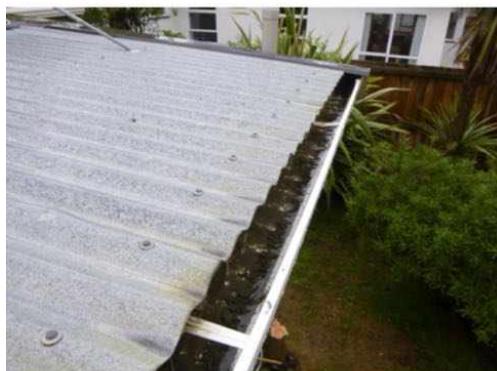
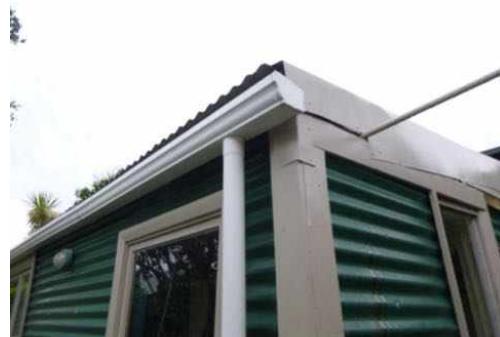
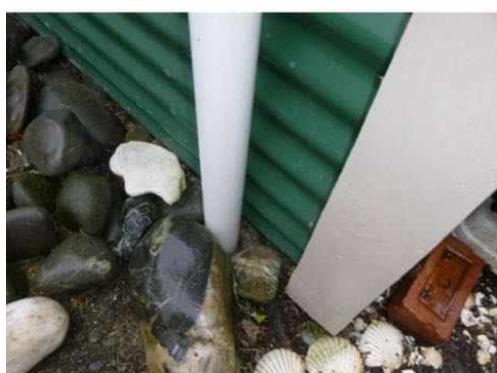
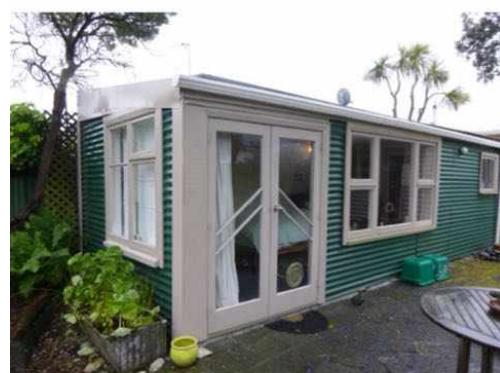
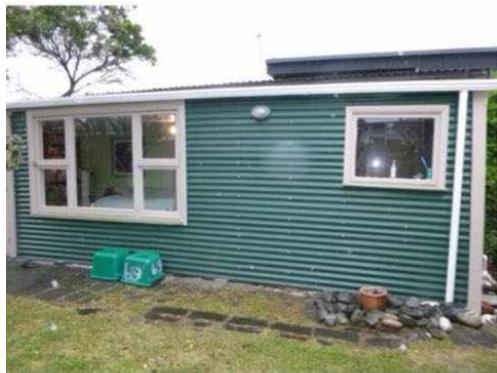
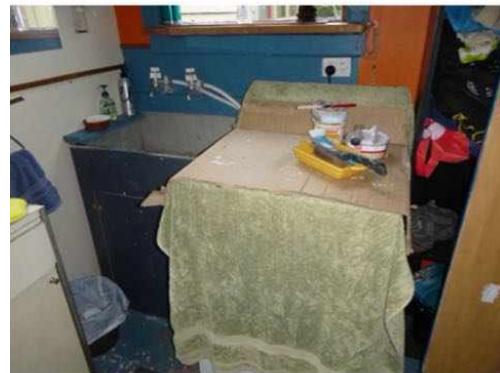
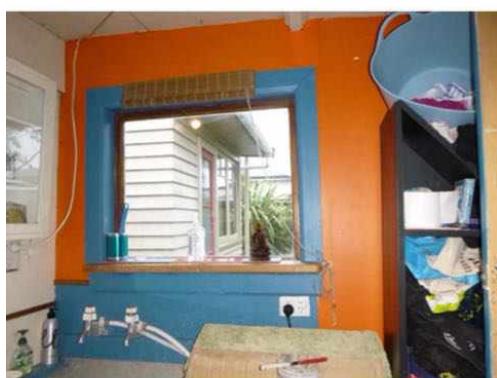
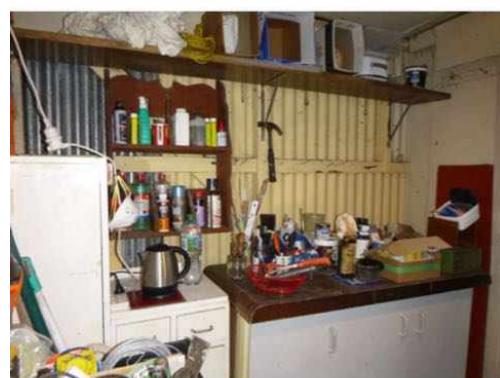
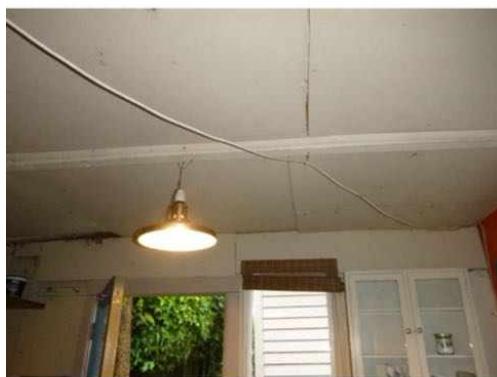
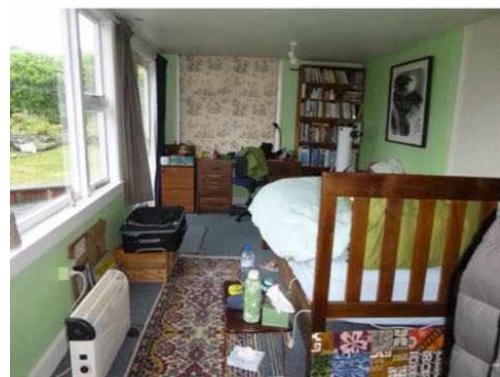
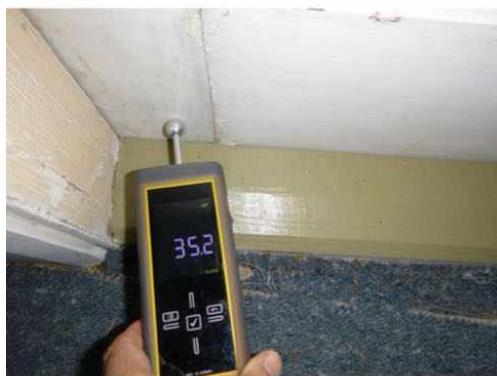
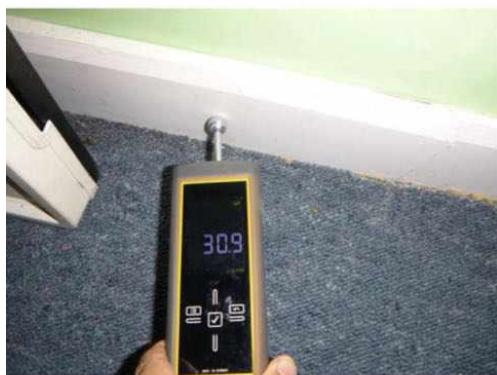
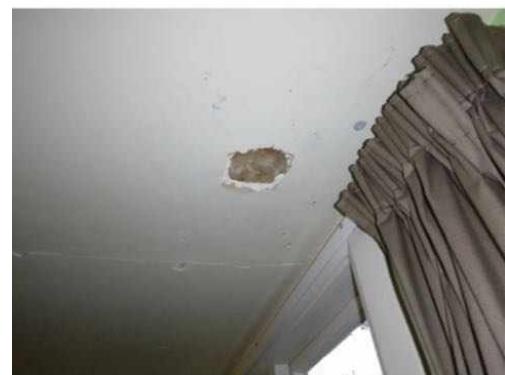
Building: Studio  
Location: All Areas  
Finding: Laundry/Studio - Condition  
Information: The detached building is timber framed construction with coated corrugated metal roofing. This sits on a concrete slab. The exterior cladding is horizontal corrugated iron.

This appeared in good overall condition and structurally sound.
