## BUILDING INSPECTION REPORT

## **NZ Residential Property Inspection Report**

Inspection Date: Thu, 13 Nov 2025

Property Address: 43 Tovey Street, New Brighton,  
Christchurch 8061, New Zealand

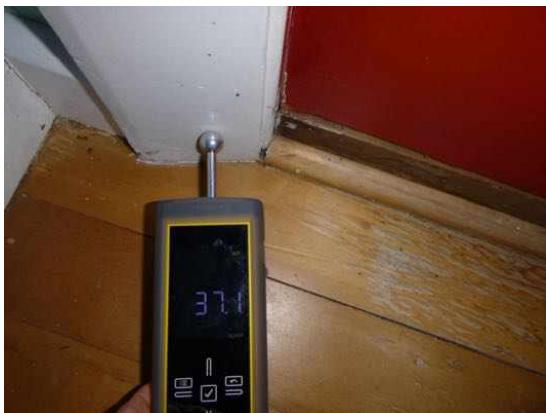
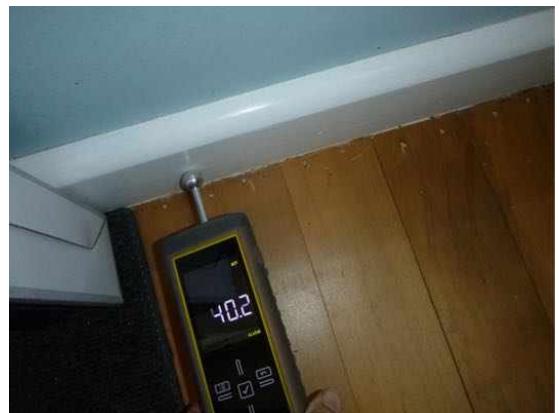
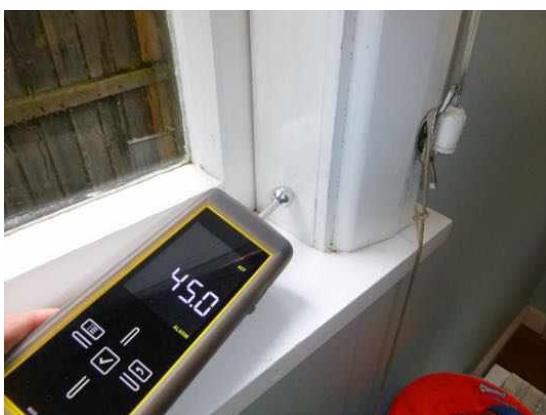
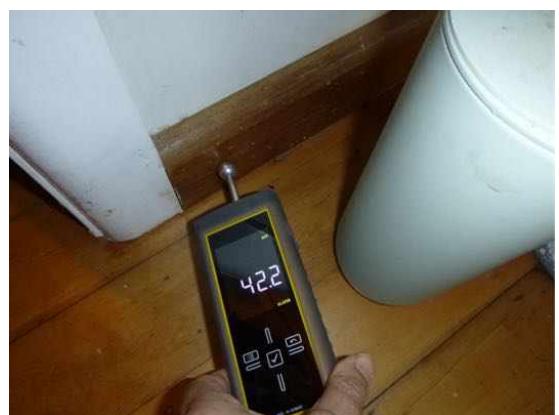
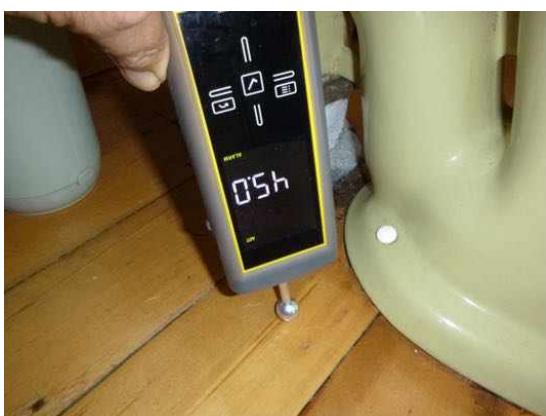
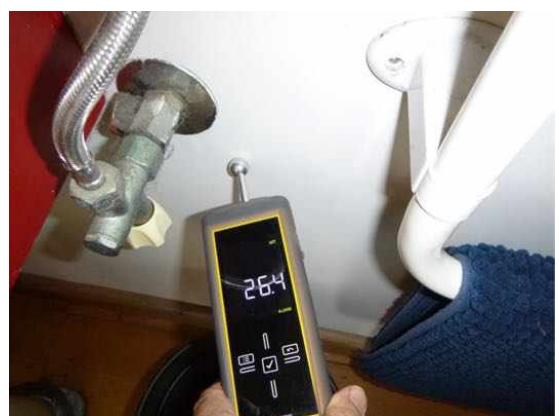
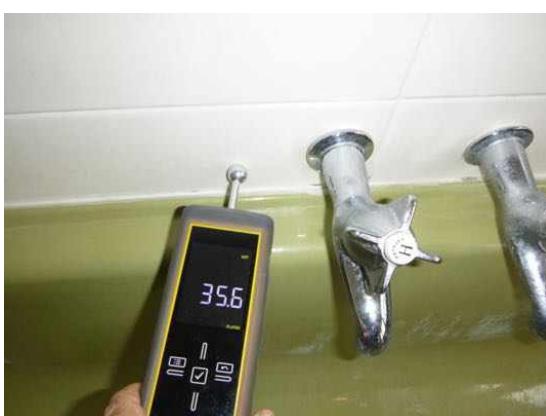
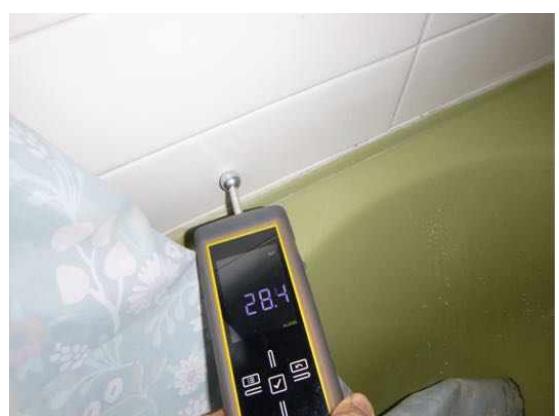
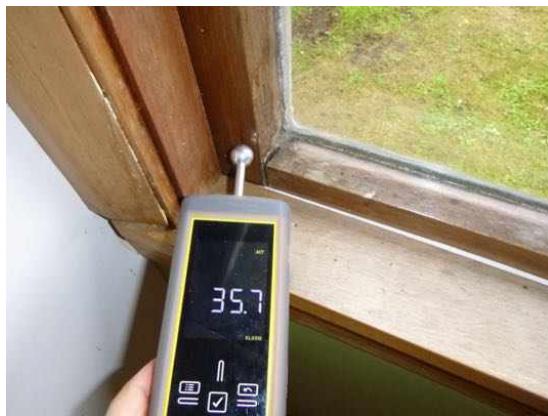
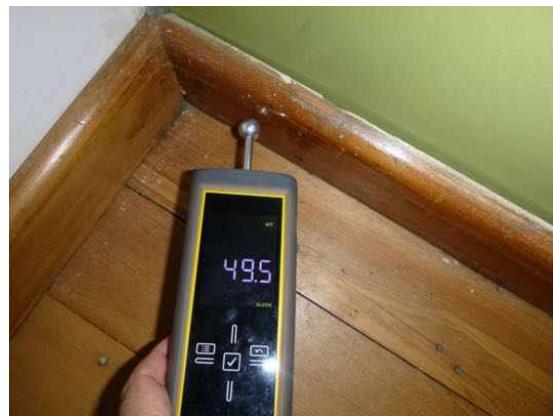
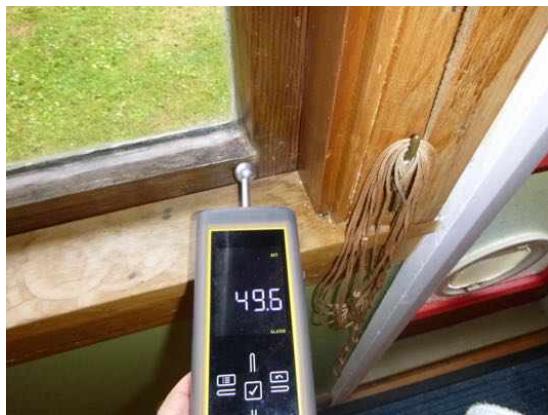
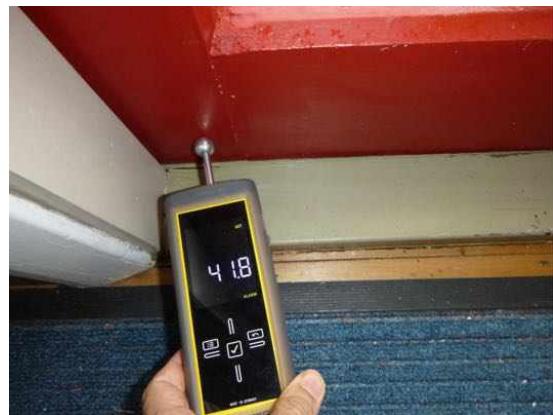
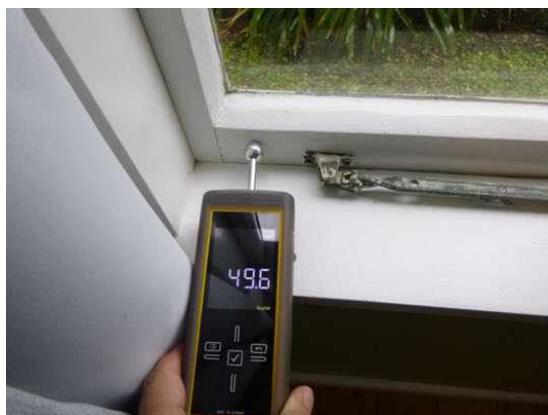
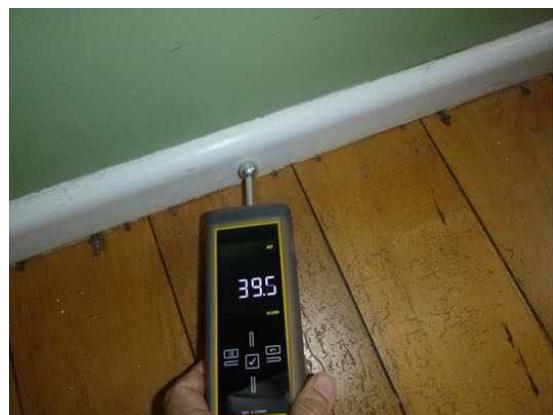
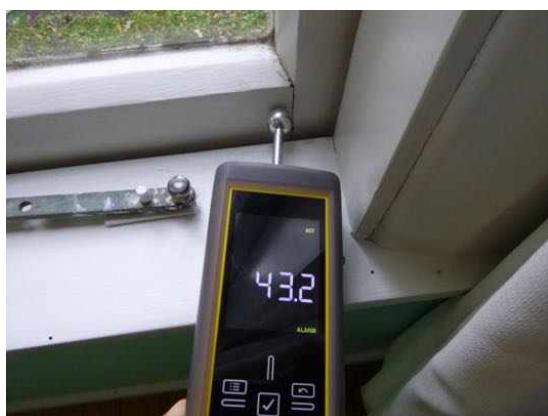
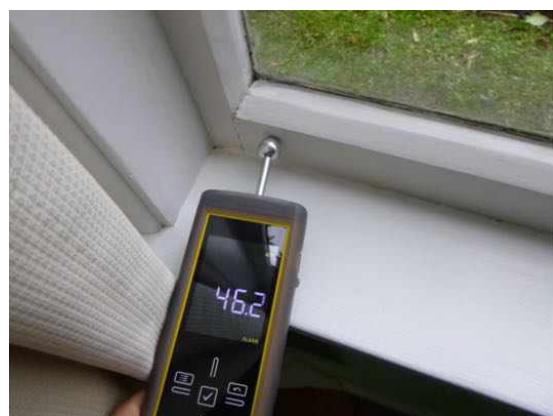
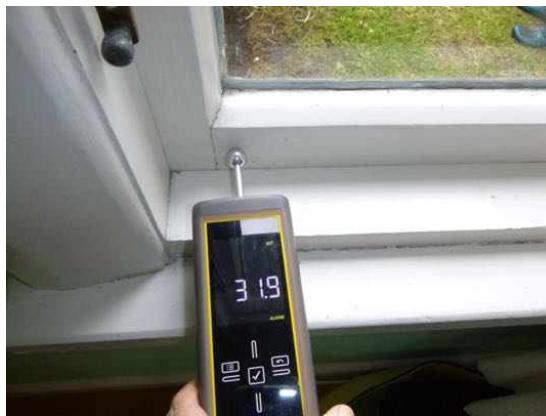
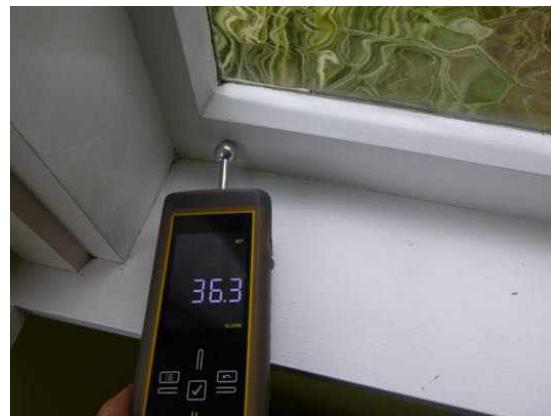
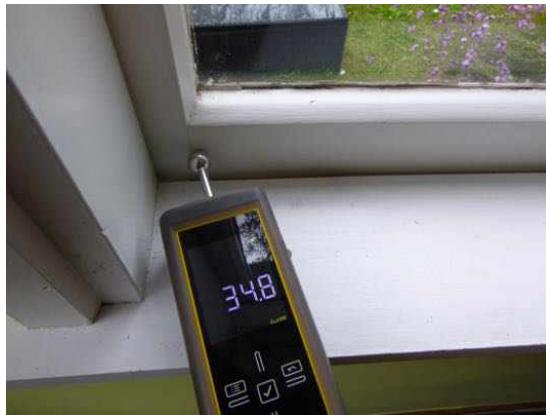
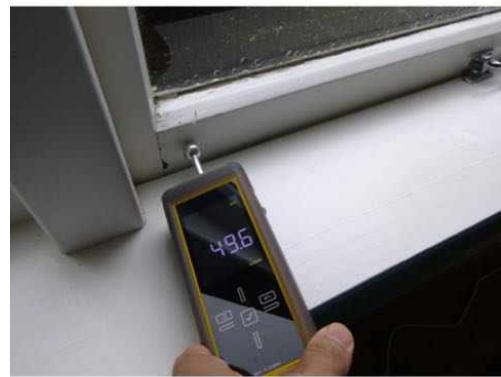
Building: Main Building  
 Location: All Areas  
 Finding: Moisture Readings  
 Information: Moisture readings were taken using a Trotec T660 capacitive non-invasive moisture meter. No indications of any elevated moisture levels were detected.

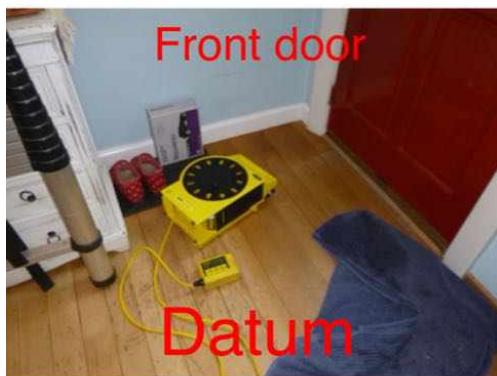
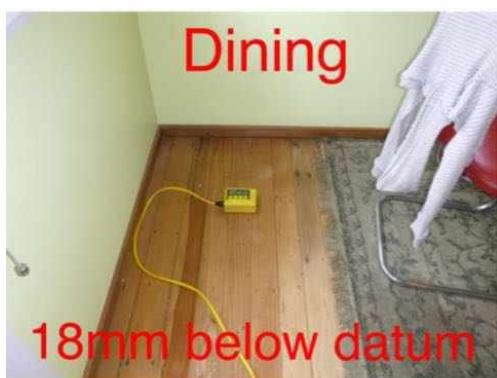
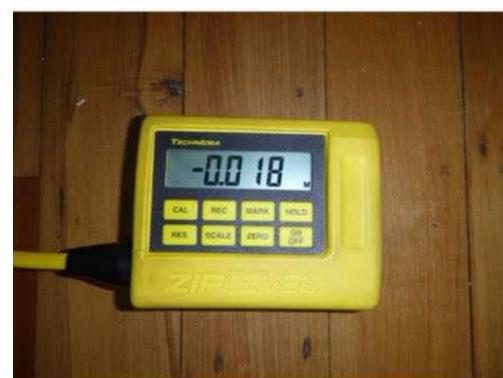
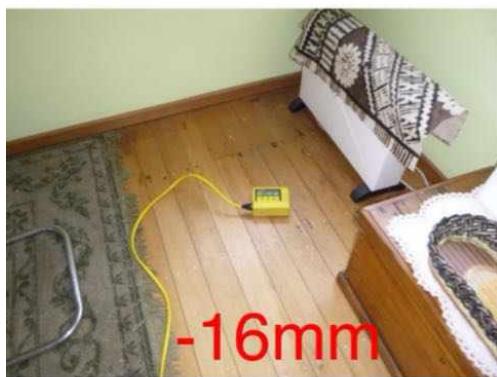
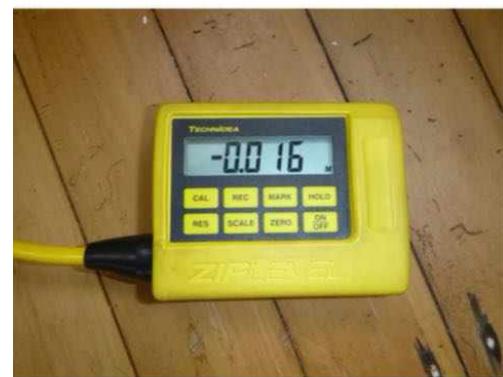
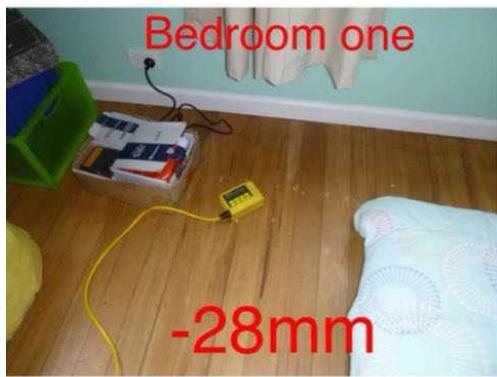
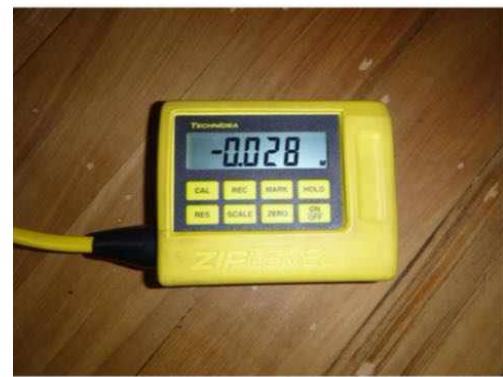
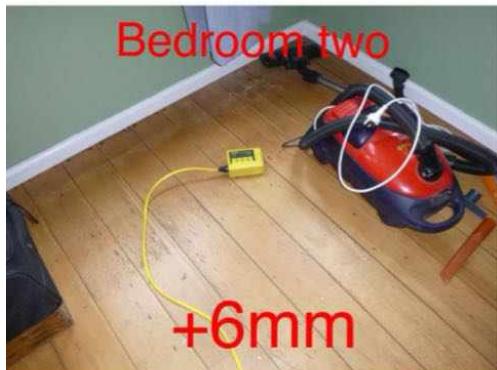
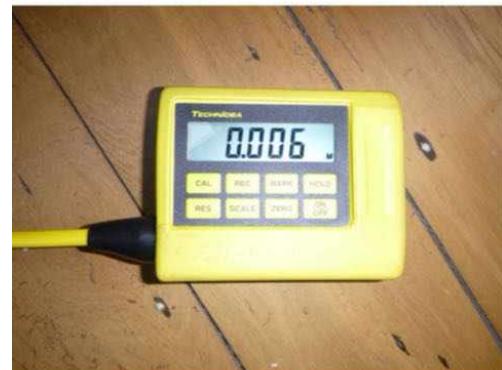
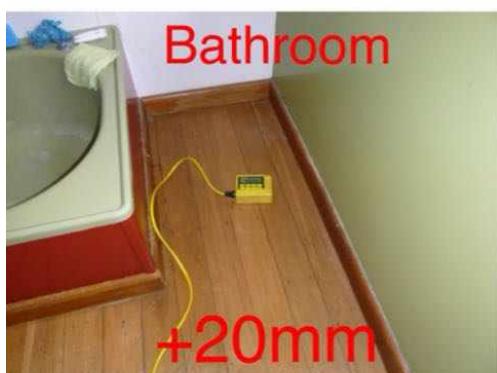
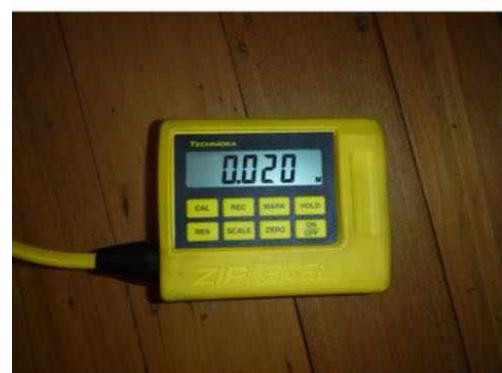
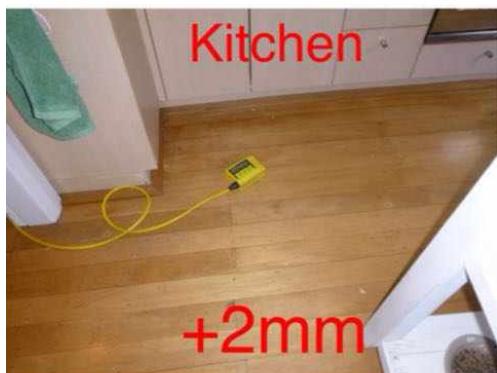
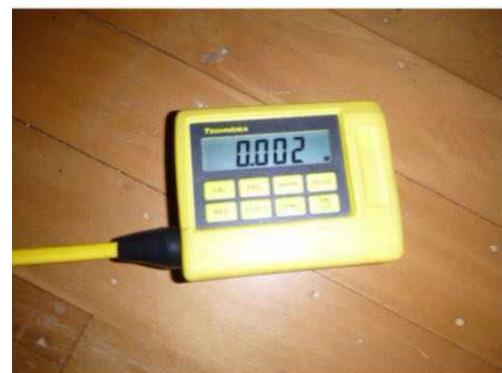
Building: Main Building  
 Location: All Areas  
 Finding: Floor - Levels  
 Information: Spot floor level readings were taken throughout the main floor areas of the dwelling where accessible. (JBI take into account floor covering thicknesses as needed throughout the dwelling)

This falls within the MBIE guidelines of 50mm over 10 metres.

All levels are within the MBIE guidelines over a short distance, being less than 0.5% or 10mm over 2 meters.

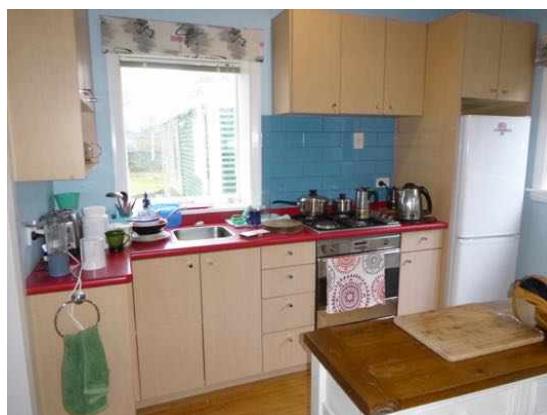
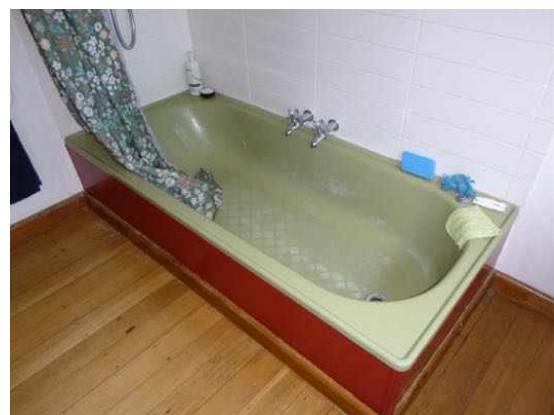
Building: Main Building  
Location: All Areas  
Finding: Additional Photos - Obstructions and Limitations  
Information: These photographs are an indication of the obstructions and limitations which can impede a full inspection of the property at the time of inspection. These obstructions can hide an array of defects.

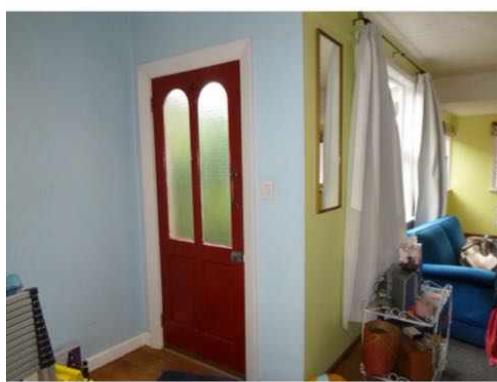
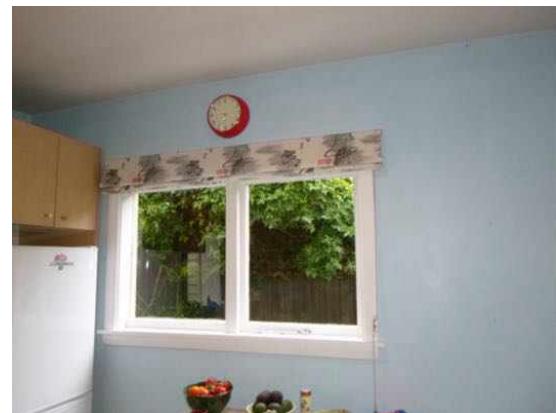
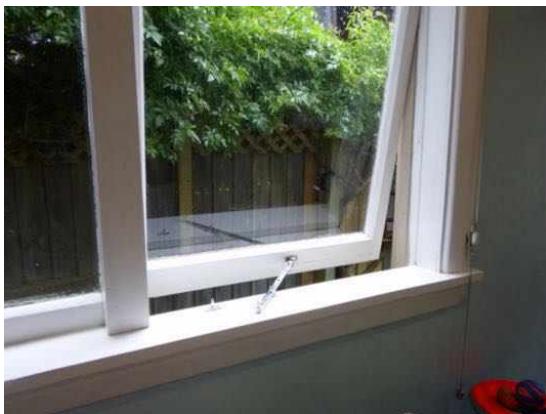
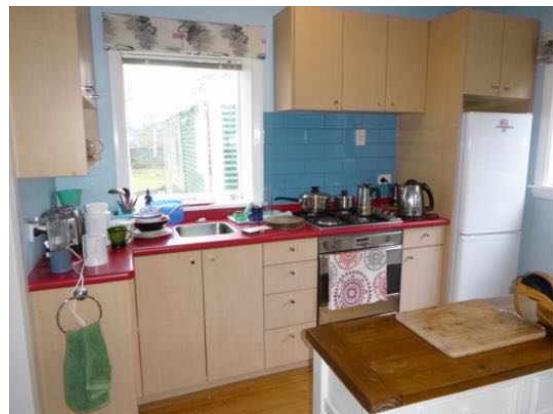
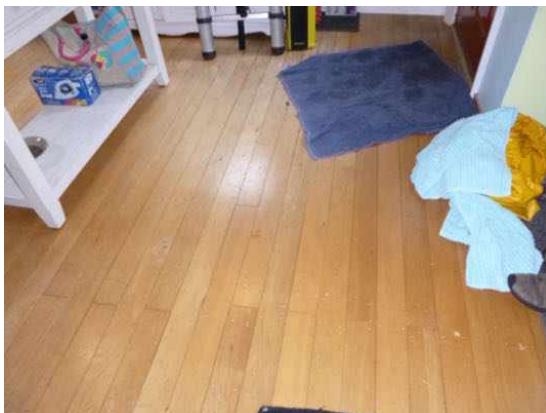
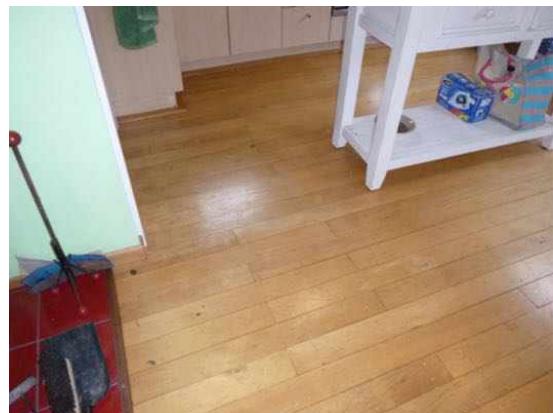
Building: Main Building  
Location: All Areas  
Finding: Additional Photos  
Information: Additional photos are provided for your general reference, and can be considered to be in good condition.
