**SUBJECT: STRUCTURAL INSPECTIONS AND SIGN-OFF FOR REPAIR / RE-LEVEL TO EXISTING  
RESIDENTIAL BUILDING AT 19 BELFIELD STREET, DALLINGTON, CHRISTCHURCH 8061.**

## STRUCTURAL REPAIR ASSESSMENT

**Project Number** 25288 **Issue Date** 05 December 2025

19 Belfield Street, Dallington, Christchurch 8061

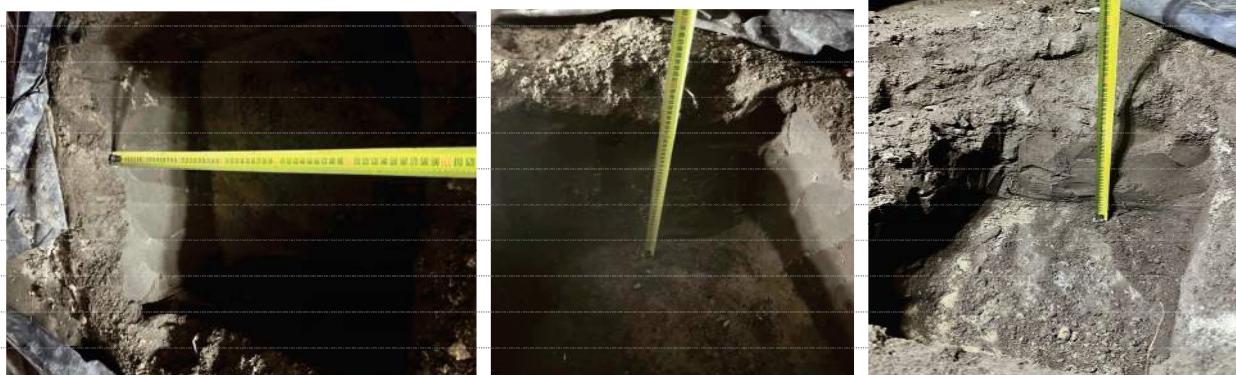
1. Photos of pile footings for pile replacement of 2 piles was provided by the contractor. Dimensions observed from photos for load bearing and non-load bearing piles were as per our plan.

2. No topsoil was observed at the excavated depth based on the photos received. Due to inaccessibility, the bearing conditions for the pile footings could not be checked. However, soil bearing was inspected at a nearby excavated pad footing and was OK.
