Inspection Report

TWINSPECTORS
BUILDING & PEST INSPECTIONS

9/50 Ferndale Street Annerley QLD 4103

Building Inspection

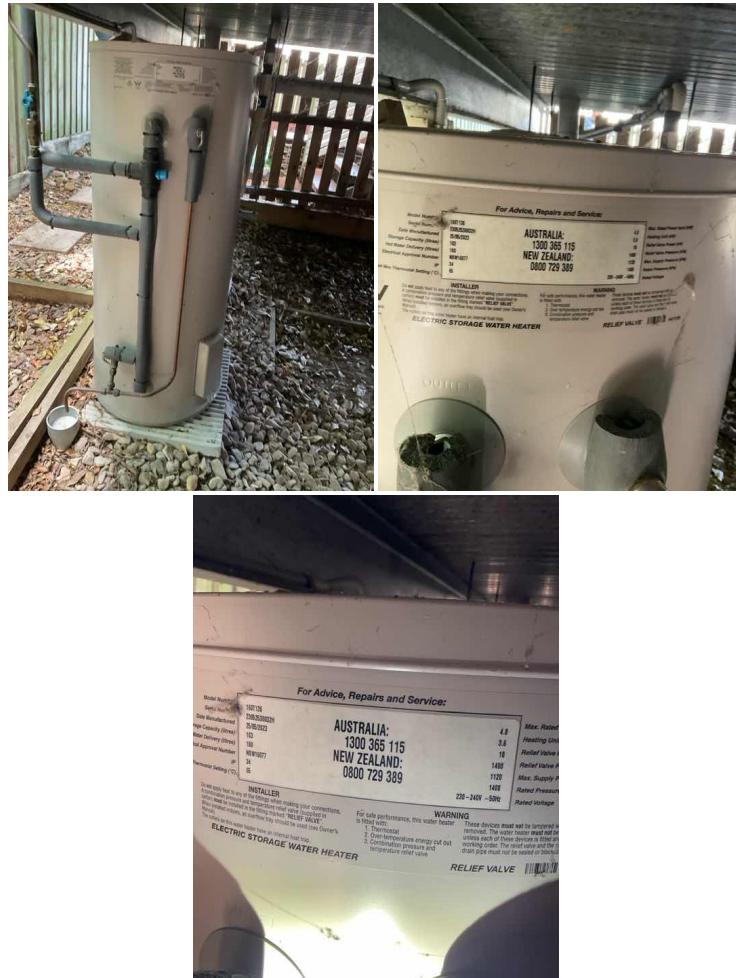
The hot water system appears to be in a serviceable condition. No specific tests other than running the hot water from a tap was carried out. No determination has been made as to the suitability or adequacy of the hot water system in relation to capacity or otherwise.

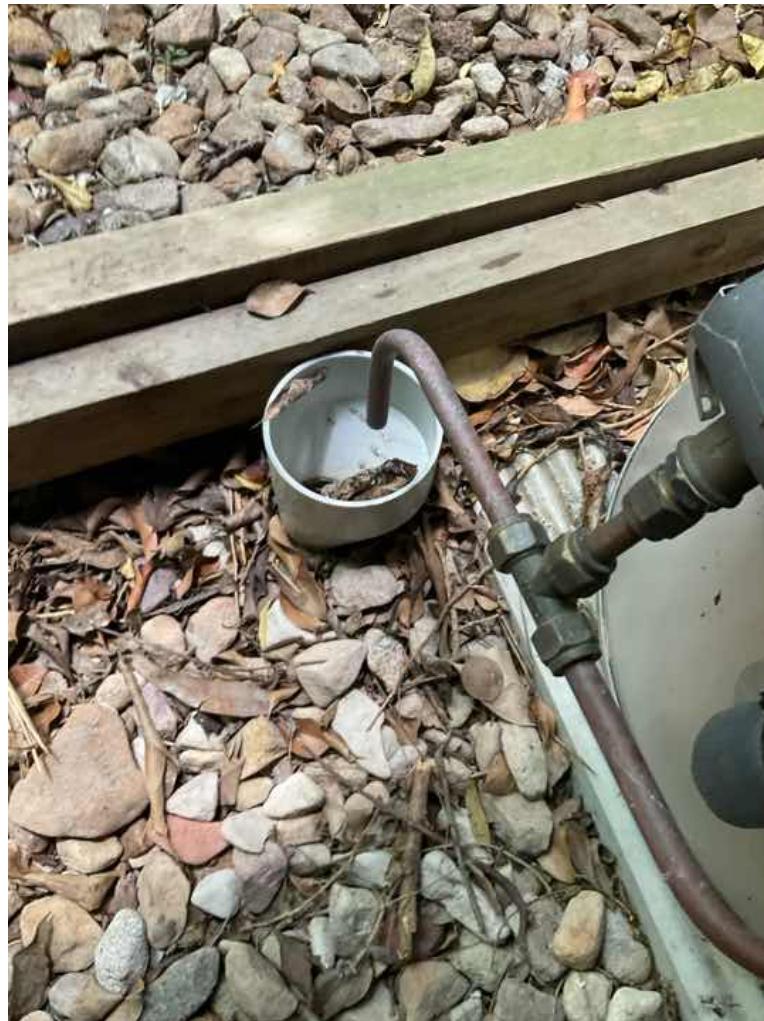
On visual inspection the external plumping pipes appear serviceable, but should be checked by a qualified plumber.

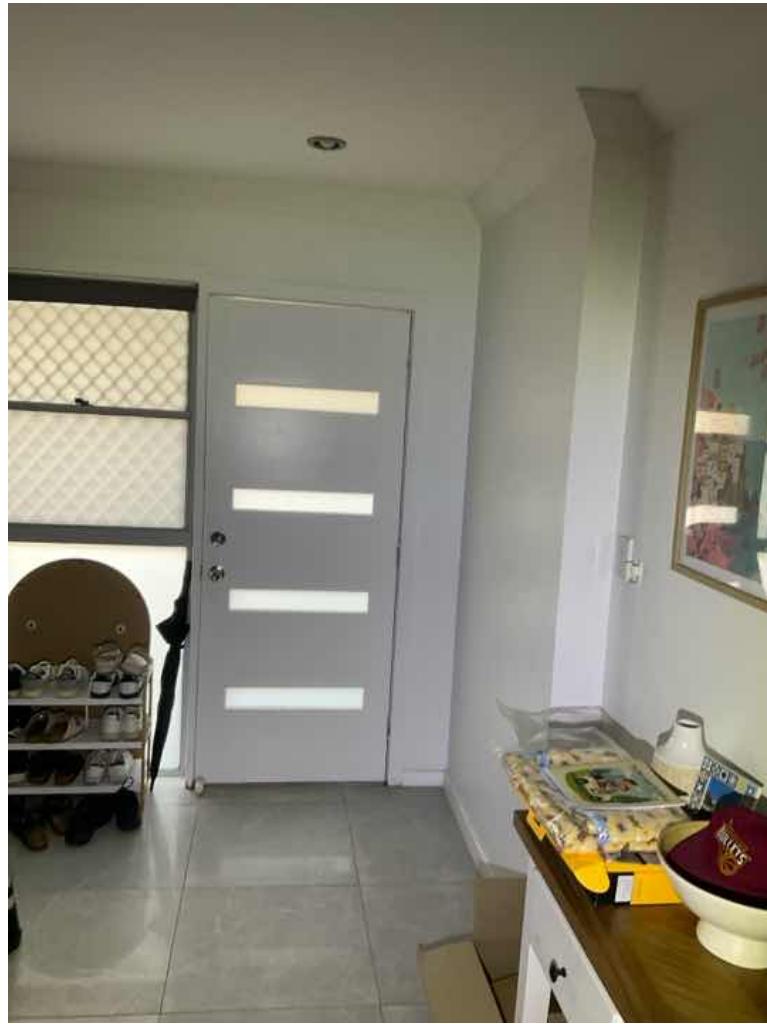
On inspection, defects were present that will require further assessing and recommendations by a qualified trades persons, please read below for details.

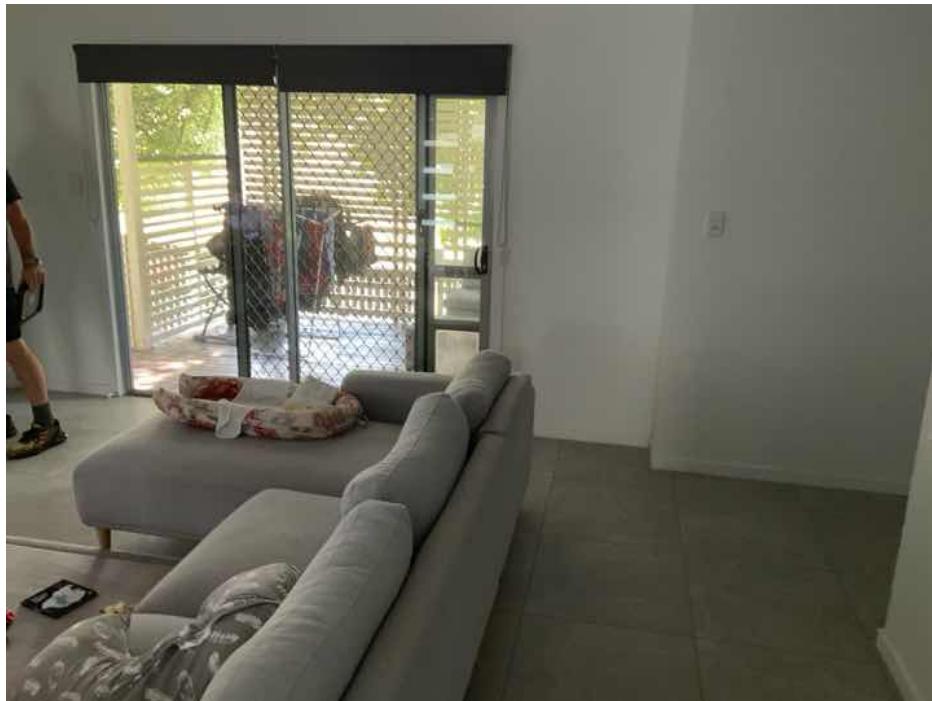
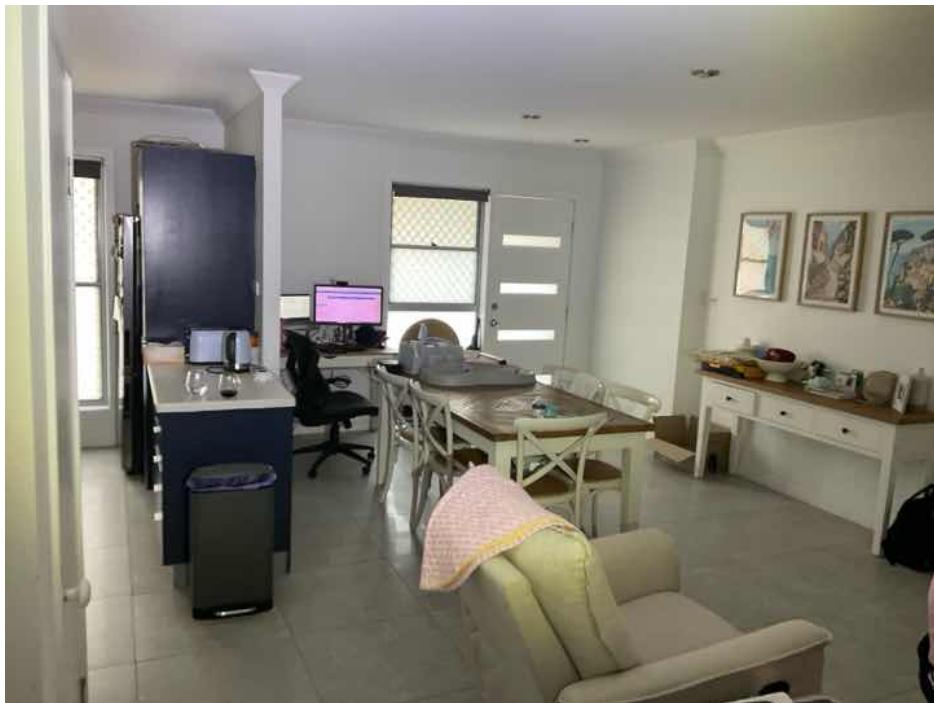
Ceiling

Incomplete patch/paint repairs noted. I recommend you contact a qualified painter for repairs.

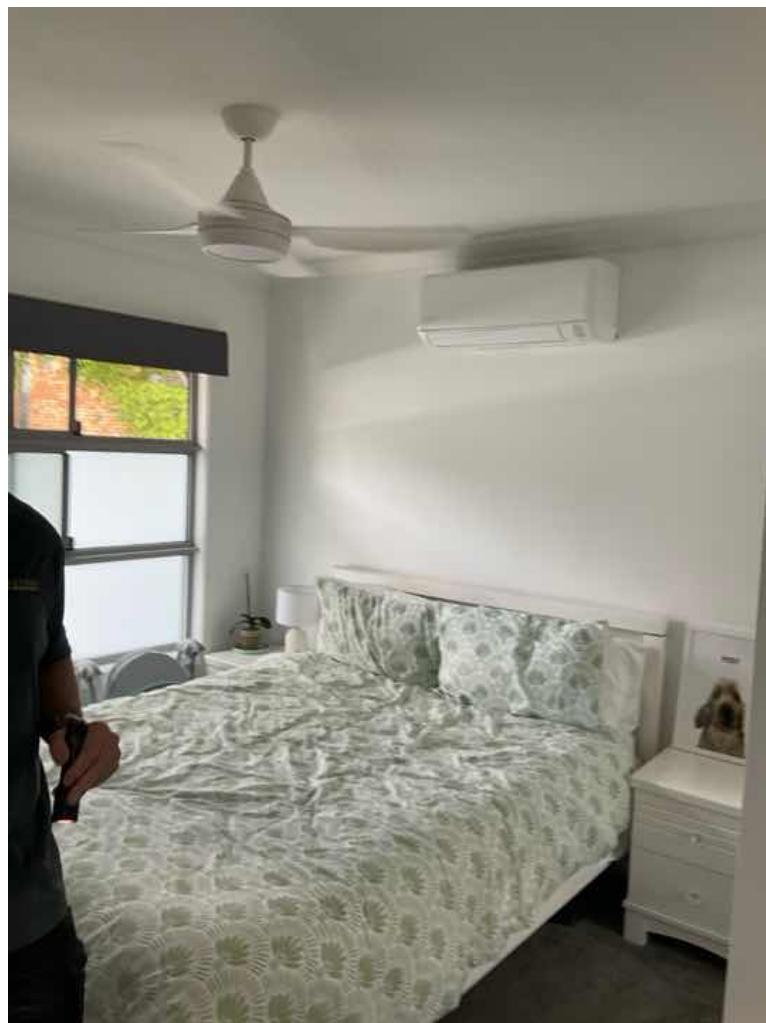
INTERIORS	Bedroom 2	Door	#4. The architrave to the door is Swollen/damaged. Contact a qualified carpenter for repairs
INTERIORS	Bedroom 1	Windows	#5. The opening limiter/restrictor is missing. Ensure one is installed to every window with accord to state requirements. Window openings should not exceed 125mm. In some circumstances, this regulation was non existent depending on the age of the dwelling and technically there is no requirement to rectify. However, we strongly advise you to rectify to comply with safety concerns to young children. This is the same in bedroom one and two
KITCHEN & LAUNDRY	Laundry	Walls	#6. General ageing and/or denting and/or wear and/or previous wall patching and the like is evident on wall linings - Recommendations: A qualified painter should be engaged to assess and repair as required.
CONCLUSION	Condition Of Inspected Structure	The Incidence of Minor Defects	#7. The incidence of minor defects in this residential building as compared with similar buildings is considered LOW

#4. The architrave to the door is Swolen/damaged. Contact a qualified carpenter for repairs

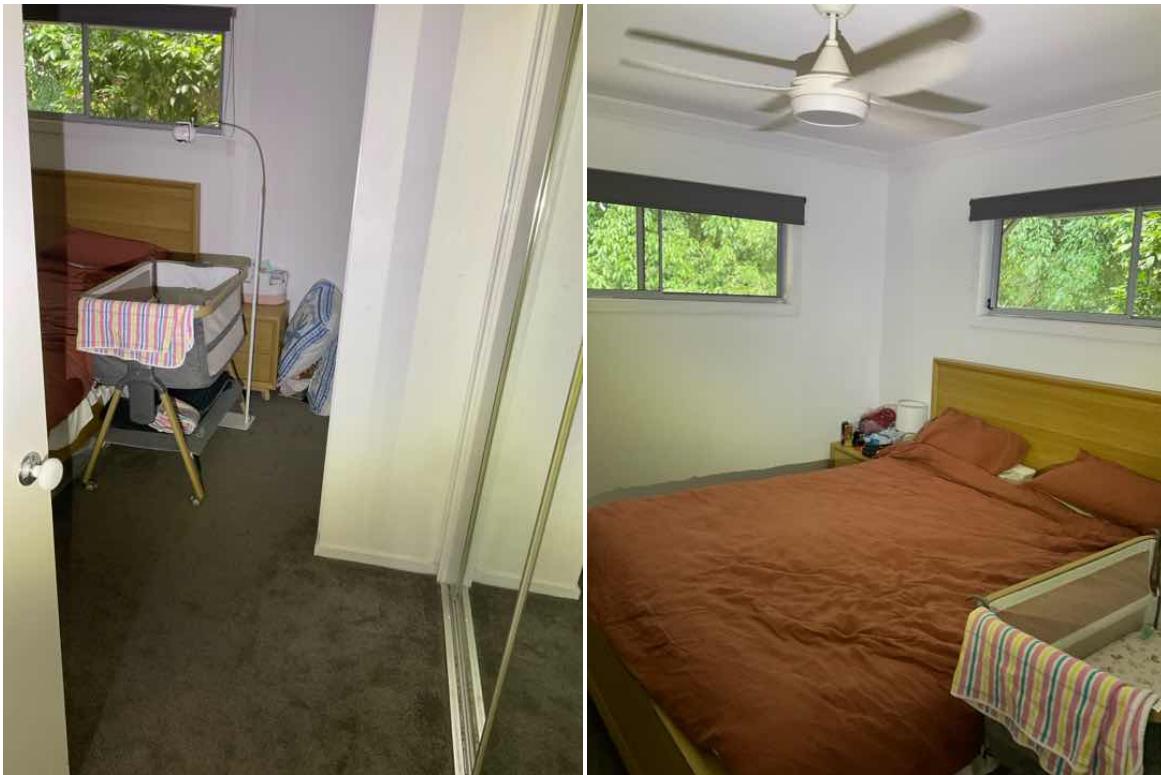
Windows

#5. The opening limiter/restrictor is missing. Ensure one is installed to every window with accord to state requirements.

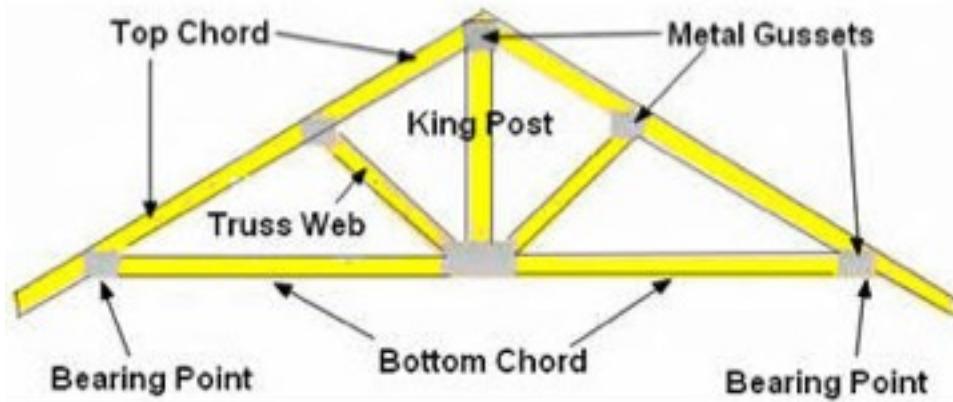
Common Roof Truss

The roof frame is a truss timber frame.
