**All Building Inspections Limited**  
PO Box 532 | Waikanae 5250 | New Zealand  
**T** 04 905 9707 **M** 021 979 707  
**E** [info@allbuildinginspections.co.nz](mailto:info@allbuildinginspections.co.nz)  
**W** [allbuildinginspections.co.nz](http://allbuildinginspections.co.nz)

## Building Report

105 Winara Avenue  
Waikanae

**Date/s of inspection:** 20-Jan-2026

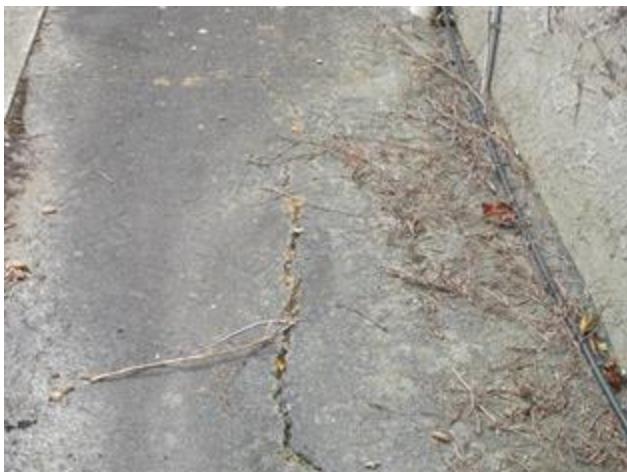
Side of the dwelling

The path to the side of the dwelling was showing its age and will require repair to some sections as the deterioration continues.

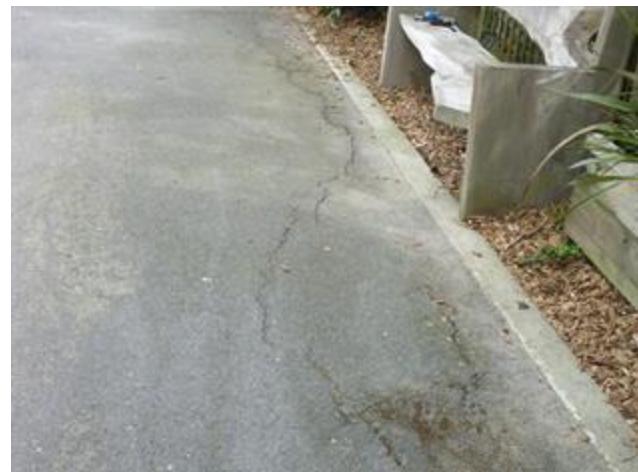
Side of the drive

The tar-seal drive leading to the garage was in good condition with a fall away from the foundations.

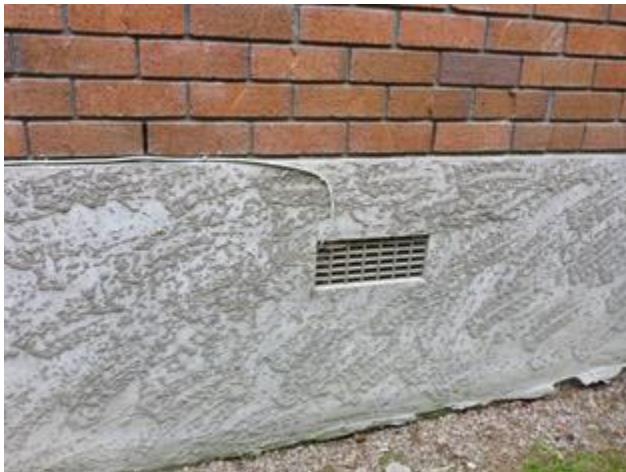
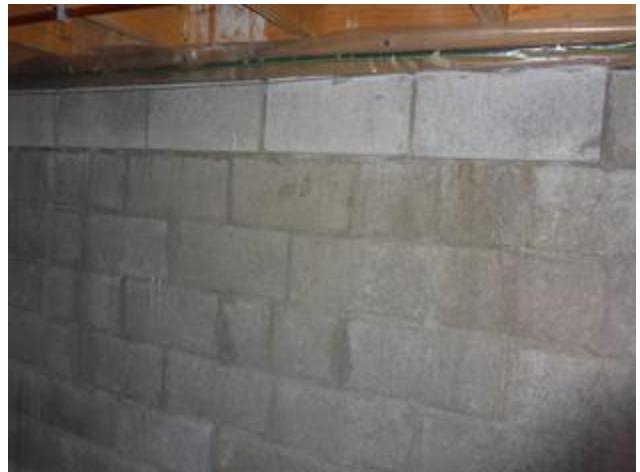
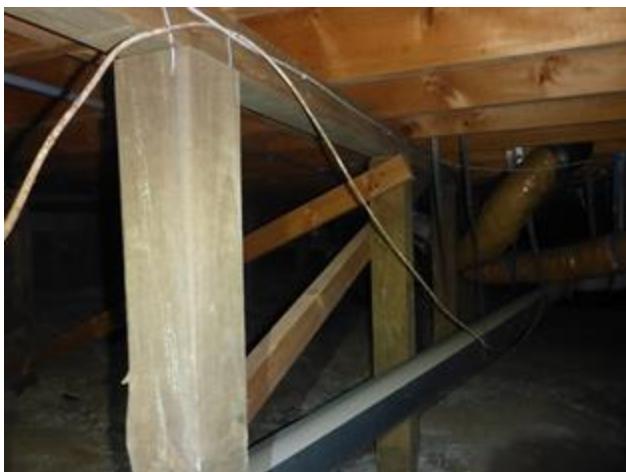
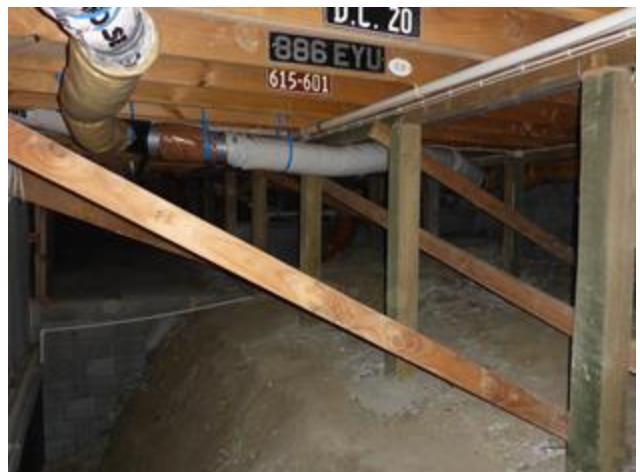
The insulation was in good condition however it is now deemed to be not very effective as well having health and safety issues.

The insulation has been removed from the en-suite flooring as a new plywood flooring has been fitted with the insulation still to be installed.

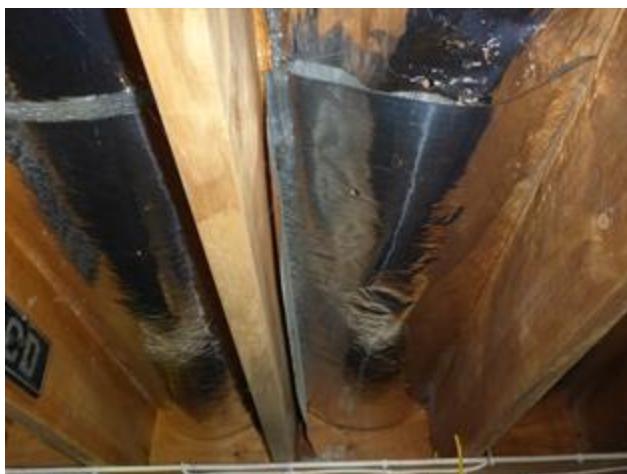
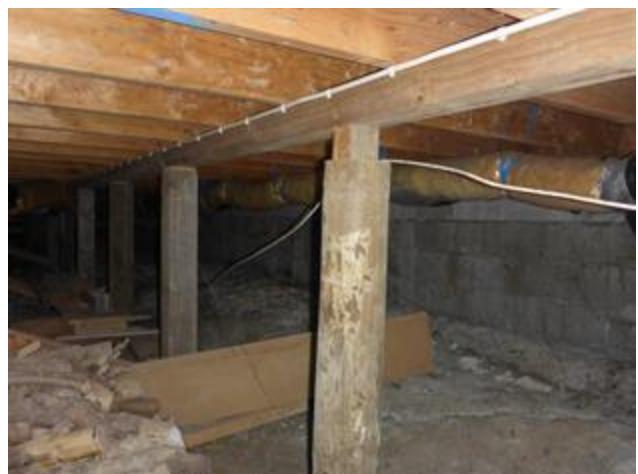
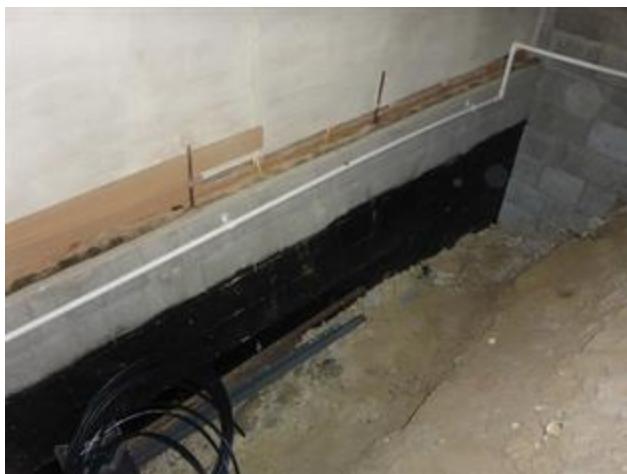
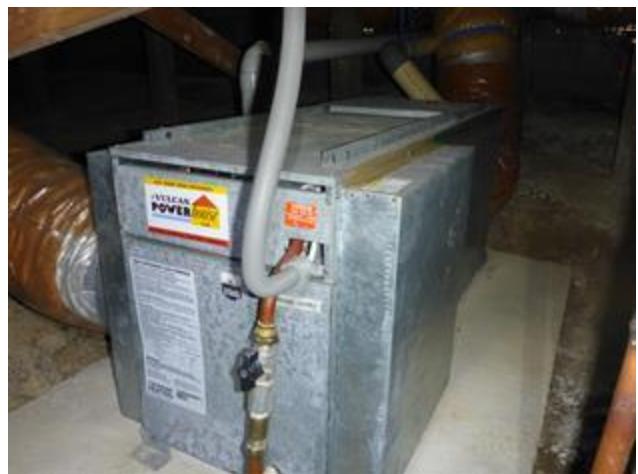
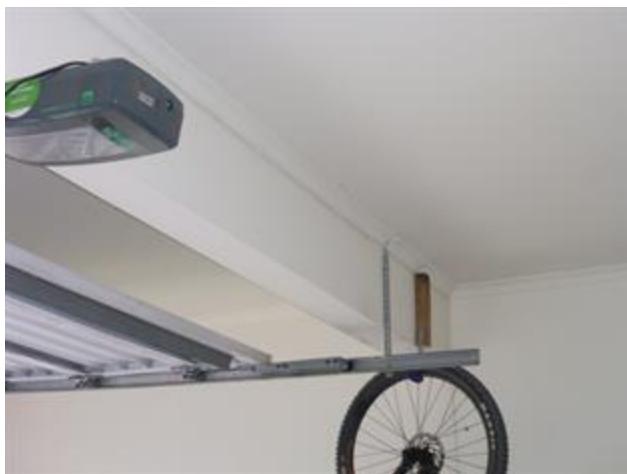
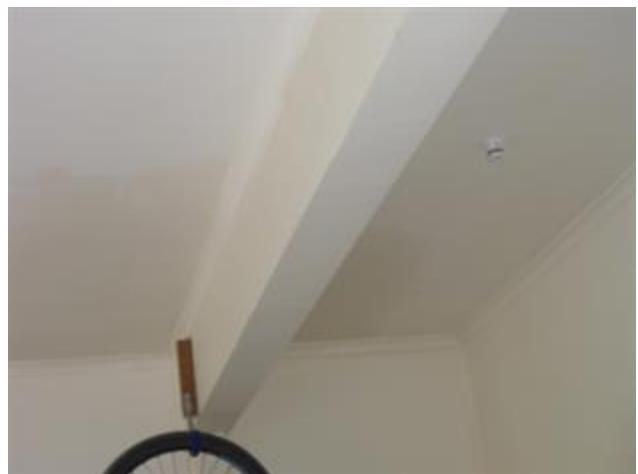
Garage steel supports

The foundation construction consists of a concrete block ring foundation to the exterior walls with tanalised piles to the mid span. Wood bearers sit on top of these piles and the floor joists run over the bearers. The timber is tied to the piles with wire. The two garages appear to be supported by steel beams.

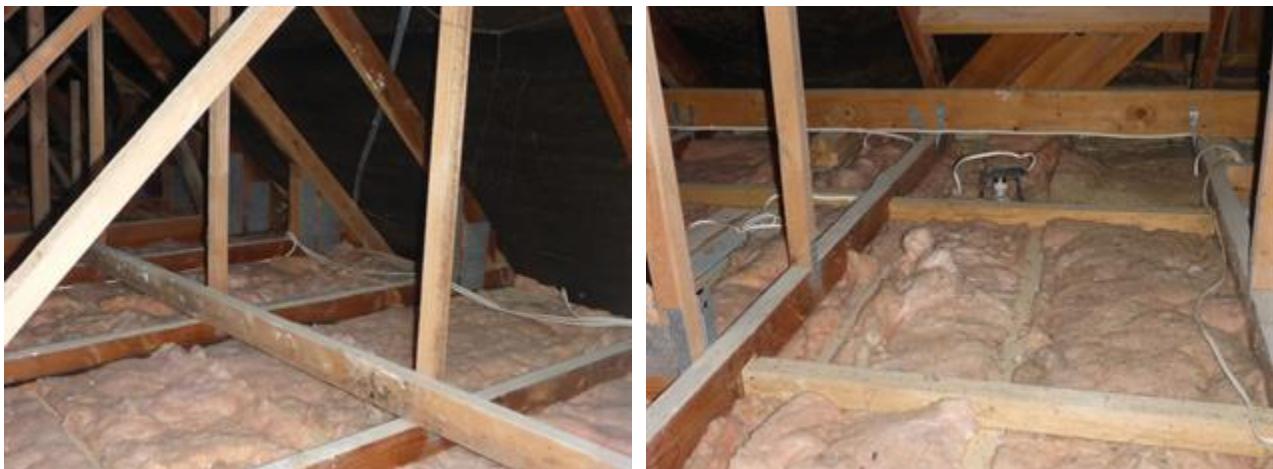
There were small areas identified in the attic space where the insulation could be fitted better. To gain maximum benefit from the insulation it needs to cover like a blanket as any gaps will cause heat loss. Filling the gaps would benefit the dwelling and the occupants.

Some existing recessed downlights require clearances to insulation. Where clearances are required they can cause a significant reduction in the insulation performance. In addition, many older recessed downlights allow for conditioned (heated or cooled) air to escape from the habitable space through the building envelope, or cold air to enter from the roof space. Removing recessed downlights that require clearances, or replacing them with modern recessed downlight that can be insulated up to or over, improves insulation effectiveness.

As part of the maintenance planning, I recommend consultation with a registered electrician about replacing the ten existing recessed downlights that require clearances from insulation with new recessed types that can be safely covered with insulation.

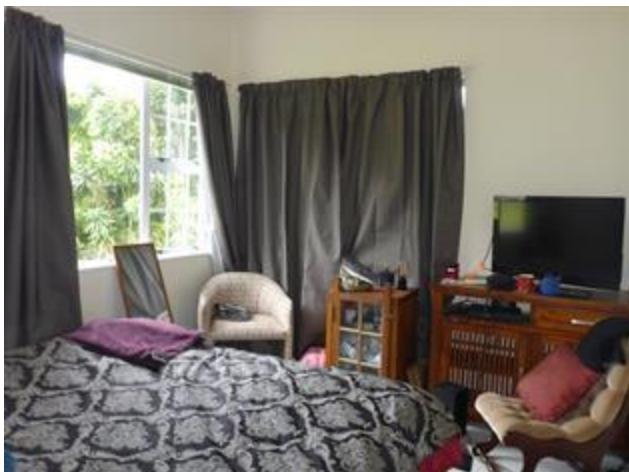
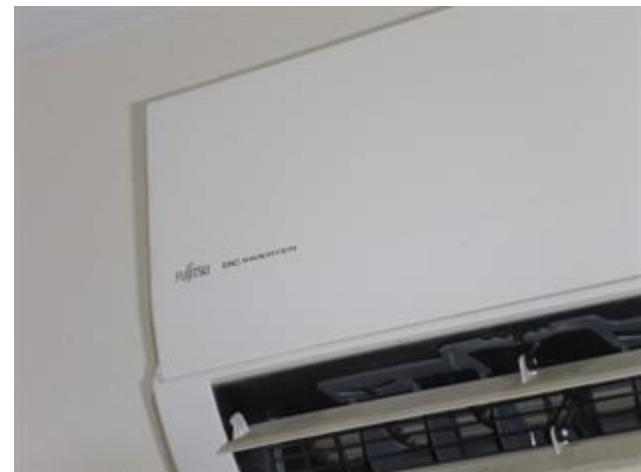
Flat

Heating for the dwelling is supplied by a Mitsubishi air-conditioning heat pump system that is directed into the living area. Filters require cleaning on a regular basis. There was also a heat pump in the flat.

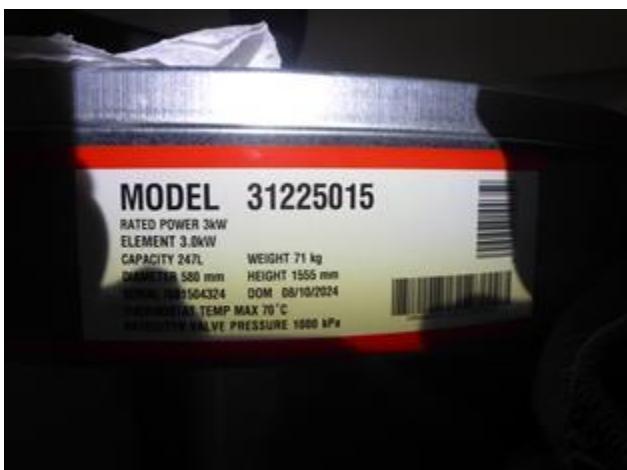
Dwelling

The hot water supply to the dwelling is via a 247 litre Rheem mains pressure electric cylinder manufactured 8/19/2024. The cylinder is located in a hall cupboard.

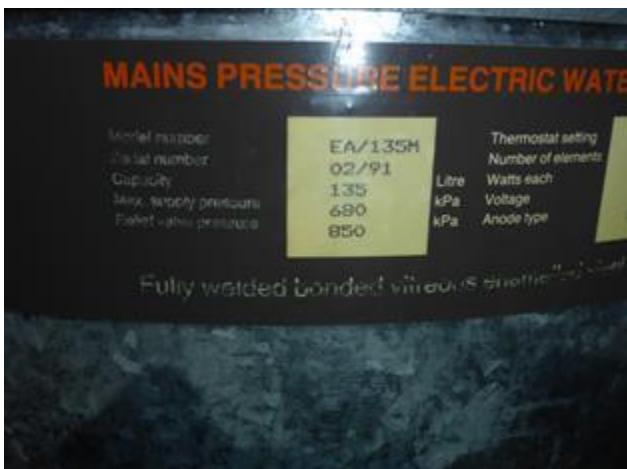
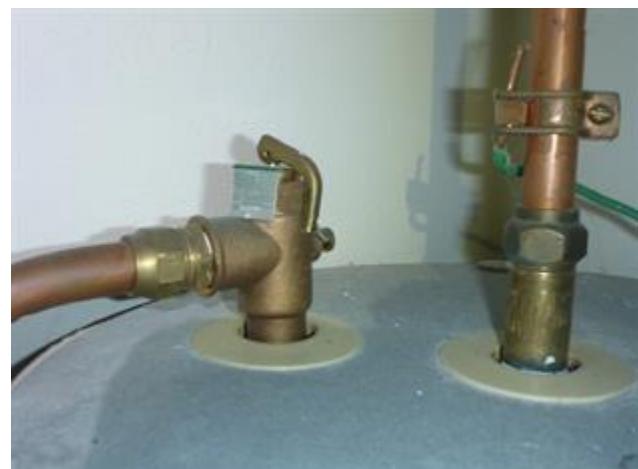
Pressure relief valve

Located on the top of each cylinder is a valve to relieve pressure in the hot water cylinder. It is recommended that the relief valve be checked for adequate performance or replaced at intervals not exceeding 5 years, or more frequently in areas where there is a high incidence of water deposits and that the valve easing gear be operated at least every six months.

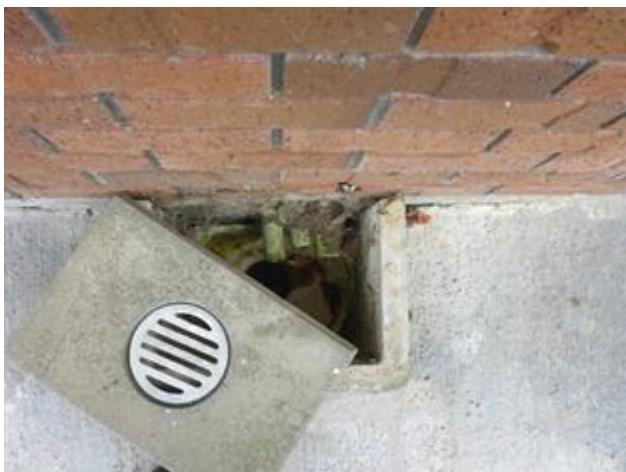
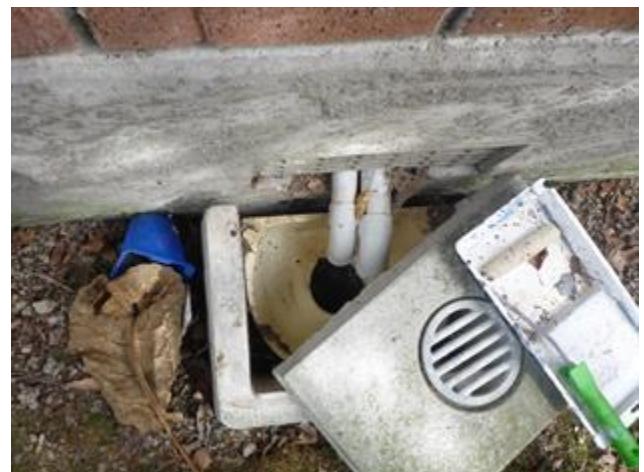
The gully traps appeared clear and clean at the time of inspection.
