Building Report

73A Ngaio Road
Waikanae

Date/s of inspection: 17-Dec-2025

Type of inspection: Building Inspection

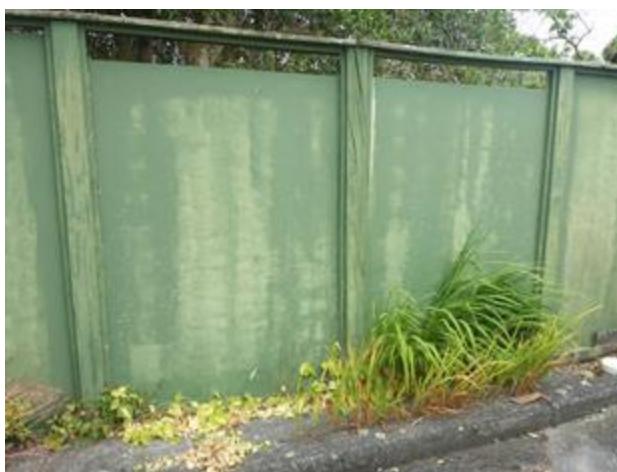
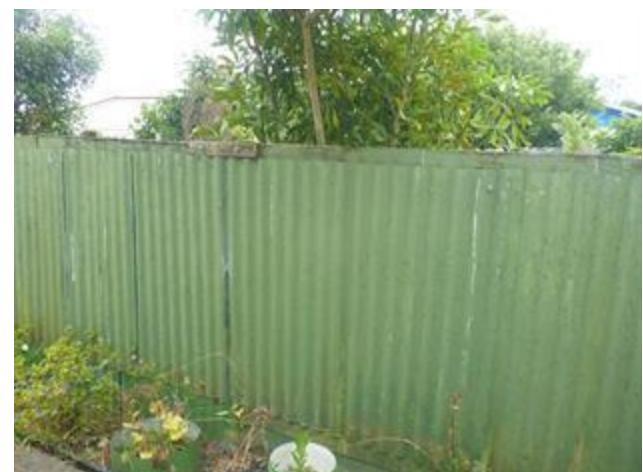
The property has a variety of fence types, which were generally in reasonable condition where visible and in terms of maintenance planning, areas would benefit from a coat of paint or stain to protect the integrity of the timber. Sections of the fencing have cement board panels that may have an amount of asbestos present.

May contain asbestos

Although there are no perceived health issues with this product when sealed, there are precautions with working with asbestos such as no dry sanding or scraping. You should not grind, waterblast, cut or remove asbestos sheet and contacting professionals is recommended.

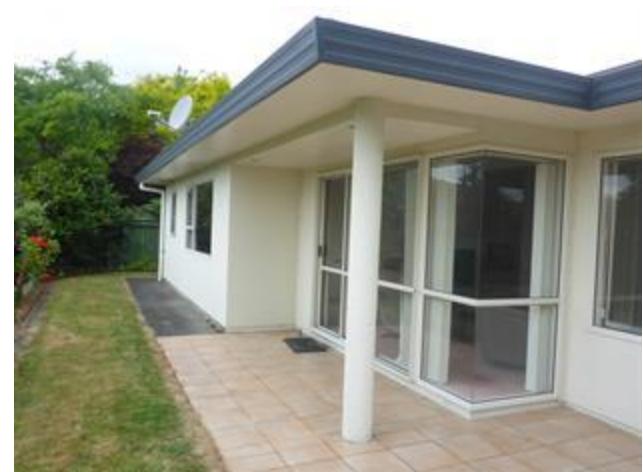
Cladding cracks were sighted to the front and rear of the dwelling.

Cladding crack to the front

My recommendation is that the cladding now have further specialist appraisal to give you advice about the crack's repair requirements, the areas with indications of high moisture levels, the small area of impact damage, joinery transitions and for an indication of costs.

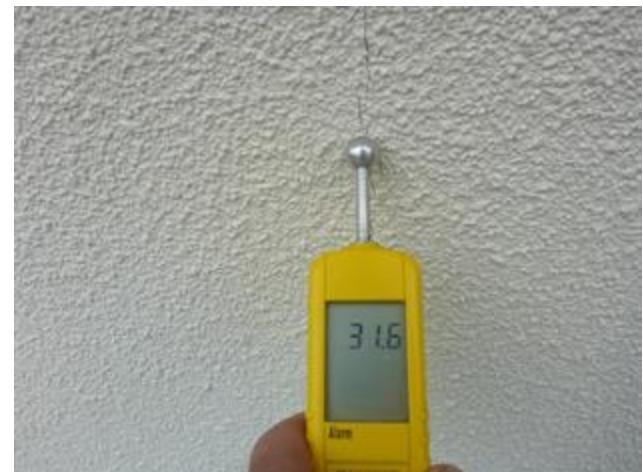
Moisture levels acceptable parameters

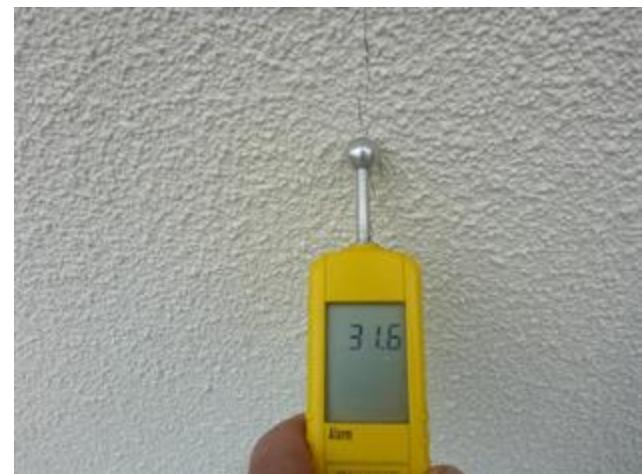
Cladding crack to the rear

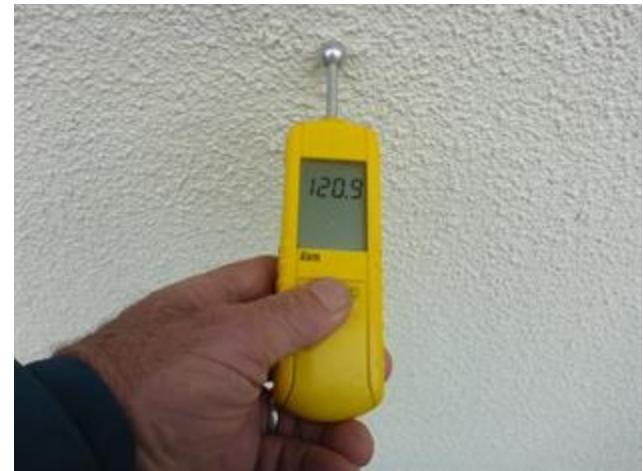
With this type of cladding, it is possible to use my moisture meter on the exterior. At the time of inspection moisture levels to the base and sides of the joinery penetrations were within acceptable parameters except to the right side of the master bedroom window.

High moisture levels master bedroom

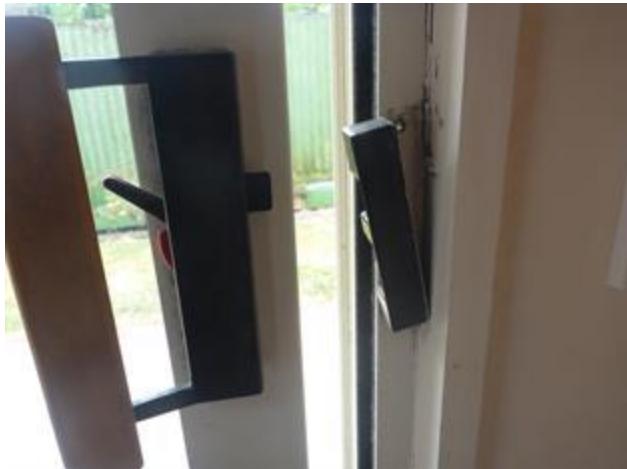
I noted that the keep to the ranch slider requires re-fixing.

Ranch slider keep

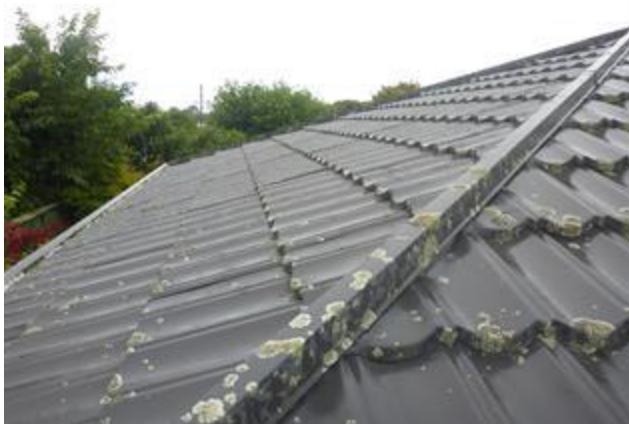
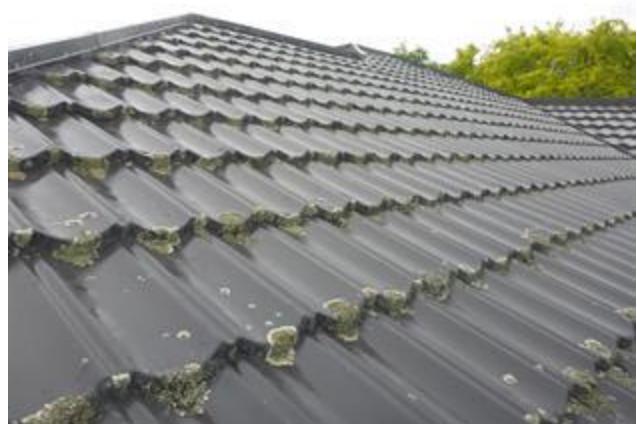
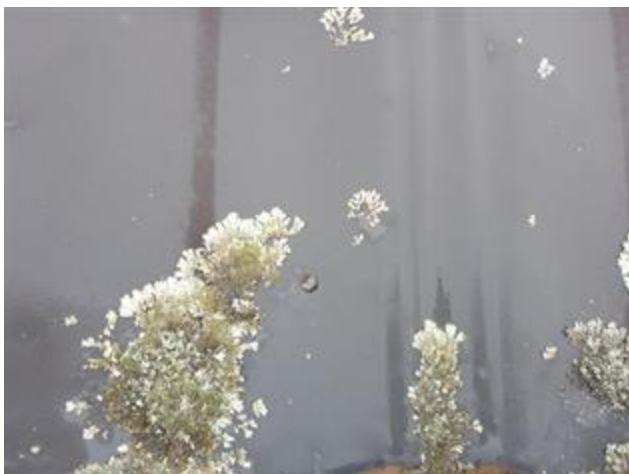
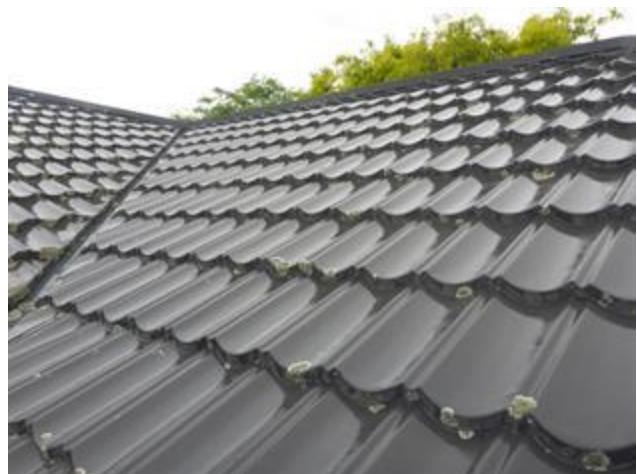
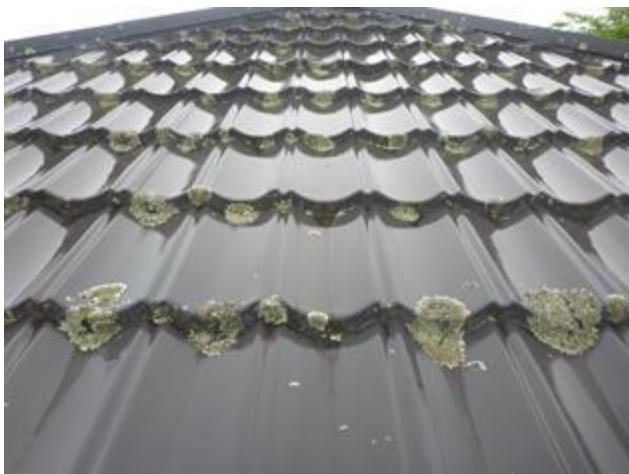
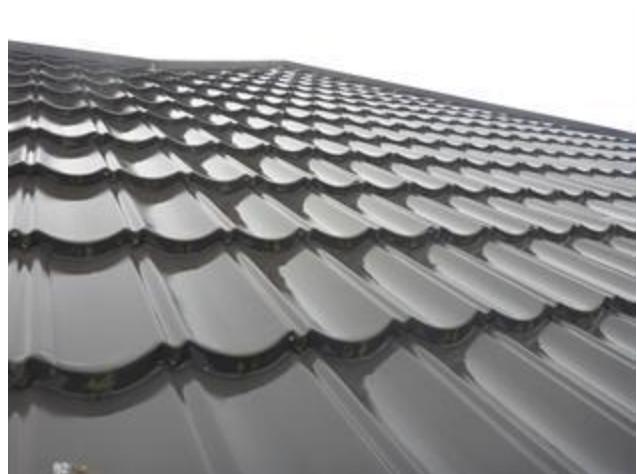
The colour tile roof cladding appeared in good condition bar one dented tile, the factory finish on the tiles showed no signs of deterioration or corrosion.

It is recommended that any moss is removed as part of the ongoing maintenance schedule as moss will retain moisture and start the corrosion process.

In general a once-a-year check of the roof cladding, any chimneys and the flashings is recommended to ensure problems are not developing.

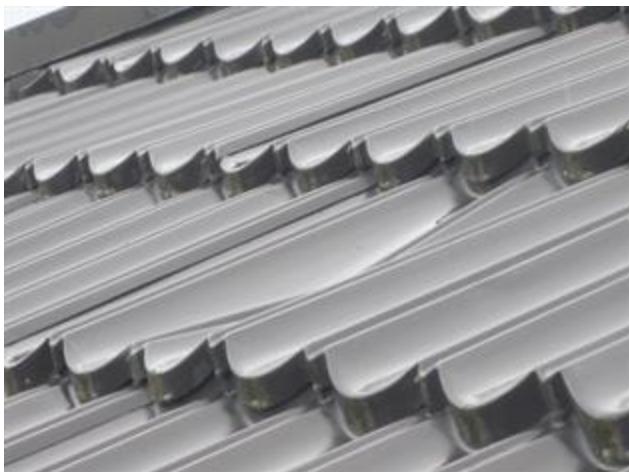
Tile dent

I recommend that the roofing material have further appraisal by a licensed roofer to give you advice on the degree of fastener replacement, washer upgrades and costs for maintenance planning.

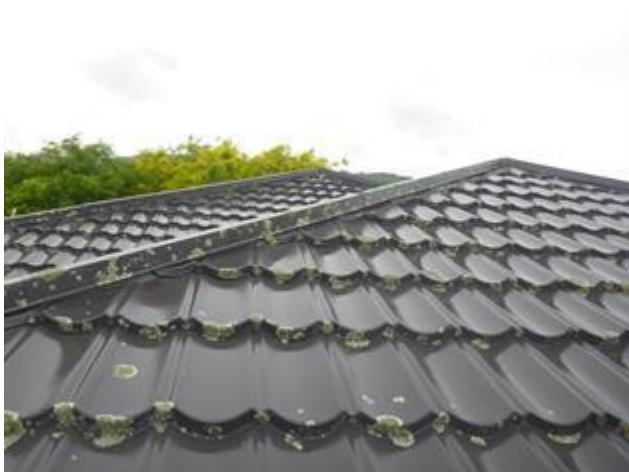
There were some loose or damaged fasteners that I recommend are pulled and replaced with new fasteners to secure the roof cladding and to prevent moisture ingress.

Also, the tiles of the lower run above the spouting have been fixed through the tops of the tiles without rubber washers. This would have been compliant at the time of construction but does not meet today's standards as this can allow moisture ingress issues.

Lower run/ loose fastener

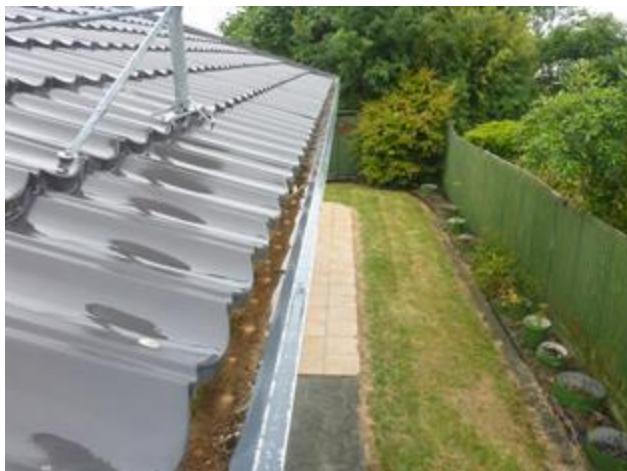
The spouting where visible appeared in good condition with the correct fall to the downpipes.

Clearing of the spouting is part of the general maintenance for all dwellings.

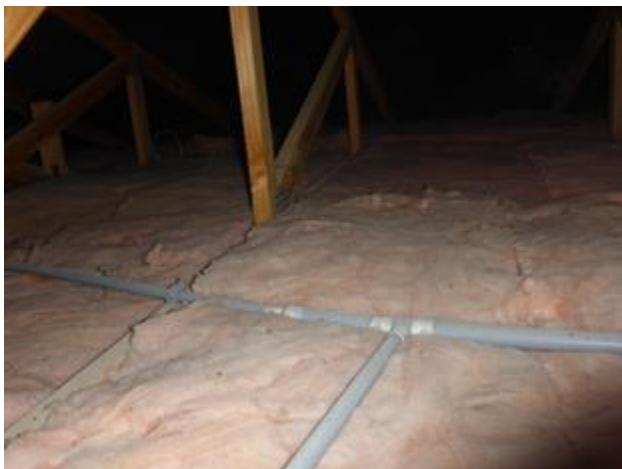
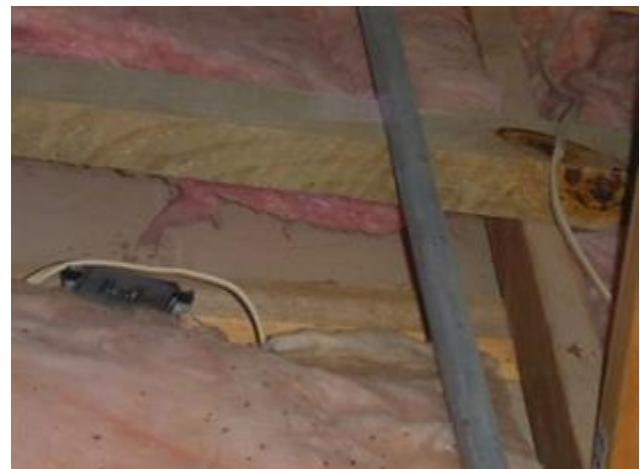
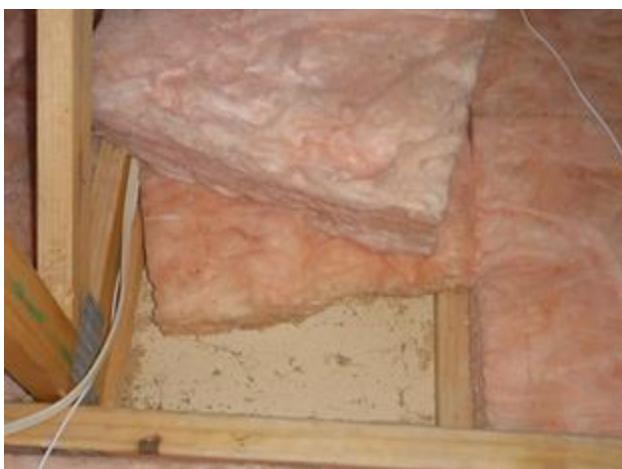
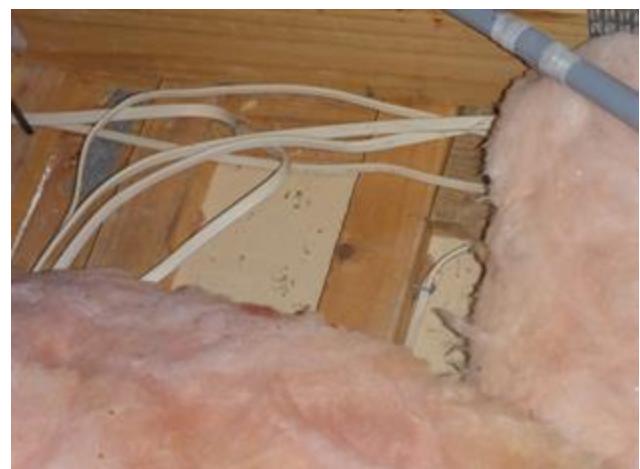
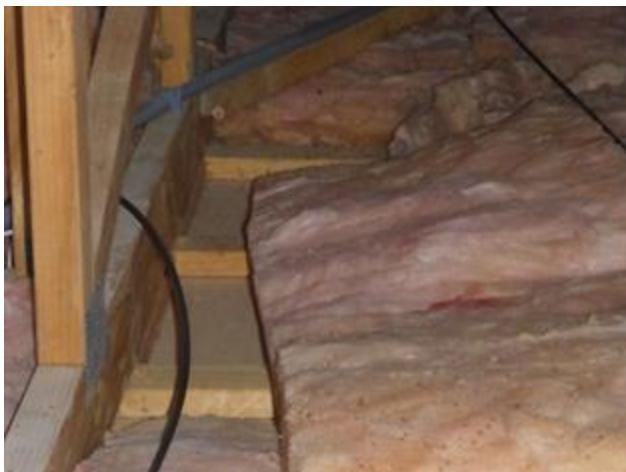
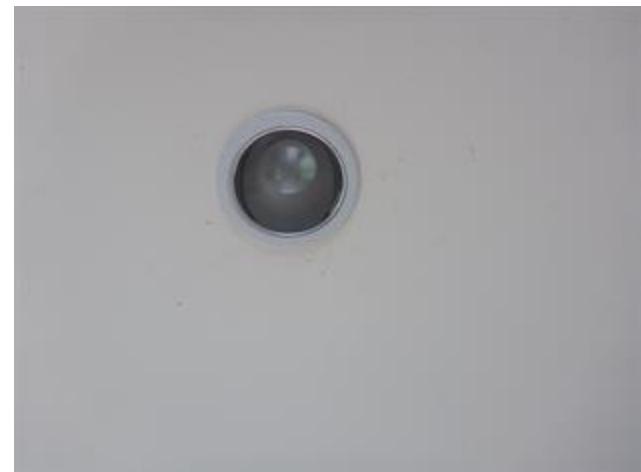
No signs of decay or leaks were identified where accessible.

There were small areas identified in the attic space where the insulation could be fitted better. To gain maximum benefit from the insulation it needs to cover like a blanket as any gaps will cause heat loss. Filling the gaps would benefit the dwelling and the occupants.

Some existing recessed downlights require clearances to insulation. Where clearances are required they can cause a significant reduction in the insulation performance. In addition, many older recessed downlights allow for conditioned (heated or cooled) air to escape from the habitable space through the building envelope, or cold air to enter from the roof space. Removing recessed downlights that require clearances, or replacing them with modern recessed downlight that can be insulated up to or over, improves insulation effectiveness.

It is also recommended that insulation is fitted snugly between framing without gaps, tucks or folds but not compressed or packed tightly around electrical wiring.

As part of the maintenance planning, I recommend consultation with a registered electrician about replacing the seventeen existing recessed downlights that require clearances from insulation with new recessed types that can be safely covered with insulation.

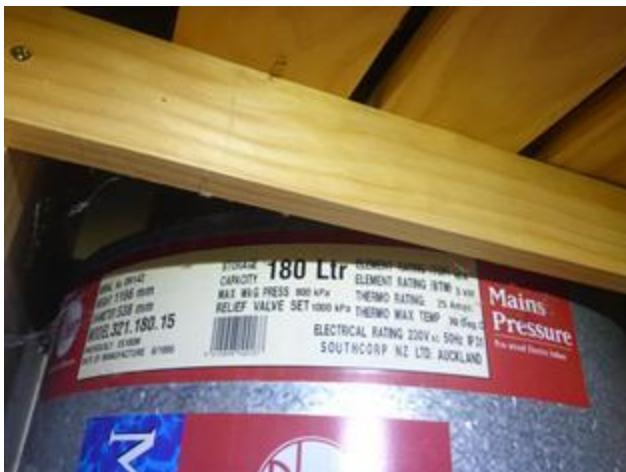
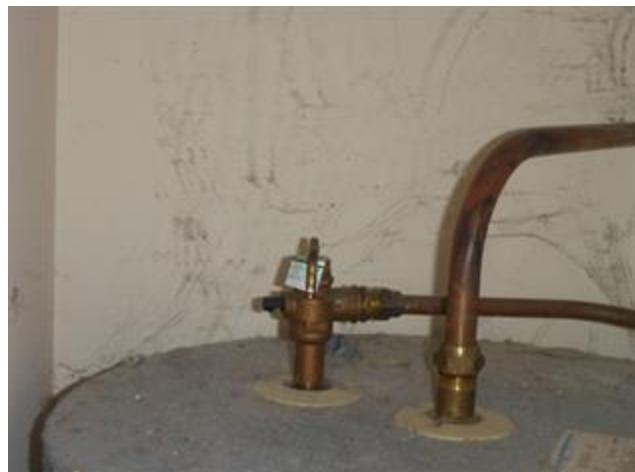
The hot water supply to the dwelling is via a 180 litre Rheem mains pressure electric cylinder manufactured 6/1996. The cylinder is located in a hall cupboard.

Located on the top of the cylinder is a valve to relieve pressure in the hot water cylinder. It was noted that the pipe from this valve was dripping probably due to the valve not being used. It is recommended that the valve is used every six months for the system relief and for water conservation.

Hot water cylinders built prior to 2003 benefit from additional insulation to reduce heat loss. Heating a home's hot water makes up one-third of the average power bill. Insulating the hot water cylinder with a hot water cylinder wrap is a quick easy way to make a difference to the energy use.
