EQC CLAIM DOCUMENTATION

EARTHQUAKE RECOVERY (EQR) DOCUMENTATION

NZ Residential Property Inspection Report

Canterbury Claims – Drainage Assessment Report

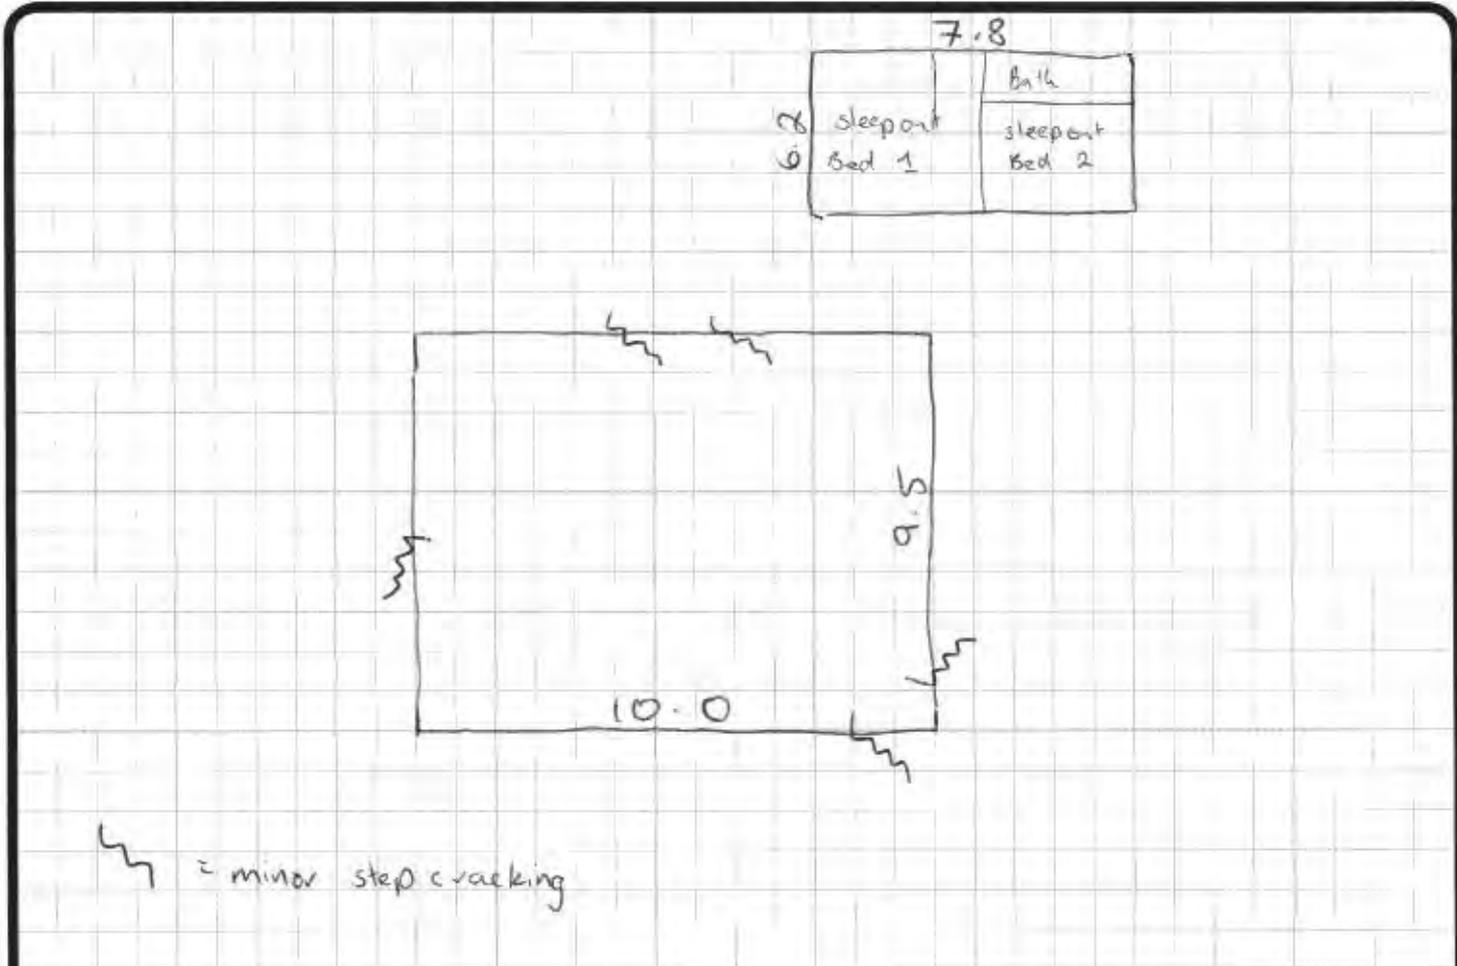
Area m2:	143.36
Stud Heights:	2.6
Wall Finish:	Wallpaper Plastered <u>Paint Finish</u>
Other:	
Services:	Specify Damage: no damage
Chimneys:	Construction Type: Height: removed. Damage Description: Above Roof Below Roof Total Repair
Foundations Damage:	Timber <u>Concrete Ring</u> Concrete Slab Other (Specify): Minor Moderate Severe no damage House Moved off Foundations? Concrete Slab Cracked? Crack Width: n/a ... Crack Length: n/a ...
Roof:	<u>Framed</u> Trussed Type: Clay Tiles <u>Concrete Tiles</u> Rolled Metal Other Damage: no damage - old cracks to mortar
Cladding Type:	Weatherboard <u>Brick Veneer</u> Hardi Plank Other

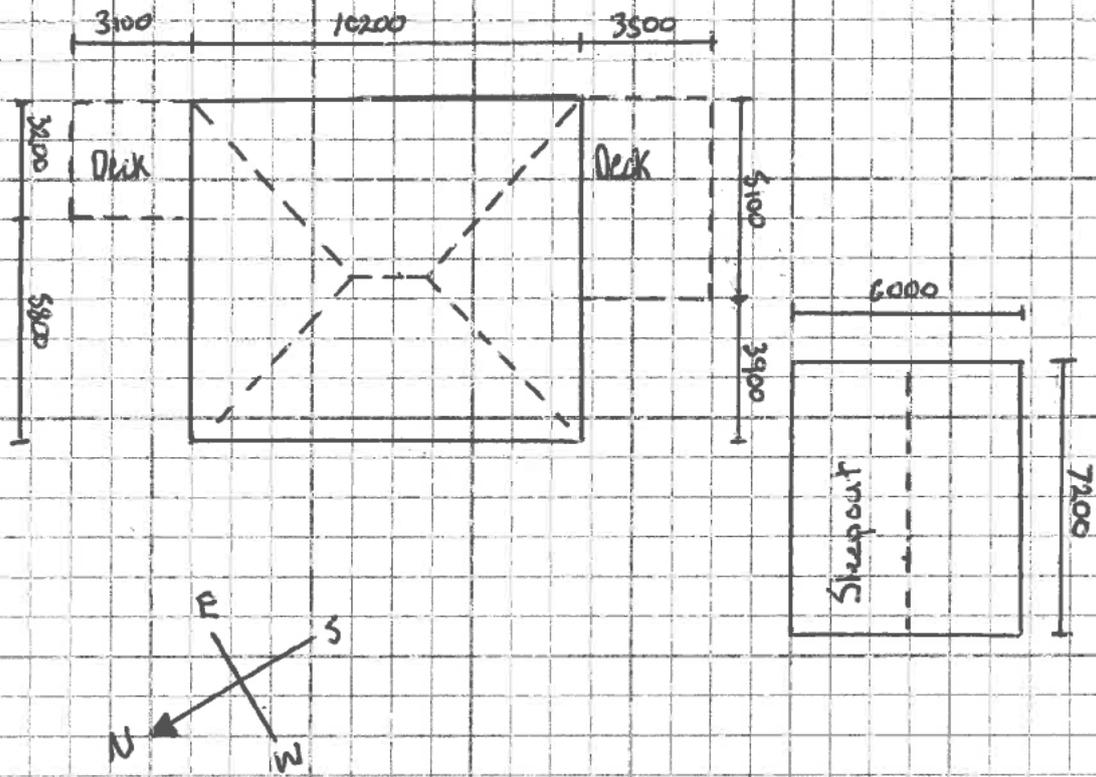
Scale 1:200

Area m ² :	135
Stud Heights:	2.7
Wall Finish:	Wallpaper Plastered <u>Paint Finish</u>
Other:	
Services: N/D	Specify Damage: <u>NIL</u>
Chimneys: N/A	Construction Type: Height Damage Description: Above Roof Below Roof Total Repair
Foundations Damage: N/D	Timber <u>Concrete Ring</u> Concrete Slab Other (Specify): Minor Moderate Severe House Moved off Foundations? <u>NO</u> Concrete Slab Cracked? Crack Width: Crack Length:
Roof: N/D	<u>Framed</u> Trussed Type: Clay Tiles <u>Concrete Tiles</u> Rolled Metal Other Damage: <u>NIL</u>
Cladding Type: N/D	Weatherboard <u>Brick Veneer</u> Hardi Plank Other

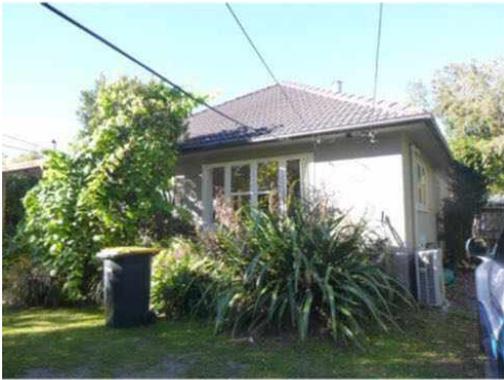
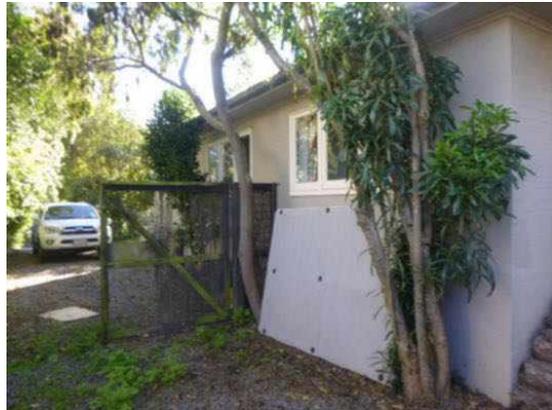
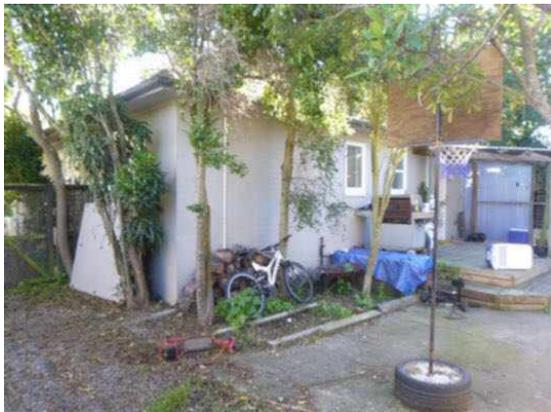
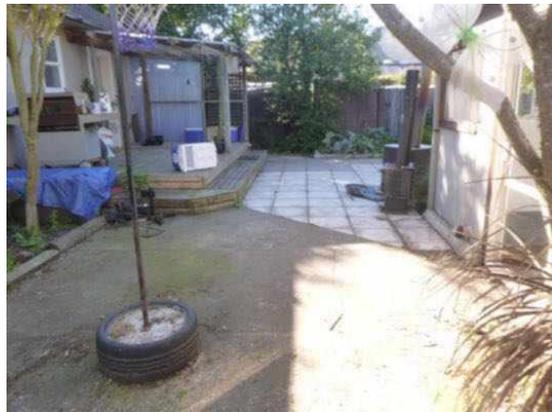
Noted Item

Building: Main Building
Location: NZ Only > All Areas
Finding: Additional Photos - Obstructions and Limitations
Information: These photographs are an indication of the obstructions and limitations which impeded full inspection of the property at the time of inspection. These obstructions can hide an array of defects and should be removed to allow full inspection to be carried out. A re-inspection is recommended once the areas are made accessible.

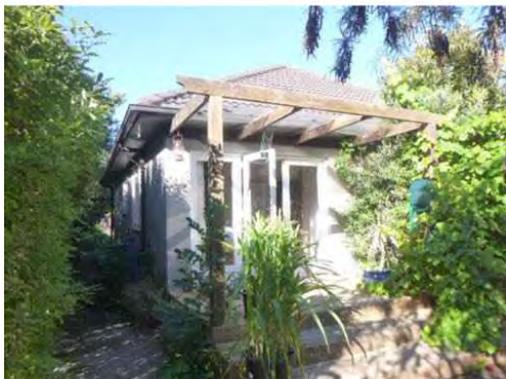
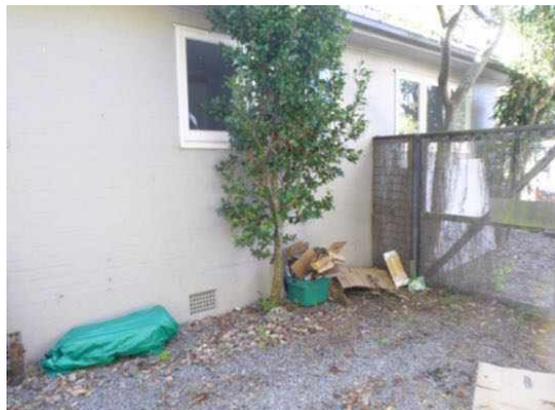
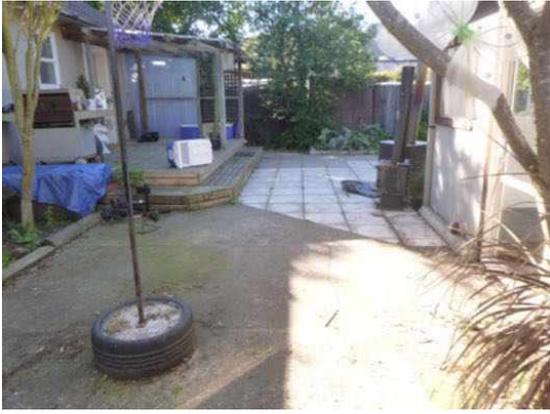
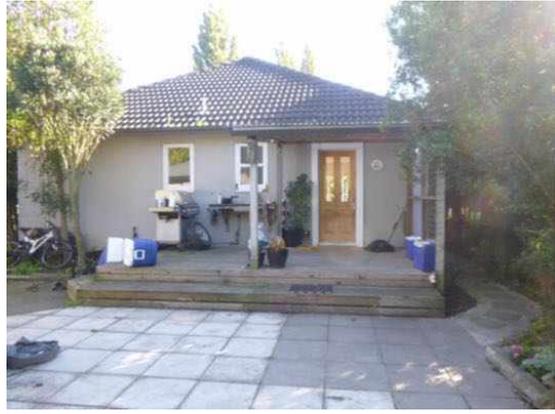
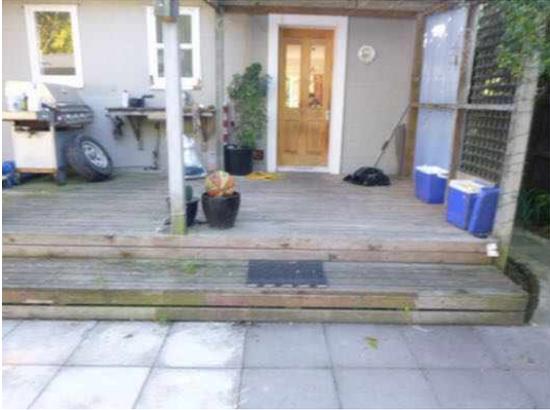
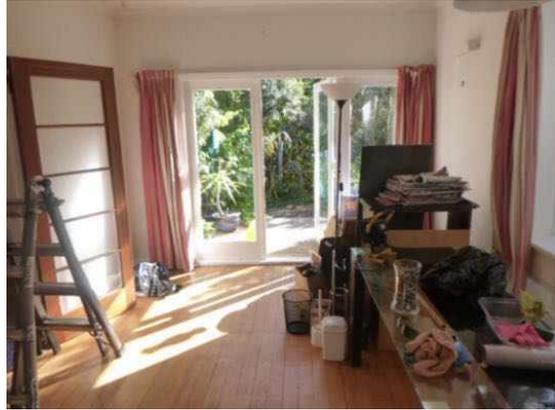
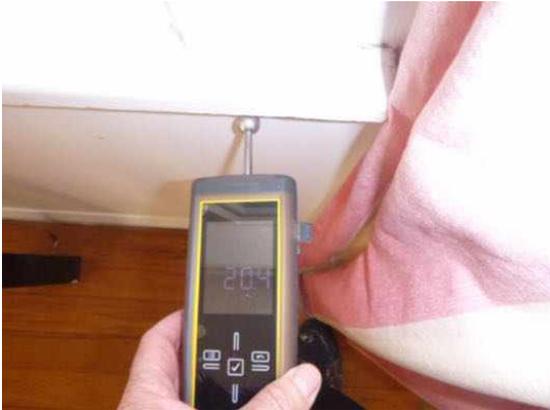
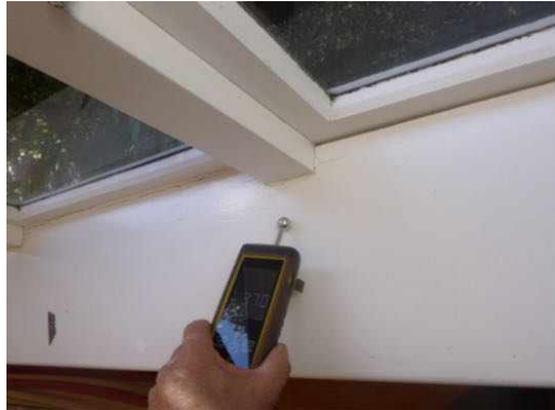
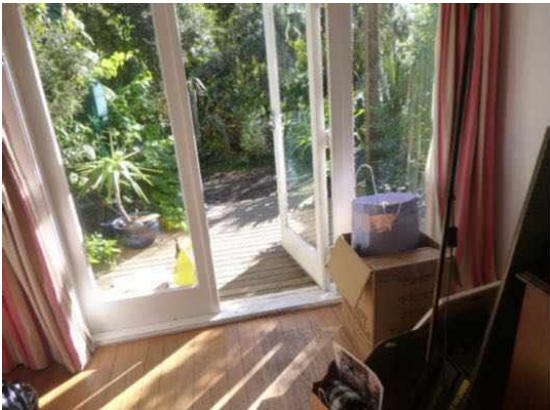
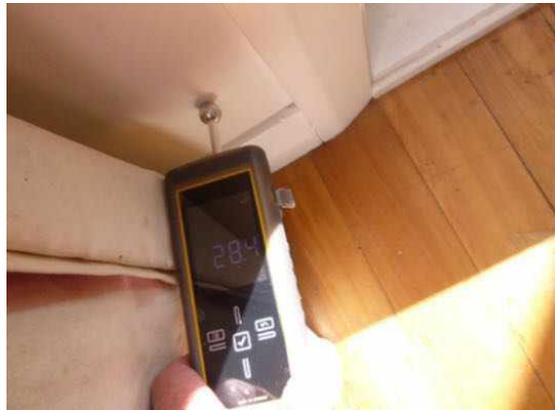
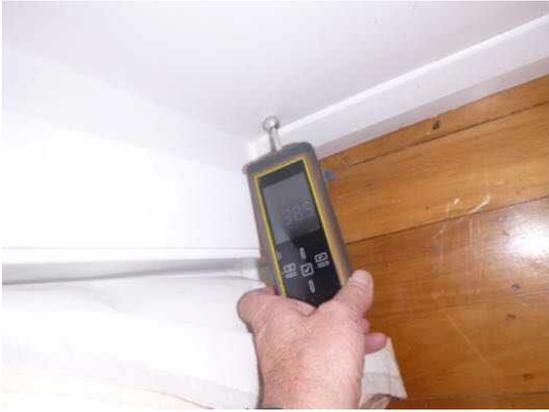
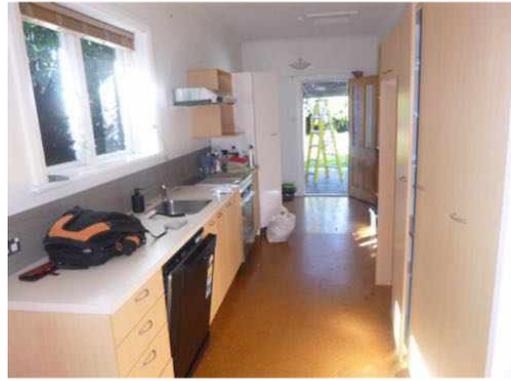
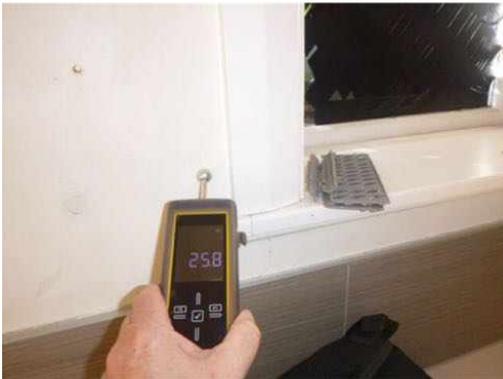
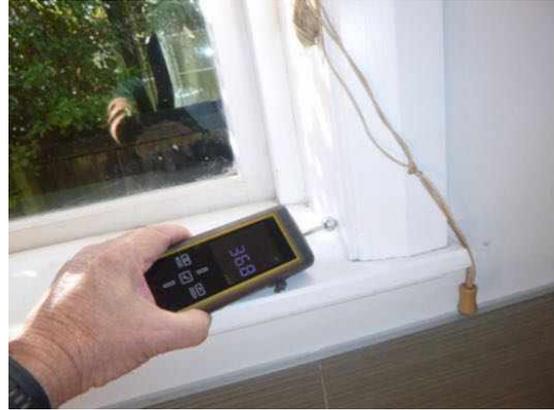
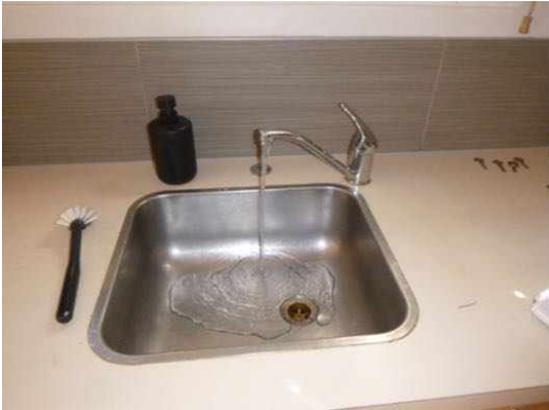
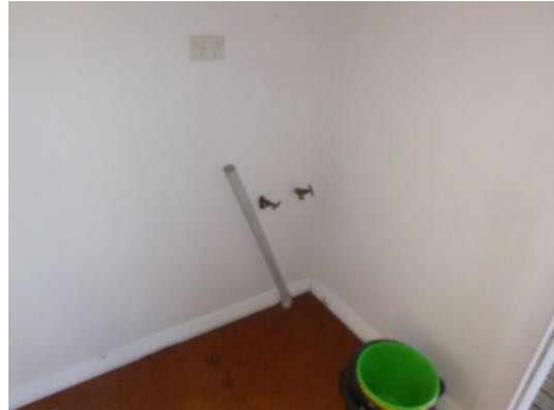
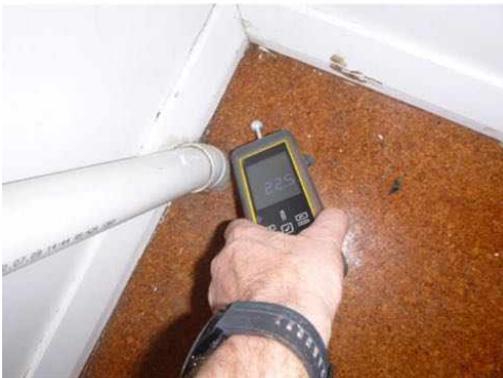
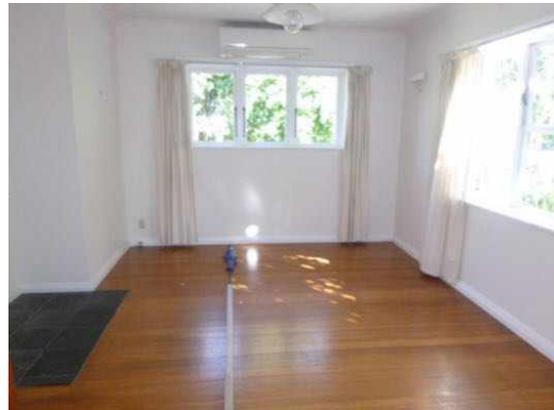
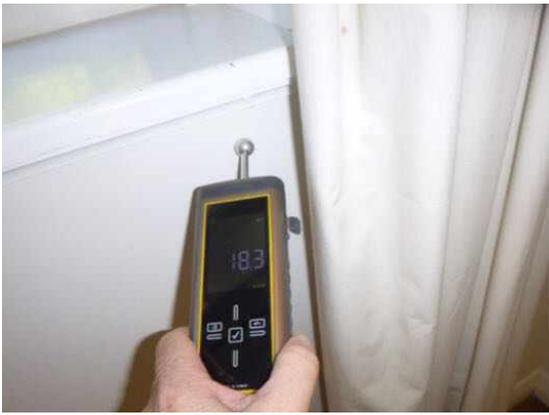
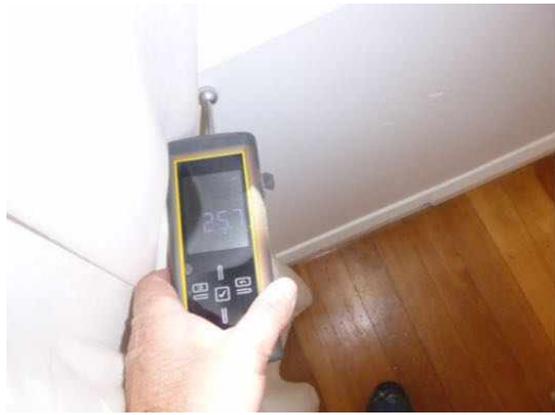
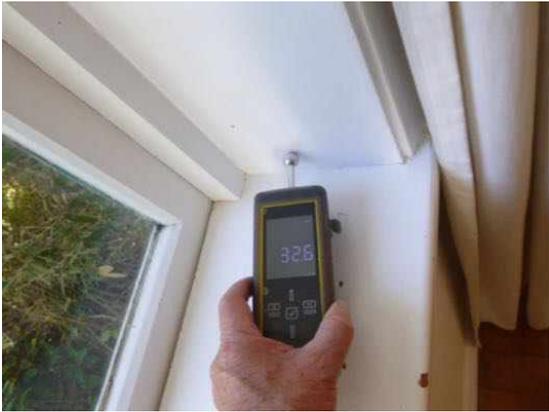
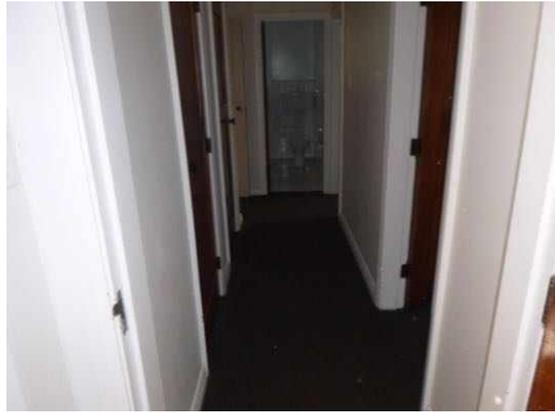
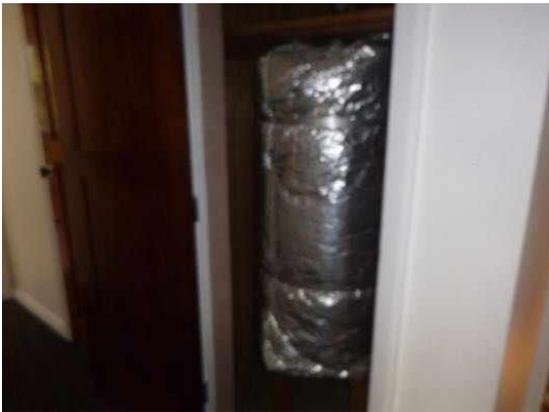
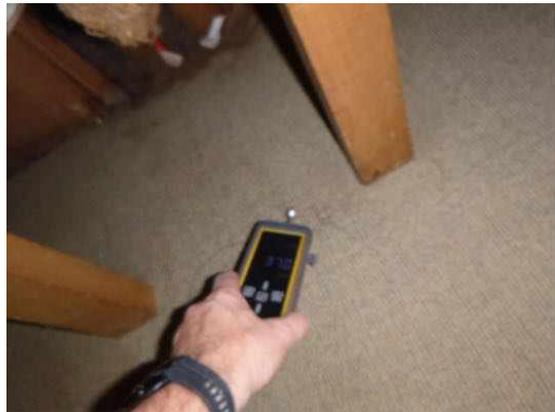
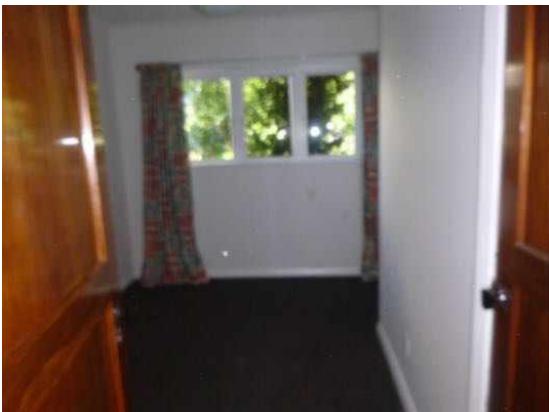
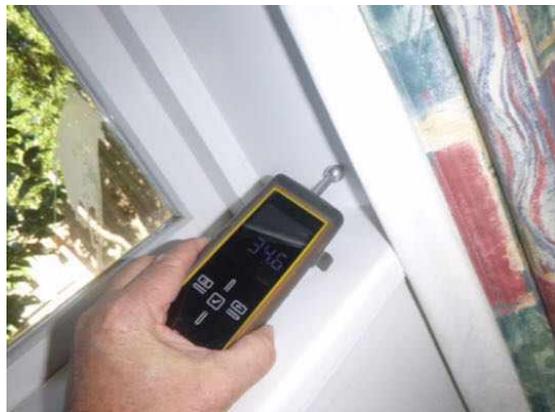
Building: Main Building
Location: NZ Only > All Areas
Finding: Additional Photos
Information: Additional photos are provided for your general reference. Arrows have been included to highlight areas of importance. Please discuss these photos with your building consultant for clarification.

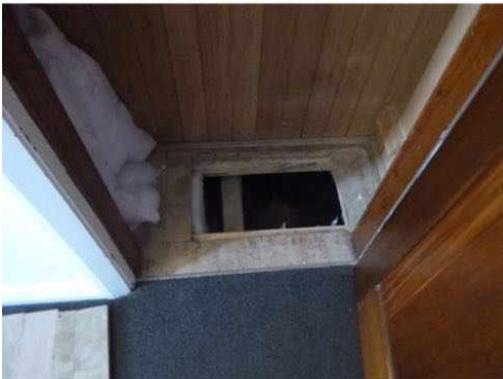
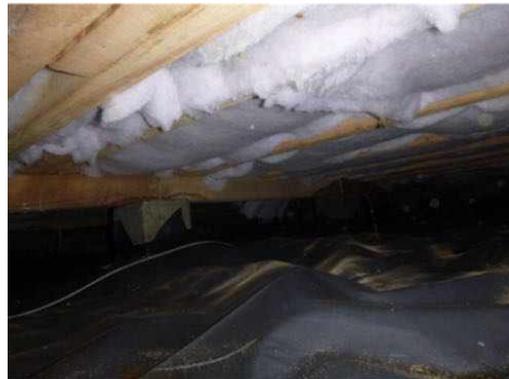
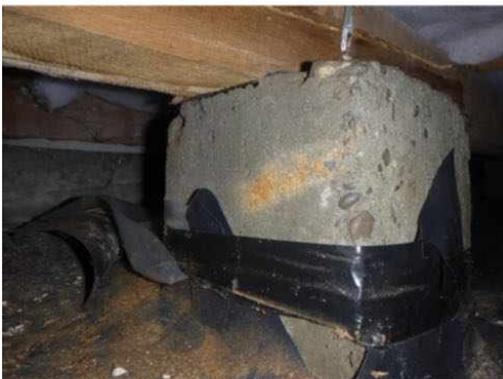
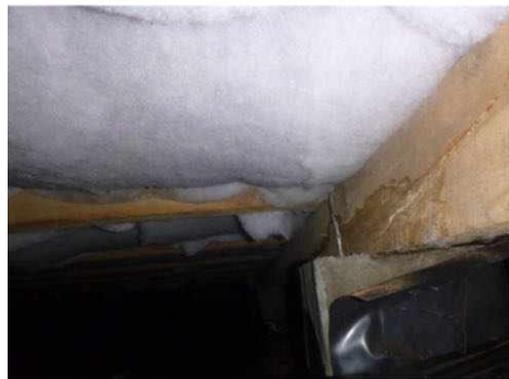
Building: Main Building
Location: All Areas > All Areas
Finding: Subfloor
Information: At the time of inspection the concrete piles appeared to be in good condition and visually plumb. It does appear that the piles observed were fixed to the structure.

The subfloor structure consisting of a ring foundation and concrete piles generally appeared to be in good condition with viewing from the manholes only.

The timber subfloor has insulation fitted to a good standard. A PVC vapour barrier installed to the ground level to a good standard.

Basic floor levels were checked and within MBIE tolerances and guidelines.

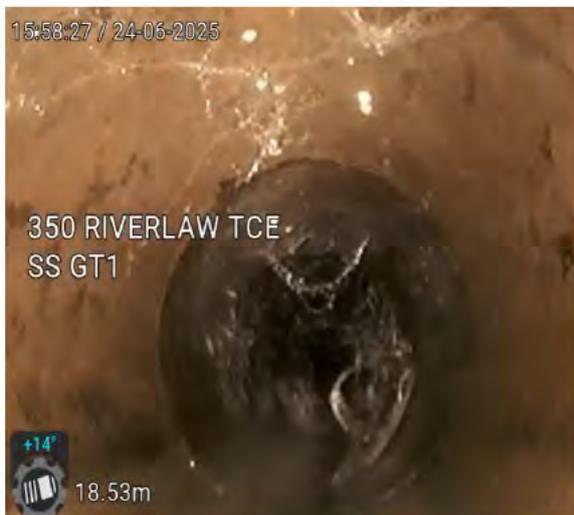
Root intrusion through IP – Sewer

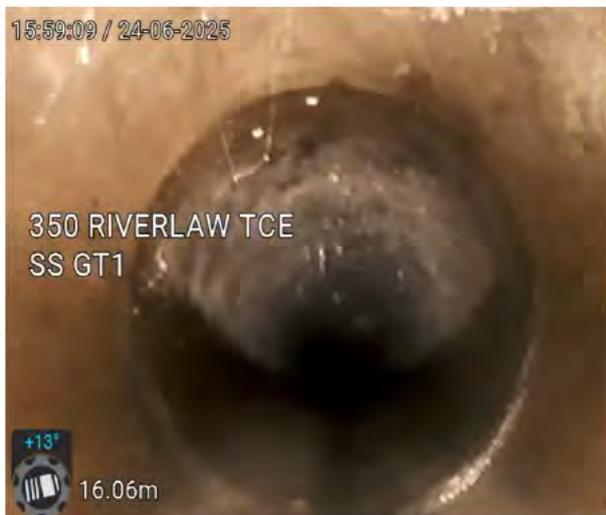
Pipe joint – Sewer

Minor joint displacement – Sewer

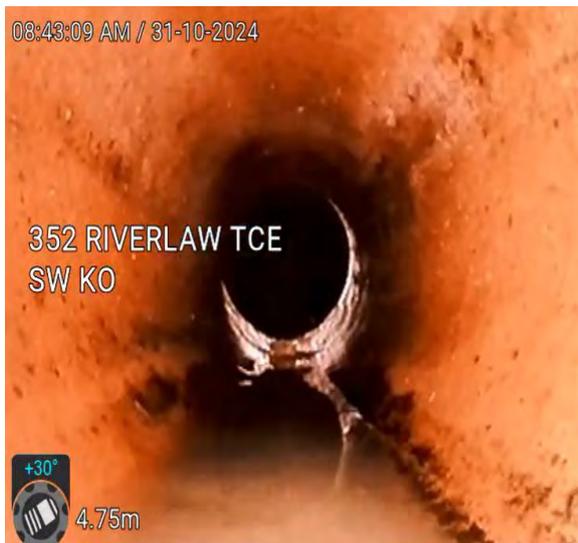
PVC pipe addition – Stormwater

Displaced joint – Stormwater

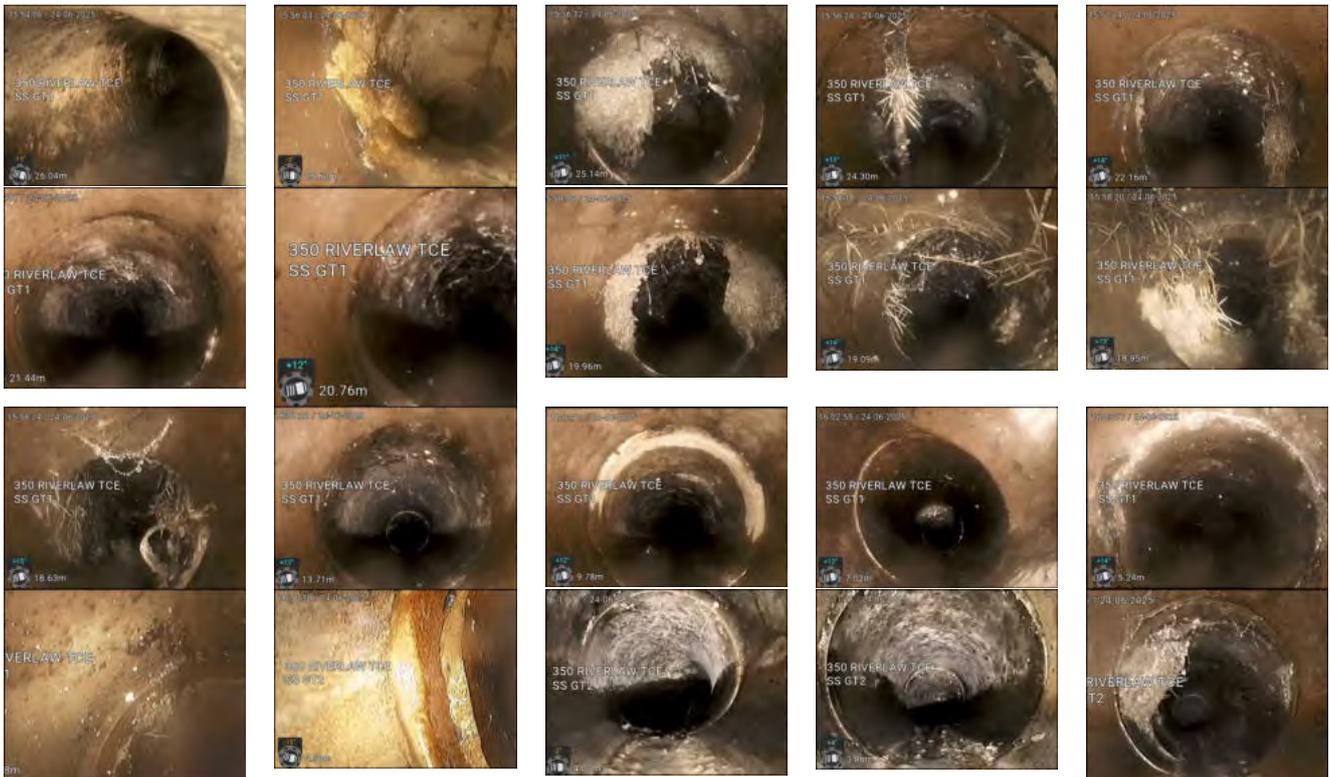
Cracking does not occur over time and isn't caused by roots alone which are slow to grow. This is more indicative of the sudden force from ground movements, the roots & soil being secondary to the trauma caused to the pipes from sharp ground movements.

The earthenware damage has been caused by ground movements from the Canterbury earthquake sequence (CES) and is in need of repairs.

Included in Repair Strategy
