# 5b Madeley Place, Mount Pleasant.

## **Structural Assessment & Building Report Property File Document Summary**

## **5b Madeley Road, Mount Pleasant, Christchurch**

RedFox Structural and Seismic Engineers have been engaged by Blackmilk Interiors NZ Ltd to provide a structural inspection report for the property at the above mentioned address.

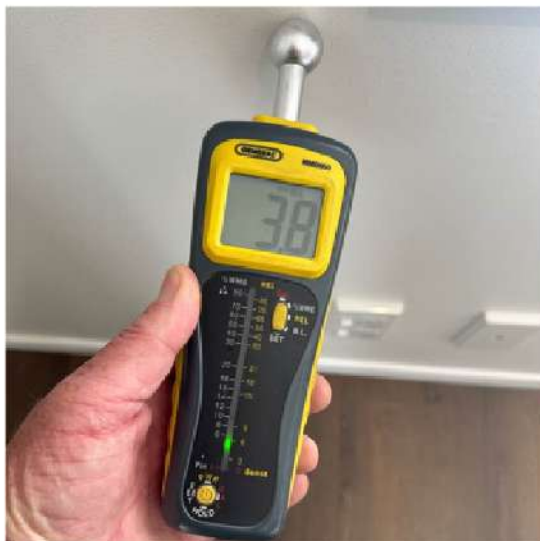
Low moisture reading,  
green = Good

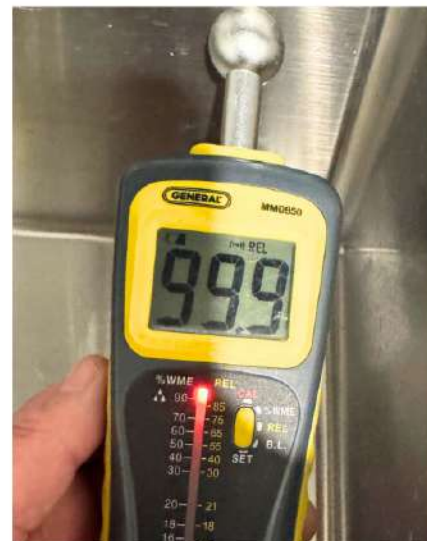
High moisture reading:  
Red:  
Damp = 20+  
Wet = 50+

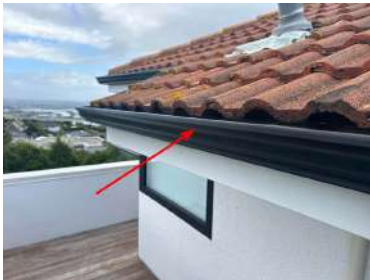
Colour steel gutter system

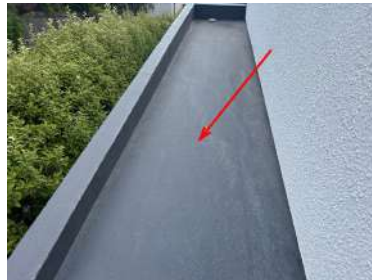
Butynol membrane roof

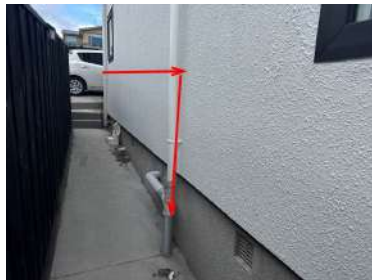
All downpipes directed into stormwater as intended

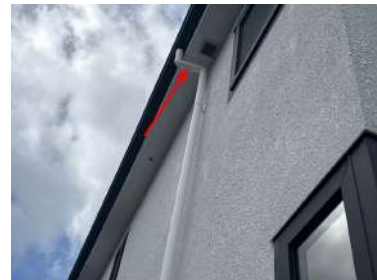
All downpipes connected to the gutter correctly

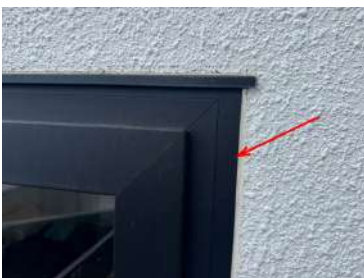
Window silicon seals
