# Independent Builders Report

Total Home Inspection Services Porirua City Ltd

Tue 24 Feb 2026

**87 The Esplanade, Raumati South, Paraparaumu, 5032,  
New Zealand**

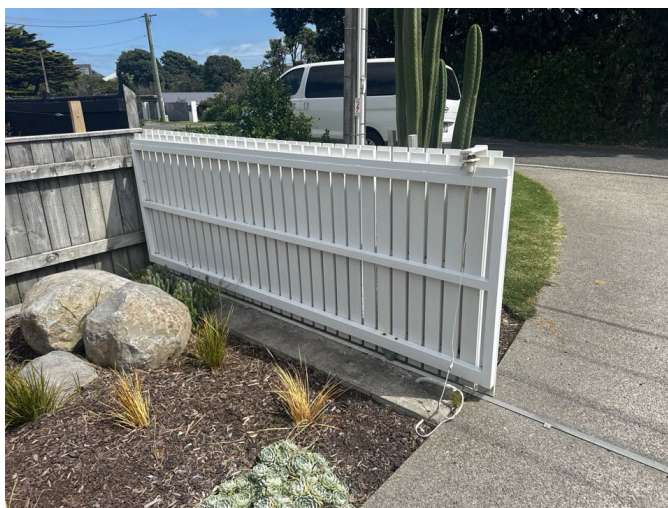
The electric gate to the driveway was not tested by T.H.I.S

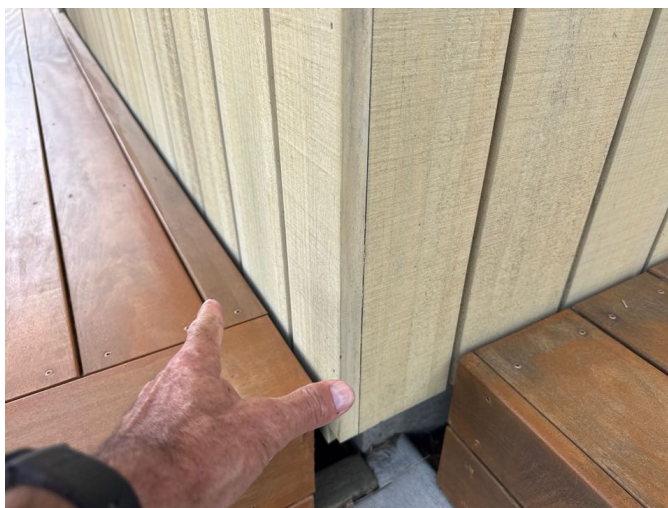
Good clearance between the decks and the cladding which will allow water to drain away.

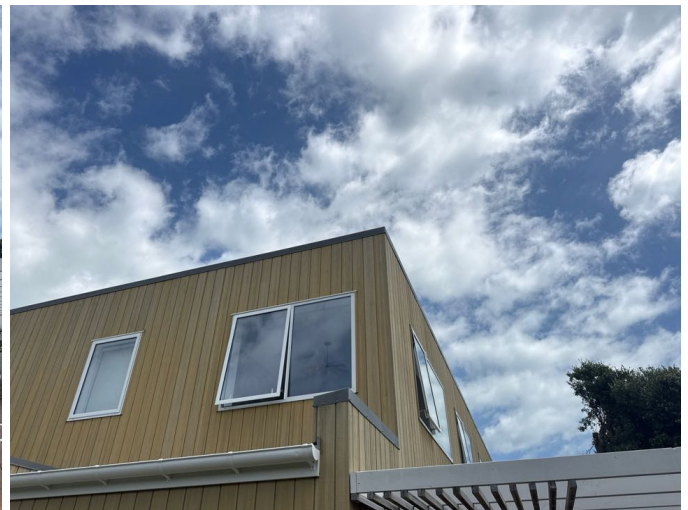
No soffits to most areas

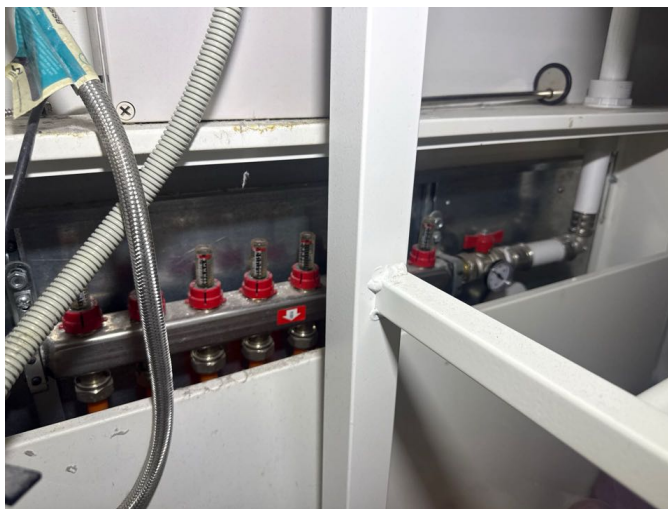
The manifold control for the in floor heating system is located by the hot water cylinder

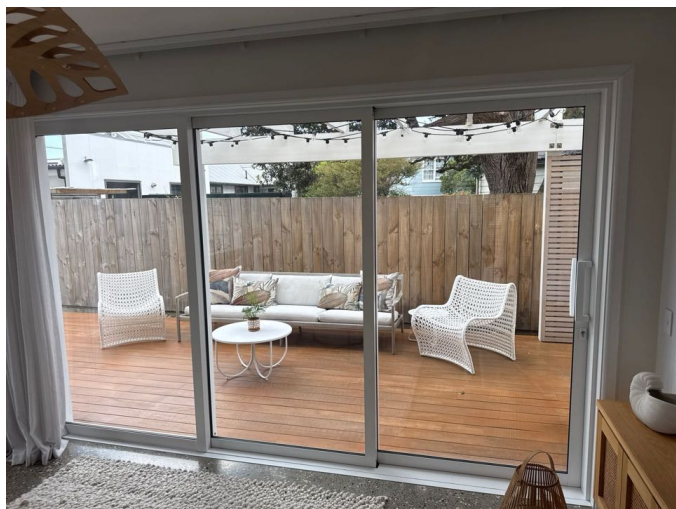
External doors are functioning well

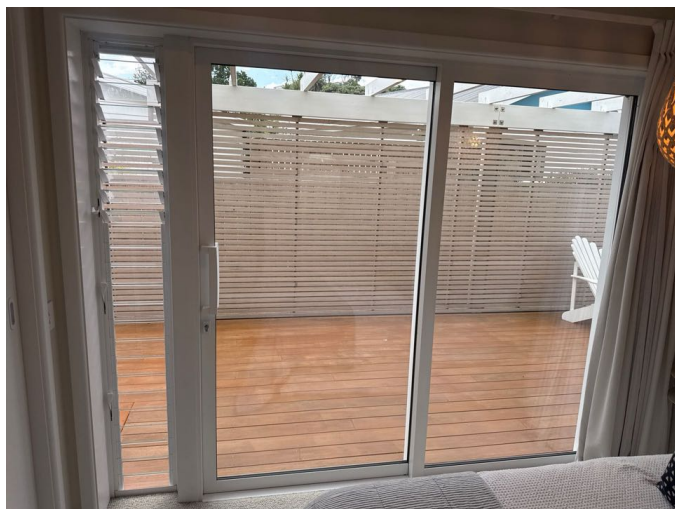
The louvre windows and sliding door are functioning well

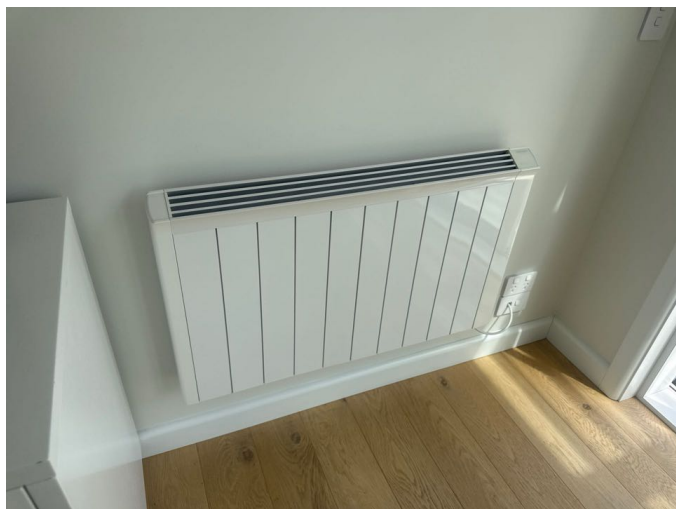
Electric heater installed
