**Information request - CLM/2010/094890 - 53 Marshall Street, Woolston, Christchurch 8023**

# Scope of Works

## Assessment of Property at 53 MARSHALL STREET, WOOLSTON, CHRISTCHURCH 8023 on 8/09/2011

## EQC Full Assessment Report

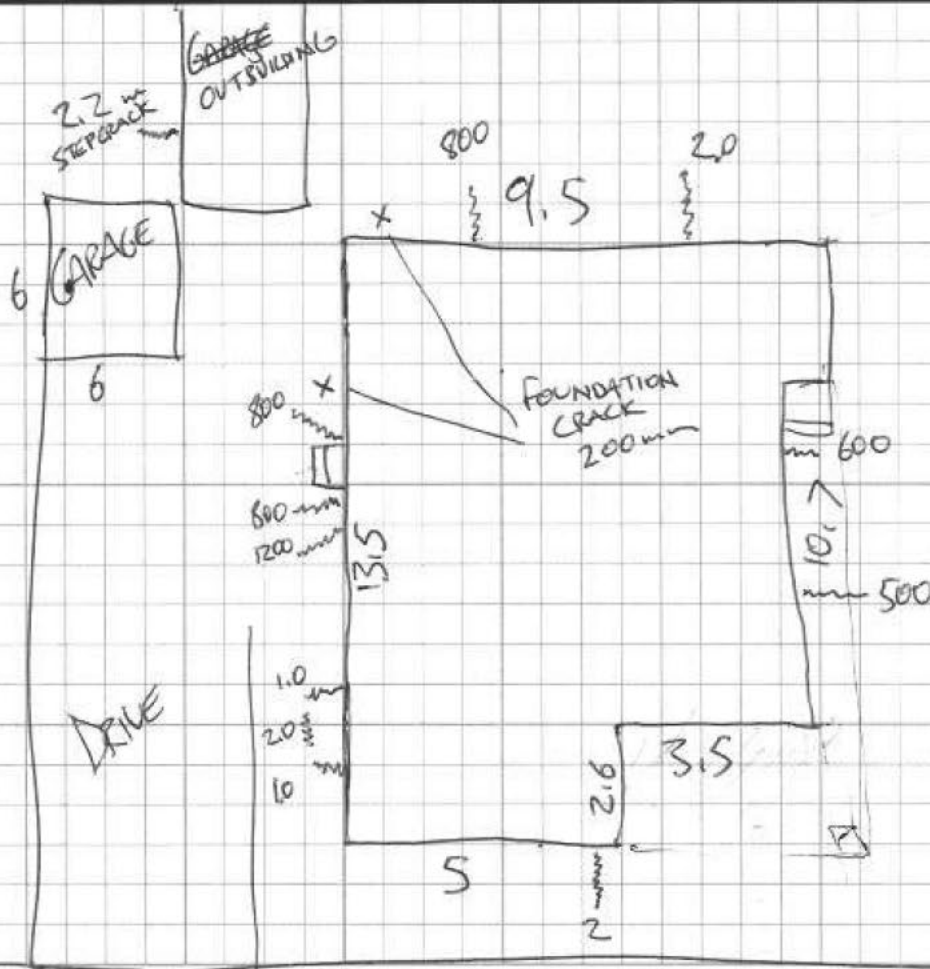
Area m2:	136
Stud Heights:	2.7
Wall Finish:	Wallpaper      Plastered <u>Paint Finish</u>
Other:	
Services:	Specify Damage:
Chimneys:	Construction Type: Height: Damage Description: Above Roof    Below Roof    Total Repair
N/A	
Foundations Damage:	Timber <u>Concrete Ring</u> Concrete Slab    Other (Specify): Minor    Moderate    Severe House Moved off Foundations? <u>Y</u> Concrete Slab Cracked? Crack Width: ..... Crack Length: .....
Roof:	Framed    Trussed Type:    Clay Tiles    Concrete Tiles <u>Rolled Metal</u> Other Damage:
Cladding Type:	Weatherboard    Brick Veneer    Hardi Plank <u>Other</u> <u>Stucco</u>
