2026 | COMPREHENSIVE WEATHERTIGHTNESS REPORT H/V

56 Kakariki Grove
Waikanae, Wellington Region 5036

MARCH 12, 2026

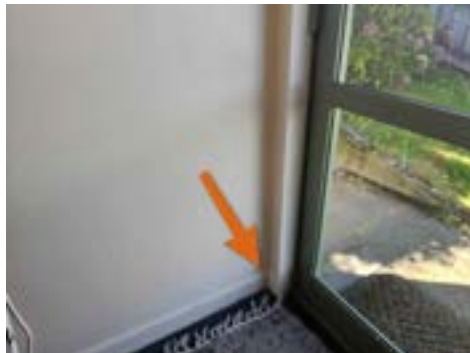
Garage - 23.6% Elevated reading due to concrete nib wall

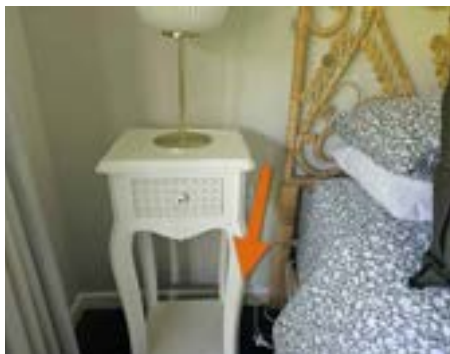
Corner Bedroom - 47.1% Elevated reading due to concrete nib wall

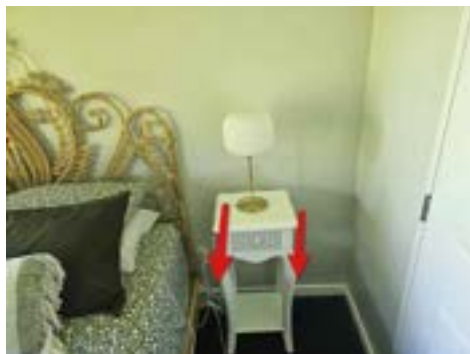
Corner Bedroom - 78.3% Elevated reading due to concrete nib wall
