2026 | COMPREHENSIVE WEATHERTIGHTNESS REPORT H/V

15 Runanga Grove
Waikanae, Wellington Region 5036

APRIL 1, 2026

Travis Mackay

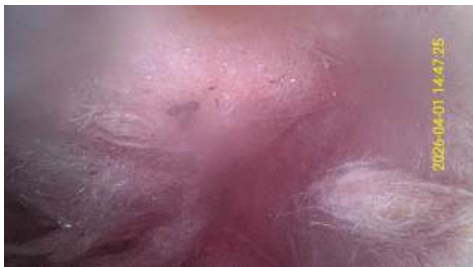
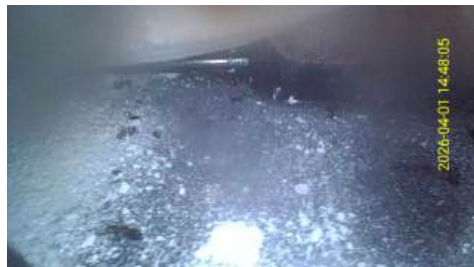
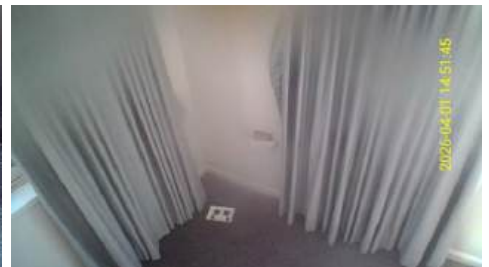
Living Room

CONDENSATION DAMAGE AT JOINERY

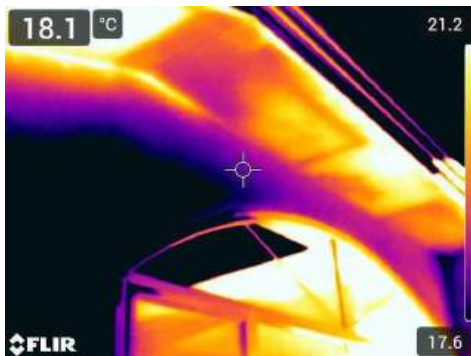
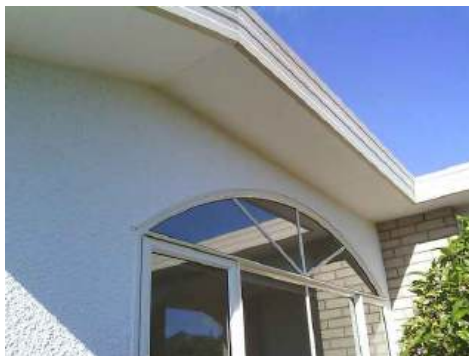
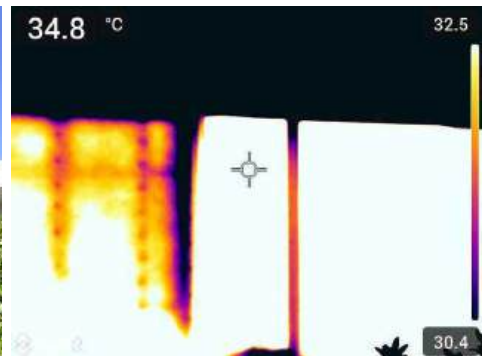
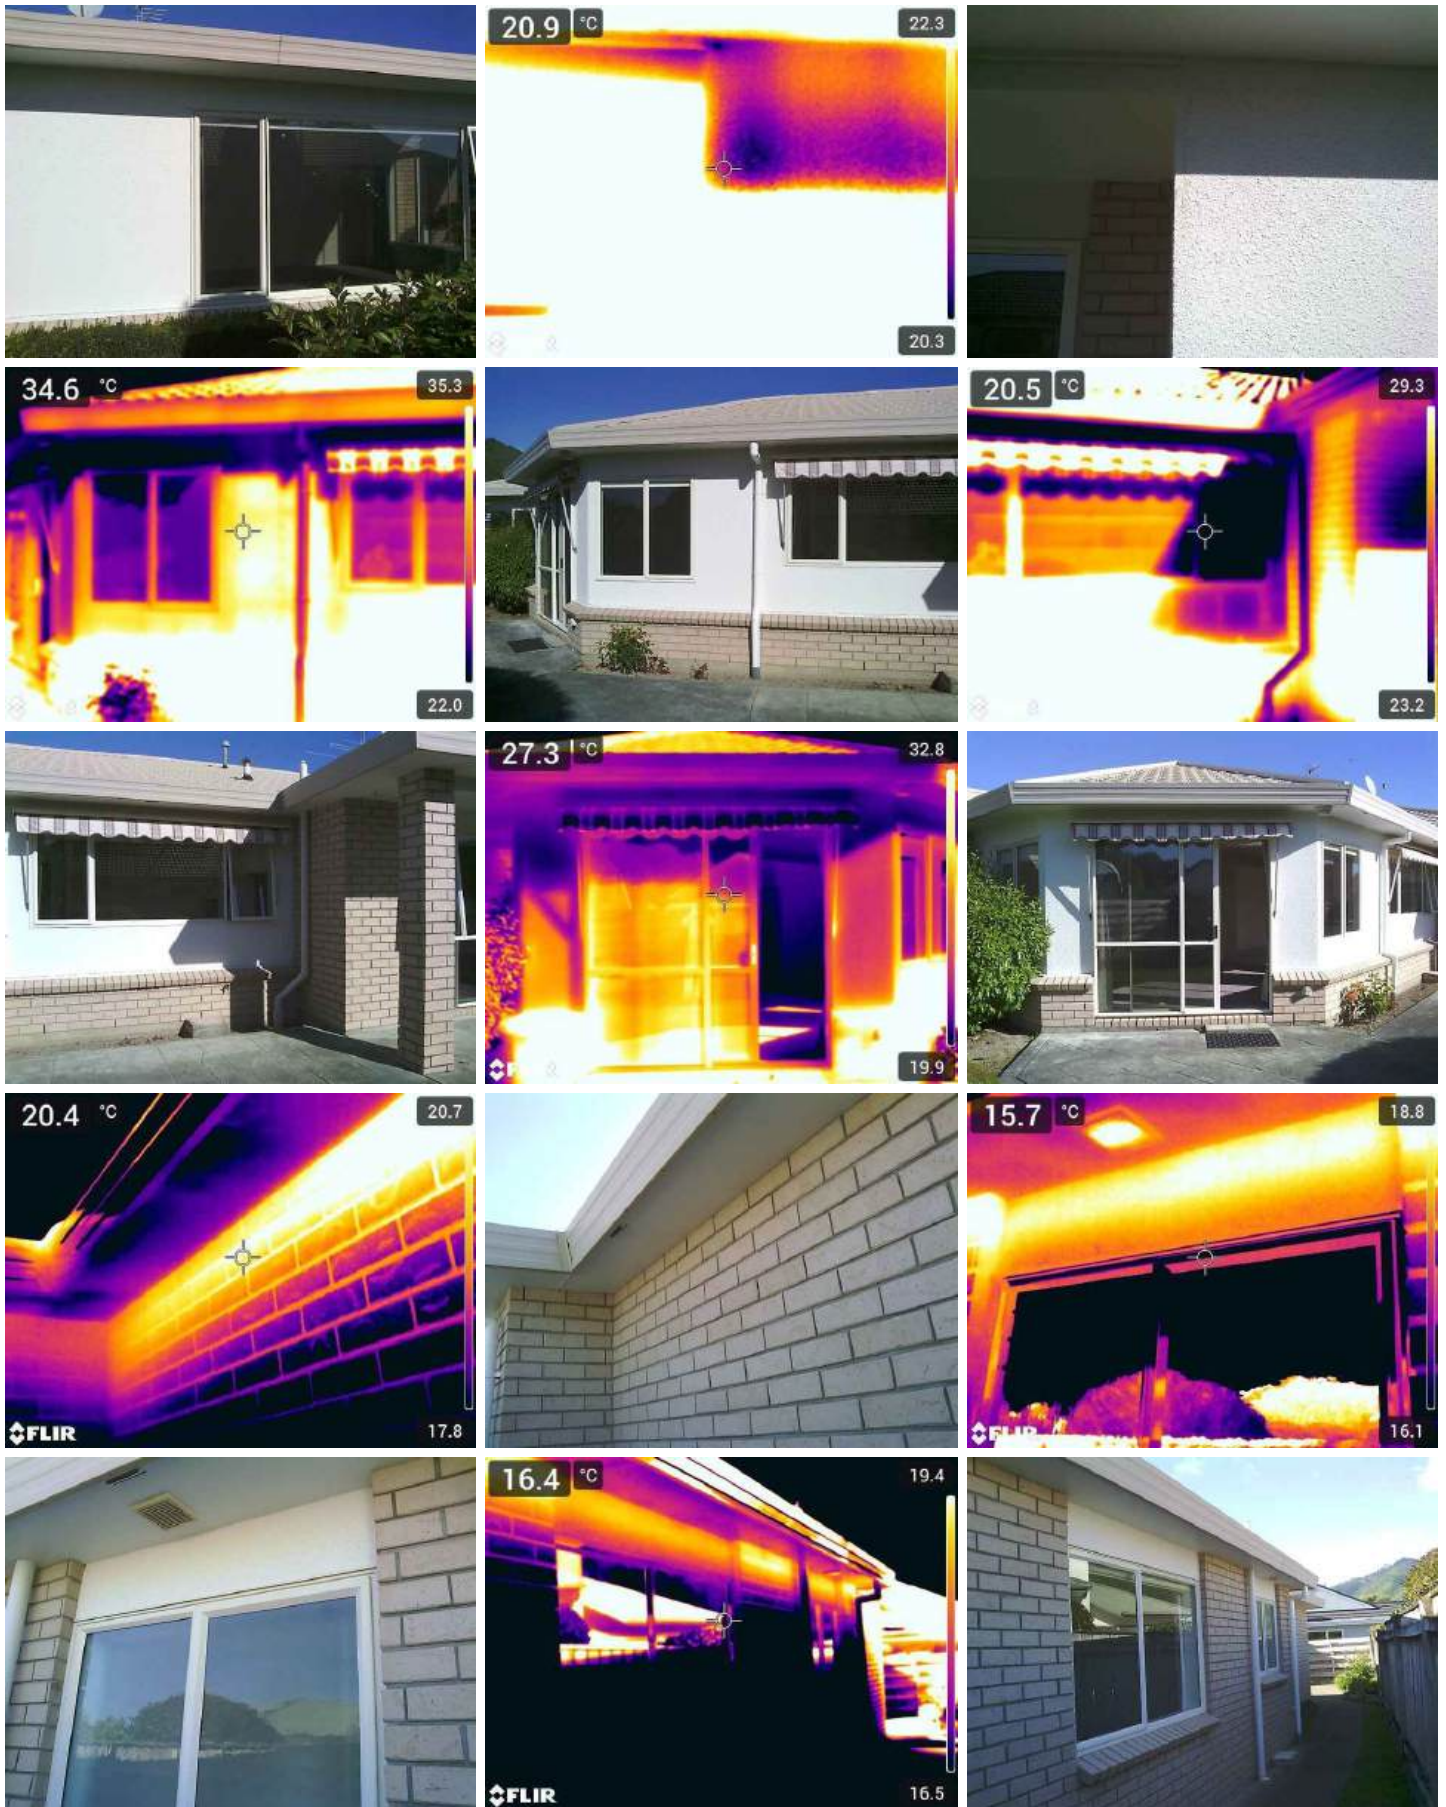
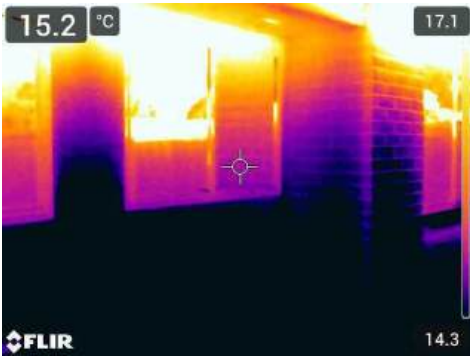
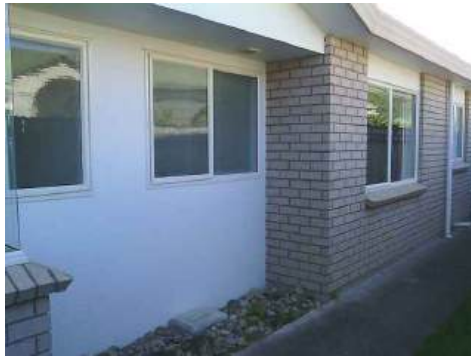
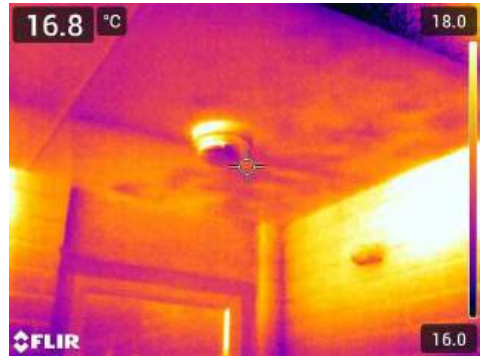
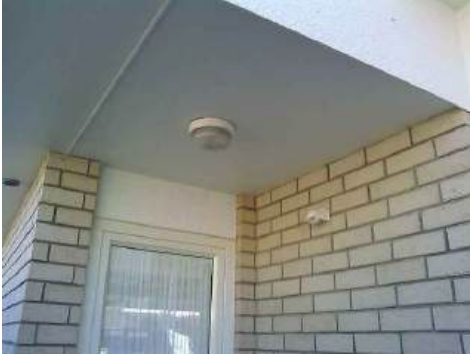
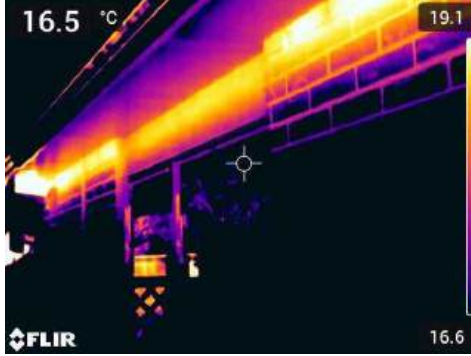
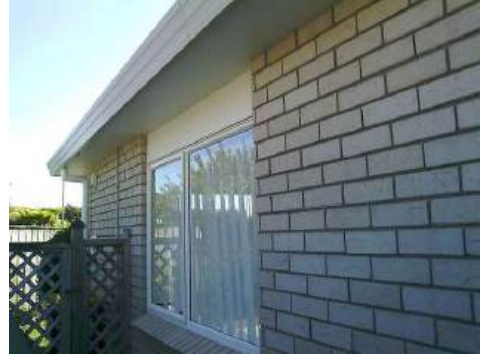
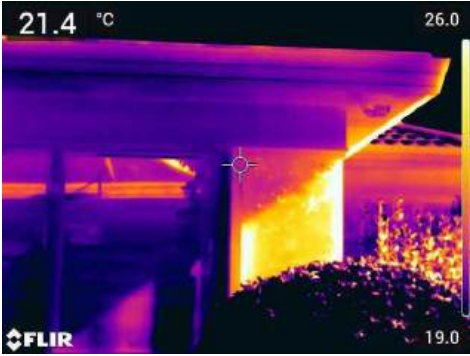
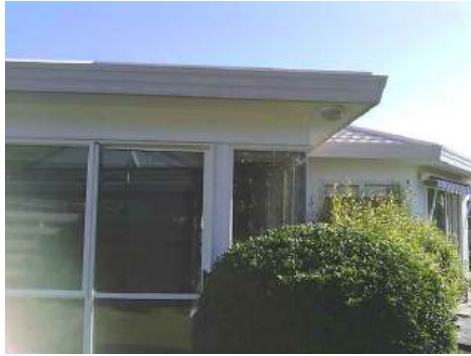
THERMAL IMAGING RESULTS FLIR T560

MODERATE TO MAJOR TEMPERATURE DIFFERENTIALS and/or VISUAL THERMAL ANOMALIES SIGHTED

- Moisture may or may not have been detected with definitive certainty in all these particular areas of observation. However, these areas were indicating a moderate to major temperature differential through the FLIR T560 Thermal imager and/or visual signs of moisture ingress/damage may also have been observed.
