BUILDING INSPECTION REPORT

PROPERTY CHECK EXPRESS REPORT

Job Number	54389
Client	Olivia Harris
Property Inspected	241 Lake Terrace Road, Shirley, Christchurch
Inspection Date	15 April 2026
Building Surveyor	Darin Devanny
NZIBS Registration Number	BSI0100
Weather Conditions	Fine
Scope of Report	Visual inspection of the buildings that are listed in this report for the purpose of a residential inspection in accordance with NZS4306: Residential Property Inspections.
Report Ordered By	Olivia Harris - Vendor
Orientation	For the purpose of this report, the elevation of the house facing the road is the east elevation.

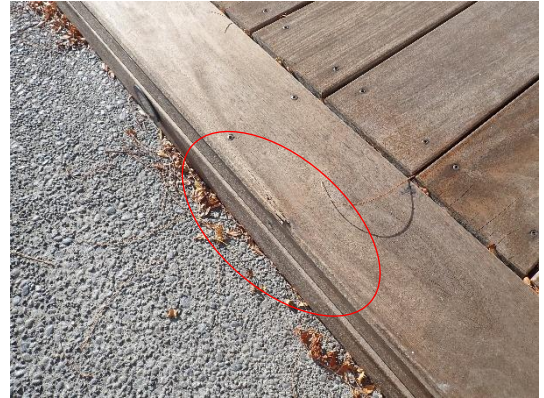
On the deck on the eastern elevation of the property, there is a board with a split area that should be replaced or altered for safety purposes.

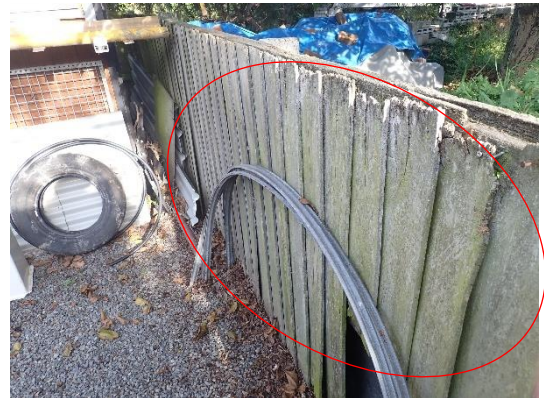
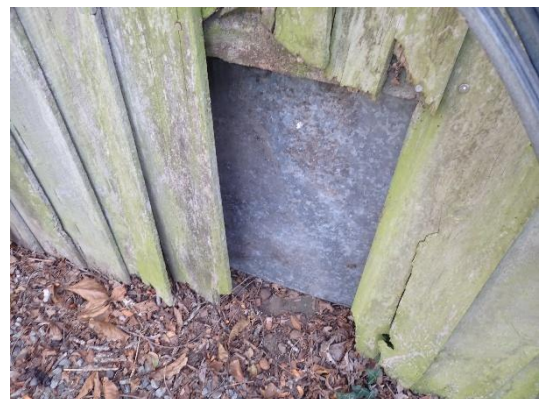
The perimeter fence to the rear of the property at the northwestern corner is showing signs of age with several palings damaged and decayed. This perimeter fence will likely need to be replaced in the future.

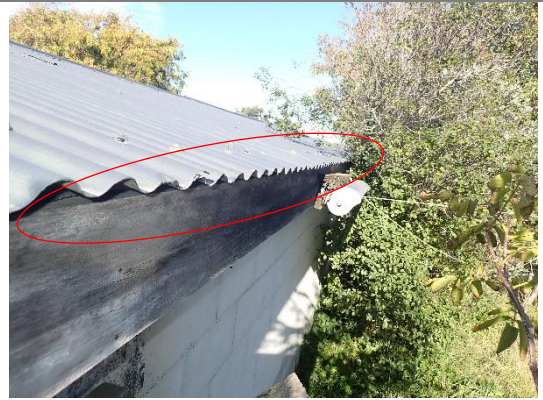
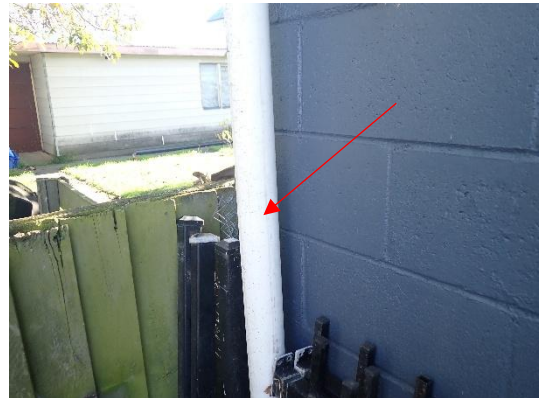
The riser to the northwest corner of the garage and the spouting above requires clearing out as part of routine maintenance to allow free flow of water.

This downpipe is loose. Consideration could be given to fixing this with a clip to the corner of the building to provide stability.

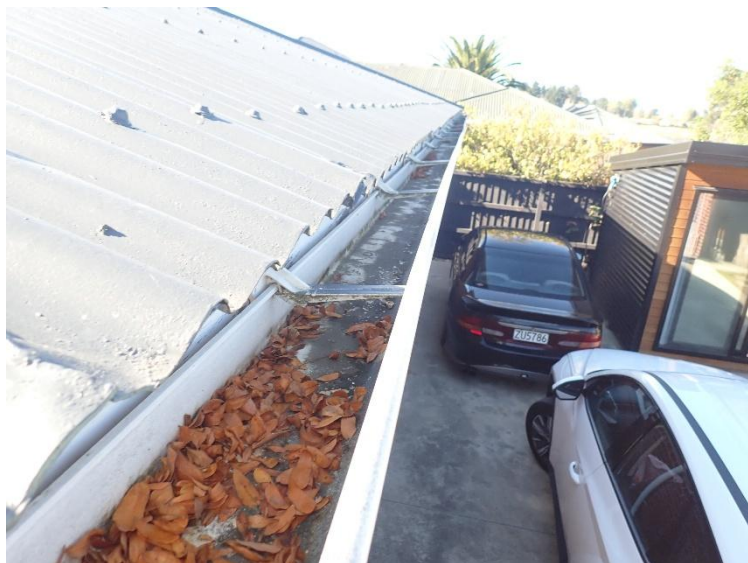
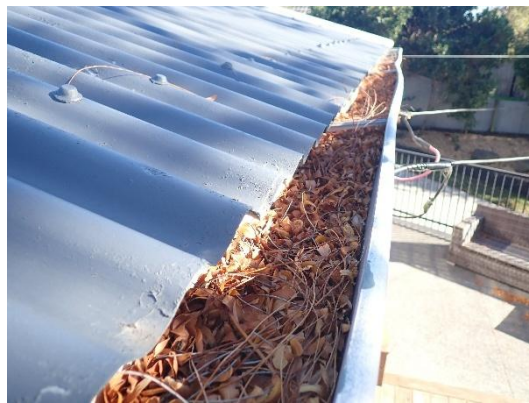
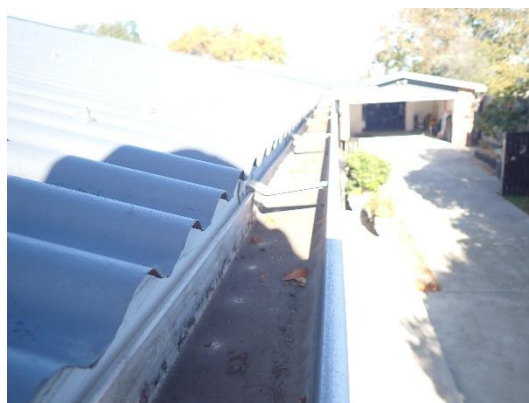
There is organic debris build-up in the spouting that should be cleared as part of routine maintenance.

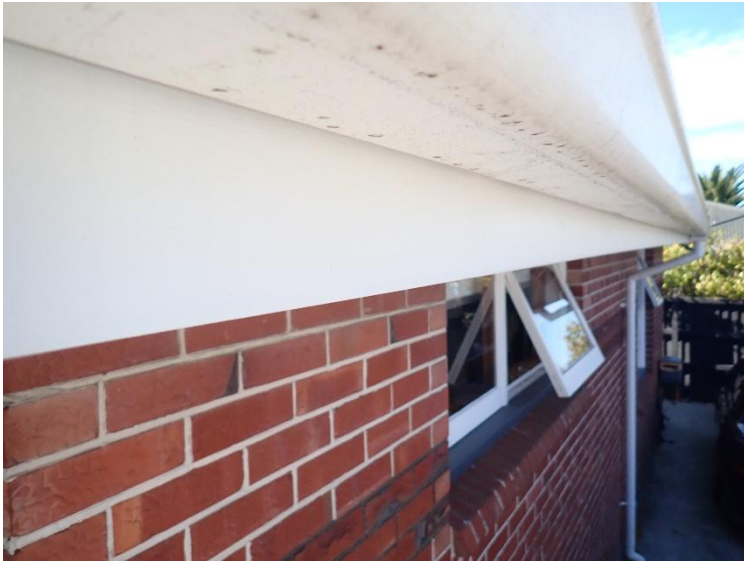
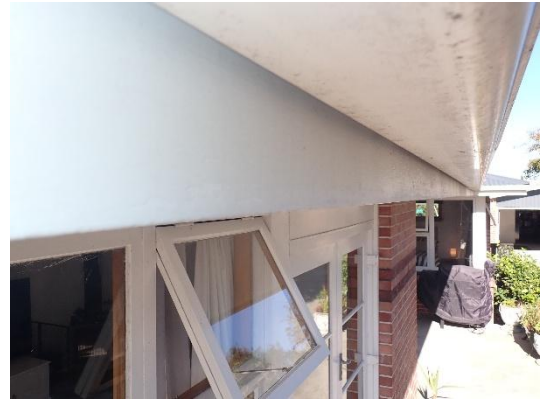
FASCIA
Timber

No significant defects identified.

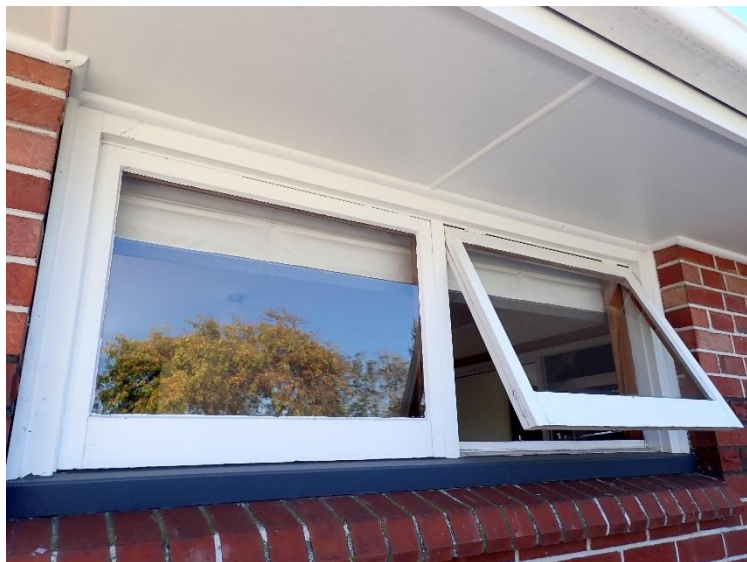
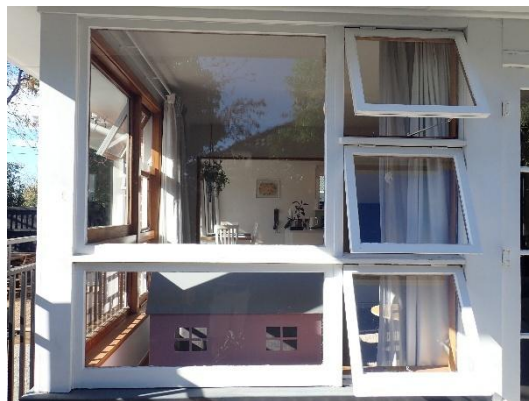
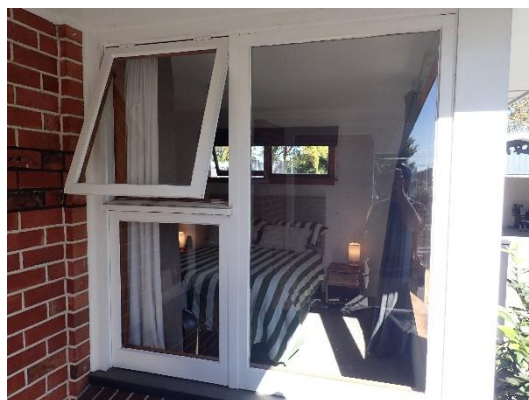
EXTERIOR WINDOWS AND DOORS

No significant defects identified.

There are double glazing units in the lounge and bedroom 3 mixed in with the single glazed units.

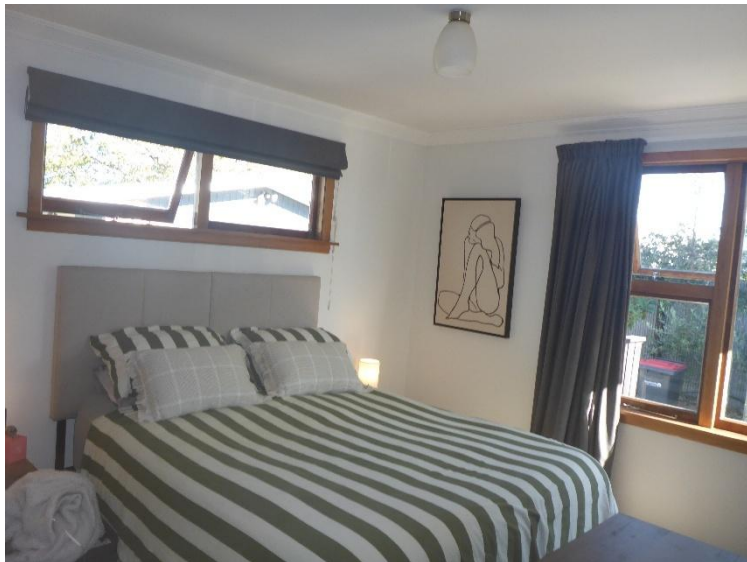
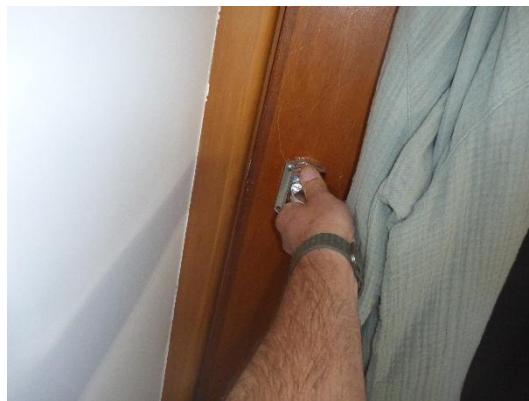
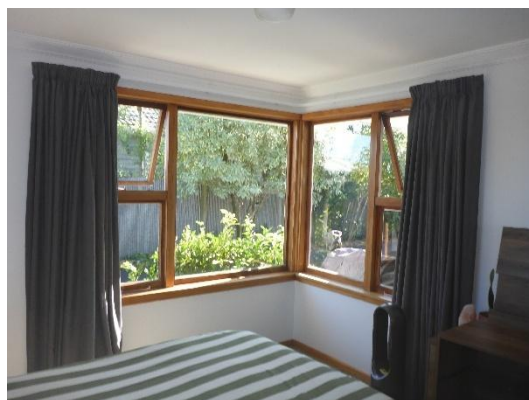
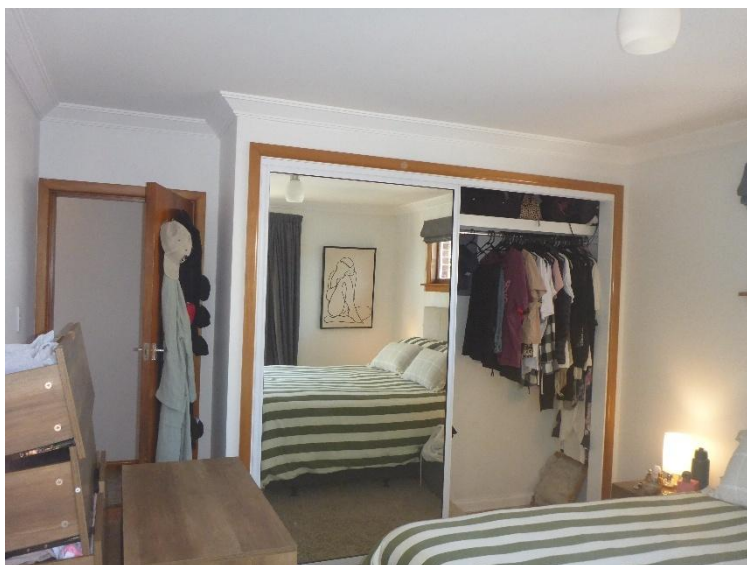
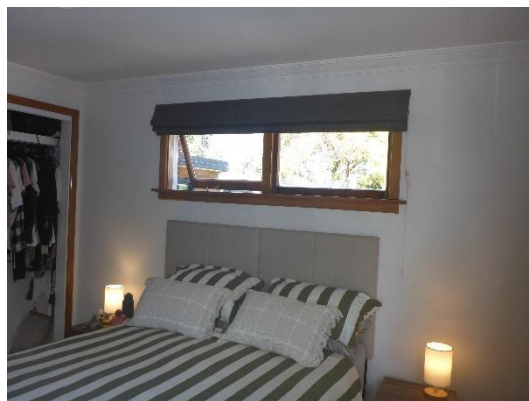
BEDROOM 1
Northwest corner

The entry latch is not engaging correctly with the striker plate and requires minor adjustment to operate correctly.

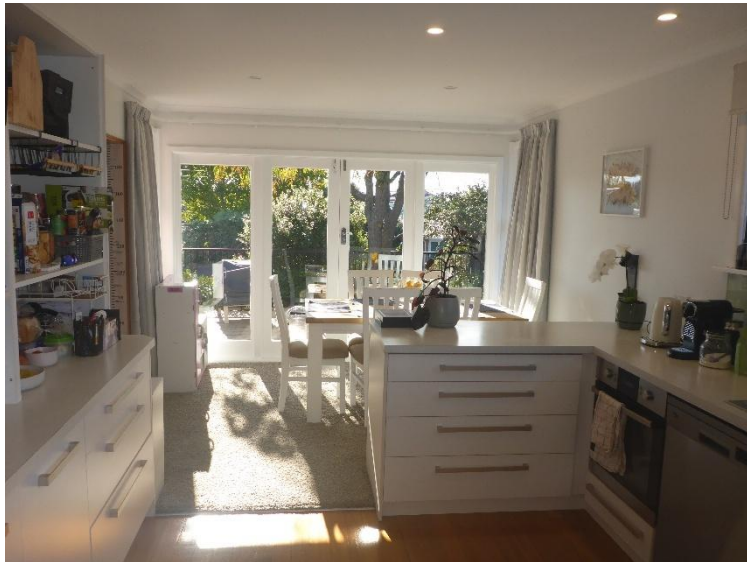
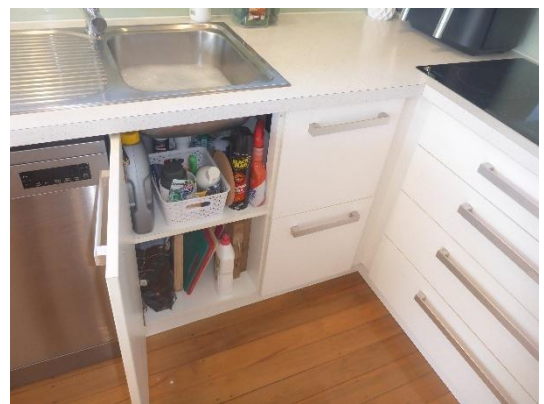
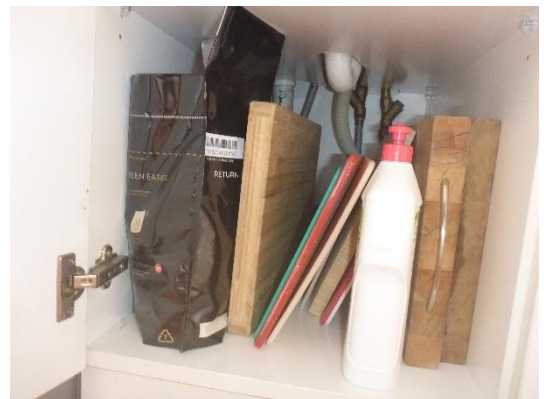
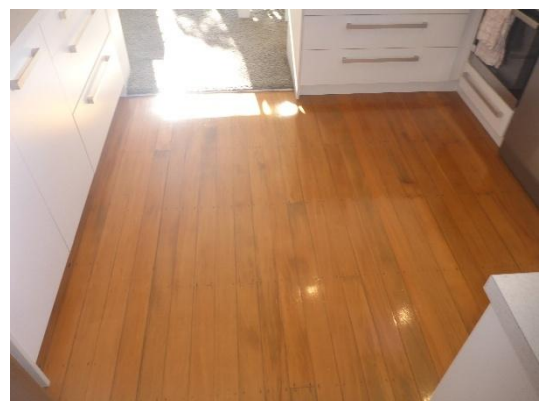
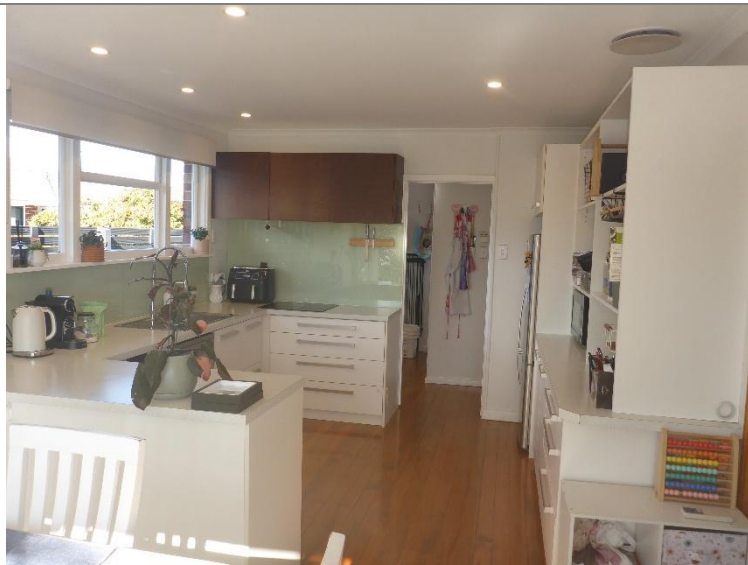
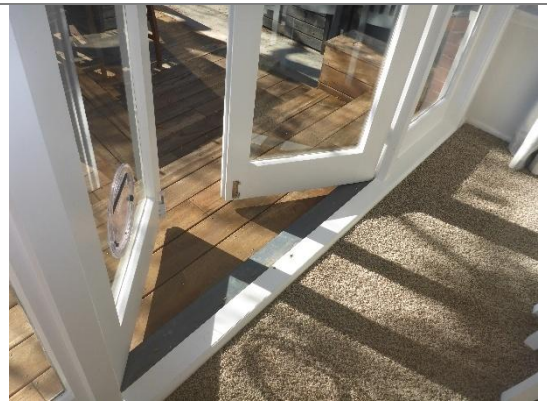
KITCHEN / DINING

No significant defects identified.

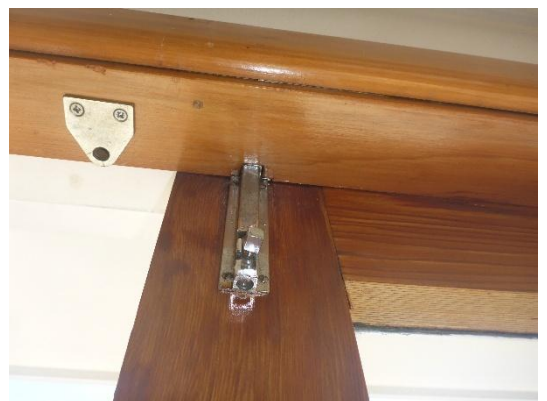
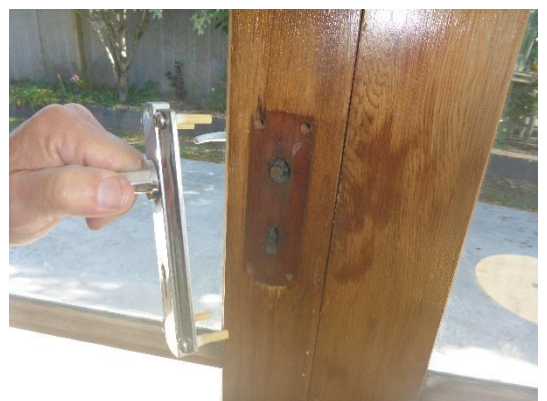
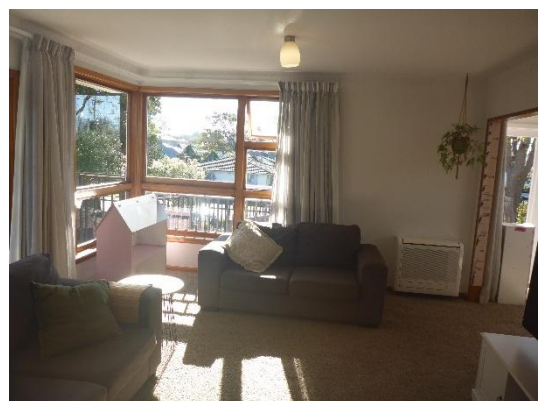
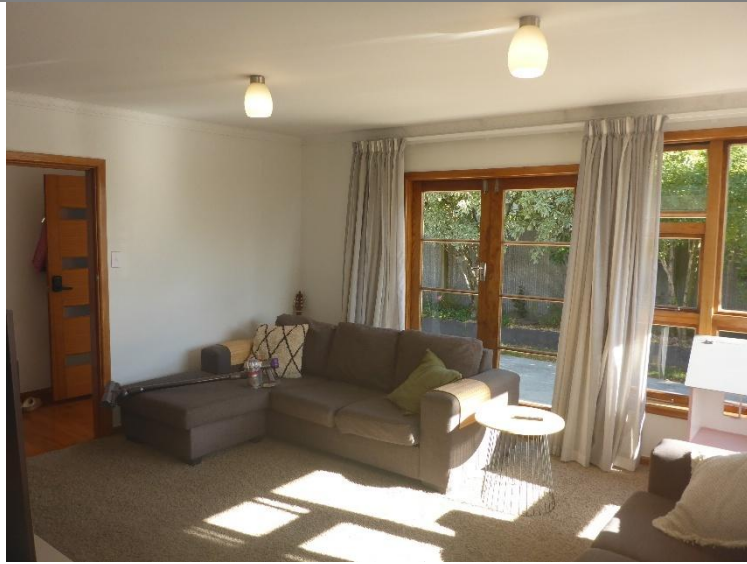
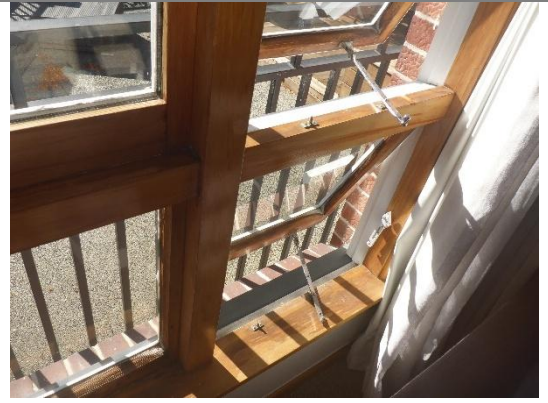
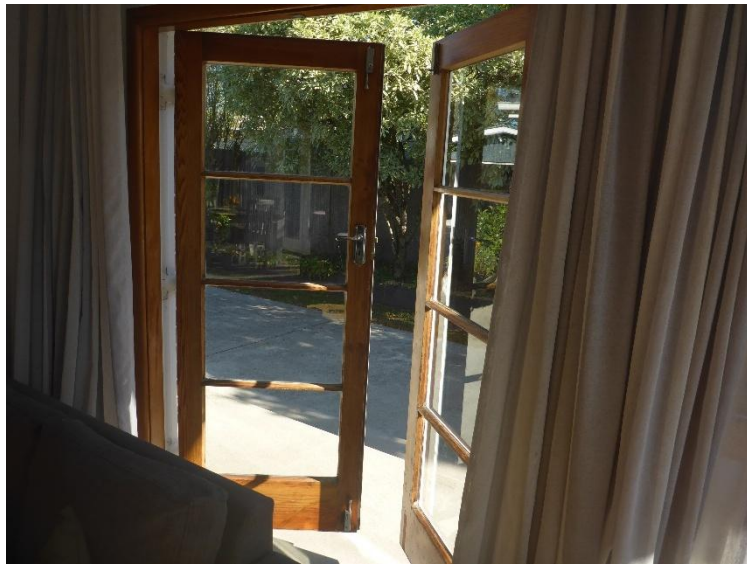
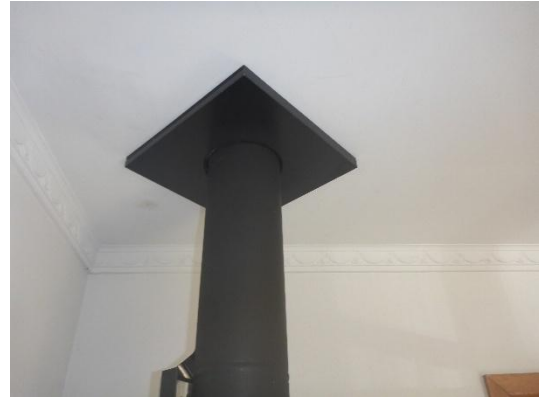
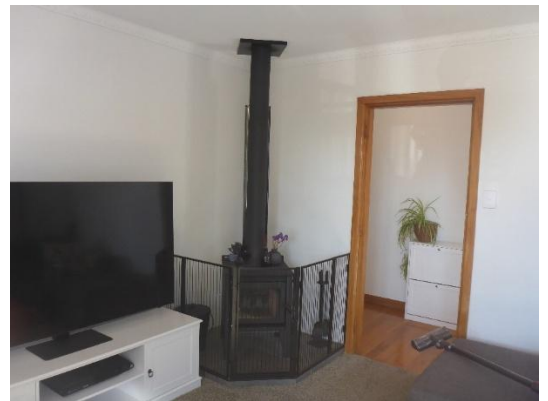
LOUNGE

The door hardware on the north-facing French doors requires adjustment as the top tower bolt is not aligned correctly with the keeper in the frame.

The door handle is not anchored to the framing adequately. Improvements may be considered.

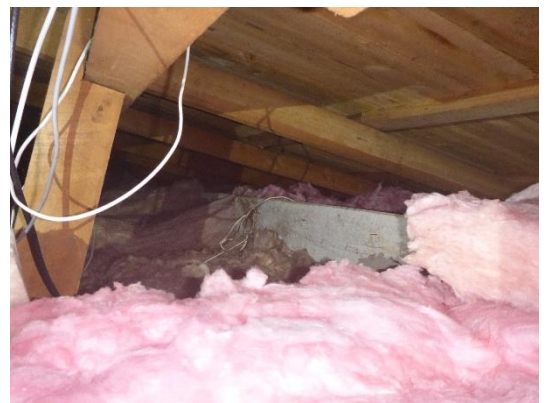
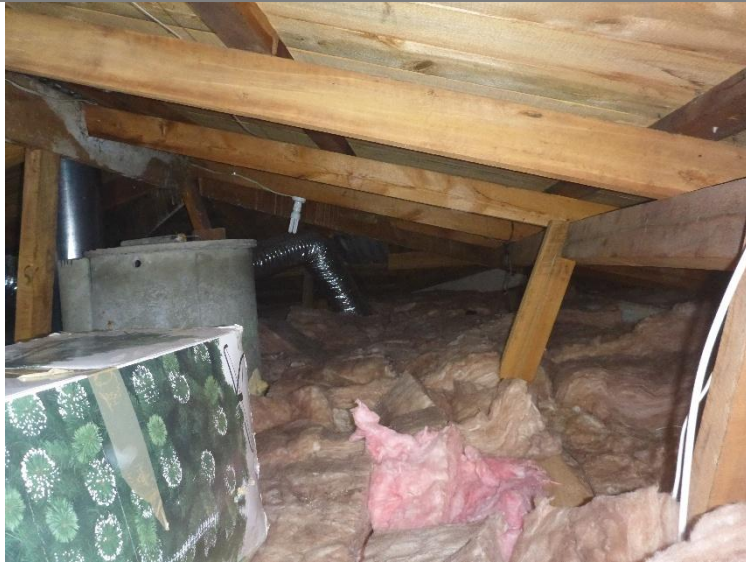
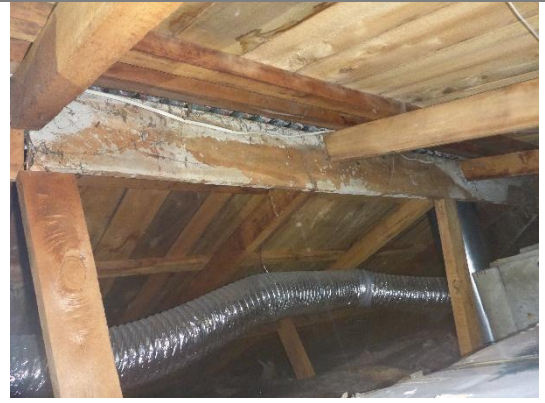
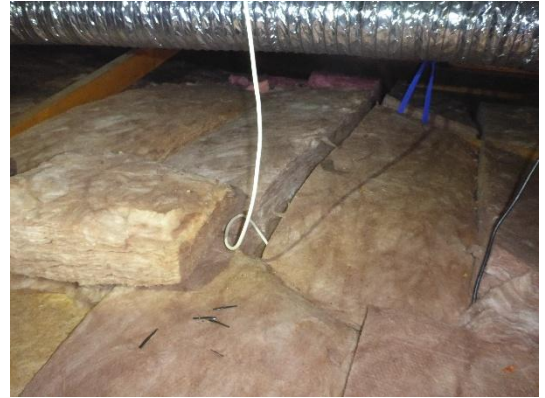
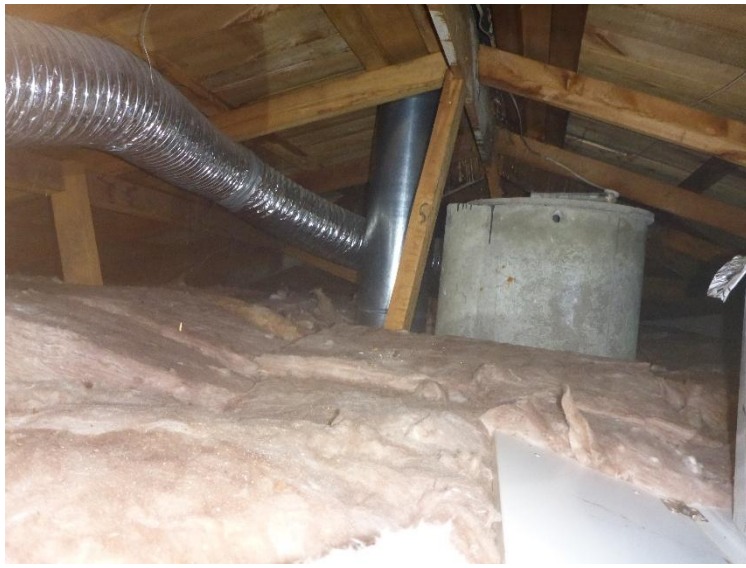
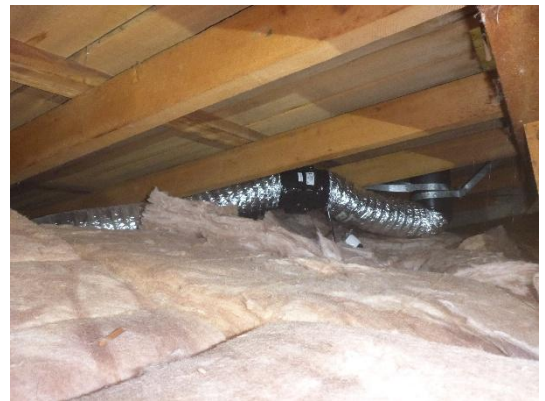
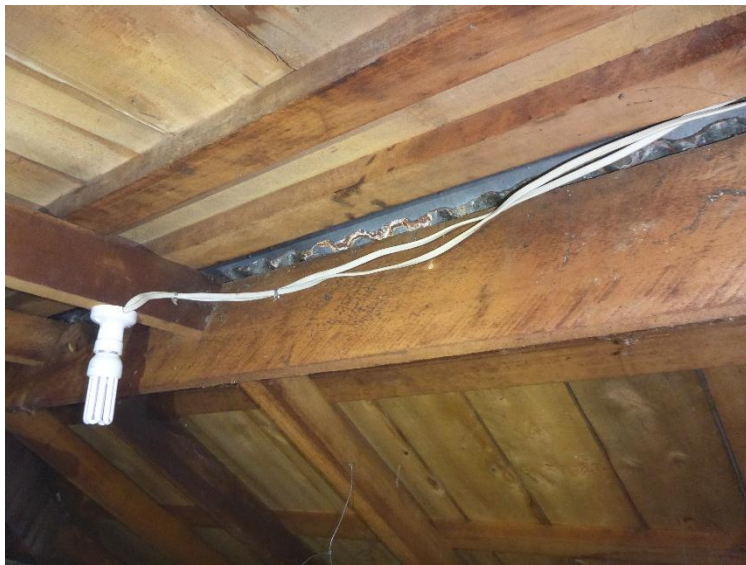
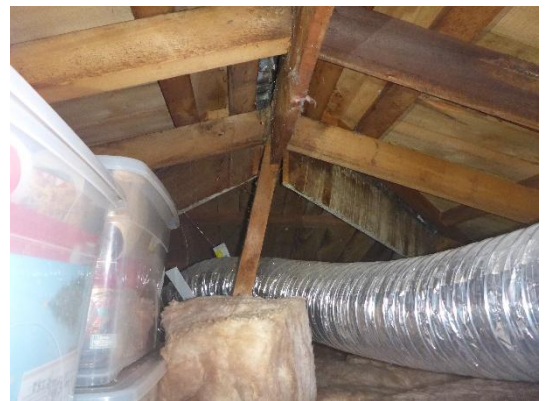
ROOF SPACE

No significant defects identified.

The ceilings are insulated with fibreglass batts which appear adequate in thickness and in cover.

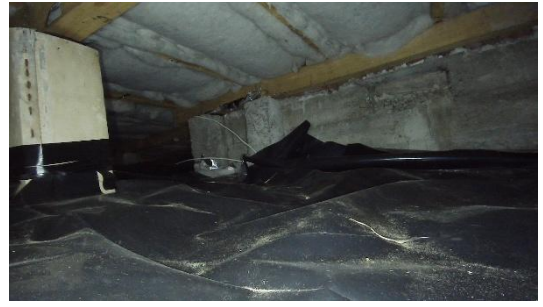
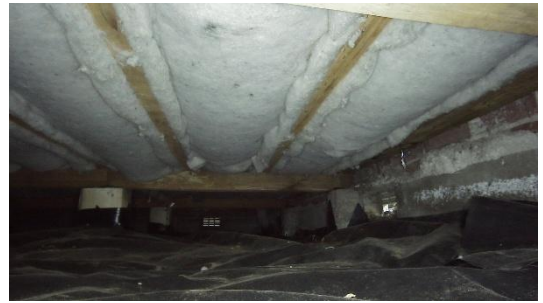
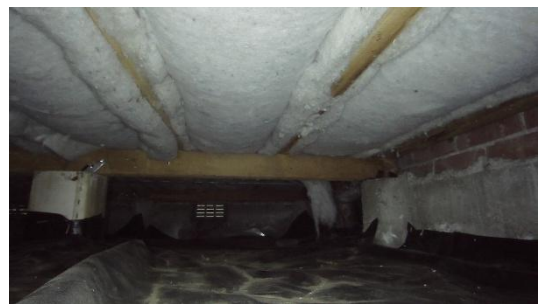
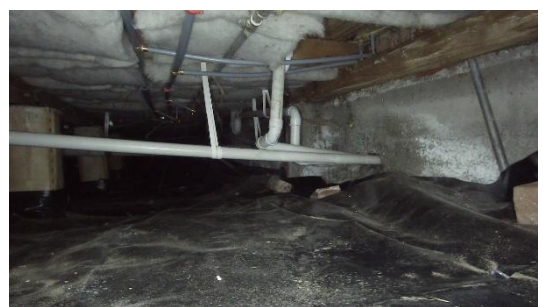
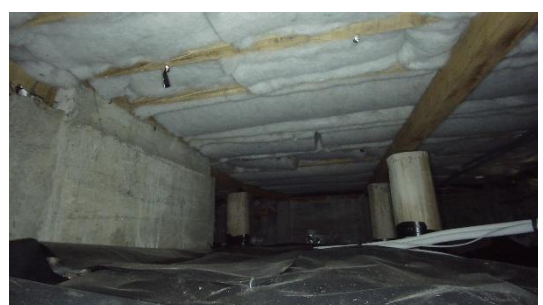
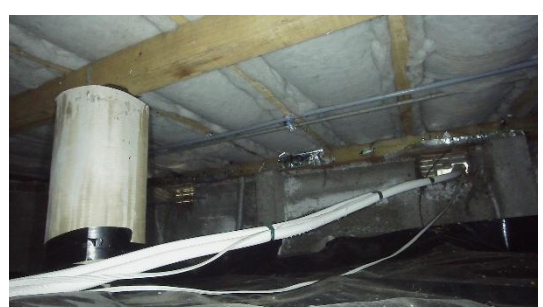
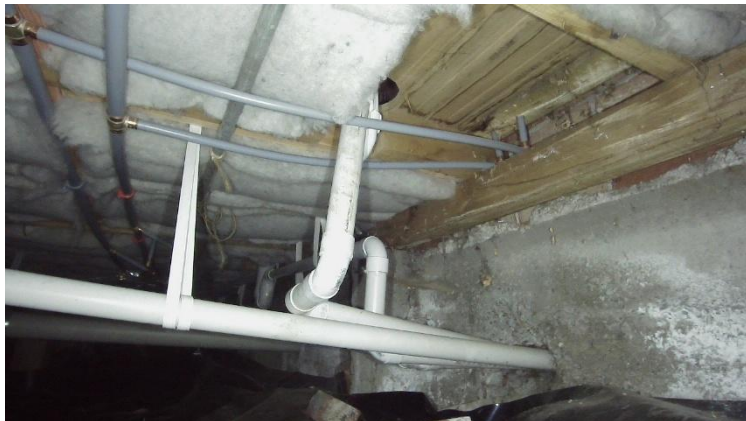
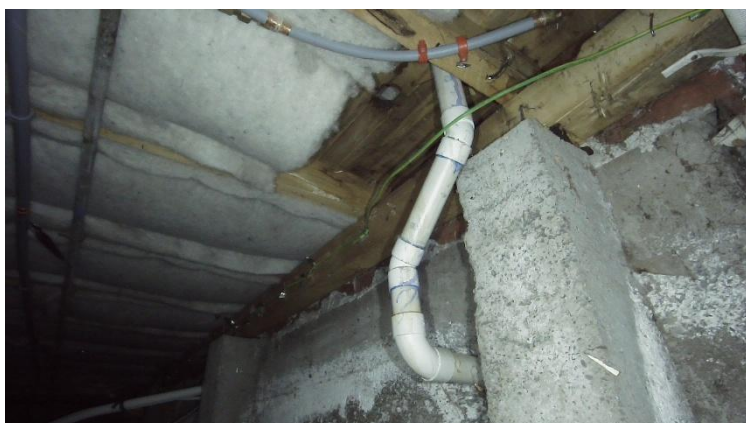
FLOOR VOID

The subfloor structure appears in good condition.
There are no signs of damage to the perimeter foundation or concrete piles.

A polythene vapour barrier has been installed across the ground, which appears in good condition.

The subfloor conditions overall appear in good condition.

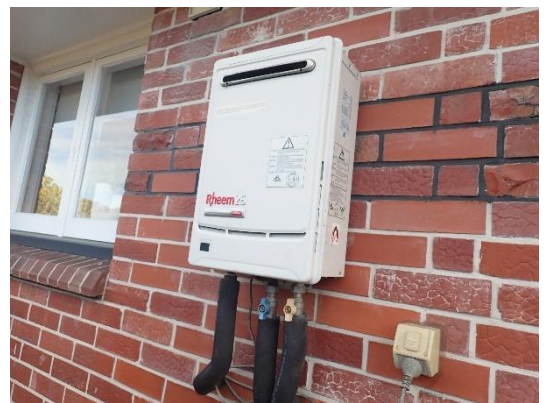
HOT WATER SUPPLY
Gas water heater
No significant defects identified.

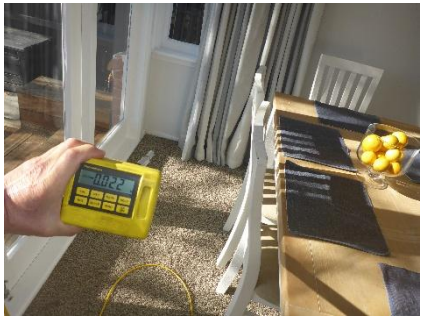
Description	Locations	Photographs
Overall Variation Across Floor (note: some displayed readings may not match the readings provided due to the adjustments made for differing floor covering thicknesses and steps in floor levels)	Lowest reading: Dining Room (-22mm)

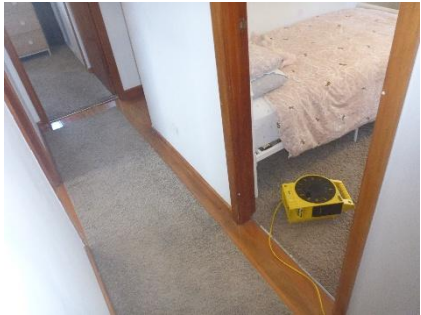
Highest reading: Bedroom 2 (0mm)

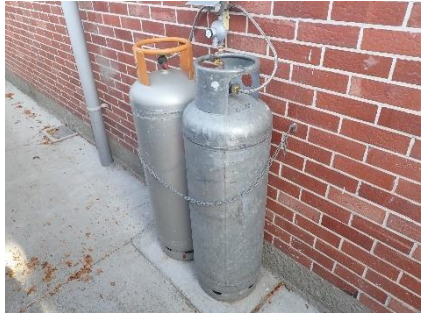
Comments	Photographs
Water Supply	Turned on. No significant faults identified.	
Gas Supply	The gas is provided by gas storage tanks that are located on the south elevation. No significant faults identified.

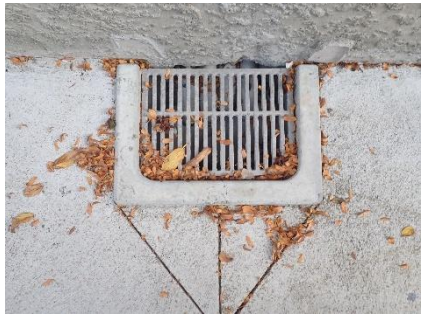
Drainage System	The wastewater system was tested by running water through to the gully traps. The water appeared to drain freely through the wastewater system.

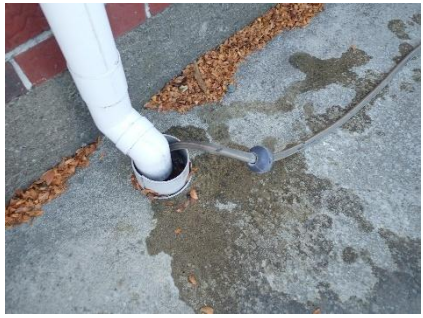
Stormwater System	A hose test was carried out on the storm water system and the water flowed freely through the system, eventually to its destination.

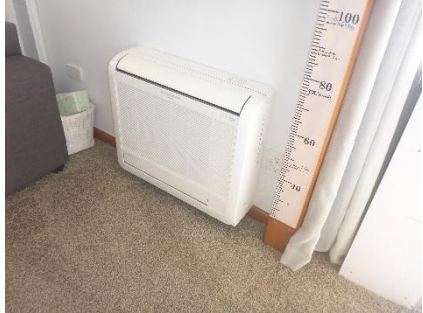
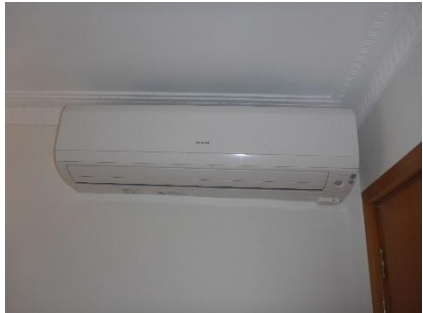
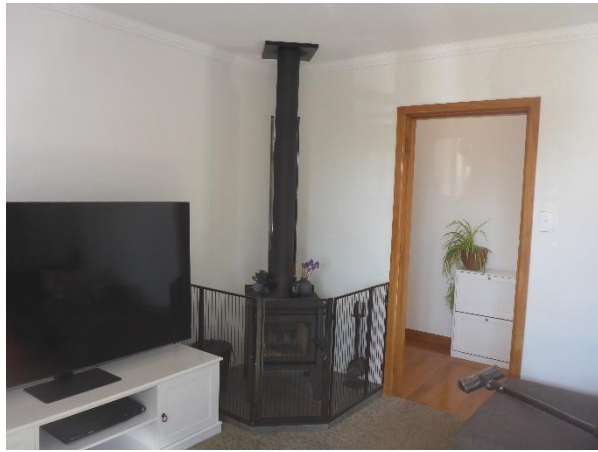
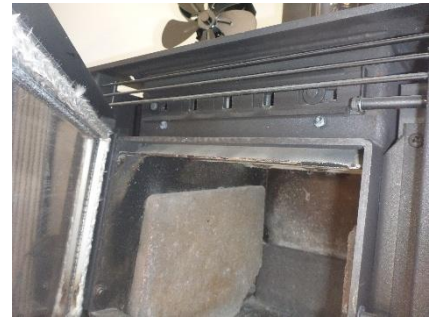
Electrical Services	Turned on. No significant faults identified.	
Heating	<p>Heat pump located in the lounge. Not tested. The battery in the controller appears to be flat.</p> <p>Heat pump located in the hallway. Not tested. The controller was not located.</p> <p>A solid fuel heater located in the lounge. Not tested. No significant faults identified.</p>

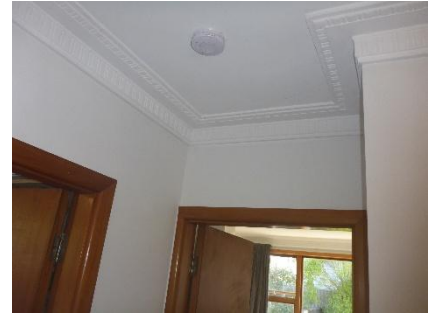
Smoke detectors were located in the compliant locations.
