EQC CLAIM DOCUMENTATION

EARTHQUAKE RECOVERY (EQR) DOCUMENTATION

Released under the Official Information Act 1982
EQR Property Overview Report

EQC Property ID	Property Address	Vulnerable?	Property F Status	Property Finalisation Indicator		
2010061240	41 MACKENZIE AVENUE, WOOLSTON		F3 - Complete & Finalised	Some Finalisation has taken place		
Main Contractor:	CLOSED OUT-S.K. Hand Builders Limited ***** (SC30)		Property F2'd By:	Blair Jones	F2 Completed Date:	20-06-2016
Cont Managing Hub:	Ensors	Not Vulnerable	Property F3'd By:	Blair Jones	F3 Completed Date:	20-06-2016

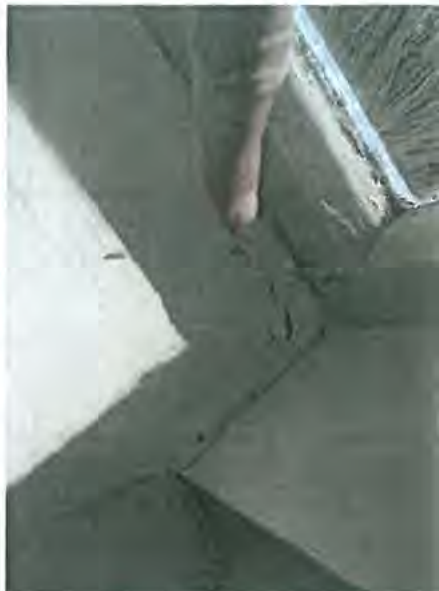
Rot noted to bedroom one window sill.

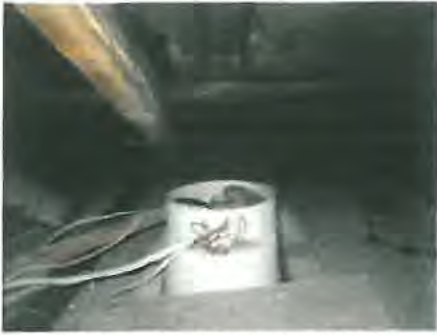
Bathroom extraction fan vents to the roof space.

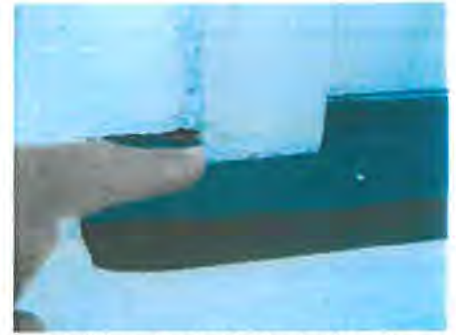
Filler patches were noted to the painted perspex cladding to the laundry and conservatory areas, not a recommended cladding for a house. A little softness or rot was noted to the bottom of bedroom two window facing. The conservatory has been built on top of the timber decking, with the decking protruding out from the walls, this is a potential rot problem although sealant has been applied. The timber facing to the conservatory is unprotected from the weather at the top. The gully trap needs cleaning out. Some filler has been applied to a small section of roofing and as there is some signs of water damage to ceiling areas below it may need further investigation (possible rust holes).

A little rot noted to the bottom of bedroom two window facing.

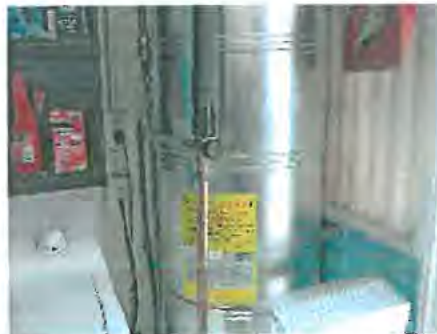
Water cylinder to laundry appears in good order.

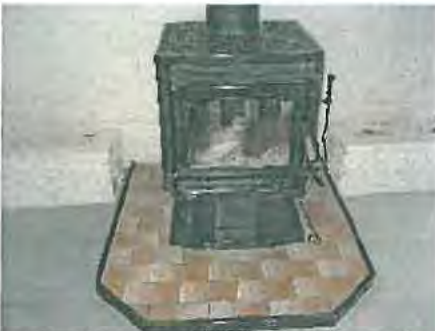
Wood burner to lounge appears in reasonable order.

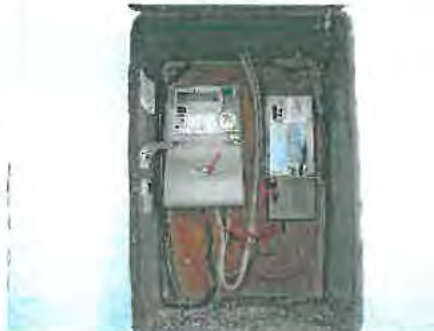
Meter box to outside wall.

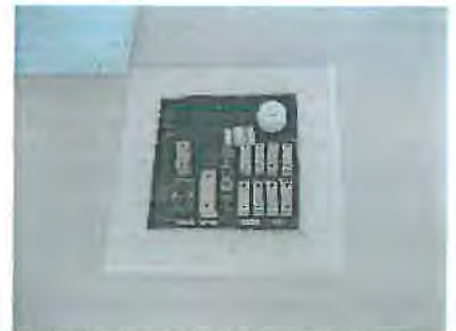
Fuse board to laundry appears in reasonable order.

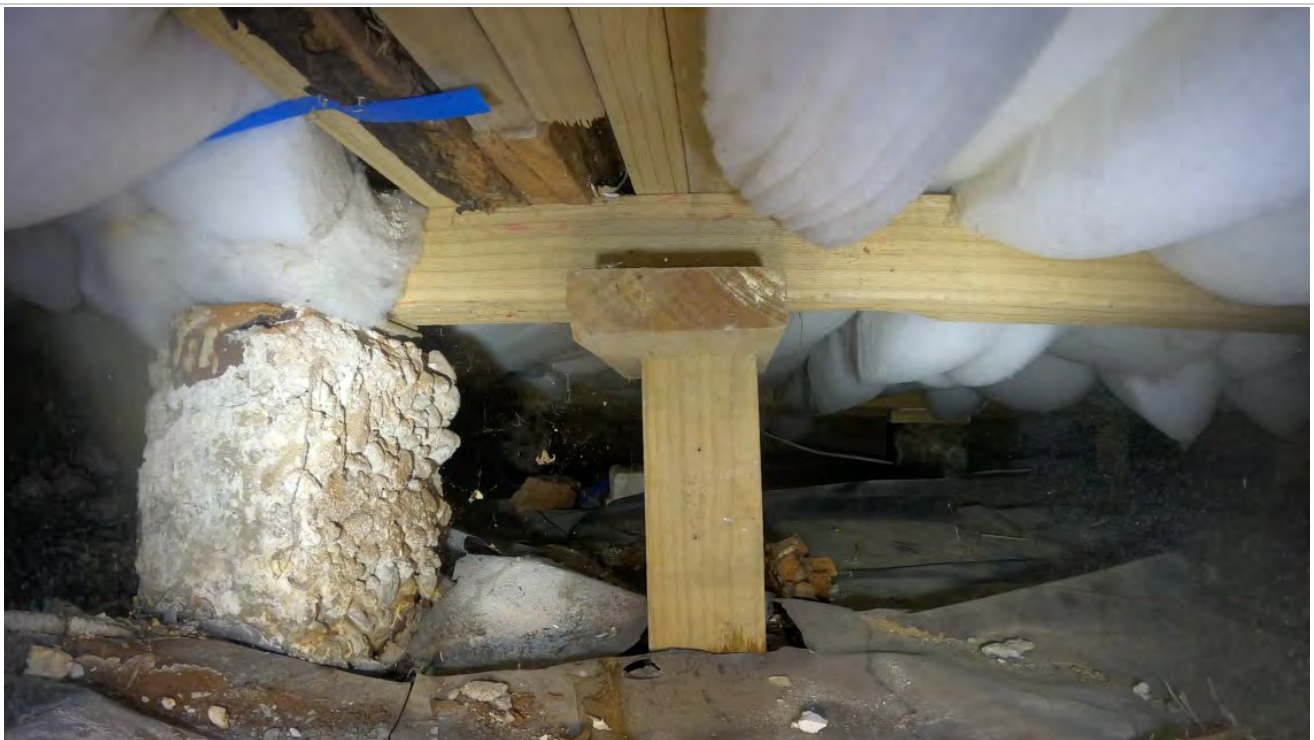
39: Jerry can pile with packing and no connection.

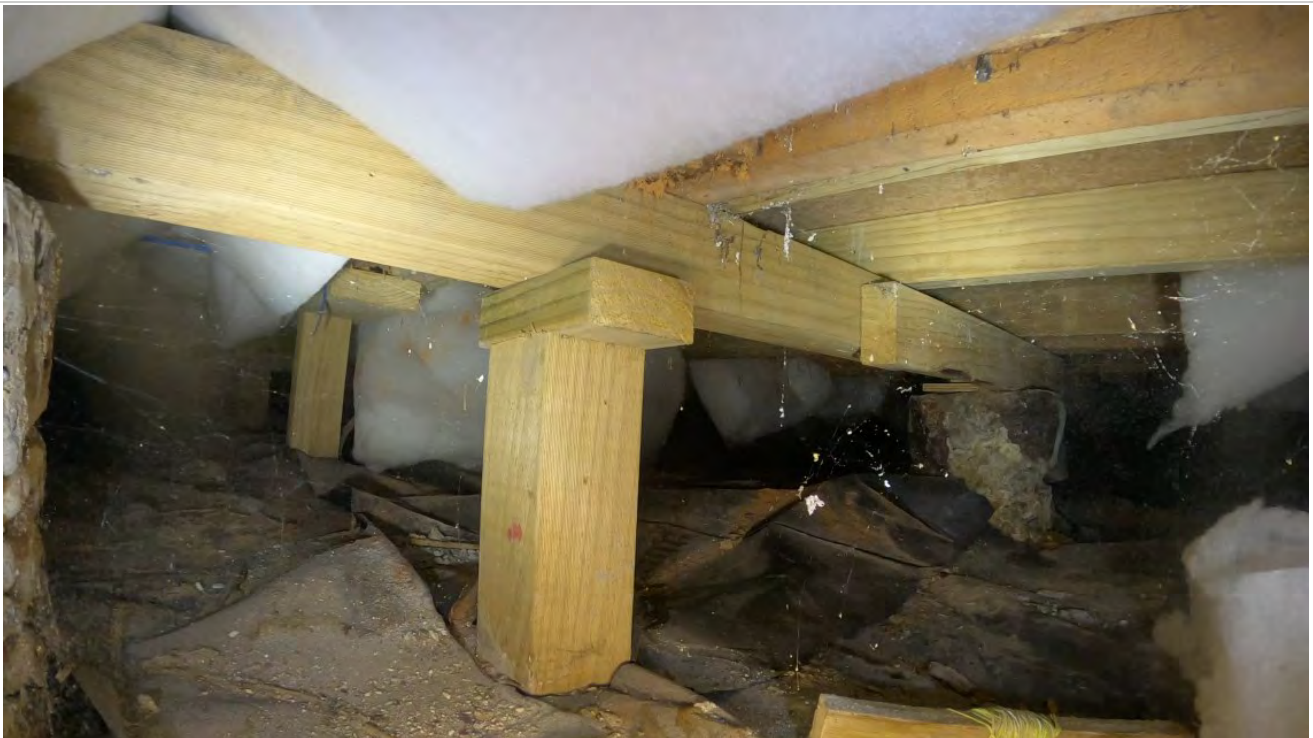
41: Jerry can pile with no connection. Note the use of particle board. It is not rated for use this close to the ground and we often see it with mould growing on it when used in this manner.

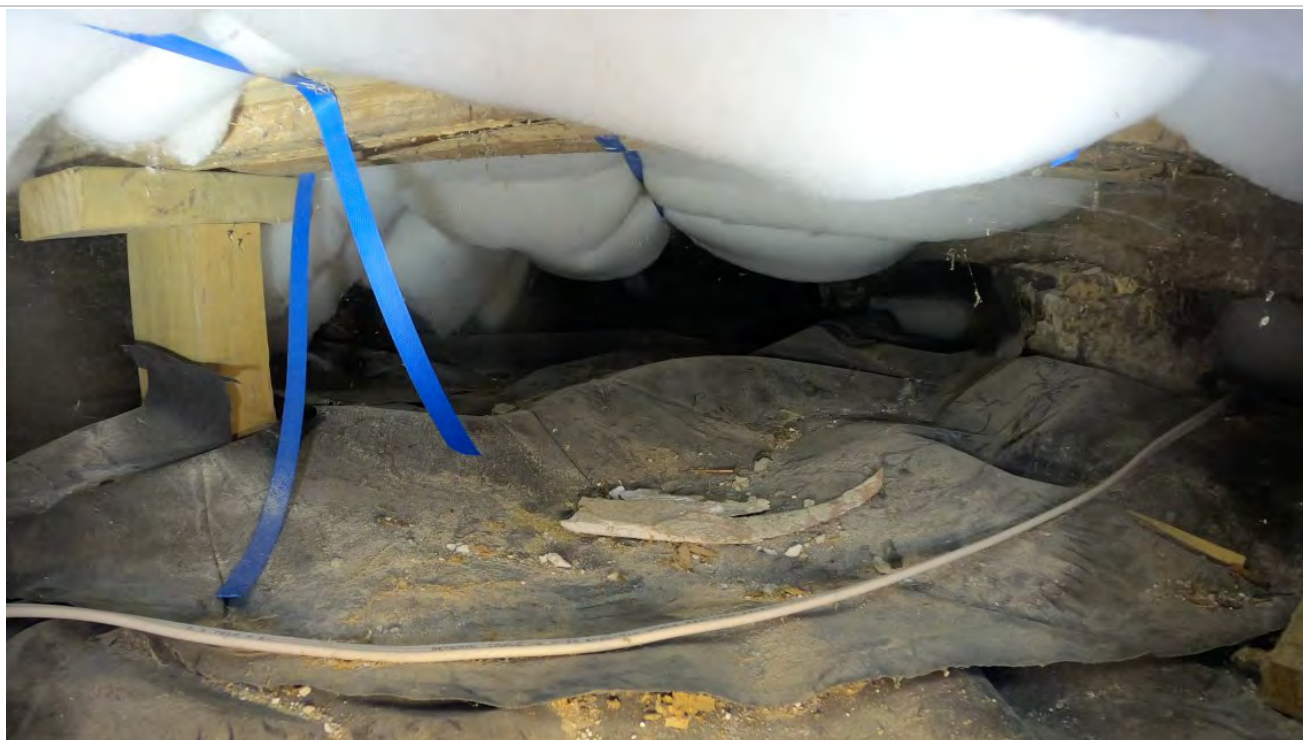
55: View of propping and the joist is cracked.

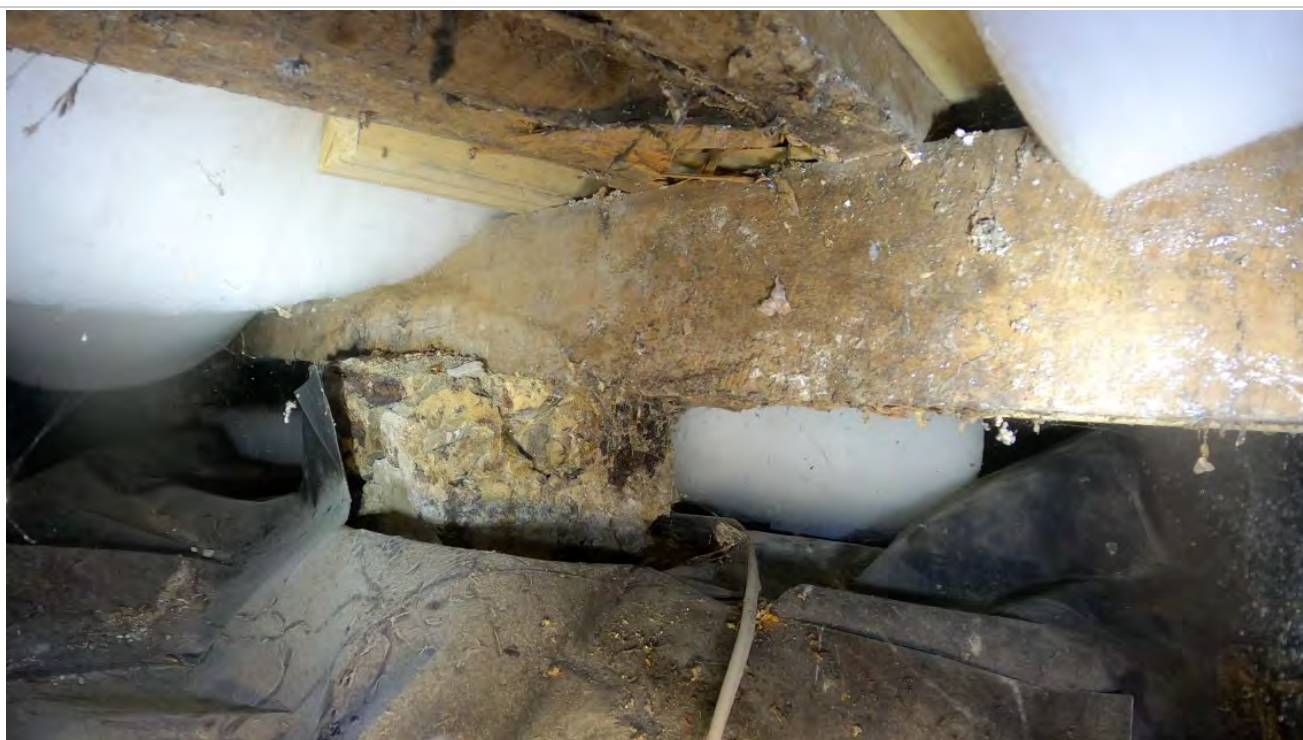
56: Jerry can pile with no connection.

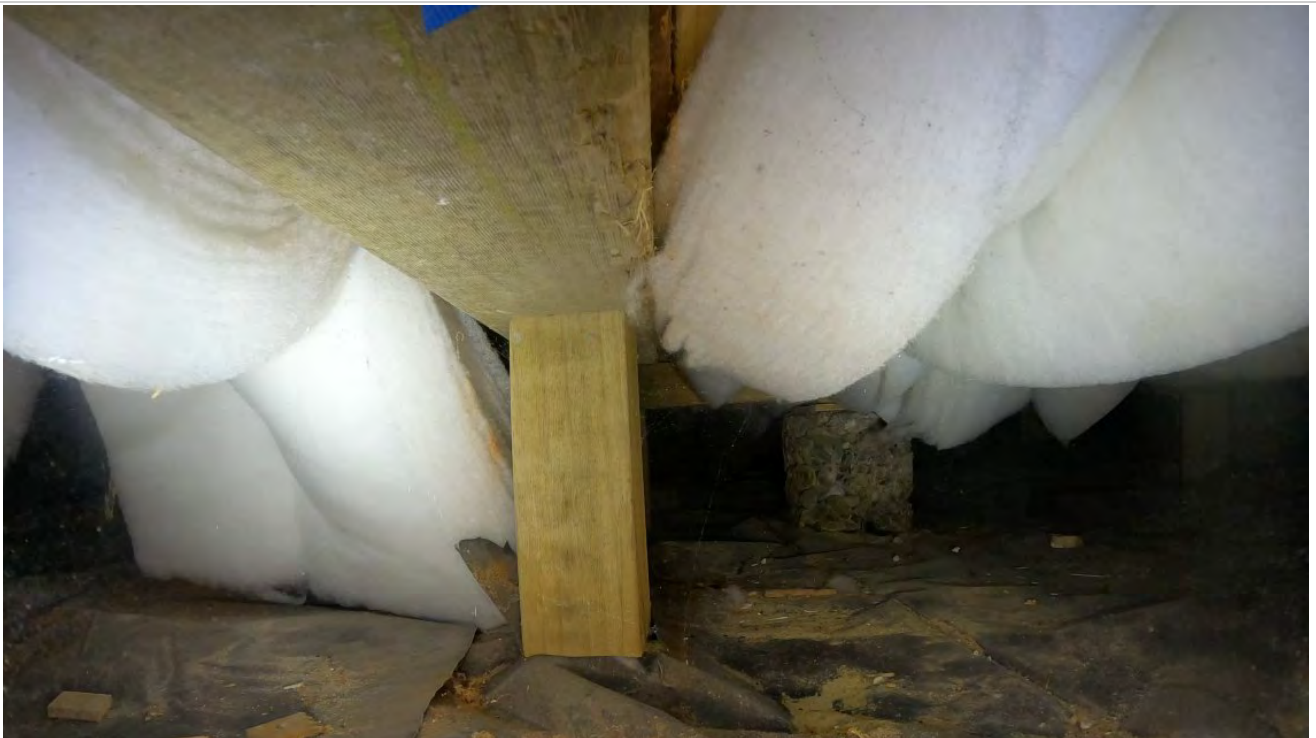
60: View of propping.

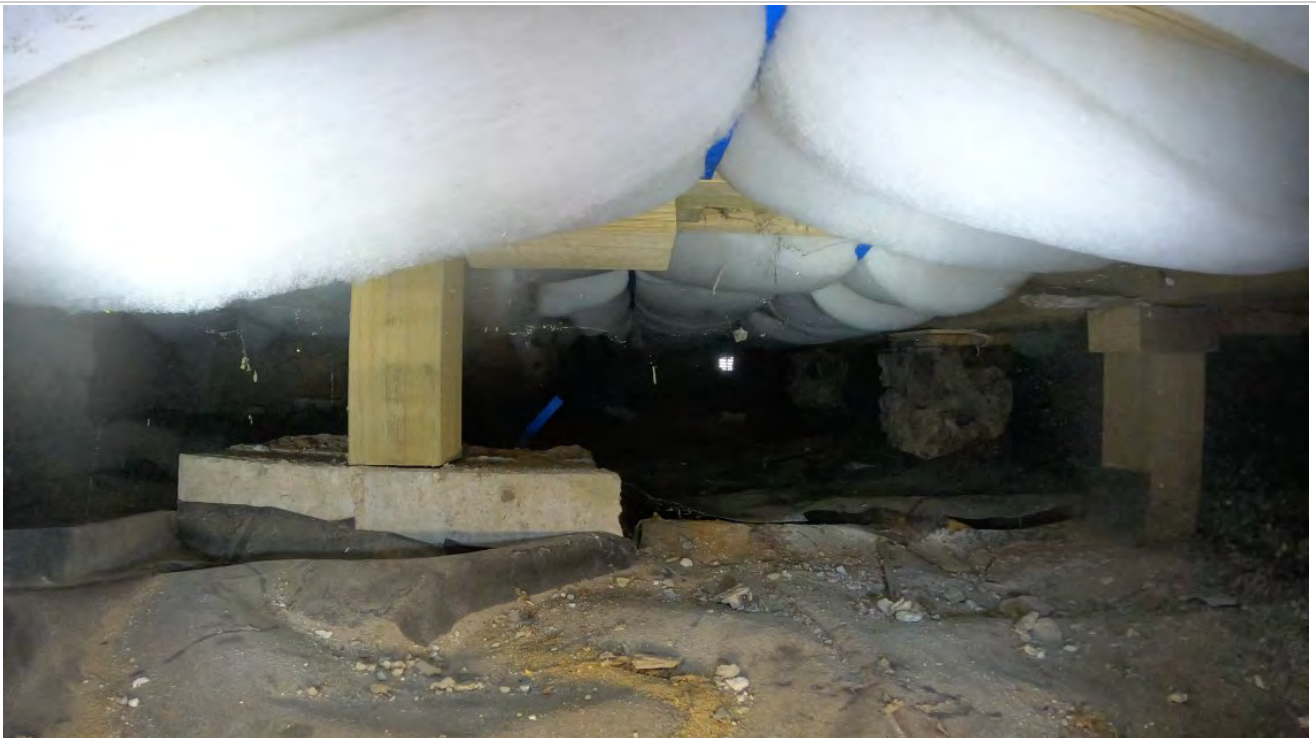
62: View of propping.
