## Building Report

21 Kanawa Street

Waikanae

**Type of inspection:** Building Inspection

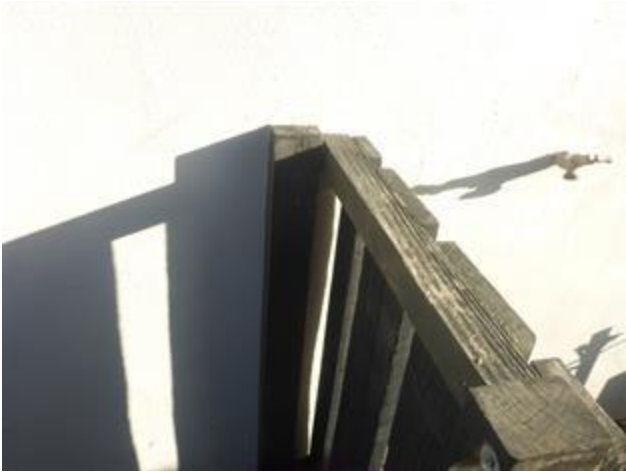
The gatepost to the fencing to the side of the dwelling and the clothesline have been direct fixed through the cladding, which is not recommended as it can be a weather tightness issue. Any wall penetrations can be a higher-risk area for ingress as moisture can find its way into the cladding through fixing penetrations. Post fixings can be modified.

Direct fixed clothesline

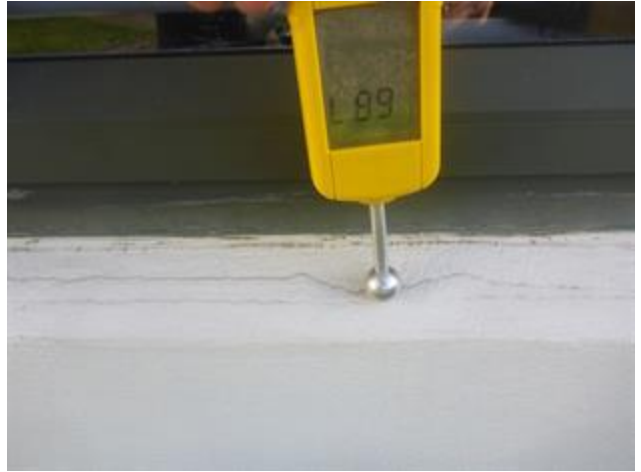
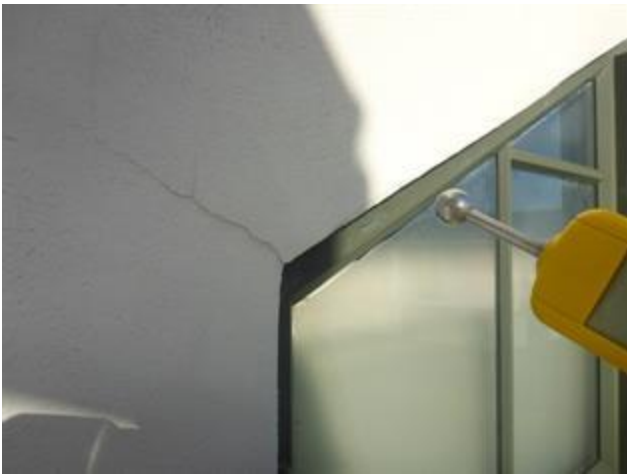
Front windowsill

Hairline cracks were sighted to the cladding to the front and side of the dwelling and impact damage was sighted to the western side and to the front, with two hole penetrations sighted to the rear.

My recommendation is that the EIFS now have further specialist invasive appraisal to give you advice about the cracks, hole penetrations, and impact damage repair requirements, for the installation of kick out flashings, for the area with indications of moisture retention, and for an indication of costs.

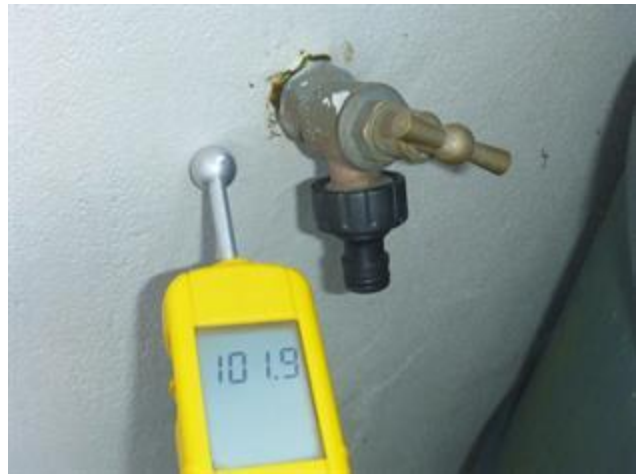
At the time of inspection moisture levels to the base and sides of the joinery penetrations and the hairline cracks were within acceptable parameters but high moisture levels were sighted to the cladding to the sides and base of the rear tap.

Rear tap high moisture levels

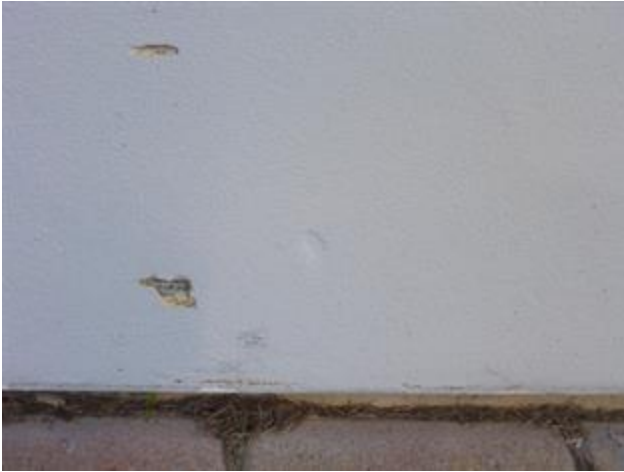
Impact damage side

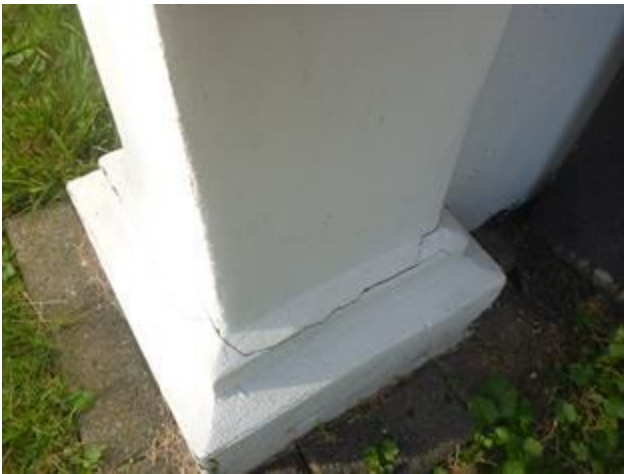
Impact damage front

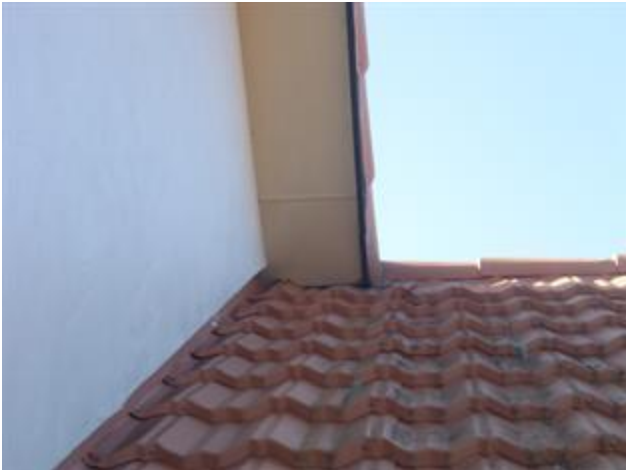
End-grain decay was sighted to the fascia where in contact.

Fascia and soffit in contact

I recommend further investigation for repair to prevent progressive damage.

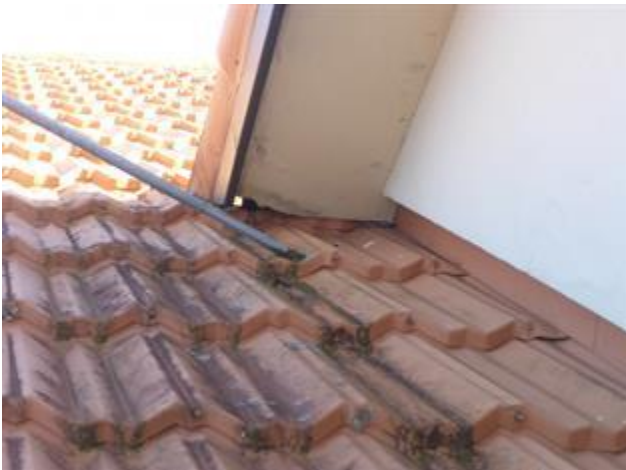
In contact/soffit deterioration

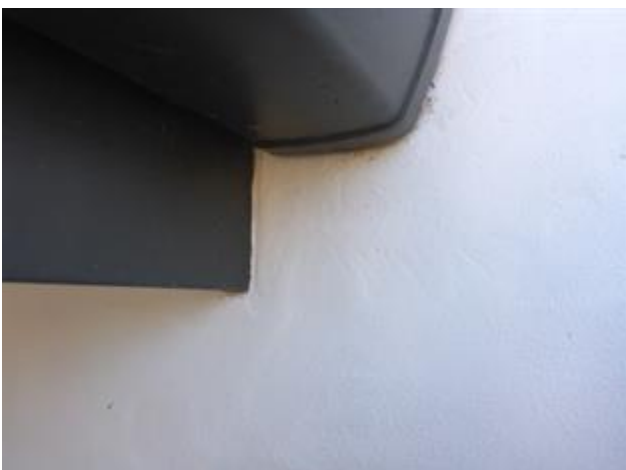
I also noted that the fascia is embedded in the cladding to the sides and rear of the dwelling. This construction can cause the small amounts of expansion and contraction to allow moisture ingress, and these areas are often modified to avoid this known issue. I recommend further investigation, modification and repairing the junctions.

Embedded fascia

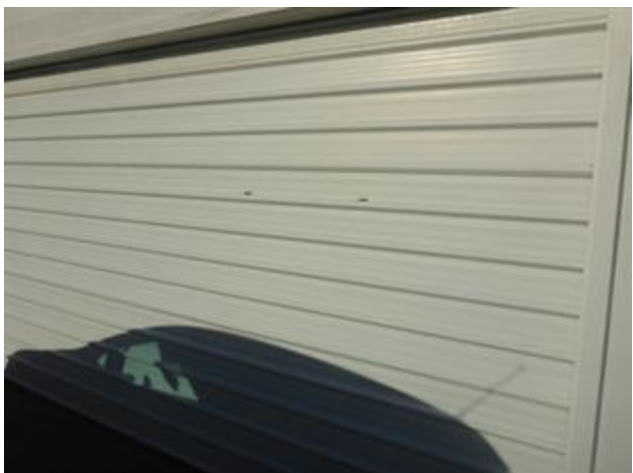
The timber batten to the garage door cladding junction had areas of decay with replacement required to prevent progressive damage.

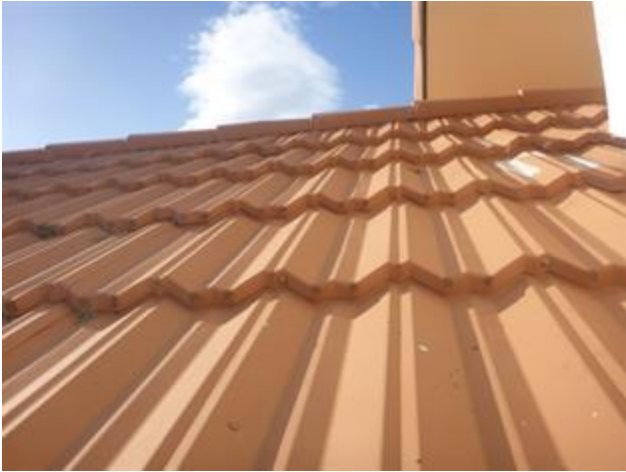
Direct fixed fastener

I did note that the tiles of the lower run above the spouting have been fixed through the tops of the tiles without rubber washers. This would have been compliant at the time of construction but does not meet today's standards as this can allow moisture ingress issues.

I recommend that the roofing material have further appraisal by a licensed roofer to give you advice on the degree of fastener / butynol / washer upgrades and potential costs.

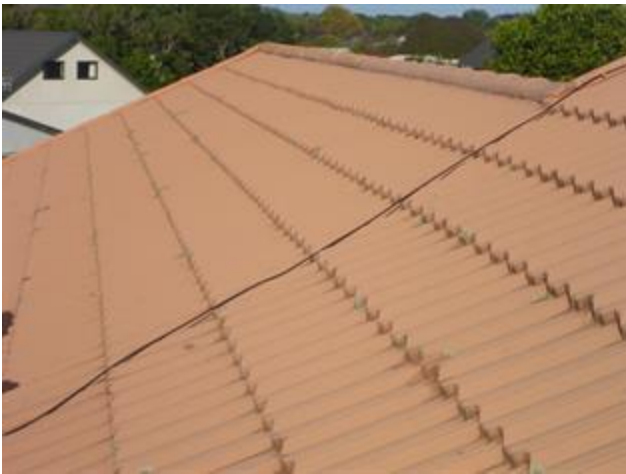
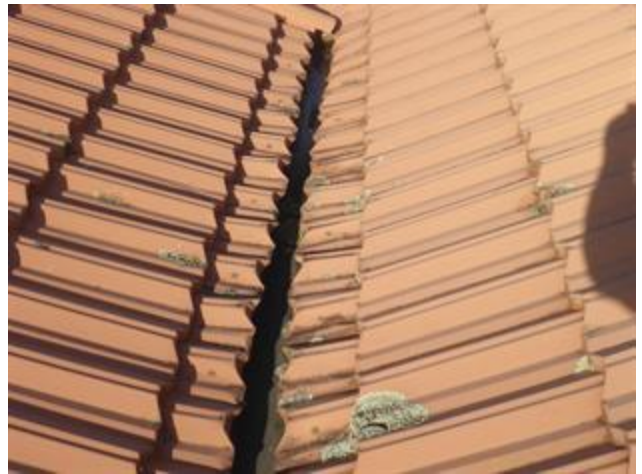
Butynol

The butynol appeared aged and I recommend this now have further specialist appraisal.

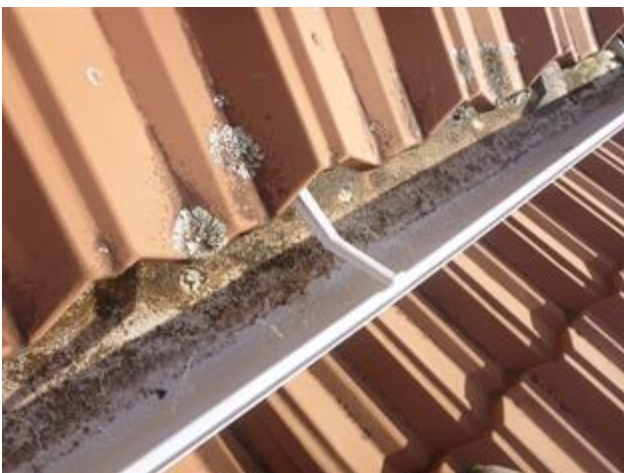
Popped bracket

I noted one spouting bracket has popped to the side of the front door covered area and would benefit from being re-fixed.

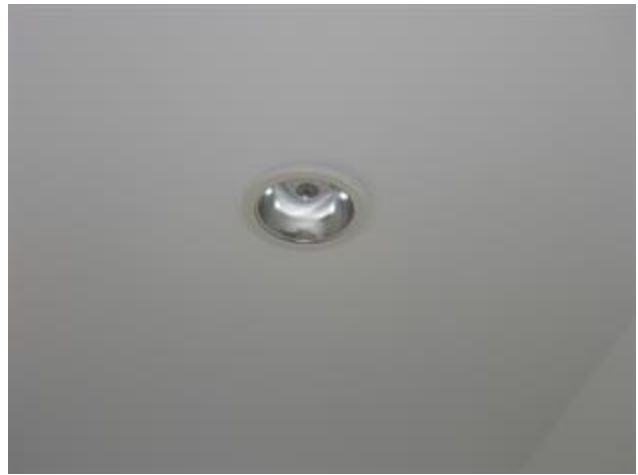
Original

There were small areas identified in the attic space where the insulation could be fitted better as the original downlights have been replaced with LED lighting and the insulation to these penetrations has not been refitted.

As part of the maintenance planning, I recommend consultation with a registered electrician about replacing the one remaining recessed downlight that requires clearances from insulation with a new recessed type that can be safely covered with insulation.

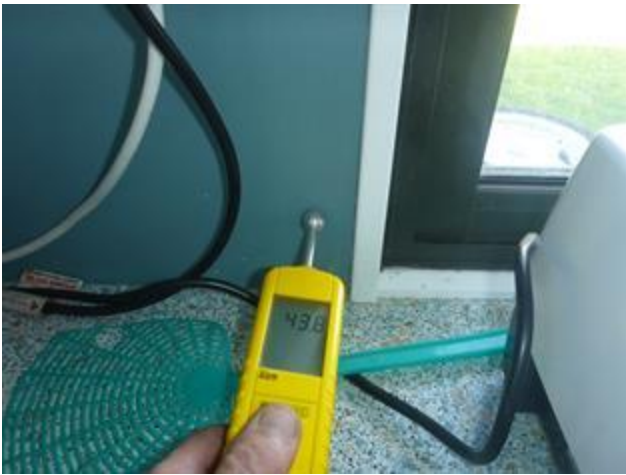
All moisture readings were within acceptable parameters at the time of inspection. I was unable to access the corresponding interior area of the outside tap due to the furniture in place.

Moisture levels acceptable parameters

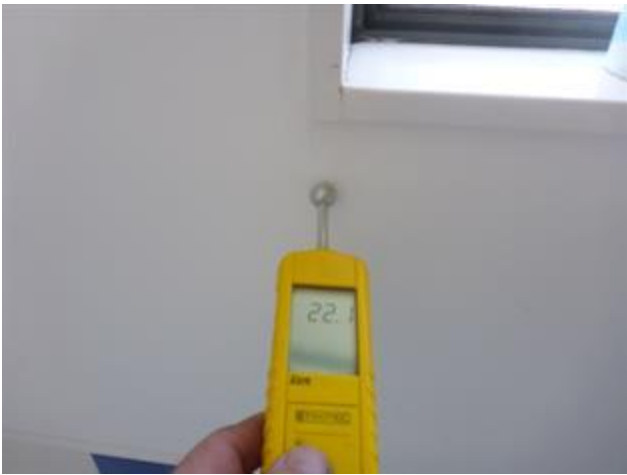
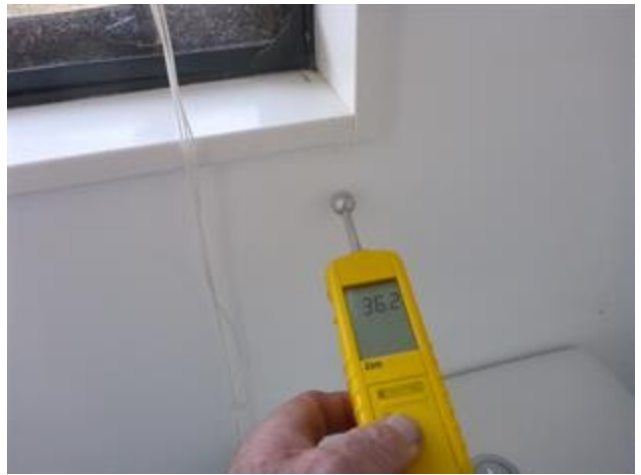
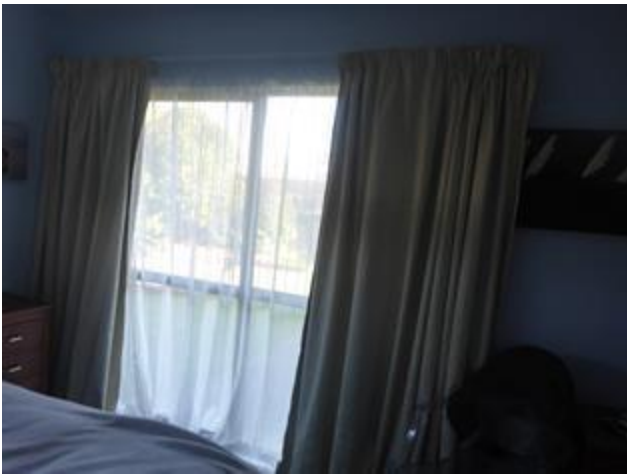
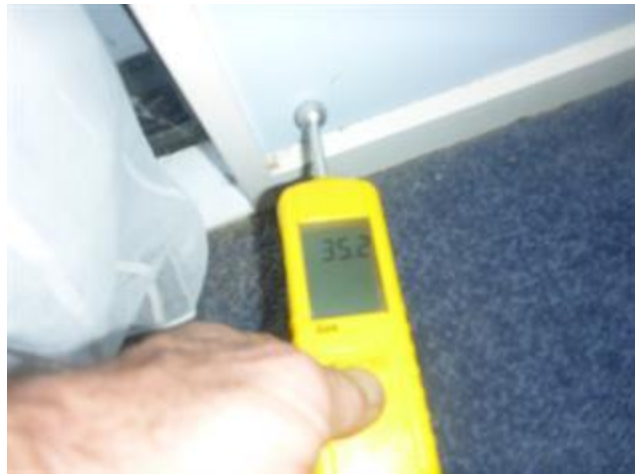
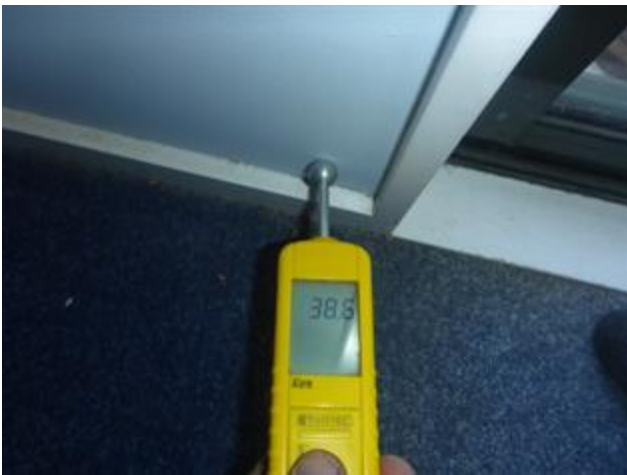
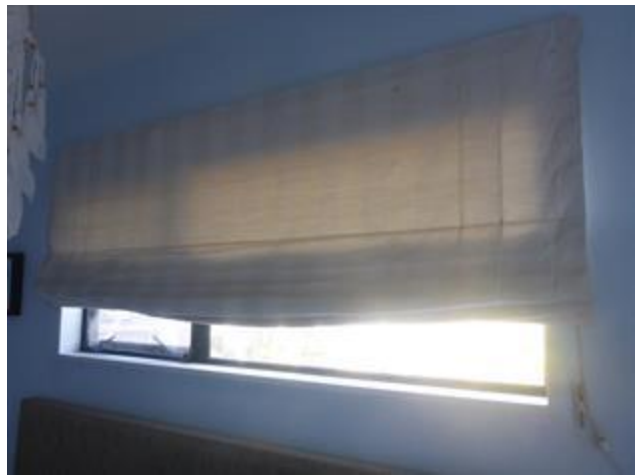
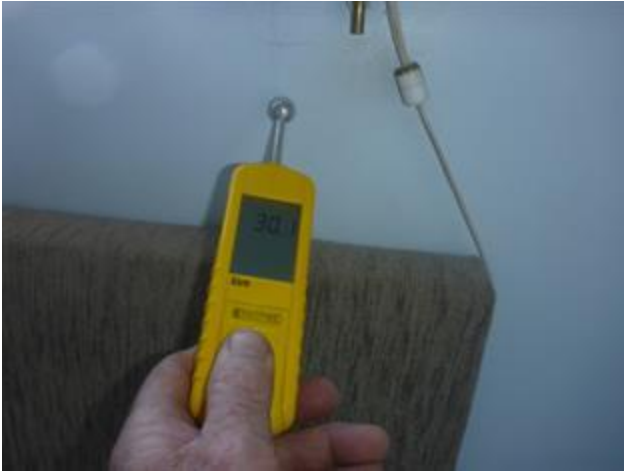
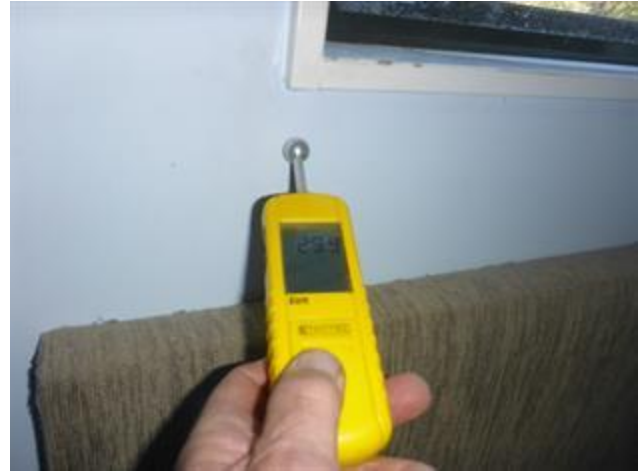
The ceilings appeared to be in good condition with no signs of sagging. Dampness and moisture damage were not seen in the ceilings or walls.

There were a few cracks noted to the plasterboard (gib board) wall linings due to the inevitable movement or setting of the dwelling. Gib board tends to crack at the sheet joints

on ceilings and around the window and door openings. This type of cracking is not uncommon and could be addressed the next time the dwelling is to be redecorated. Mechanical ventilation was fitted to the kitchen and the bathroom.

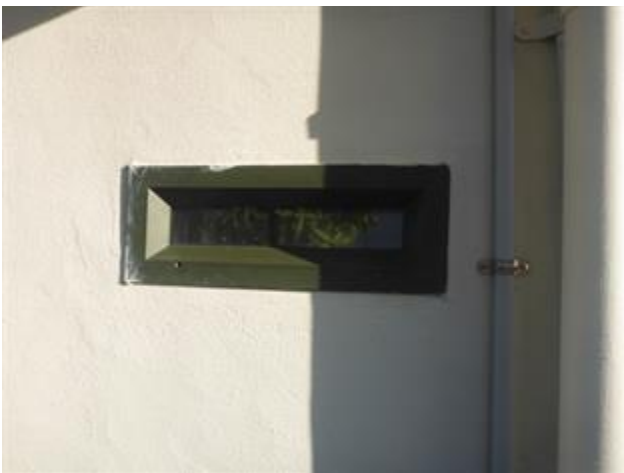
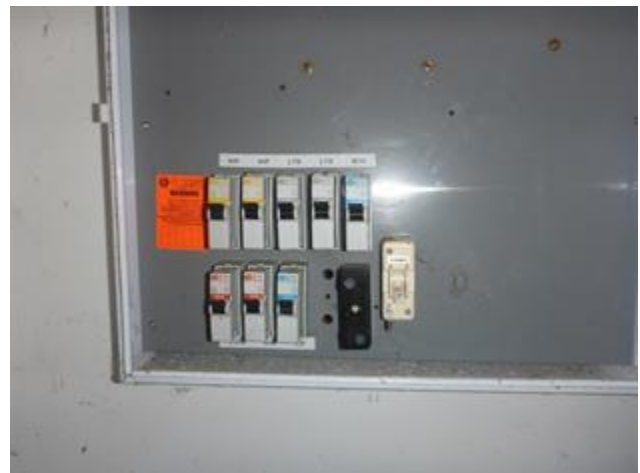
## Circuit Board

The electrical system consists of an internal circuit board located in the garage with the meter located in the garage and viewed from the exterior. All the fuses were modern circuit breakers.

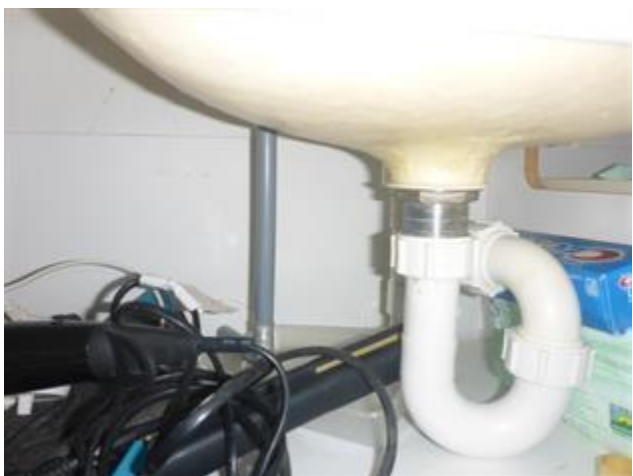
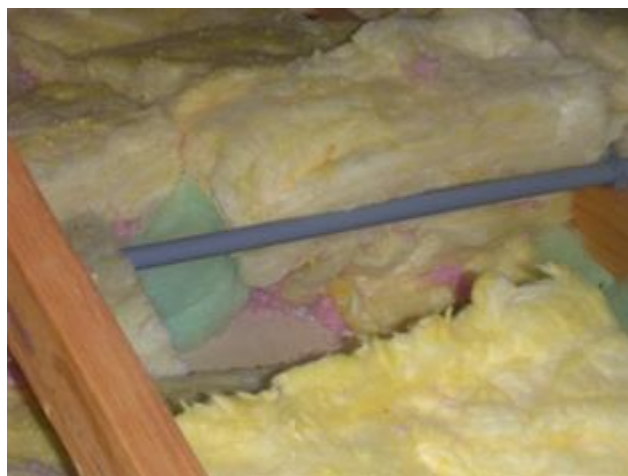
Some copper water piping was also present and supplying the hot water cylinder.

Where the plumbing was visible, there were no indications of any issues to report.

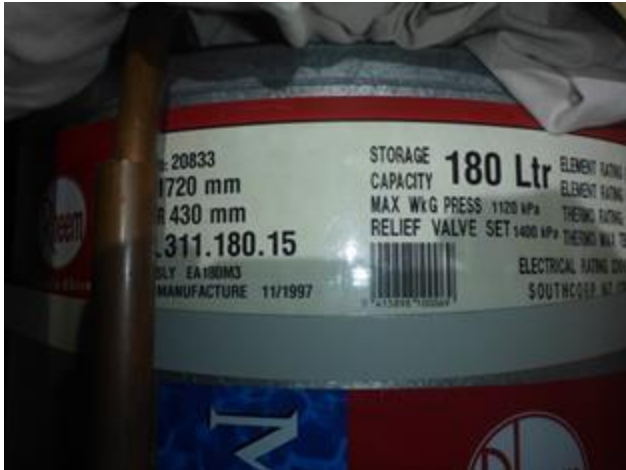
## Hot water system

The hot water supply to the dwelling is via a 180 litre Rheem mains pressure electric cylinder manufactured 11/1997.

In terms of maintenance planning, due to the age of this cylinder, an appropriate sum could be set aside for the replacement of the cylinder as and when necessary.

Located on the top of the cylinder is a valve to relieve pressure in the hot water cylinder. It is recommended that the relief valve be checked for adequate performance or replaced at intervals not exceeding 5 years, or more frequently in areas where there is a high incidence of water deposits and that the valve easing gear be operated at least every six months.

Hot water cylinders built prior to 2003 benefit from additional insulation to reduce heat loss. Heating a home's hot water makes up one-third of the average power bill. Insulating the hot water cylinder with a hot water cylinder wrap is a quick easy way to make a difference to the energy use.

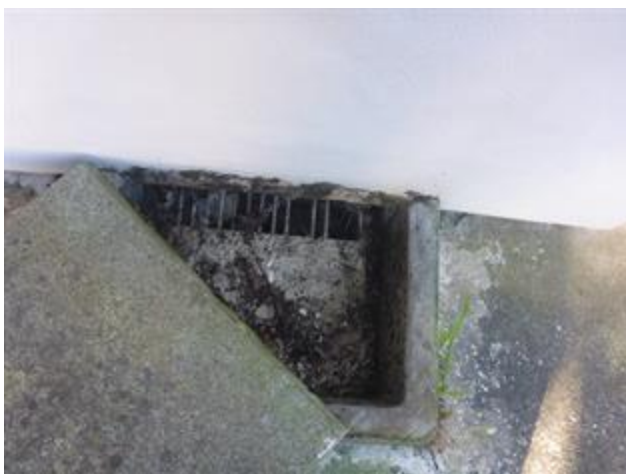
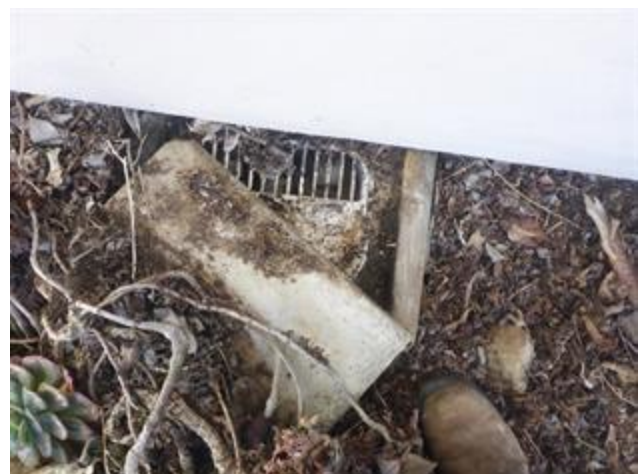
## Drainage

The gully traps appeared clear and clean at the time of inspection.
