## EQC CLAIM DOCUMENTATION

**Claim Number:** CLM/2016/010270  
**Damage Address:** 18 Heathglen Avenue, Parklands, Christchurch 8083  
**Claimant:** Christopher Colvill

<b>Address</b>	18 HEATHGLEN AVENUE, PARKLANDS, CHRISTCHURCH, 8083	<b>EQC Claim Number</b>	CLM/2011/198599
<b>Hazards</b>	Nil hazards	<b>EQC Assessor (L,F)</b>	fellows, chris
<b>Inspection Date</b>	01-Jul-2011	<b>Placard</b>	No Sticker
<b>Status</b>	Current	<b>EQC Estimator (L,F)</b>	Goodall, Mike

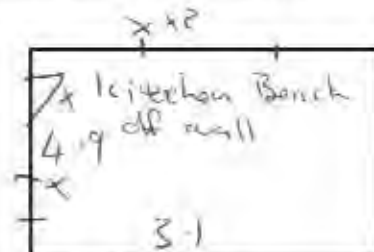
Room	Damage	Walls	Ceiling	Floor	Description of Damage
	Y/N	✓	✓	✓	
Lounge	Y	✓			cracking door frames
Dining Room	Y	✓			door frames cracking
Kitchen	Y	✓			bench pulled from wall, cracking door frames, cracking window frames
Family Room	N/A	—	—	—	
Bedroom 1	Y	✓			cracking window frames + cornices
En Suite	N/A	—	—	—	
Bedroom 2	Y			✓	skirting board base pulled.
Bedroom 3 UPSTAIRS	NIL				nil reported/checked
Bedroom 4	N/A	—	—	—	
Bathroom includes 2 toilets	Y	✓	✓		cracking window frames + cornices
Toilet 1	Y/NIL				cracking window frames + cornices nil reported
Toilet 2	N/A	—	—	—	
Office/Study	N/A	—	—	—	
Rumpus UPSTAIRS	NIL				nil reported/checked - balcony OK.
Entry/Hall(s) DOWN	Y	✓	✓		cracking at door frames, + cornices pulling ceiling / wall joins
Stairwell	Y	✓			skirting board base pulling
Laundry IN KITCHEN	N/A	—	—	—	cracked frame window
Other		—	—	—
