Building Report

14B Realm Drive

Paraparaumu

Building Consultant: Ian Hall, NZIBI
Present for inspection: Ian Hall
Weather at time of inspection: Showers
Date/s of inspection: 06-May-2026
Type of inspection: Building Inspection
Name of property inspected: 14B Realm Drive
Paraparaumu
Report prepared for: Eddie Cook

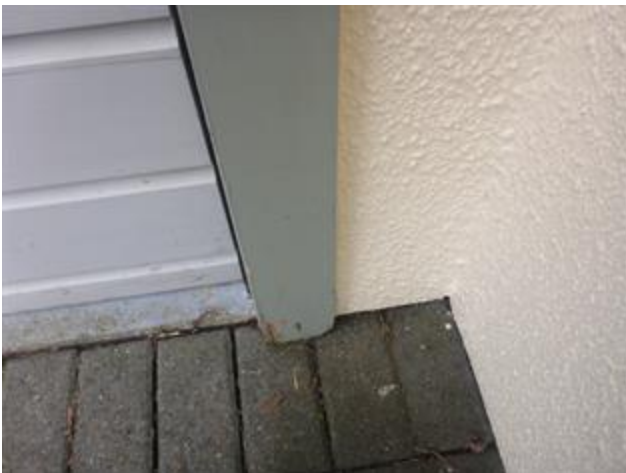
Cladding in close to contact

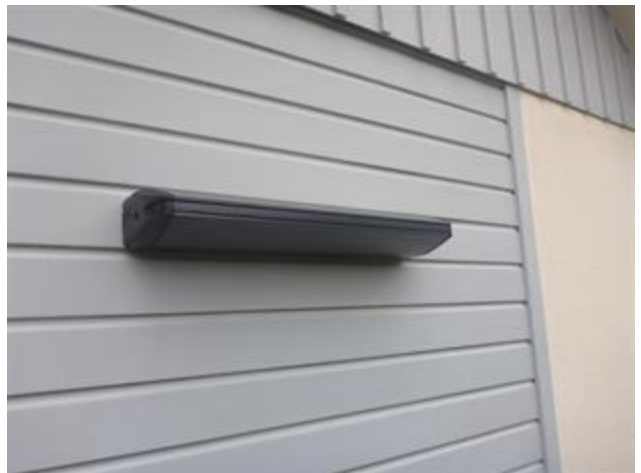
The clothesline has been direct fixed through the cladding, which is also not recommended as any wall penetrations can be a high-risk area for ingress as moisture can find its way into the cladding through fixing penetrations. Fixings can be modified.

Direct fixed

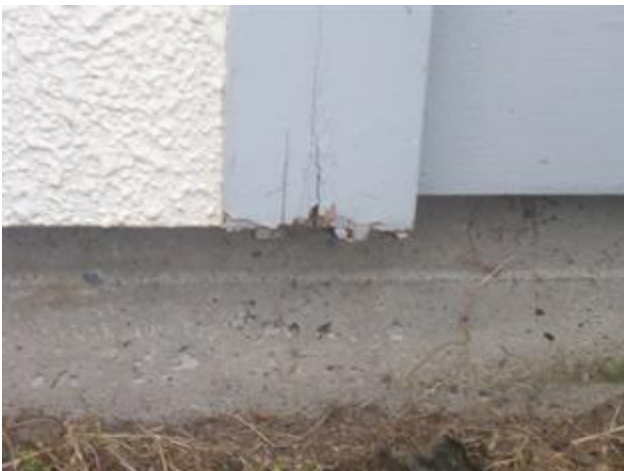
Some end-grain decay was sighted to a batten to the rear of the dwelling that I recommend has further appraisal for repair to prevent progressive damage.

Batten end-grain decay

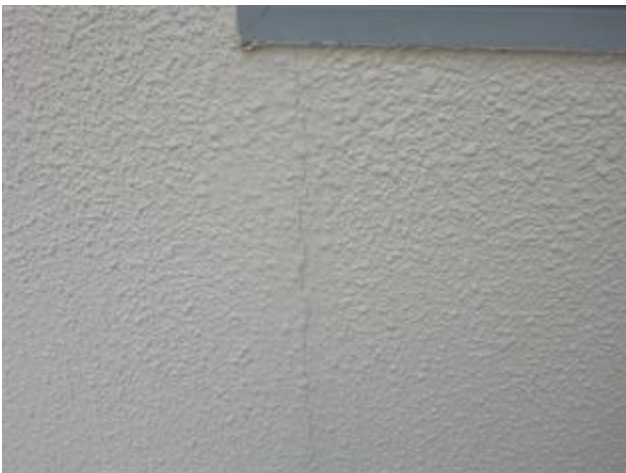
Rear of dwelling beneath

I also noted that a small area to the rear of the dwelling is in close contact to the sloping roof. It is now required that cladding where over a sloping roof have a 35 mm clearance from the bottom of the cladding. This is because if the gap is not maintained then water can wick-up behind and through the cladding and reach the framing. A solution can be to cut the cladding to ensure there is clearance. A 50 mm overlap is required to any framing at the base of the wall.

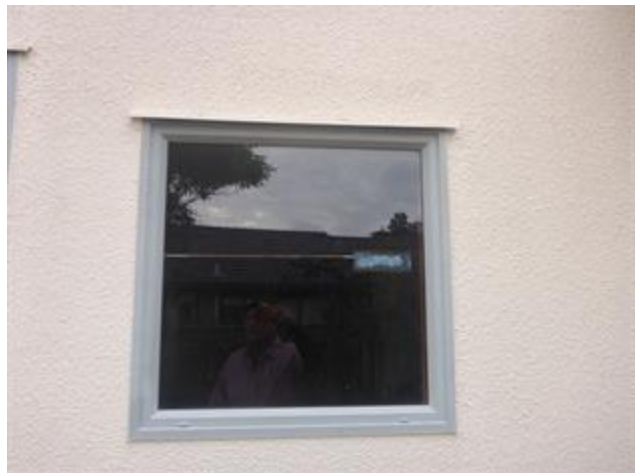
No soffit/metal cap flashed

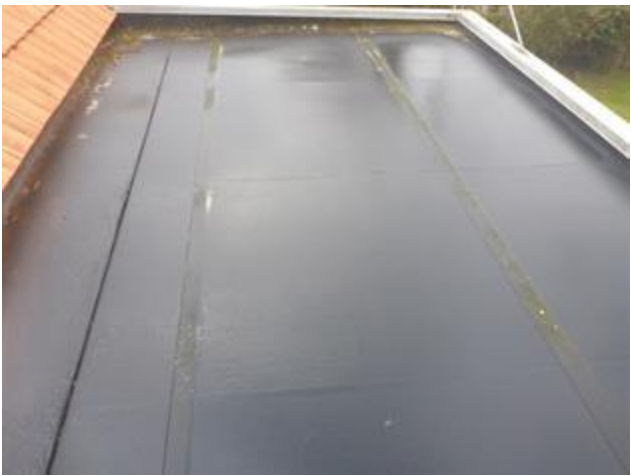
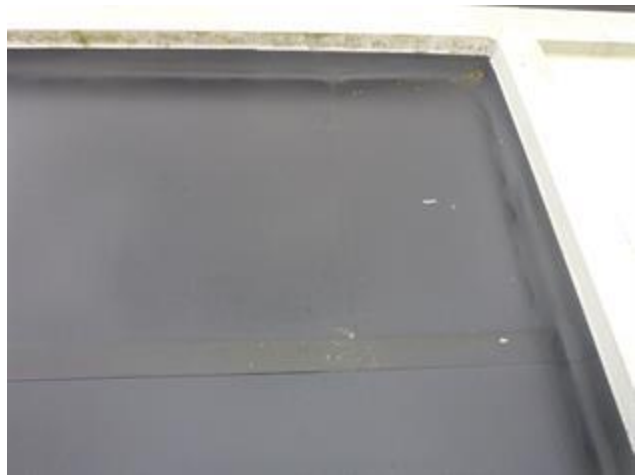
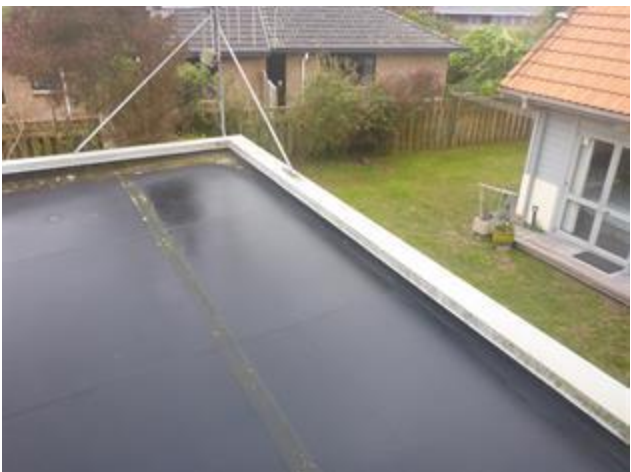
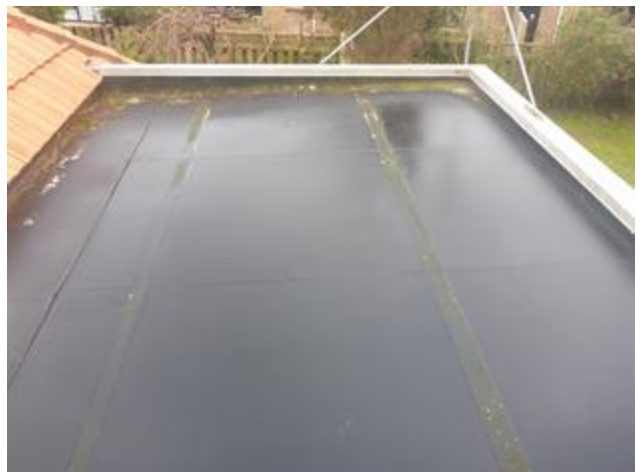
The substrate appeared solid when walked on but the fasteners fixing the substrate in place have popped in places and will in time penetrate the membrane. Pin holes and hairline cracking can appear that are difficult to sight. Material damage may already be present beneath the lining, but this cannot be known with a visual-only inspection. Corresponding moisture levels where accessible below the area were within normal parameters.

Substrate fastener penetration

My recommendation is that the butynol roofing material now have further appraisal by a licensed roofer to give advice on the degree of repair, upgrades and costs as the membrane is now 32 years old.

I recommend that the butynol roofing material now have further appraisal by a licensed roofer to give advice on the degree of repair, upgrades and potential costs as the membrane is now 32 years old.

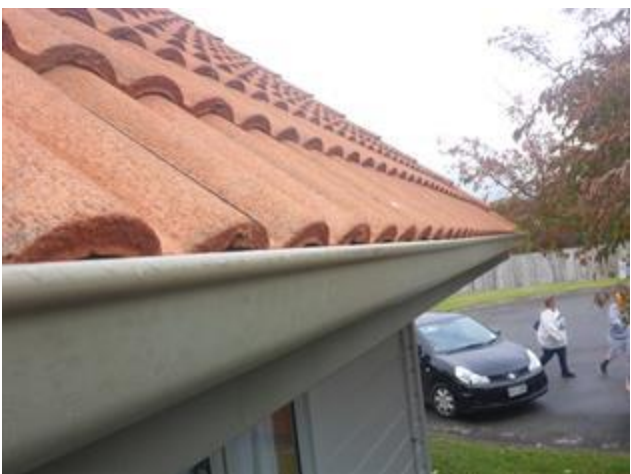
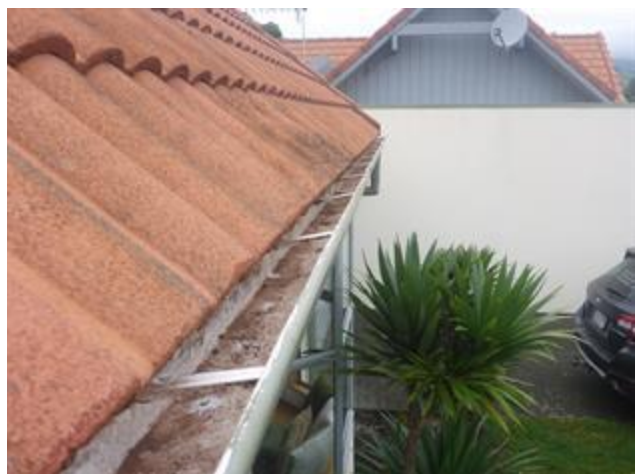
The spouting appeared in good condition with the correct fall to the downpipes.

Clearing of the spouting is part of the general maintenance for all dwellings.

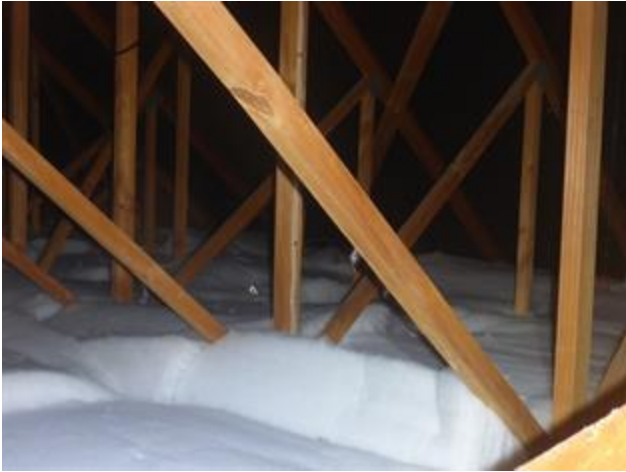
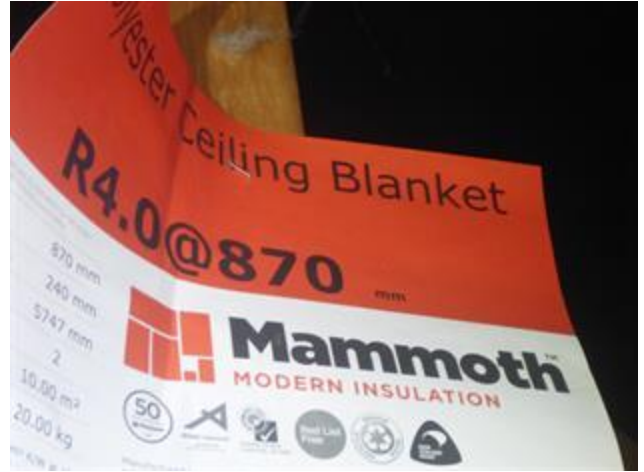
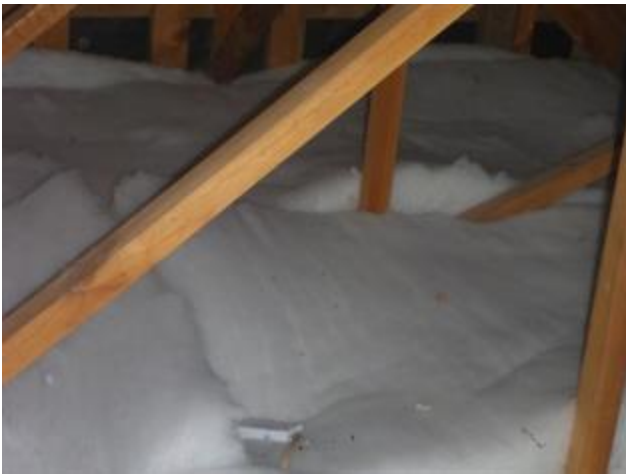
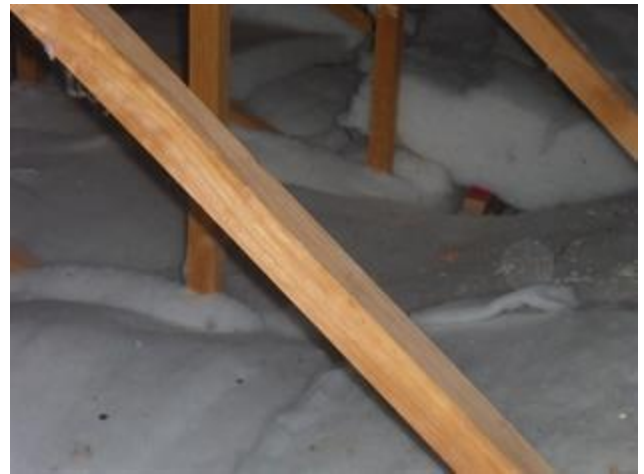
No signs of decay or leaks were identified where accessible.

There were no gaps identified in the attic insulation.

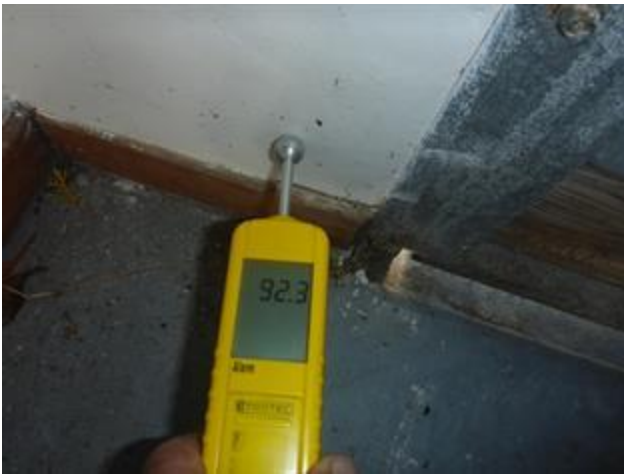
All moisture readings were within acceptable parameters at the time of inspection except to the wall lining to the left side of the garage door where high moisture levels were recorded at the top to the exterior and the base to the exterior and interior.

High moisture levels recorded ground level

As moisture retention can lead to decay, I recommend further invasive appraisal of the area.

My recommendations are that the areas that indicated high moisture levels now have further invasive appraisal to ensure repairs can be fully carried out and any compromised material can be removed and replaced.

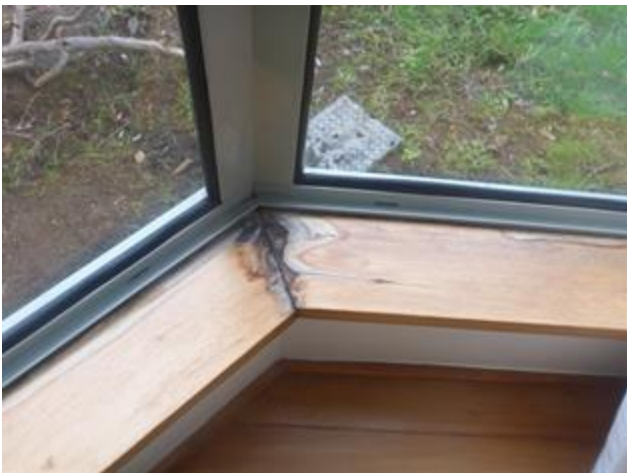
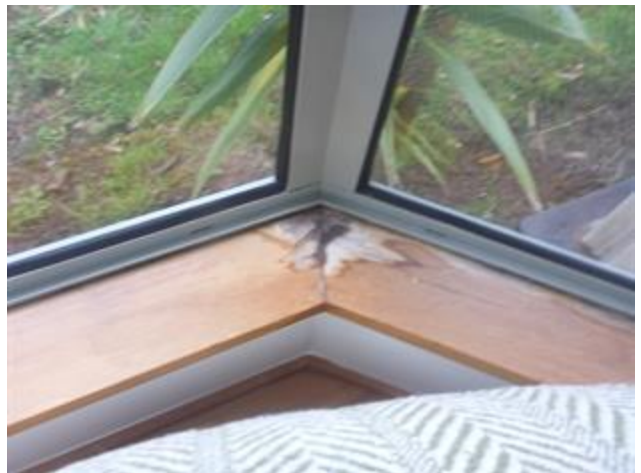
The signs of moisture/UV damage were noted on some of the windowsills. It is likely that condensation has pooled in these areas and has over time broken down the integrity of the paint.

Moisture / UV damage

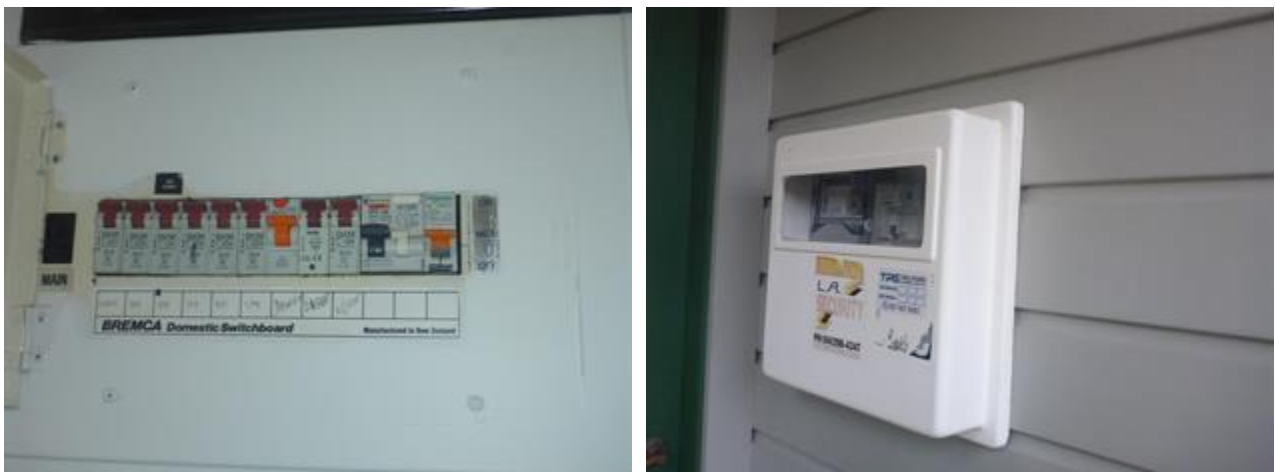
The electrical system consists of an internal circuit board located in the hall with an external meter under cover of the front door access area.

All the fuses were modern circuit breakers.

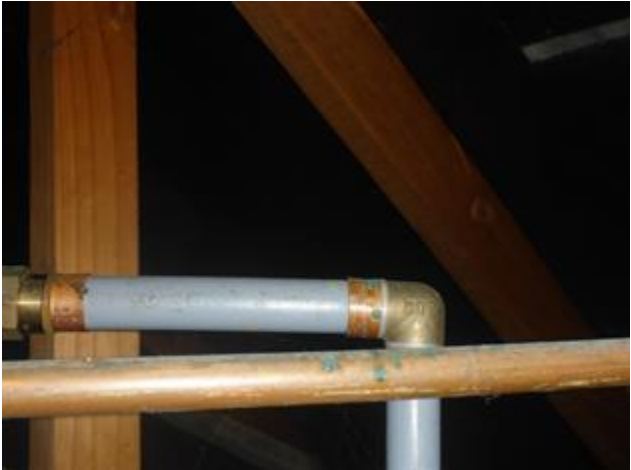
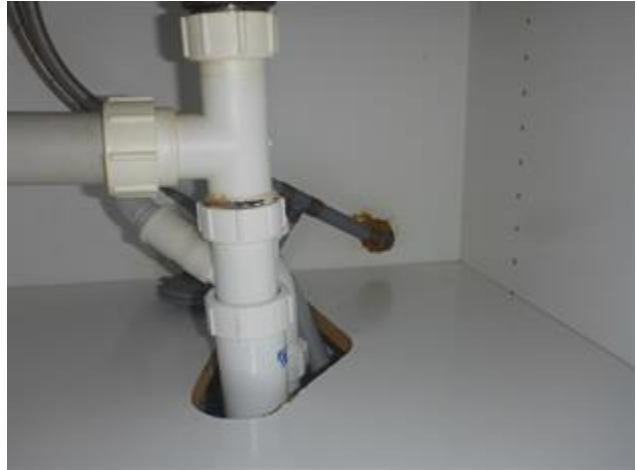
Some copper water piping was also present and supplying the hot water cylinder.

Where the plumbing was visible, there were no indications of any issues to report.

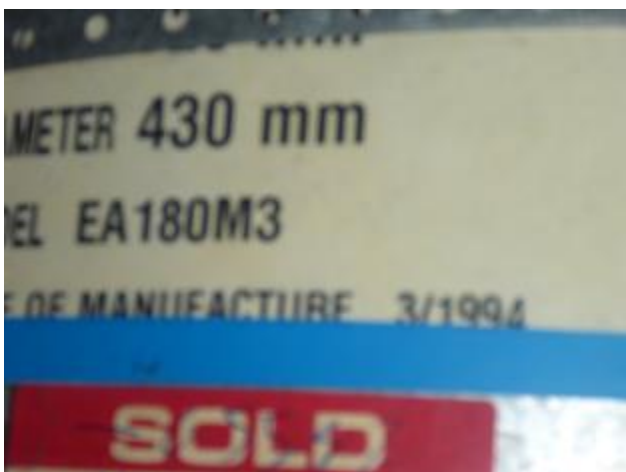
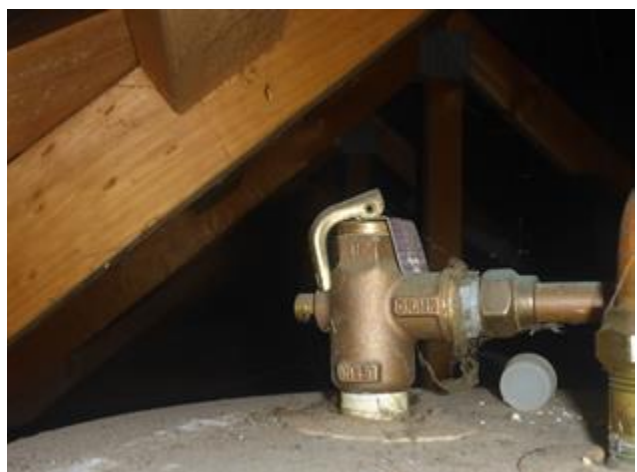
The hot water supply to the dwelling is via a 180 litre Rheem mains pressure electric cylinder manufactured 3/1994. The cylinder is located in the roof space.

Hot water cylinders built prior to 2003 benefit from additional insulation to reduce heat loss. Heating a home's hot water makes up one-third of the average power bill. Insulating the hot water cylinder with a hot water cylinder wrap is a quick easy way to make a difference to the energy use.

Located on the top of the cylinder is a valve to relieve pressure in the hot water cylinder. It is recommended that the relief valve be checked for adequate performance or replaced at intervals not exceeding 5 years, or more frequently in areas where there is a high incidence of water deposits and that the valve easing gear be operated at least every six months.

Due to the age of this cylinder, I recommend that an appropriate sum be set aside for the replacement of the cylinder as and when necessary.

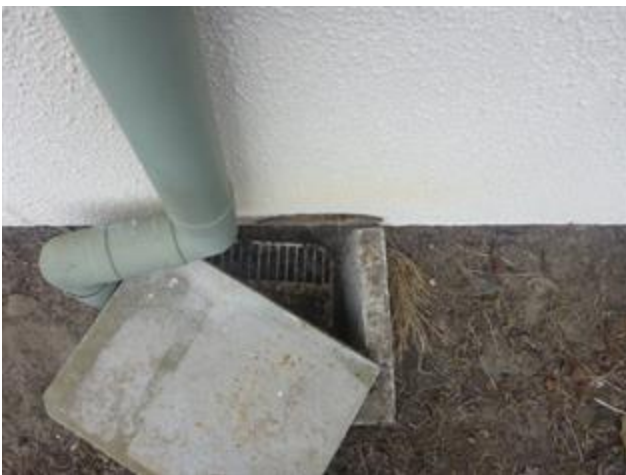
The gully trap appeared clear and clean at the time of inspection.
