Building Report

3 Bressay Way
Waikanae

Building Consultant: Ian Hall, NZIBI
Present for inspection: Ian Hall / vendor
Weather at time of inspection: Fine
Date/s of inspection: 12-Dec-2025
30-Jan 2026
Type of inspection: Building Inspection
Name of property inspected: 3 Bressay Way
Waikanae
Report prepared for: Sarah Searancke

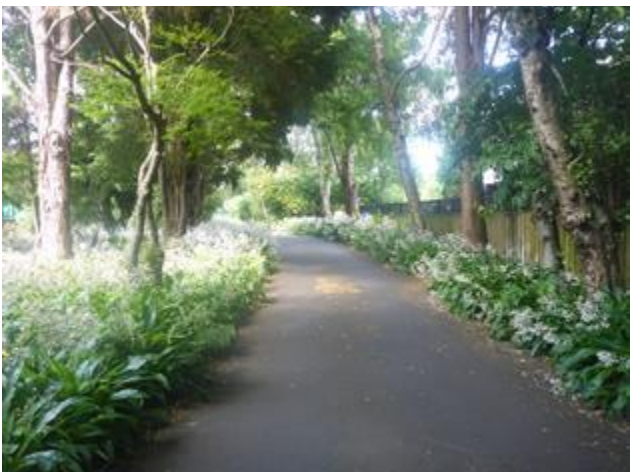
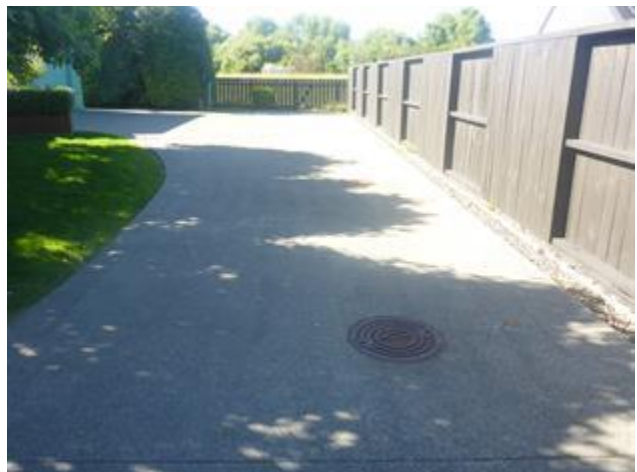
The concrete drive leading to the dwelling was in good condition with a fall away from the dwelling's foundations. Cracks were noted to the concrete drive. It appeared that the cracks have not separated or moved. This type of cracking in continuous concrete is not uncommon and can be due to past earthquakes or settling.

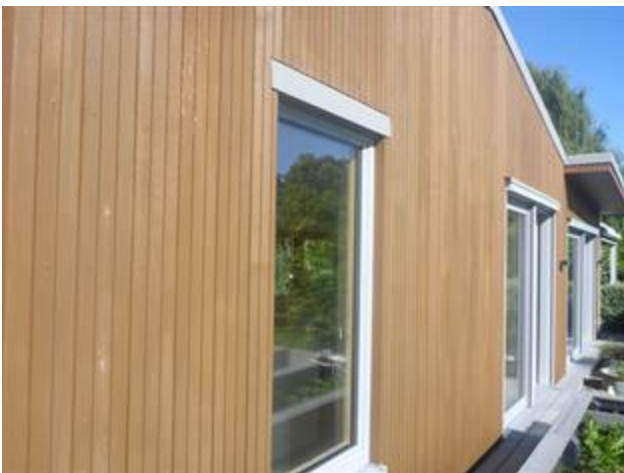
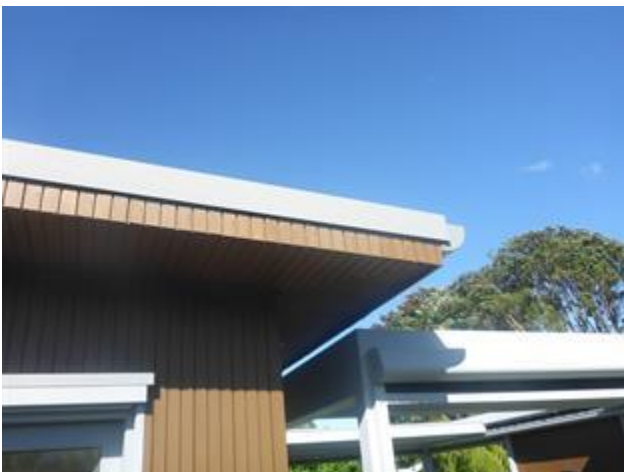
The cladding was in good condition with no visible signs of decay with an aging paint finish mainly to the sunny side of the dwelling.

The lower edge of the plywood cladding and battens has not had a paint seal. A paint seal will help prevent end-grain deterioration of the battens and seal the plywood cladding.

In terms of maintenance planning, implementing a painting program to repair the areas that require some attention now and to maintain a good paint finish to the dwelling is recommended.

***Update 20/1/26 A new paint finish has been applied where required to a good standard.**

<p>*Update 20/1/26 New paint seal applied</p>	
--	--

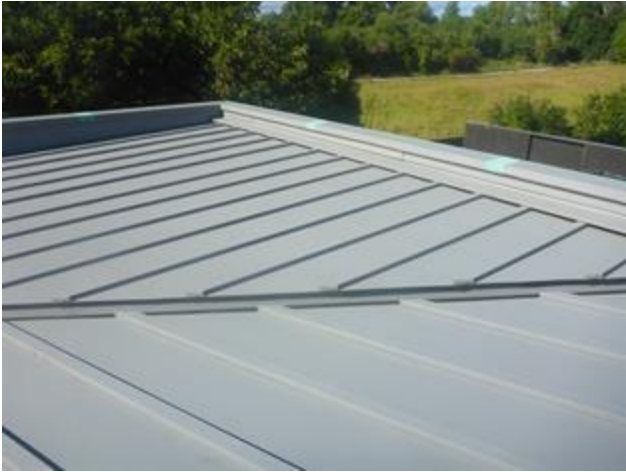
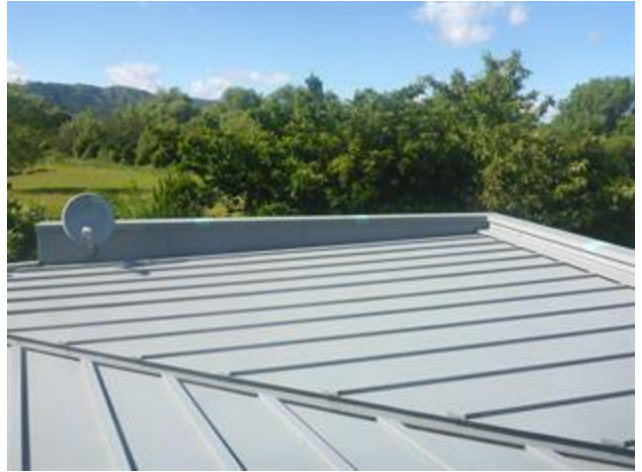
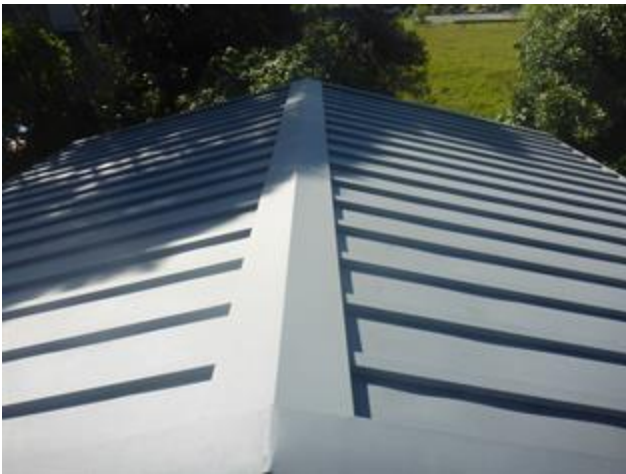
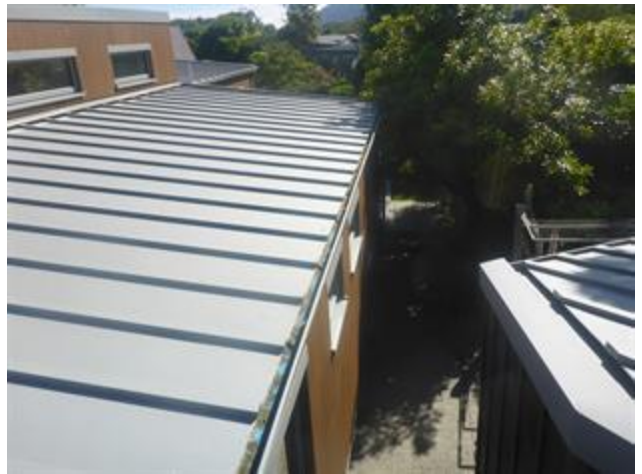
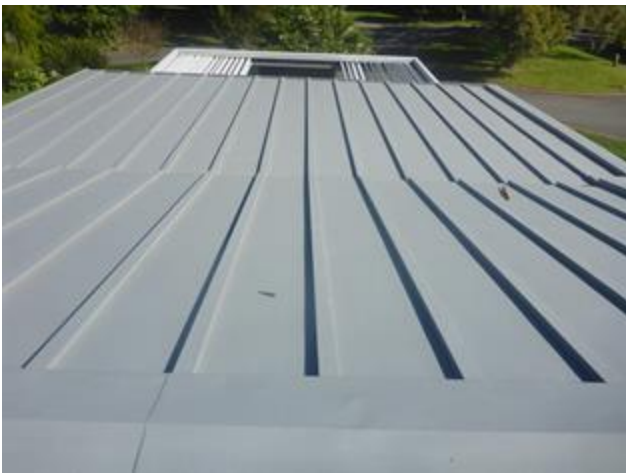
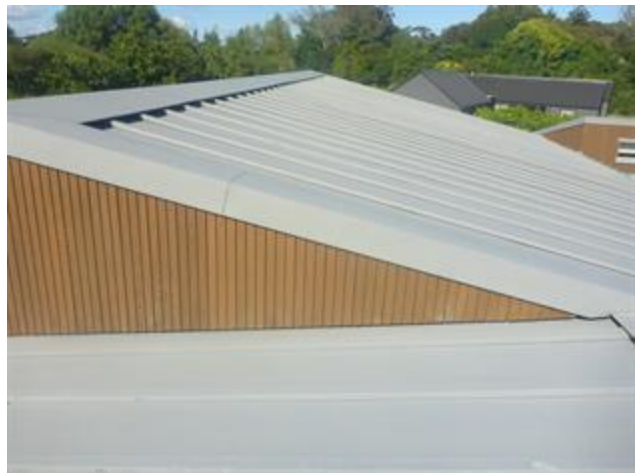
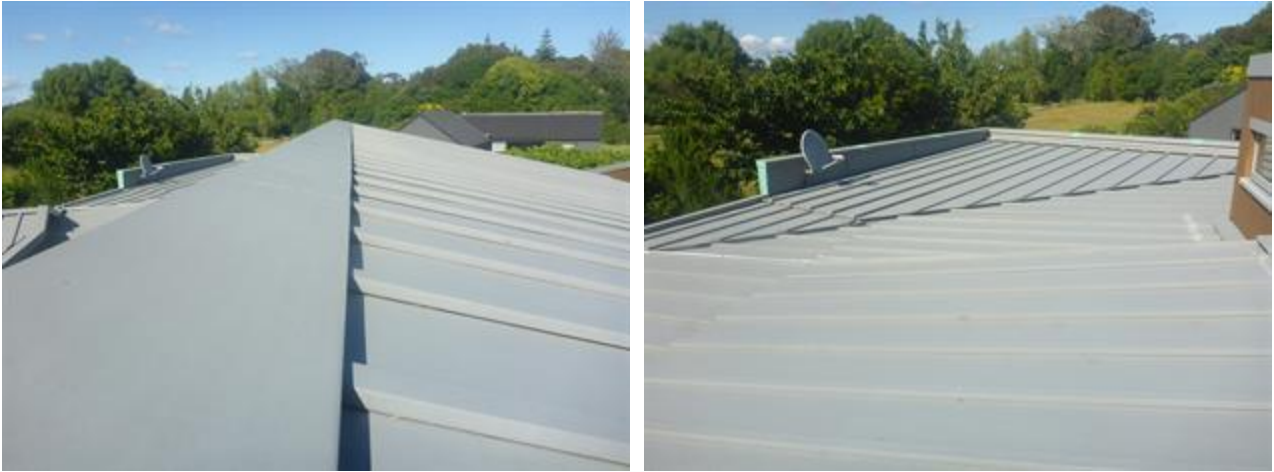
No significant deterioration, dents or corrosion was observed to the sheets of iron.

The dwellings roof cladding is long run profiled aluminum that uses large, custom-cut metal sheets with ridges and grooves (profiles) for seamless, leak-resistant coverage, offering durability, light weight, style versatility, energy efficiency, and low maintenance. Aluminum offers excellent corrosion resistance.

A once-a-year check of the roof cladding, any chimneys and the flashings is recommended to ensure problems are not developing. Things to look for include flashings that have corroded or lifted or the degradation of any sealant around the base of roof penetrations.

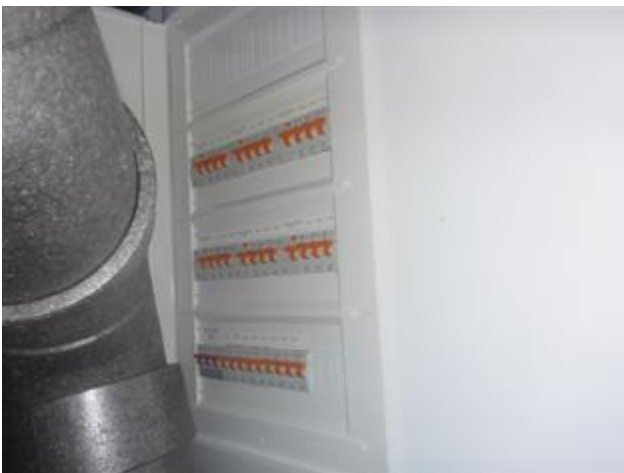
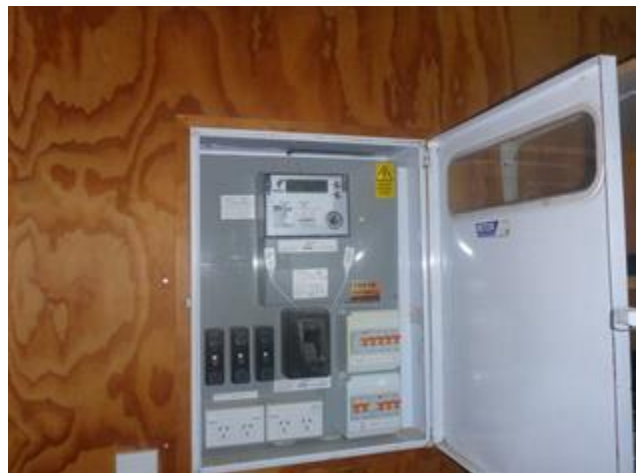
Wiring

Electrical cable was viewed supplying the meter board. TPS cable (new plastic-coated cable) was sighted.

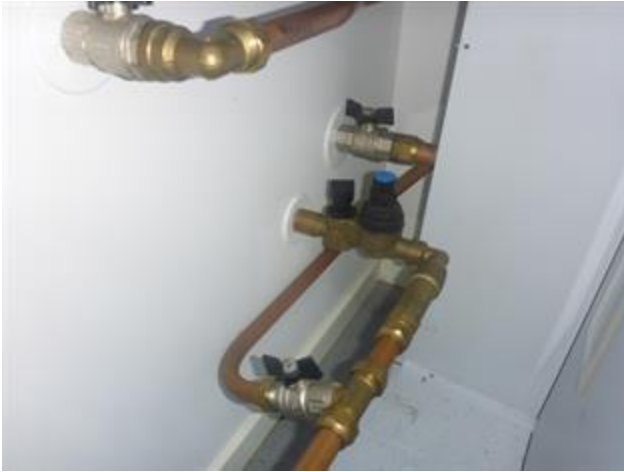
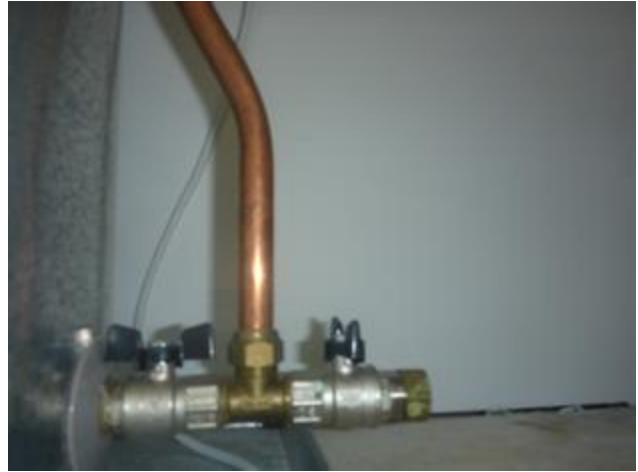
Hot water system

The hot water supply to the dwelling is via a 3000 litre Rheem mains pressure electric cylinder manufactured Dec 2016 with a 135 litre Rheem mains pressure electric cylinder supplying the kitchen.

Located on the side or top of the cylinder is a valve to relieve pressure in the hot water cylinder. It is recommended that the relief valve be checked for adequate performance or replaced at intervals not exceeding 5 years, or more frequently in areas where there is a high incidence of water deposits and that the valve easing gear be operated at least every six months.

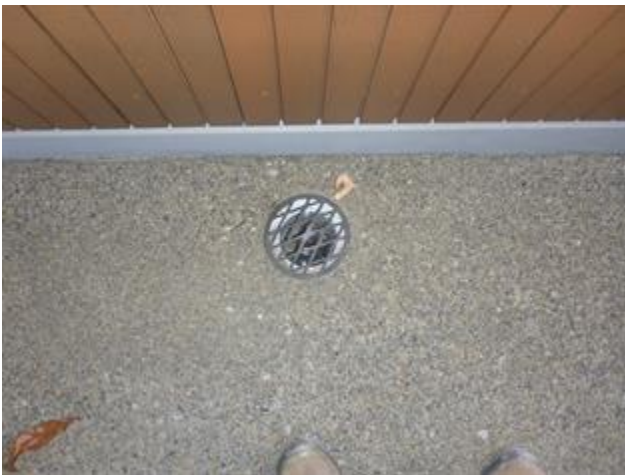
Drainage

The gully traps appeared clear and clean at the time of inspection.
