NEWCASTLE
STRATA INSPECTIONS PTY LTD

Pre-Purchase Strata Inspection Report

Strata Plan: 82167

**Address: 170-172 Gosford Road, ADAMSTOWN NSW
2289**

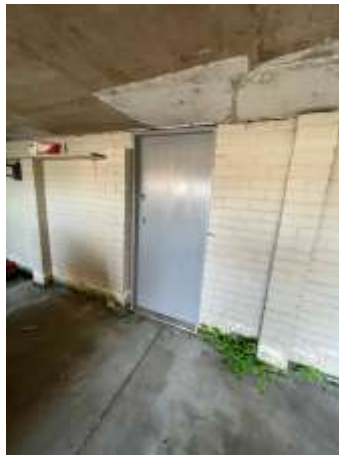
Restricted Areas Photos

Door locked in in carport 6,7,8

It is important to note that as an inspection of the above areas was not possible at the time of the inspection, termite activity or damage may therefore exist in these areas.

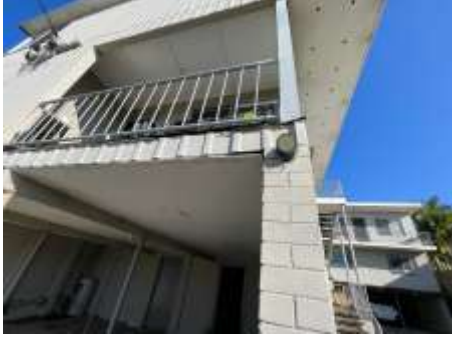
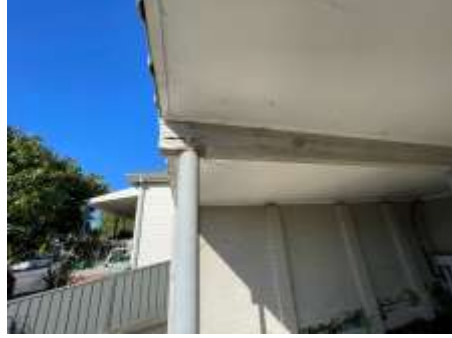
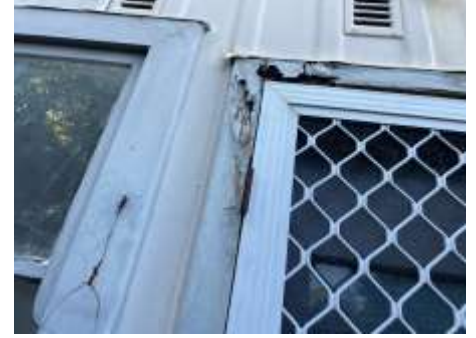
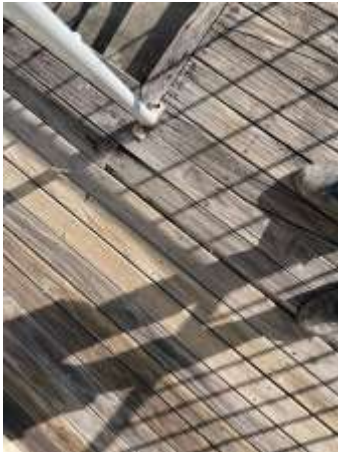
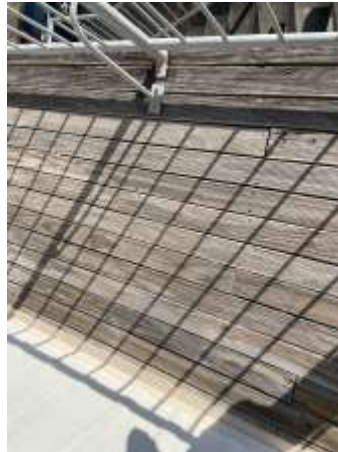
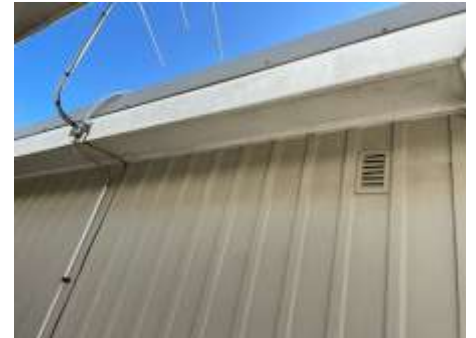
Photo

If any evidence of fungi is reported, it is strongly recommended that the full extent of any such activity and damage be fully understood through the engagement of a Licenced Builder, Structural Engineer or appropriately qualified expert.

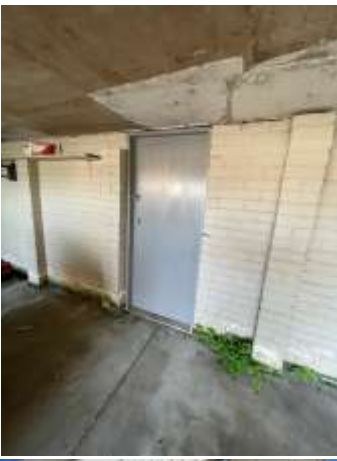
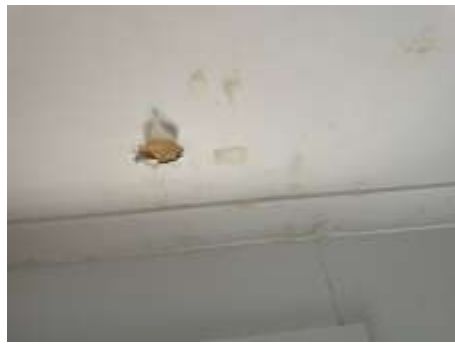
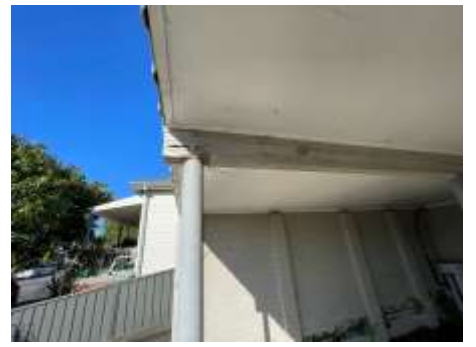
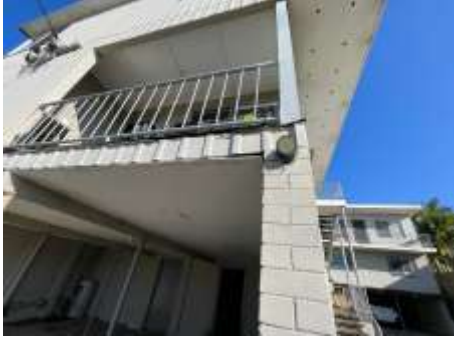
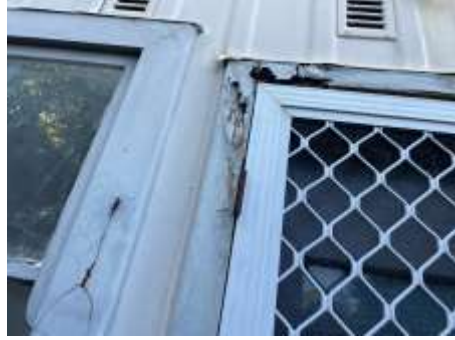
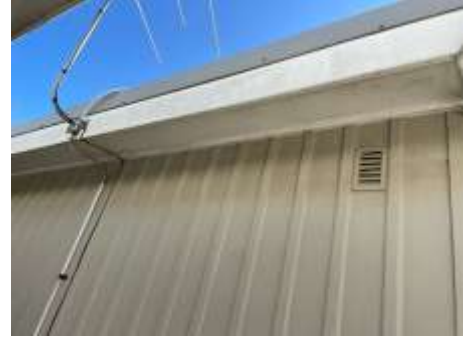
Conductive Condition Photos

Door locked and a lot wood rot sighted to external of building

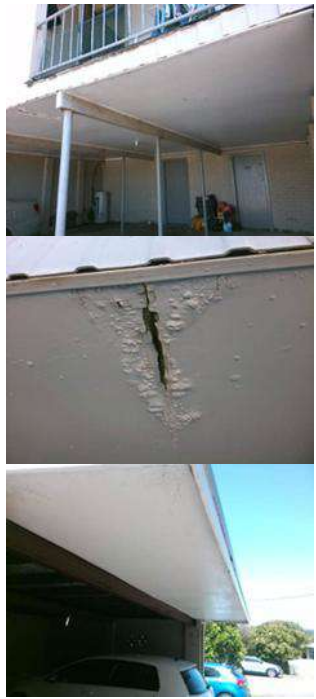
Floor Level	Room	Material at Location	Type	Condition	Priority	S / R / AA	Sample No.	Result	Photo No
G	Car park – Residential – 2 x garage ceilings (front and right hand side)	<p>Ceiling - Sheeting</p> <p>RECOMMENDATION: This item is in a poor condition and it is recommended that -</p> <p>As the priority given for this item is Moderate, then the recommended actions should be planned to be completed within the next 12 months, and, regular yearly re-assessments should be conducted.</p>	NF	P	M	S	33770-1	C, CH

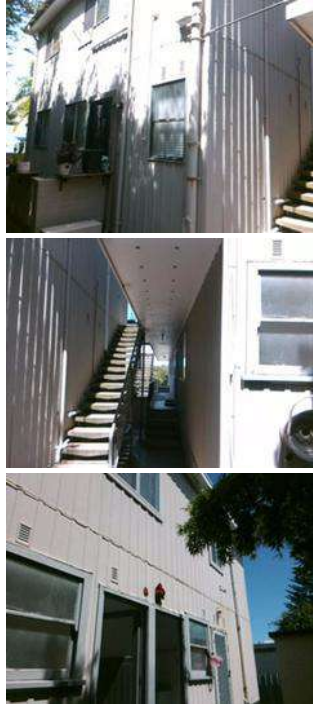
Floor Level	Room	Material at Location	Type	Condition	Priority	S / R / AA	Sample No.	Result	Photo No
G	External – All fibrous cement cladding to all levels and all external walls	<p>Wall - Sheeting to non-masonry wall/s</p> <p>RECOMMENDATION: This item is a reasonable condition and if it is not disturbed there is little risk. No immediate works are required on this item.</p>	NF	N	L	S	33770-4	C, CH

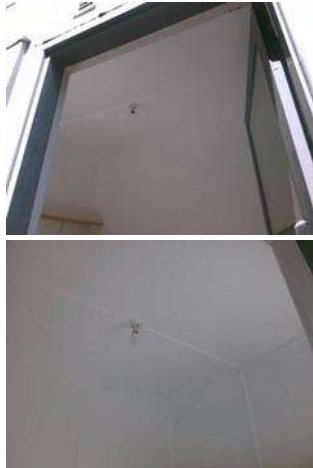
G	Laundry – 2 adjoining laundry room ceilings	<p>Ceiling - Sheeting</p> <p>RECOMMENDATION: This item is a reasonable condition and if it is not disturbed there is little risk. No immediate works are required on this item.</p>	NF	N	L	S	33770-5	C, CH

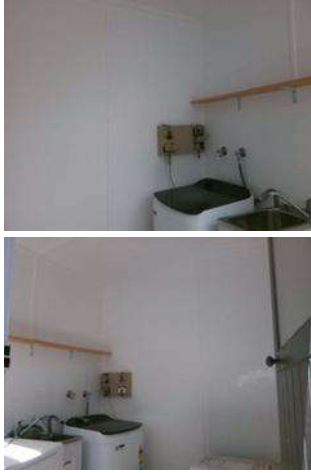
Floor Level	Room	Material at Location	Type	Condition	Priority	S / R / AA	Sample No.	Result	Photo No
G	Laundry – 2 adjoining laundry room walls	<p>Wall - Sheeting to non-masonry wall/s</p> <p>RECOMMENDATION: This item is a reasonable condition and if it is not disturbed there is little risk. No immediate works are required on this item.</p>	NF	N	L	S	33770-6	C, CH

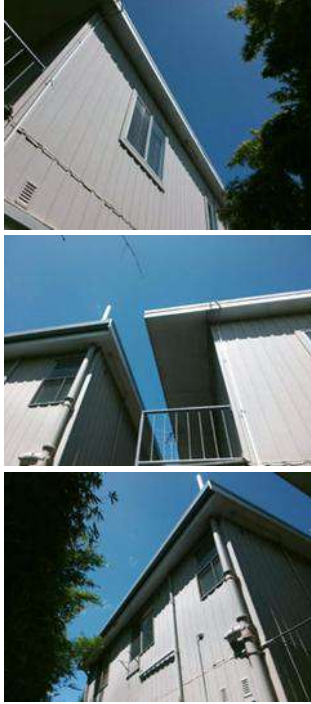
Roof	External-All soffits and balcony ceilings	<p>Soffit/Eves - Sheeting</p> <p>RECOMMENDATION: This item is a reasonable condition and if it is not disturbed there is little risk. No immediate works are required on this item.</p>	NF	P	M	S	33770-3	C, CH

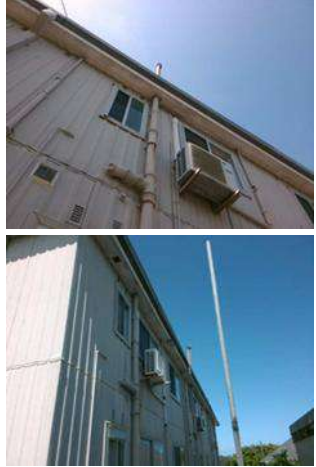
Floor Level	Room	Material at Location	Type	Condition	Priority	S / R / AA	Sample No.	Result	Photo No
Roof	External – Left hand side vents x 3	<p>Vent Pipe - Sheeting</p> <p>RECOMMENDATION: This item is a reasonable condition and if it is not disturbed there is little risk. No immediate works are required on this item.</p>	NF	N	L	AA	AA	AA

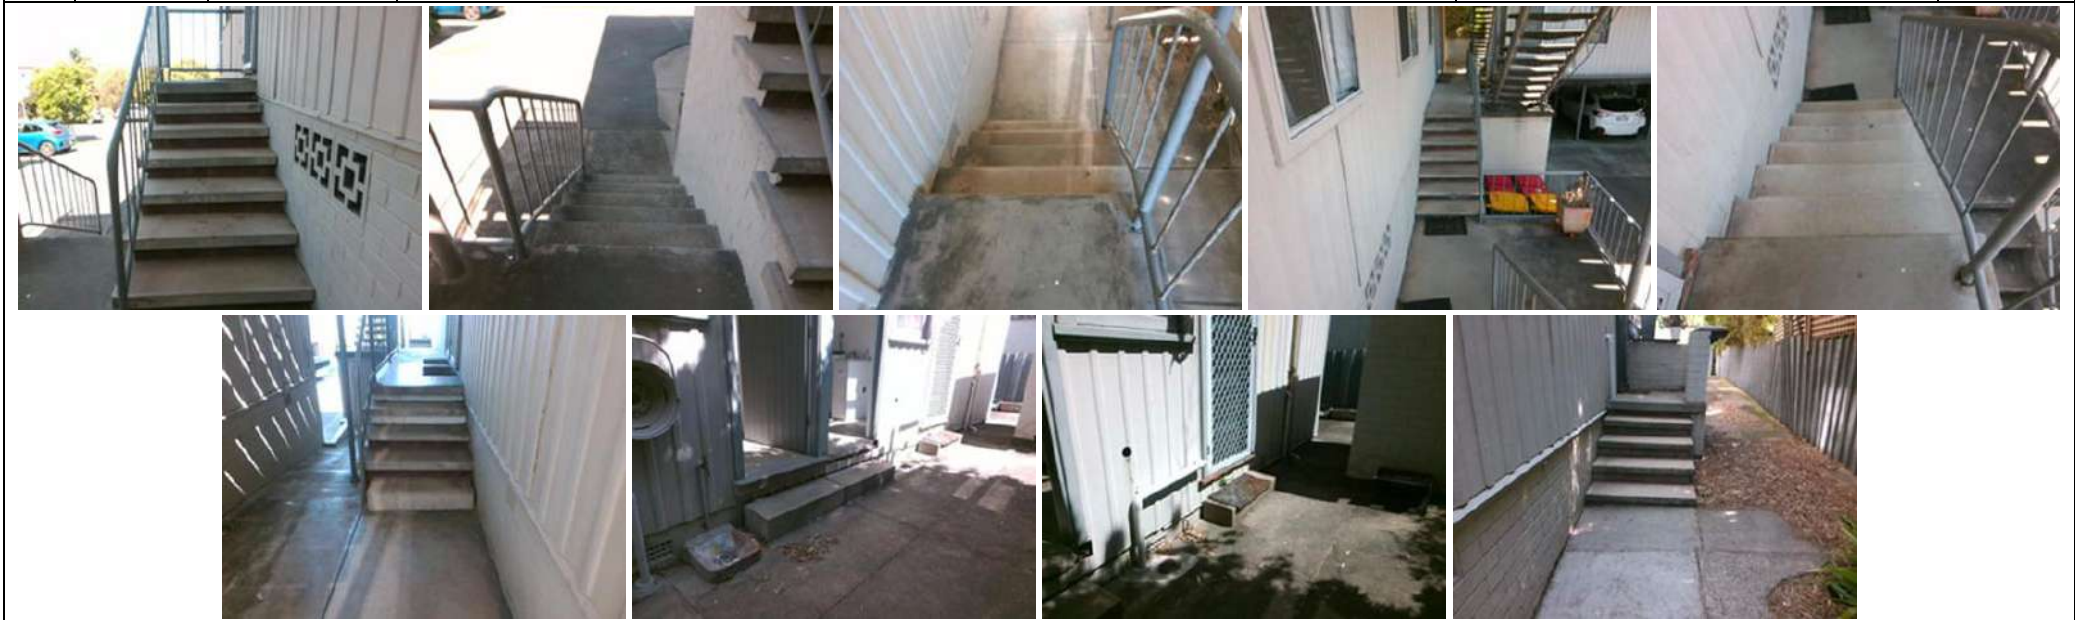
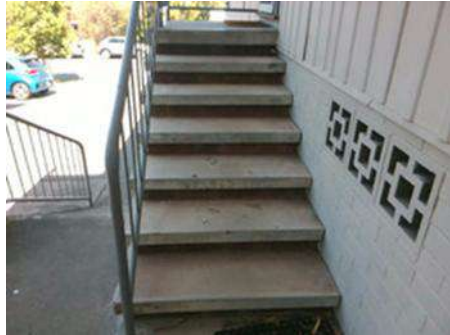
No.	Floor Level / Unit No	Location	Hazard and Recommendation	Photo	Risk Rating
4	G	Stairs	<p>Hazard Identified: All steps and/or landings ARE NOT easily identifiable and DID NOT have adequate non-slip finish or non-slip strip near each nosing installed.</p> <p>Stairs can be hazardous. Under the current National Construction Code and the previous Building Code of Australia in force since 1990, all stairs are required to have non-slip finish on treads and landings or a non-slip strip near the edges of each nosing/landing. Furthermore, for safety reasons to allow persons to identify the edge of each step, the nosing should be easily identifiable from surrounding stairs and floors. Without being identifiable, the risk of injury to a person using the stairs is heightened and the Body Corporate may face a liability claim from any injured party. - This is a Slip Trip Fall hazard.</p> <p>Recommendation: It is specifically recommended that all stairs and landings, including those at the entrance to individual units, be fitted with a contrasting, bright coloured non-slip nosing.</p>

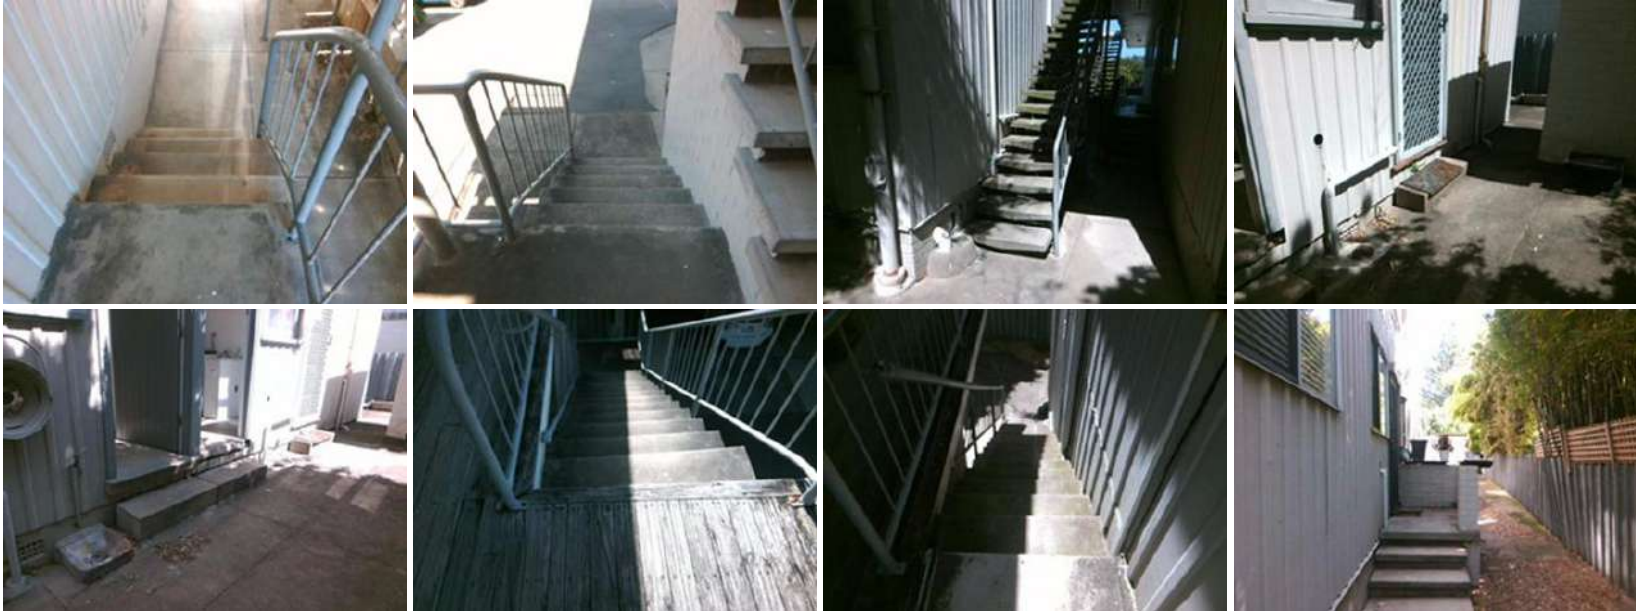
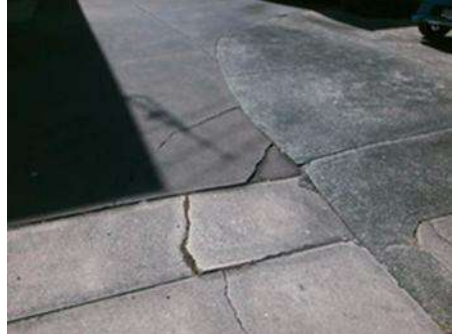
No.	Floor Level / Unit No	Location	Hazard and Recommendation	Photo	Risk Rating
5	G	Driveway / Car parking	<p>Hazard Identified: Cracking to the driveway has caused raised edges. - This is a Slip Trip Fall hazard.</p> <p>Recommendation: It is recommended to apply flexible sealant to the cracks and ramp the sealant to form a sloping surface between the both edges OR grind the raised edges level to stop the cracks being a trip hazard.</p>

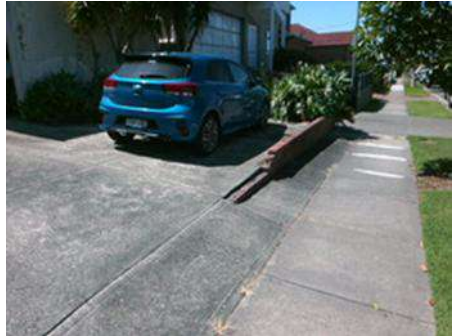
No.	Floor Level / Unit No	Location	Hazard and Recommendation	Photo	Risk Rating
7	G	Driveway / Car parking	<p>Hazard Identified: Raised edge to floor material. - This is a Slip Trip Fall hazard.</p> <p>Recommendation: A 100mm wide line is painted in yellow or reflective white paint around all edges to make the raised edge distinguishable.</p>

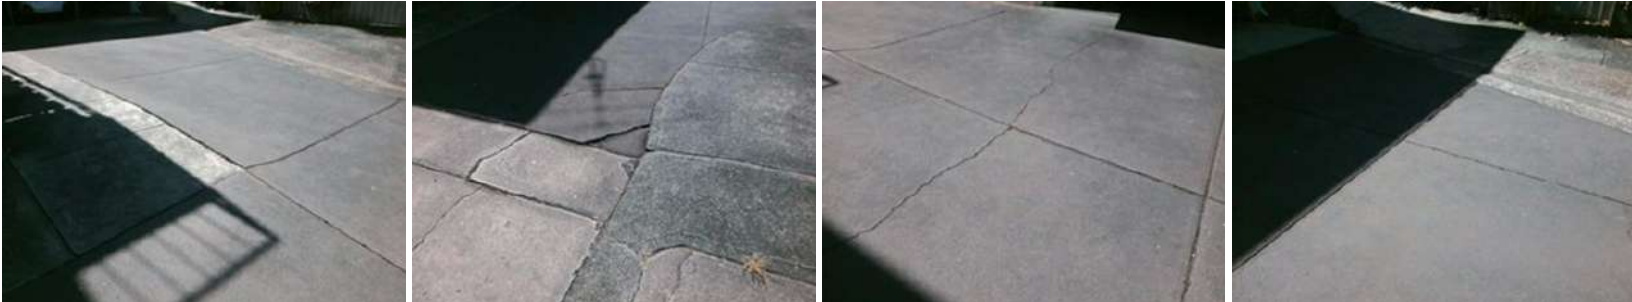
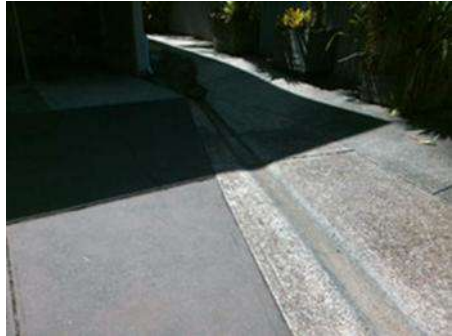
No.	Floor Level / Unit No	Location	Hazard and Recommendation	Photo	Risk Rating
8	G	Driveway / Car parking	<p>Hazard Identified: The floor surface is uneven. - This is a Slip Trip Fall hazard.</p> <p>Recommendation: Level out the floor area to remove the trip hazard.</p>

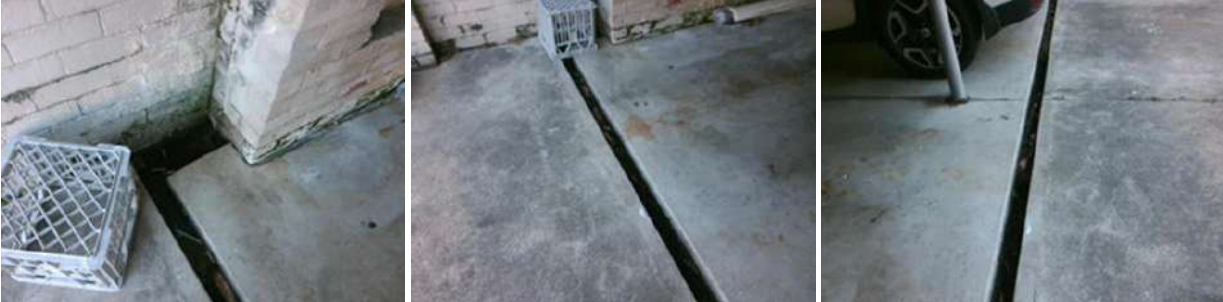
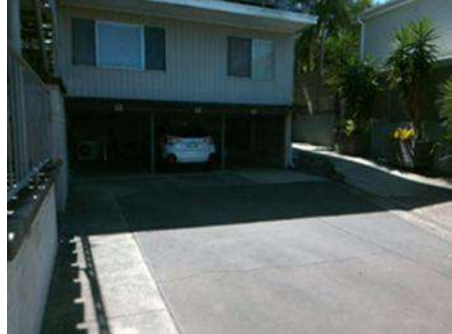
9	G	Driveway / Car parking	<p>Hazard Identified: Underground car park does not have maximum height sign installed. - This is a physical injury and vehicle damage hazard.</p> <p>Recommendation: Install maximum height sign to the entrance to the carparking areas.</p>

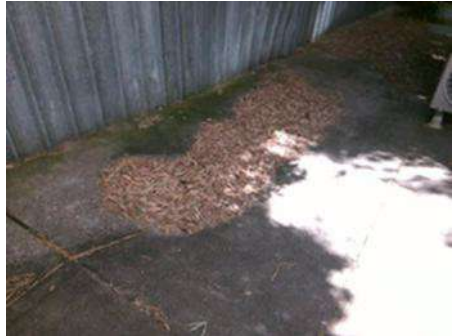
No.	Floor Level / Unit No	Location	Hazard and Recommendation	Photo	Risk Rating
10	G	Gardens	<p>Hazard Identified: There is a build-up of dry vegetation / debris onsite. - This is Public Safety - Traffic/pedestrian hazard.</p> <p>Recommendation: Remove all dry leaves, branches and other debris on a regular basis from all gardens and other areas.</p>

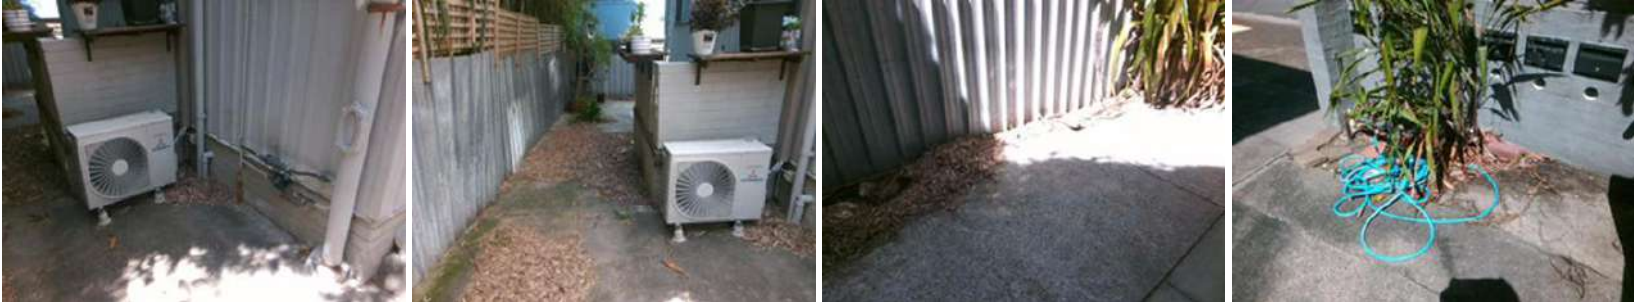
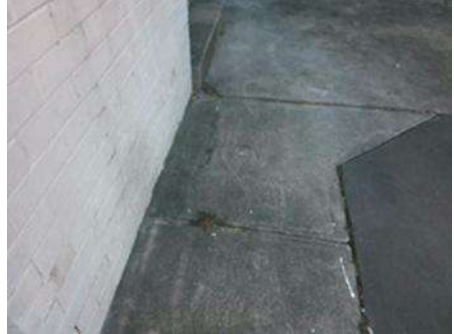
11	G	Pathways	<p>Hazard Identified: Cracking to pathways have caused raised edges. - This is a Slip Trip Fall hazard.</p> <p>Recommendation: Apply flexible sealant to the cracks and ramp the sealant to form a sloping surface between the both edges OR grind the raised edges level to stop the cracks being a trip hazard.</p>

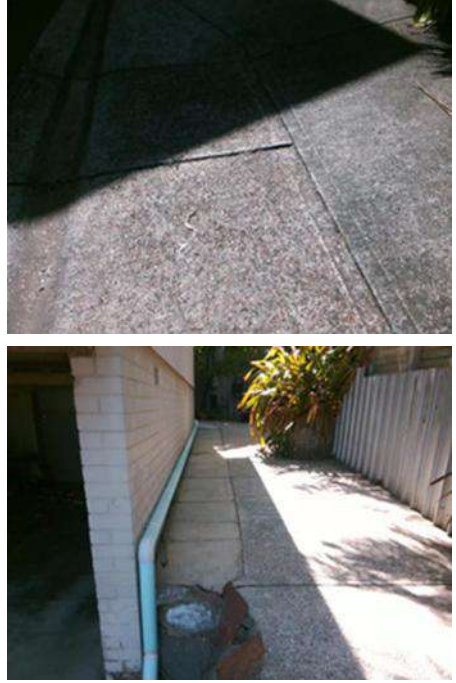
No.	Floor Level / Unit No	Location	Hazard and Recommendation	Photo	Risk Rating
12	G	Pathways	<p>Hazard Identified: The pathway is damaged. - This is a Slip Trip Fall hazard.</p> <p>Recommendation: Repair the damaged areas to all pathways.</p>

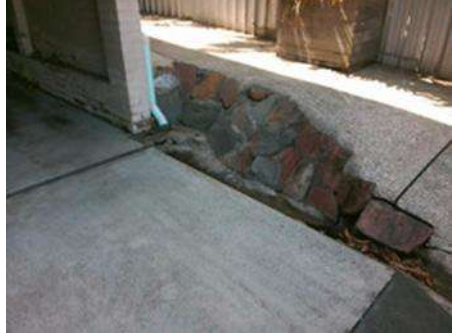
No.	Floor Level / Unit No	Location	Hazard and Recommendation	Photo	Risk Rating
13	G	Pathways	<p>Hazard Identified: Drains are not highlighted. - This is a Slip Trip Fall hazard.</p> <p>Recommendation: A 100mm wide line to be painted in yellow or reflective white paint around all edges of all drains and pits.</p> <p>It is also recommended that all stormwater and other drain covers and lids to all pits on site be regularly inspected for structural integrity by a qualified builder/ structural engineer, and replaced, repaired and/or upgraded as required. QBM specifically limit all warranty for the accuracy of this report for the integrity of all access covers and/or lids to pits to the date of the inspection only.</p>

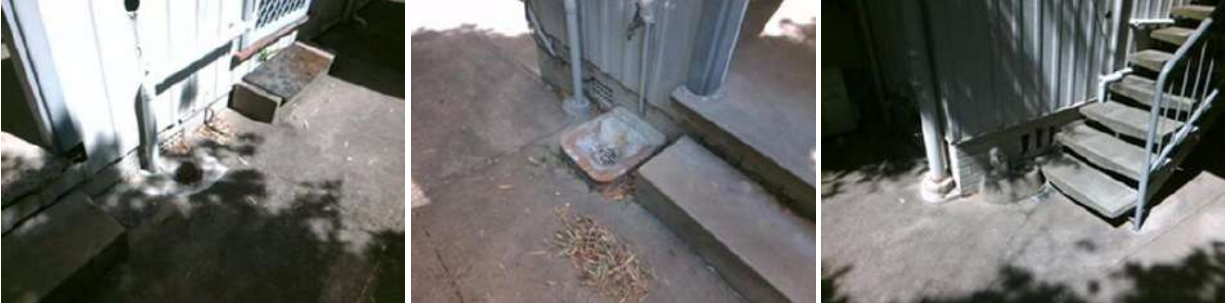
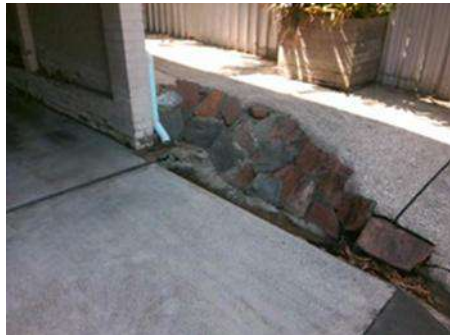
No.	Floor Level / Unit No	Location	Hazard and Recommendation	Photo	Risk Rating
14	G	Pathways	<p>Hazard Identified: Drain is raised above ground level. - This is a Slip Trip Fall hazard.</p> <p>Recommendation: Fill the ground around the drain (where possible) or refit to be ground level. Alternatively, highlight the edges with a 100mm wide line in yellow or reflective white paint.</p> <p>It is also recommended that all stormwater and other drain covers and lids to all pits on site be regularly inspected for structural integrity by a qualified builder/ structural engineer, and replaced, repaired and/or upgraded as required. QBM specifically limit all warranty for the accuracy of this report for the integrity of all access covers and/or lids to pits to the date of the inspection only.</p>

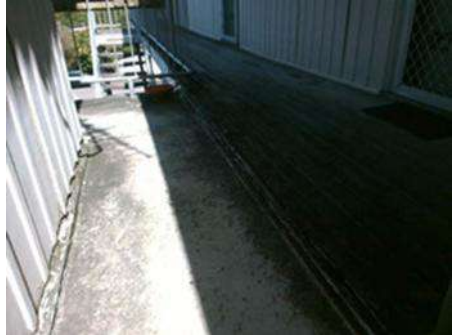
No.	Floor Level / Unit No	Location	Hazard and Recommendation	Photo	Risk Rating
16	G	Pathways	<p>Hazard Identified: Raised edge to floor material. - This is a Slip Trip Fall hazard.</p> <p>Recommendation: A 100mm wide line is painted in yellow or reflective white paint around all edges to make the raised edge distinguishable.</p> <p style="text-align: center;">Images Continued Below</p>

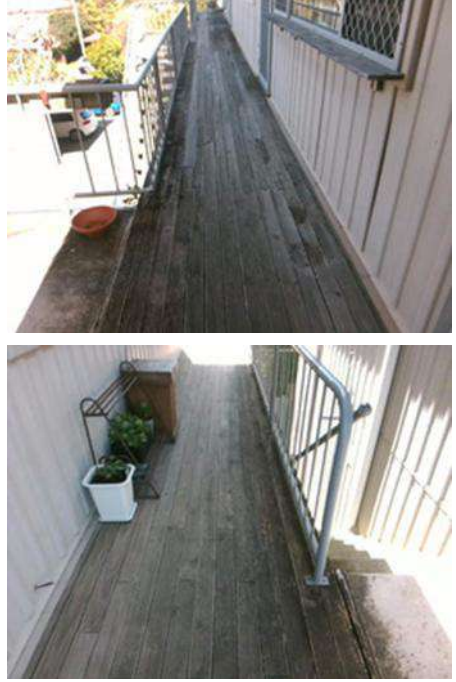
No.	Floor Level / Unit No	Location	Hazard and Recommendation	Photo	Risk Rating
17	G	Pathways	<p>Hazard Identified: The floor surface is uneven. - This is a Slip Trip Fall hazard.</p> <p>Recommendation: Level out the floor area to remove the trip hazard.</p>

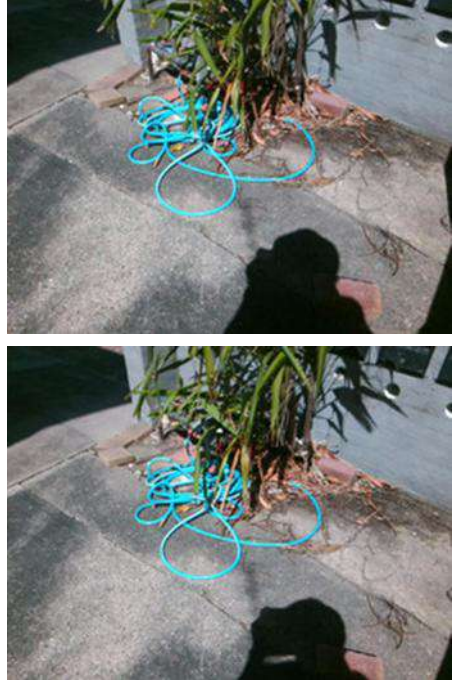
No.	Floor Level / Unit No	Location	Hazard and Recommendation	Photo	Risk Rating
18	G	Site generally	<p>Hazard Identified: Garden hose is not stored safely. - This is a Slip Trip Fall hazard.</p> <p>Recommendation: Install a garden hose hanger to store the hose safely.</p>

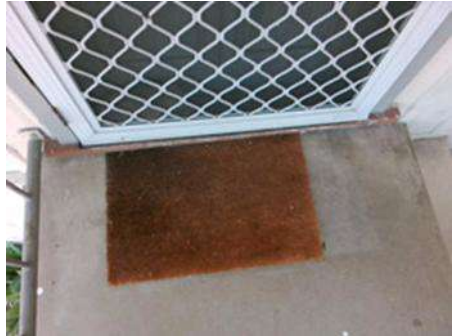
No.	Floor Level / Unit No	Location	Hazard and Recommendation	Photo	Risk Rating
19	G	Internal floors	<p>Hazard Identified: Unsecured floor mat. - This is a Slip Trip Fall hazard.</p> <p>Recommendation: Remove all unsecured floor mats and replace with a low profile non-slip rubber floor mat.</p>

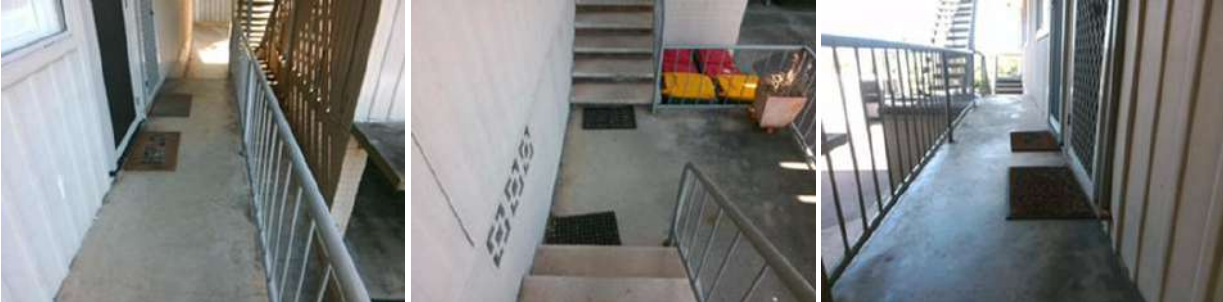
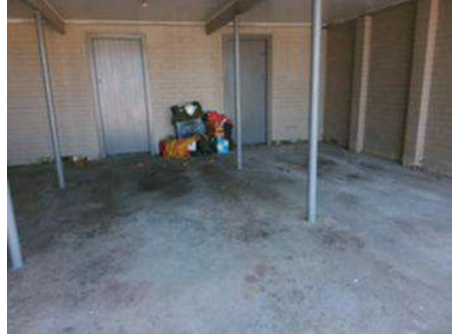
20	G	Common Areas	<p>Hazard Identified: There are stored items within the common areas which can restrict access, cause a slip, trip or fall and can be an accelerant in the event of a fire. - This is Public Safety - Traffic/pedestrian hazard.</p> <p>Recommendation: Remove all stored items from common areas and store safely in a secure location.</p>

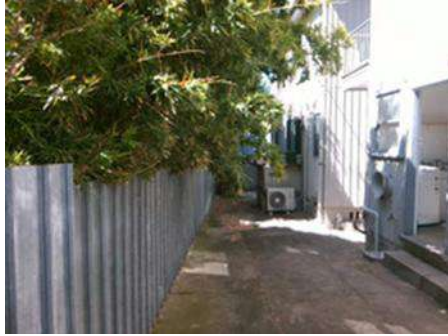
No.	Floor Level / Unit No	Location	Hazard and Recommendation	Photo	Risk Rating
21	G	Pathways	<p>Hazard Identified: There are trees and shrubs overhanging pathways. - This is a Slip Trip Fall hazard.</p> <p>Recommendation: All shrubs and trees are regularly trimmed back from all pathways and driveways.</p>

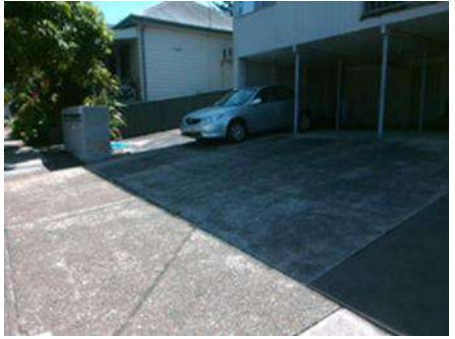
No.	Floor Level / Unit No	Location	Hazard and Recommendation	Photo
22	G	Car parking area	<p>Hazard Identified: At the time of the inspection there are no requirement for additional wheel stops to be installed to the parking bays.</p> <p>Recommendation: It is recommended that regular inspections are conducted, and results documented, to confirm that no additional wheel stops to all parking bays are required, and that all wheel stops are highlight and parking bays are marked with a in yellow or reflective white paint.</p>

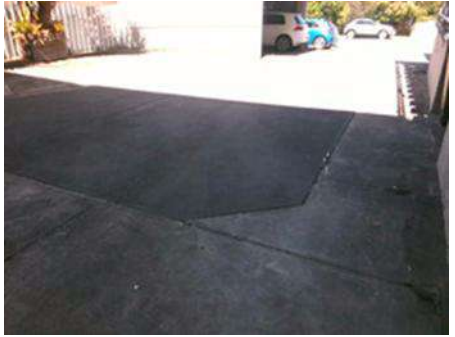
23	G	Driveway	<p>Hazard Identified: There is no evidence of the driveway being damaged at the time of the inspection.</p> <p>Recommendation: It is recommended that regular inspections are conducted, and results documented, to ensure the driveway remains safe.</p>

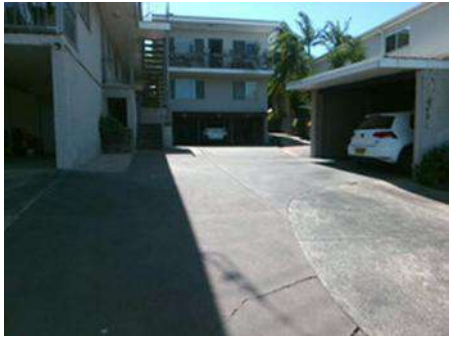
24	G	Driveway / Car parking	<p>Hazard Identified: At the time of the inspection there were no trees or shrubs overhanging the driveway.</p> <p>Recommendation: It is recommended that regular inspections are conducted, and results documented, to ensure that all shrubs and trees are regularly trimmed back.</p>

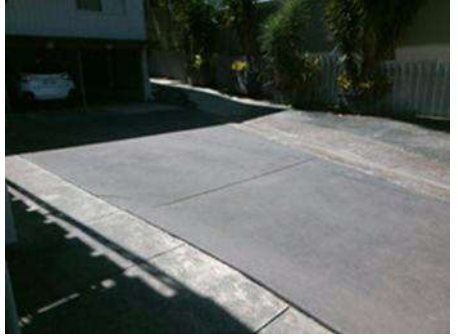
No.	Floor Level / Unit No	Location	Hazard and Recommendation	Photo
25	G	Driveway / Car parking	<p>Hazard Identified: At the time of the inspection the car park did not have oil stains to cause a safety issue.</p> <p>Recommendation: It is recommended that regular inspections are conducted, and results documented, to check for any oil stains on pathways, parking areas and driveways to ensure no safety issues develop.</p>

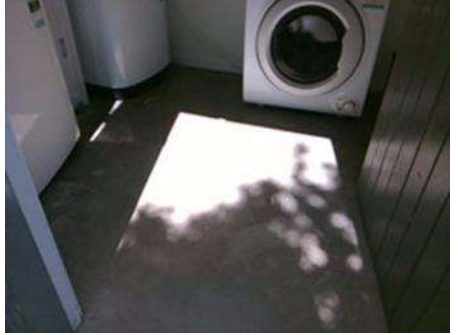
26	G	Internal floors	<p>Hazard Identified: At the time of the inspection there was no raised edge to floor material.</p> <p>Recommendation: It is recommended that regular inspections are conducted, and results documented, to ensure there are no raised edges to floors that may cause a safety issue.</p>

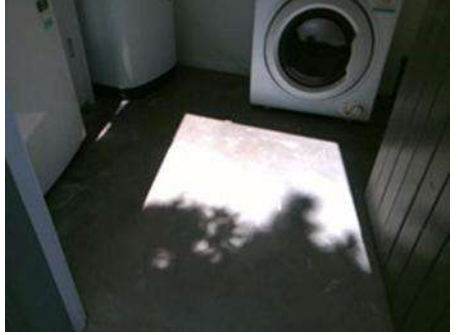
27	G	Internal floors	<p>Hazard Identified: At the time of the inspection the floor surface was not uneven causing a safety issue.</p> <p>Recommendation: It is recommended that regular inspections are conducted, and results documented, to check the evenness of pathways and driveways to ensure no safety issues develop.</p>

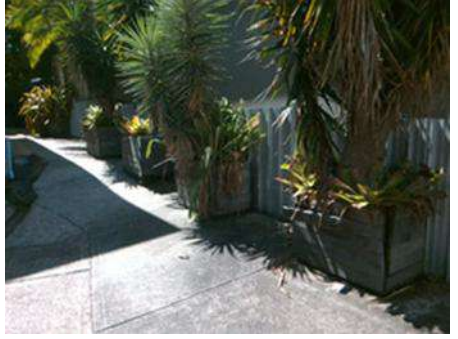
No.	Floor Level / Unit No	Location	Hazard and Recommendation	Photo
28	G	Fence/s	<p>Hazard Identified: At the time of inspection, the fencing was free of significant deterioration or damage that would result in a safety hazard.</p> <p>Recommendation: It is recommended that regular inspections are conducted, and results documented, and carry out necessary maintenance to the fence to ensure it remains free from safety hazards.</p>

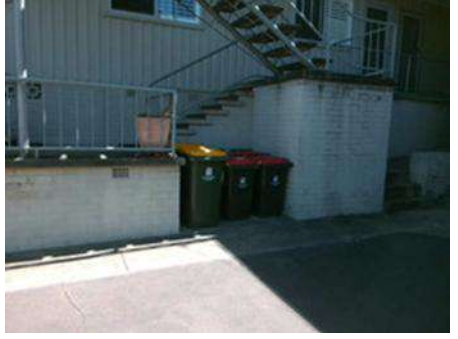
29	G	Rubbish bin enclosure	<p>Hazard Identified: All bins were stored in appropriate/designated areas with no hazards were apparent.</p> <p>Recommendation: It is recommended that regular inspections are conducted, and results documented, to ensure that all occupiers are informed of where the rubbish bins are to be securely stored.</p>

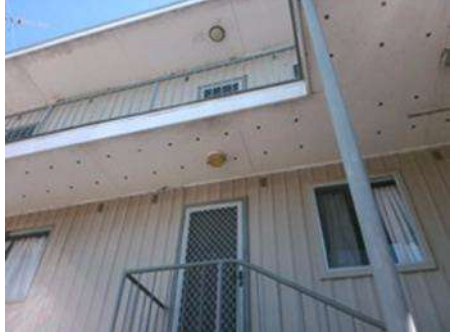
30	G	Site generally	<p>Hazard Identified: The lighting level in common areas appears to be sufficient to provide a safe well-lit environment at night.</p> <p>Recommendation: It is recommended that regular testing be conducted at night to ensure that all security lights are working correctly. No testing of lighting level has been conducted as the inspection was conducted during daylight hours. Professional lighting testing should be undertaken on a regular basis to ensure lighting meets Australian Standards.</p>

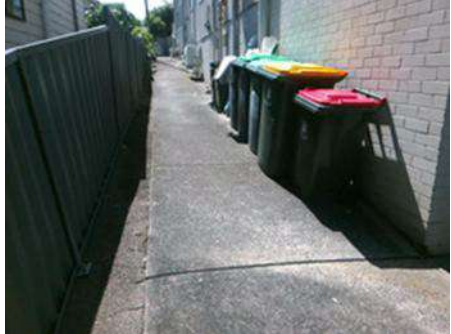
No.	Floor Level / Unit No	Location	Hazard and Recommendation	Photo
31	G	Site generally	<p>Hazard Identified: At the time of the inspection tree roots were not raised above ground level causing a safety issue.</p> <p>Recommendation: It is recommended that regular inspections are conducted, and results documented, to ensure that as tree grow, no roots are exposed above ground level that will cause a safety issue.</p>

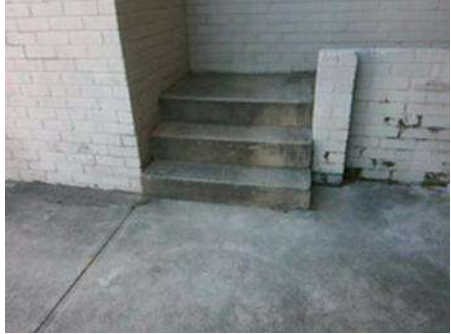
32	G	Stairs	<p>Hazard Identified: At the time of the inspection all steps seemed to be even.</p> <p>Recommendation: It is recommended that regular inspections are conducted, and results documented, to ensure all steps are level and not moved due to deterioration or movement of the surrounding ground.</p>

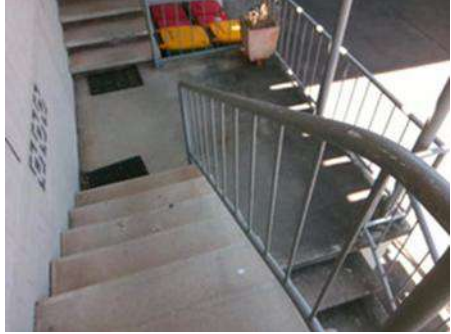
33	G	Stairs / Barriers	<p>Hazard Identified: The Barriers (handrails / balustrade) are adequate and not damaged.</p> <p>Recommendation: It is recommended that regular inspections are conducted, and results documented, to ensure all handrails to stairs are not damaged or deteriorated.</p> <p>NOTE: This report does not assess if the barriers are compliant to Australian Standards. Nor has any structural testing been undertaken. If the building was constructed before 1990, then it is likely that the barriers do not comply to current standards. An assessment should be undertaken of all Barriers, balustrades and handrails to identify if they meet the current Australian Standards. Also, regular inspections (at least 6 monthly) should be undertaken to confirm their structural integrity as all materials deteriorate over time.</p>

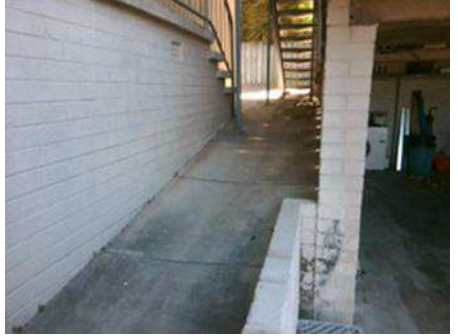
No.	Floor Level / Unit No	Location	Hazard and Recommendation	Photo
34	G	Driveway to Carparking	<p>Hazard Identified: The ramp is considered to NOT be too steep or too slippery to be safe for pedestrian use.</p> <p>Recommendation: The ramp slope seems ok for pedestrian use at present. The tractions should be tested on an on-going basis to ensure it does not become slippery over time.</p>

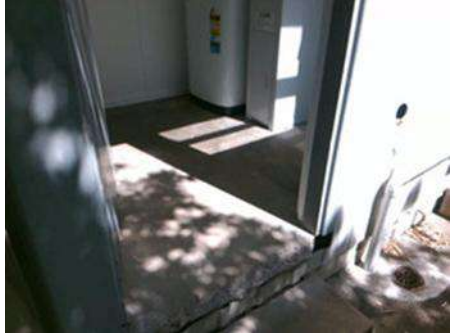
35	G	Internal floors	<p>Hazard Identified: At the time of the inspection the floors were not slippery when walking upon the floor with standard work boots in wet weather or where there was a liquid spill.. This is based on the conditions of the floor surfaces at the date and time of the inspection only, and the fact that the floors were wet.</p> <p>However, all floor surfaces may become slippery when wet resulting in a hazard to persons using the area, which may result in a fall and possible injury. This then would result in the Owners/ Managers being open to legal action from the injured party. No mechanical slip testing has been conducted during this visual inspection.</p> <p>Recommendation: It is recommended that regular inspections are conducted, and results documented, to ensure all floor continue to remain non slippery, which could cause a safety issue.</p>

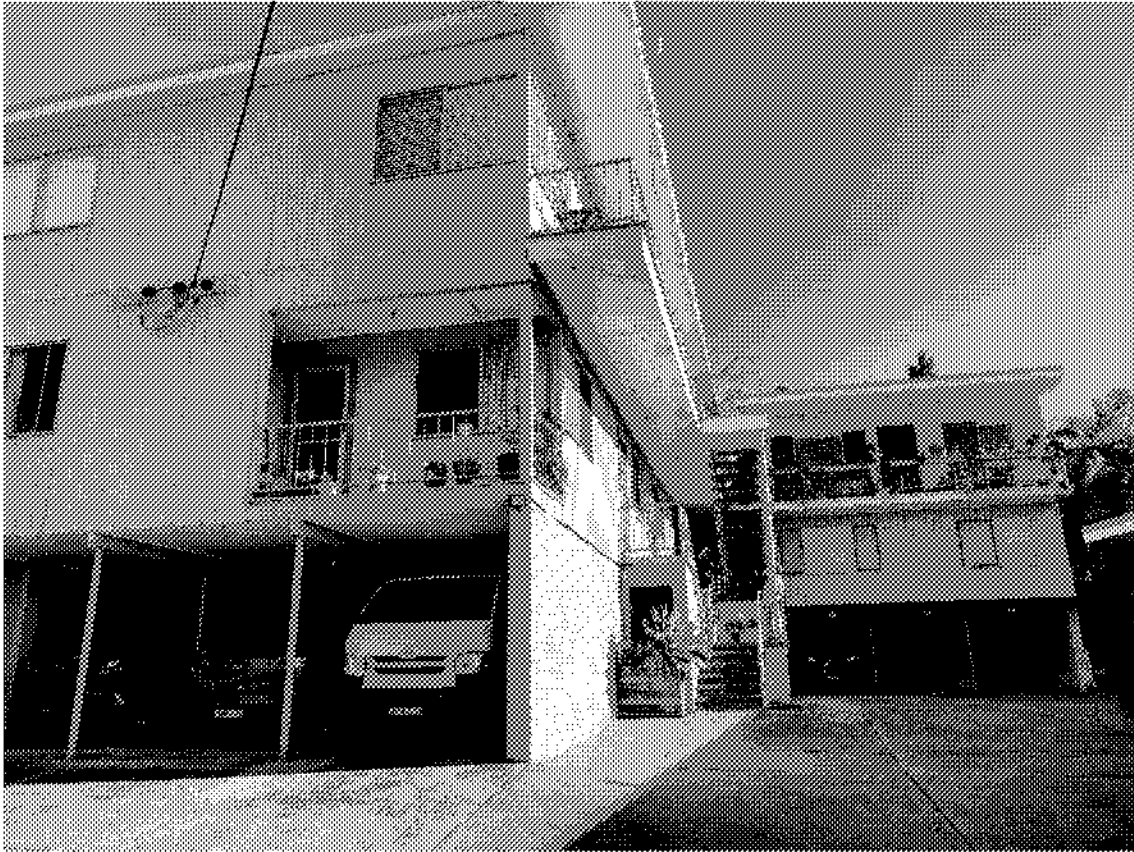
Figure 1 - Site as viewed from Gosford Road

The structure appears 40 years or more in age. The history of the flooring and cladding of the walkway is unknown, but likely to have been changed over time.

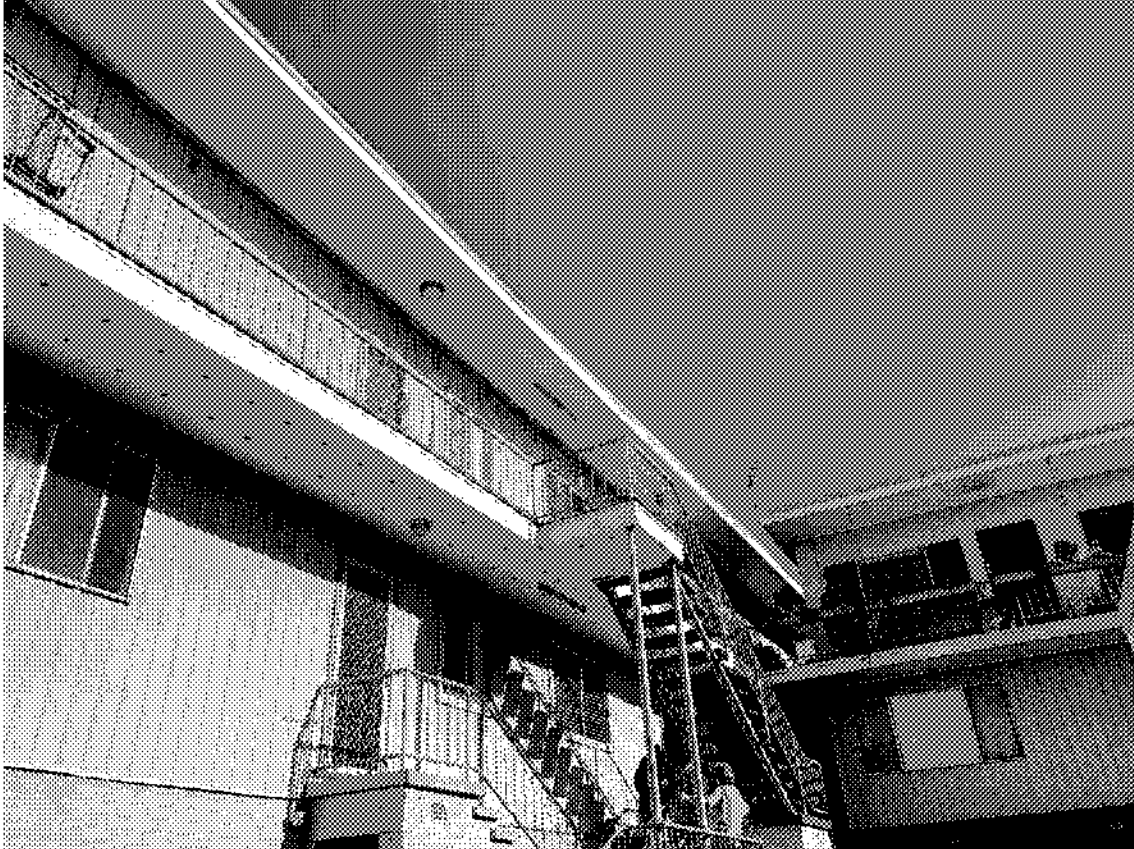
Figure 2 - Upper walkway arrangement as viewed from carpark

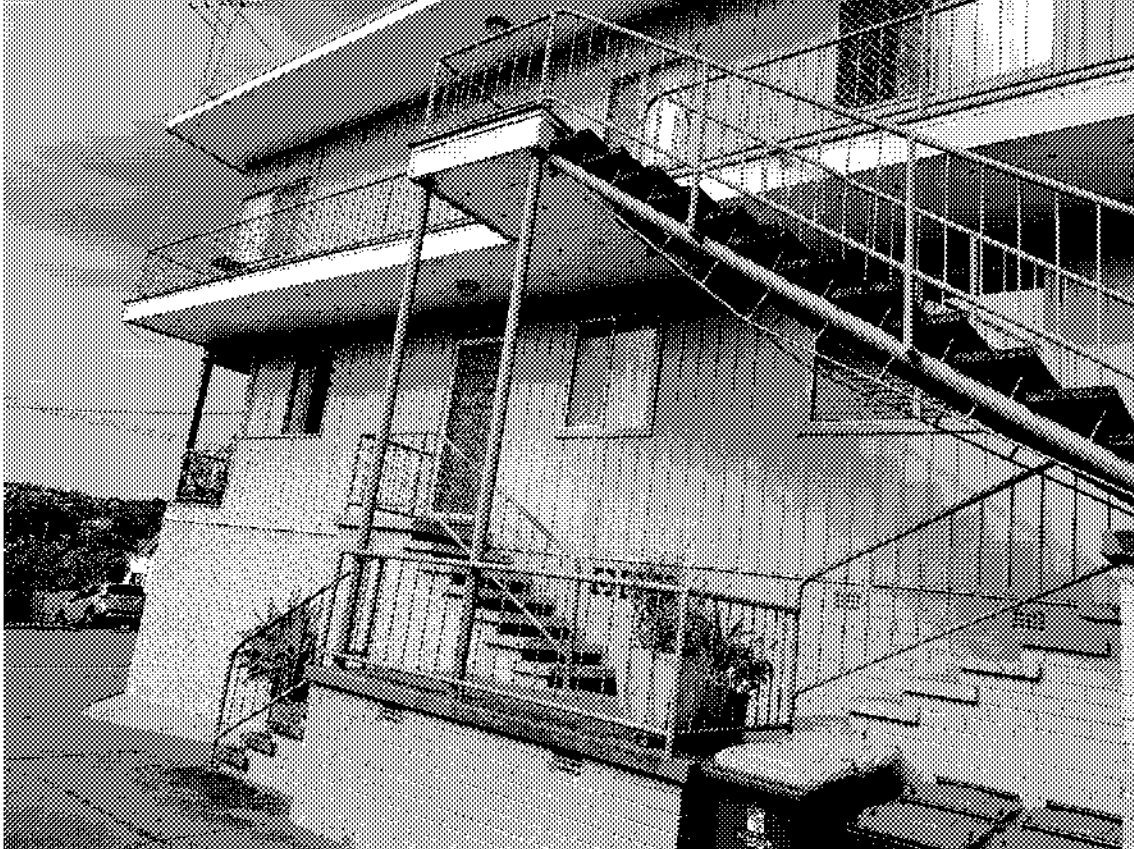
Figure 3 - Front stair arrangement

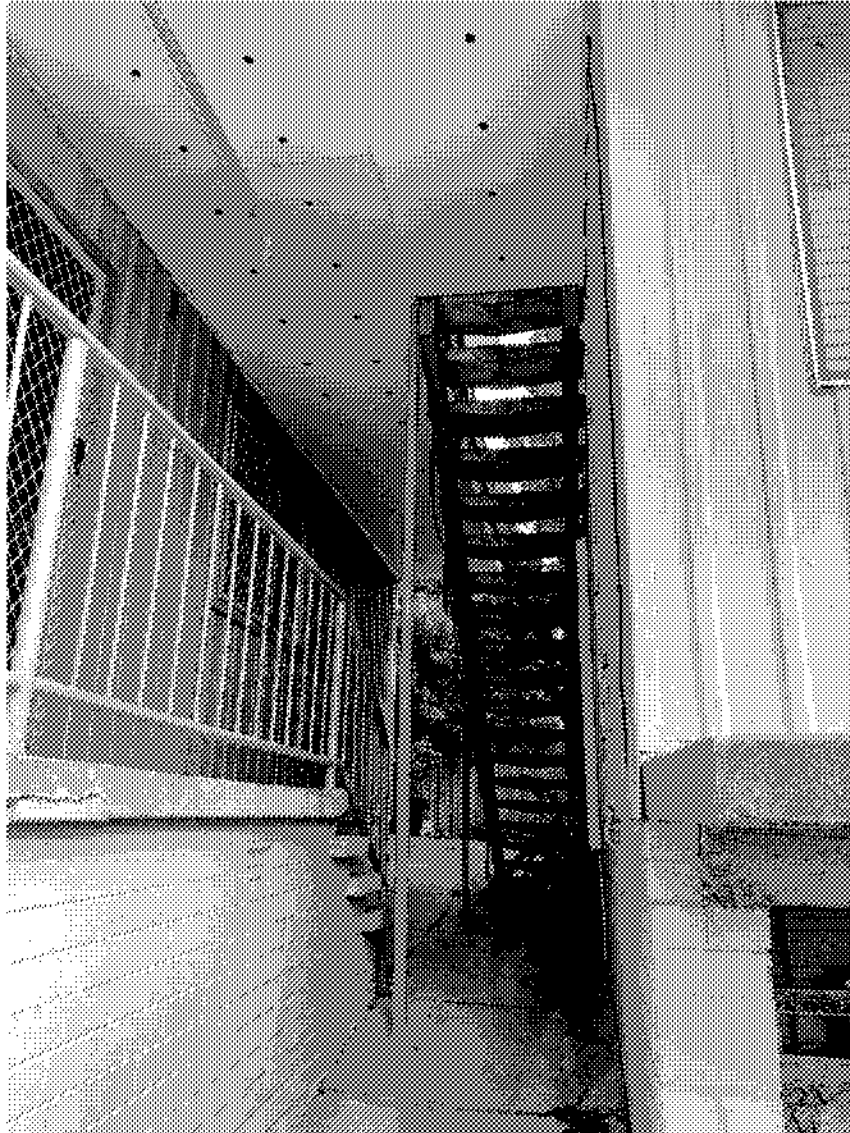
Figure 4 - Rear stair arrangement

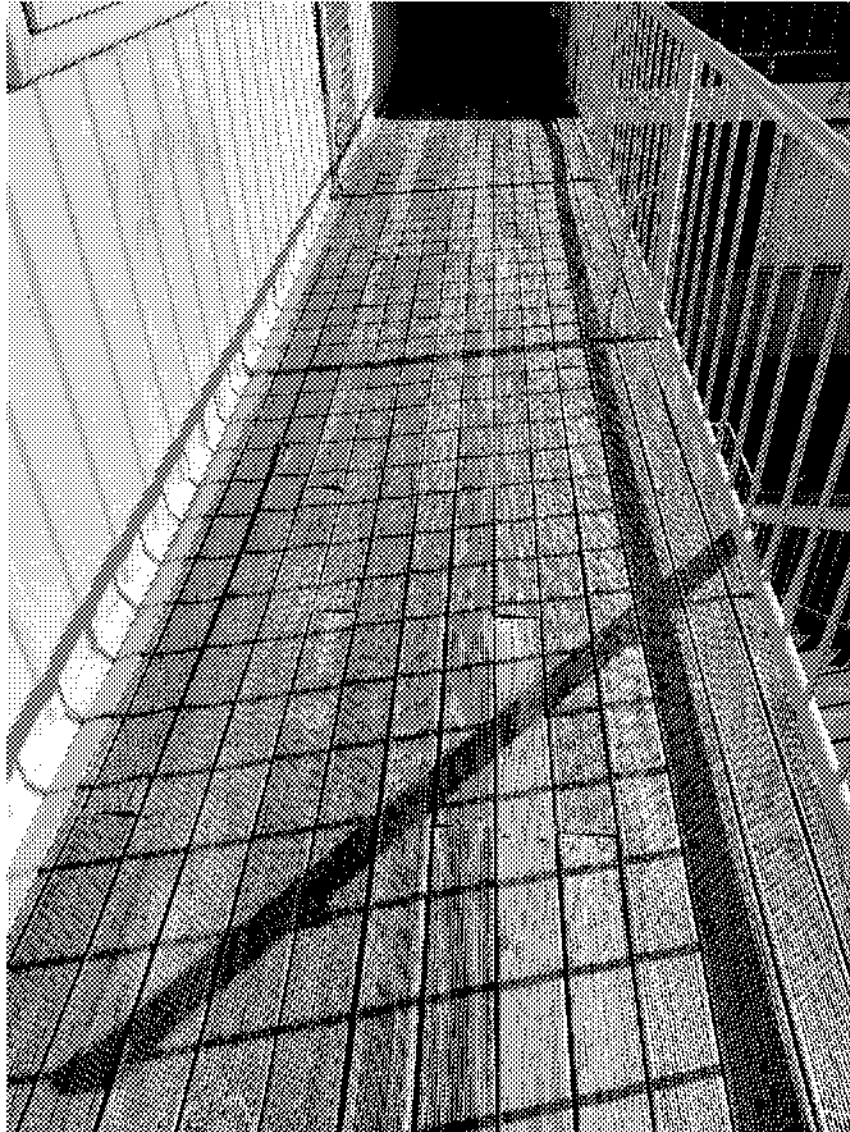
Figure 5 - Upper walkway surface adjacent to front stair
