# Independent Builders Report

Total Home Inspection Services Porirua City Ltd

Mon 18 May 2026

## **34 Clunie Ave, Raumati South, Paraparaumu, 5032, New Zealand**

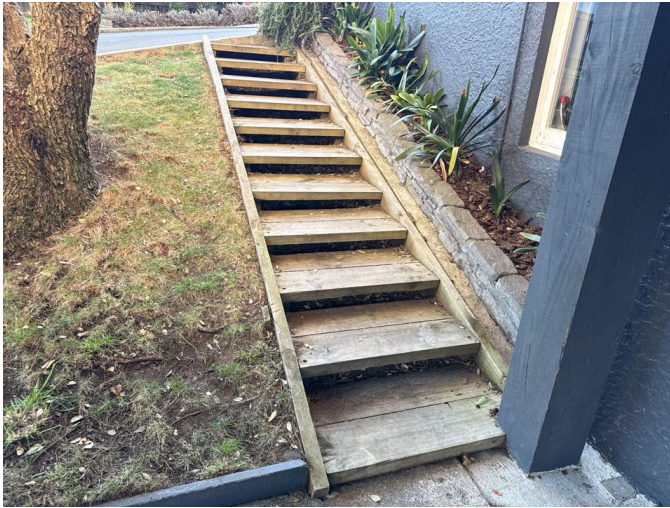
The timber stairs are secure and functional

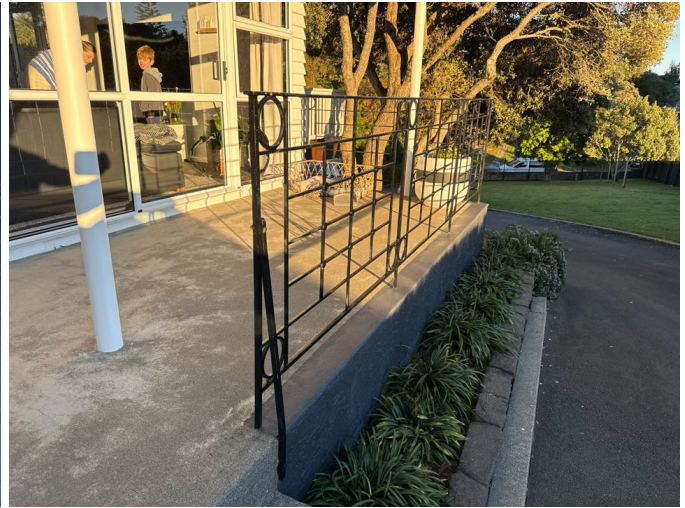
The steel balustrade is secure

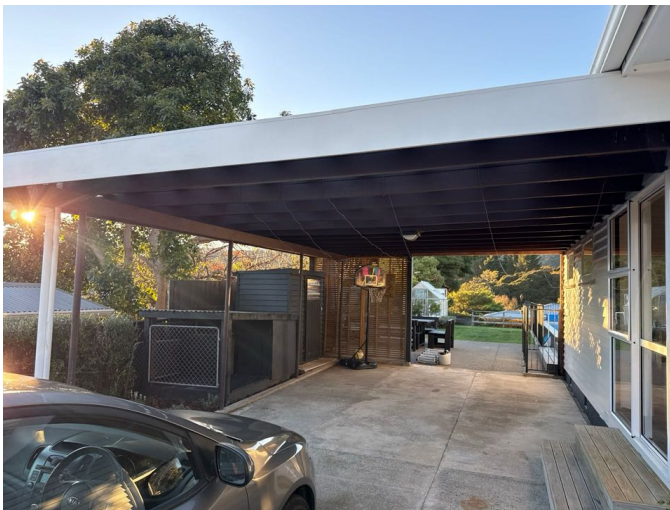
The steel and timber carport structure is showing no evidence of imminent structural issues

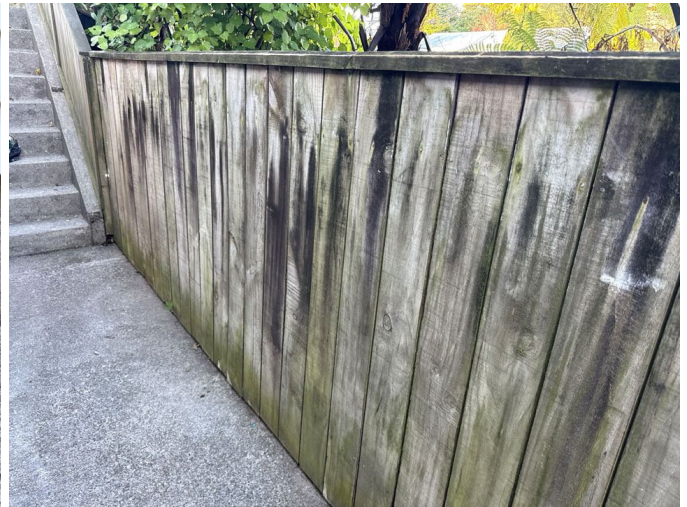
The perimeter fencing is generally solid and intact.

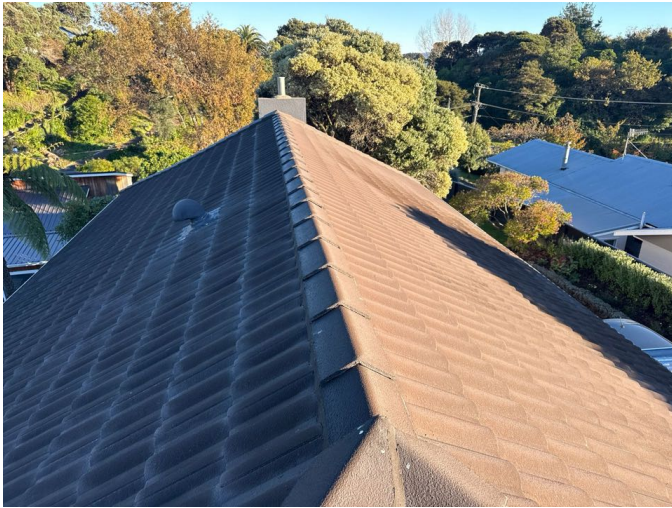
The concrete tile roof has a good overall appearance

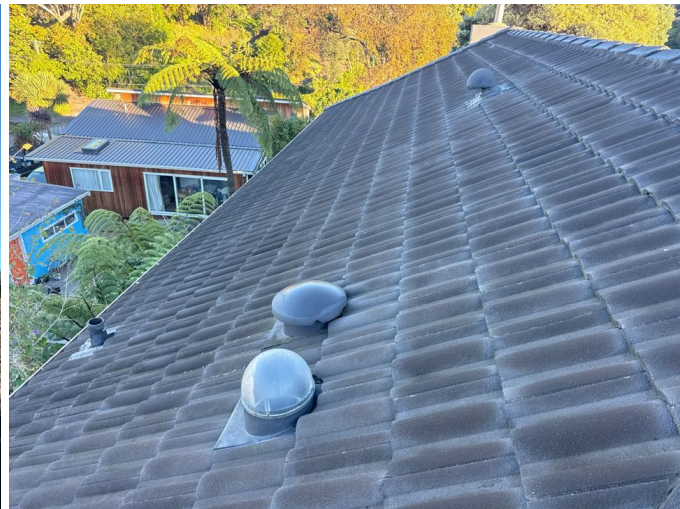
The roof penetrations were effectively sealed at the time of the inspection

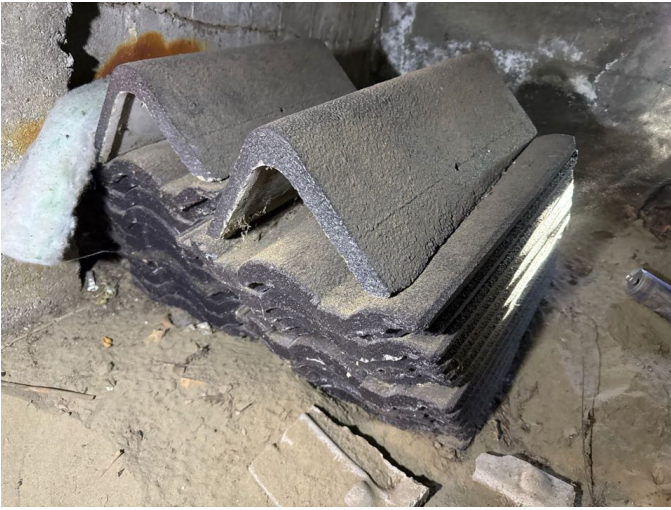
Spare roof tiles stored in the sub floor for future maintenance

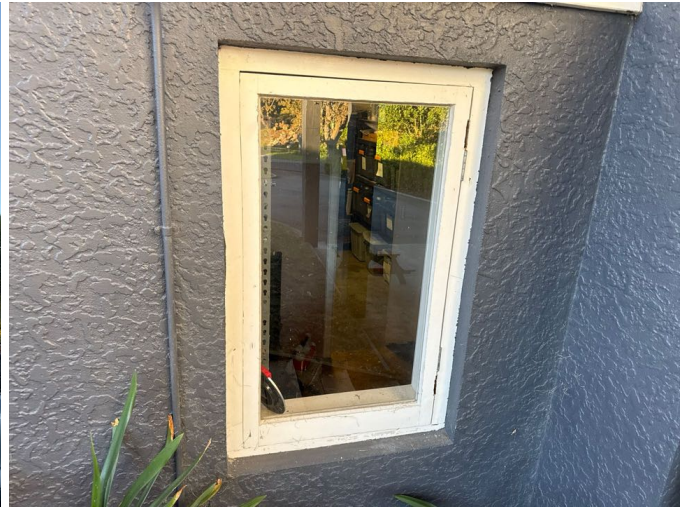
Windows rebated into the concrete foundation walls are effectively sealed

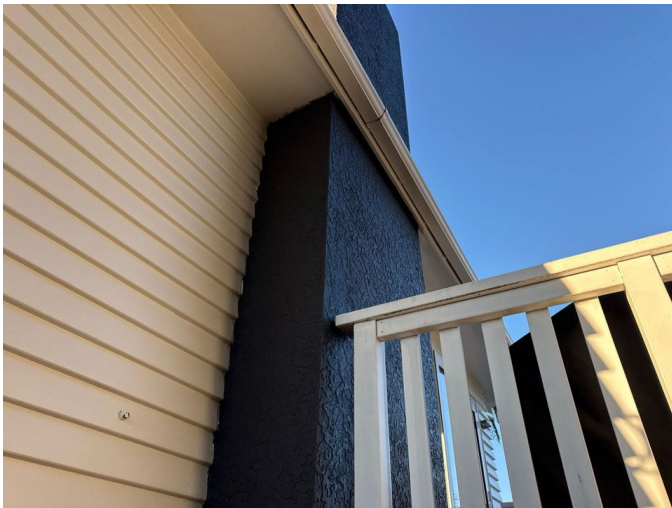
There was no evidence of damage or movement to the concrete chimney

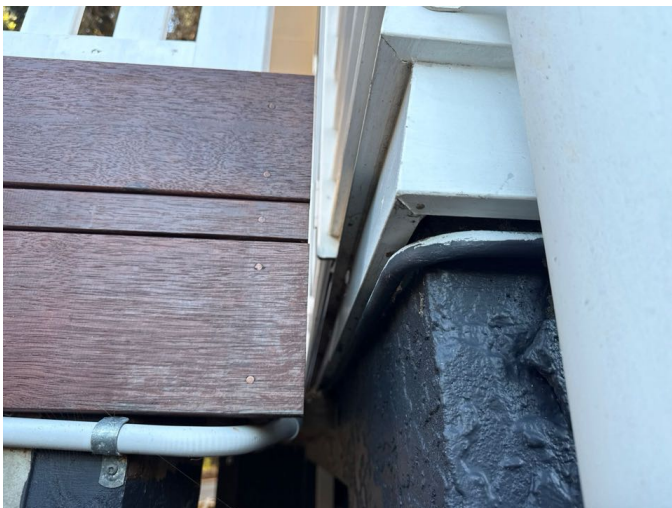
Good clearance between the deck and the cladding which will allow water to drain away.

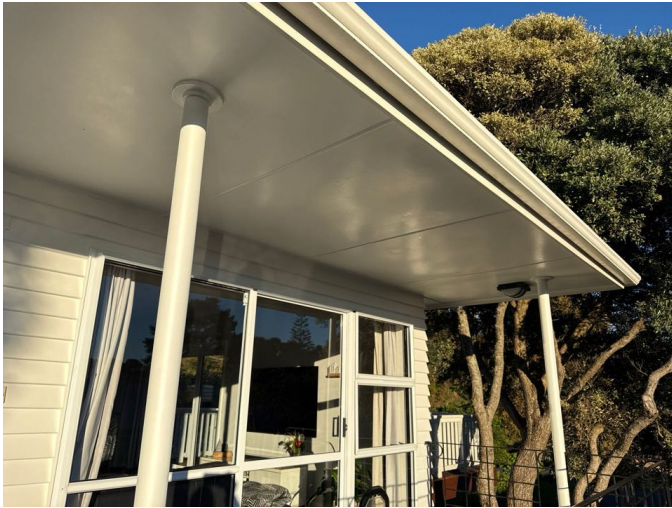
The steel roof supports are solid and secure

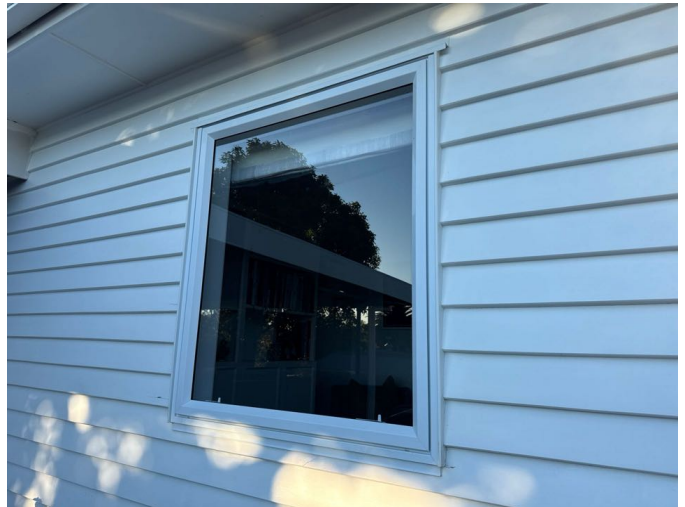
The typical single glazed aluminium window detail consists of head and sill flashings and timber scribes.

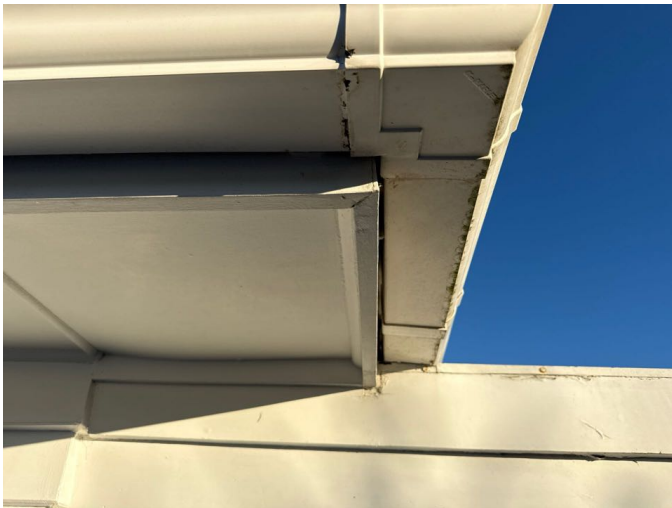
Good paint quality to the timber fascia and fibre cement soffit linings

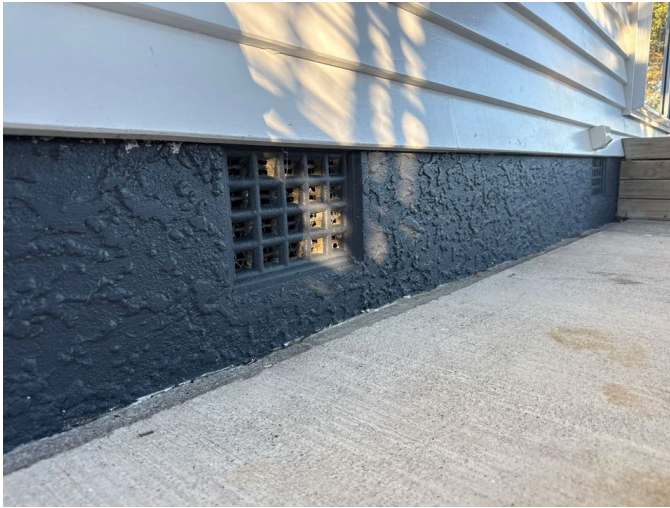
The concrete ring foundation is in a typical condition for the age. No sign of cracking or significant stress.

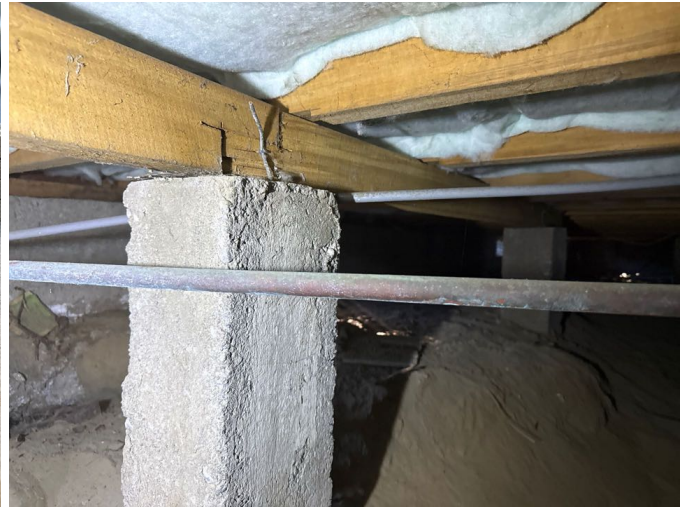
The concrete piles are solid at the time of inspection. Galvanised wire connects the bearers to the piles and anchors the structure to the ground.

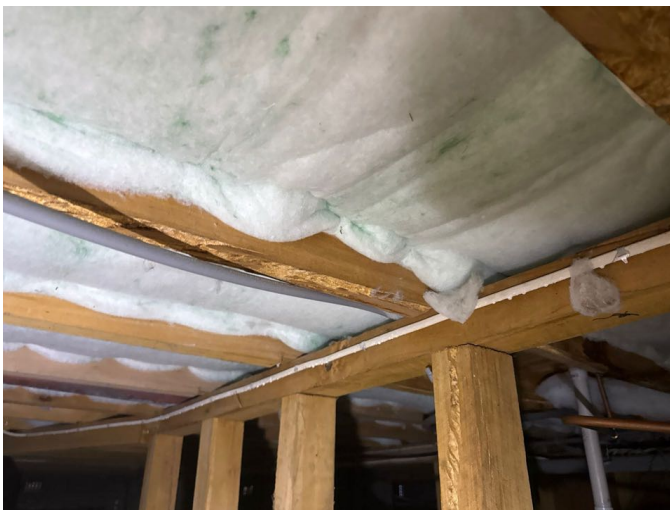
Polyester insulation is installed in the sub floor. There is no labelling present to indicate the R-Value of the material.

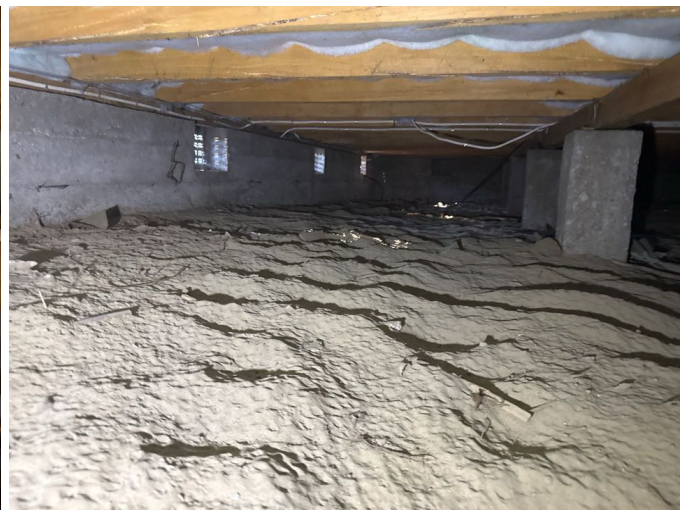
There was no evidence of significant water runoff to the sub floor

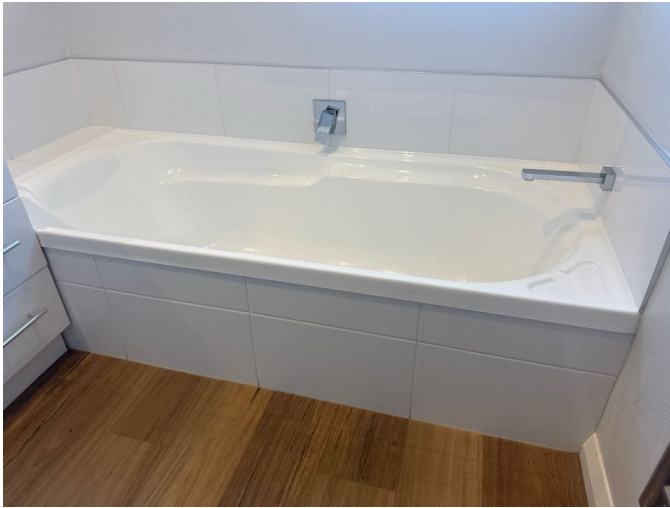
The perimeter of the bath is well sealed. The tap is functioning well.

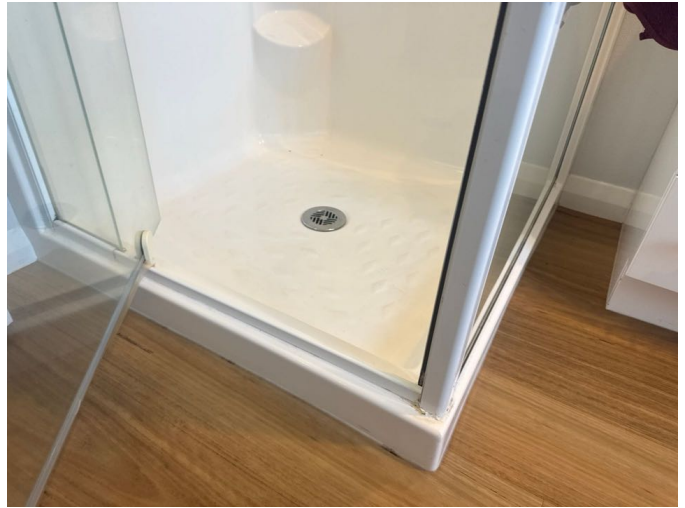
The base of the shower is well sealed. There was no evidence of damage to the shower base at the time of the inspection.

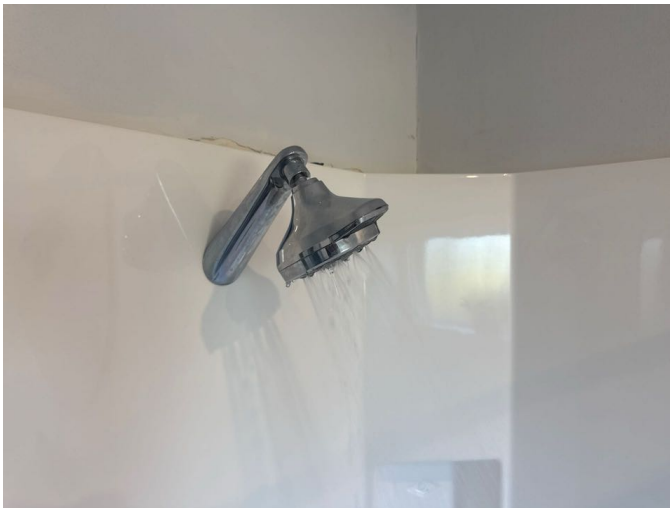
Good water pressure noted. There is some early stage paint deterioration around the top of the wall above the shower frame which will require attention in the near future.

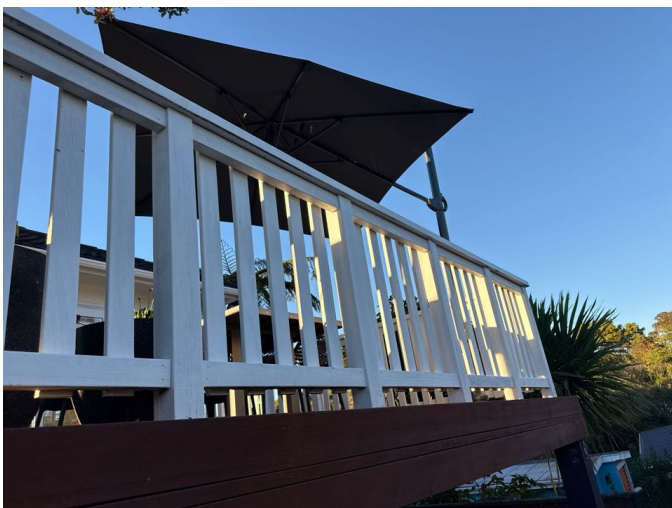
The balustrade is solid and connected sufficiently at the base

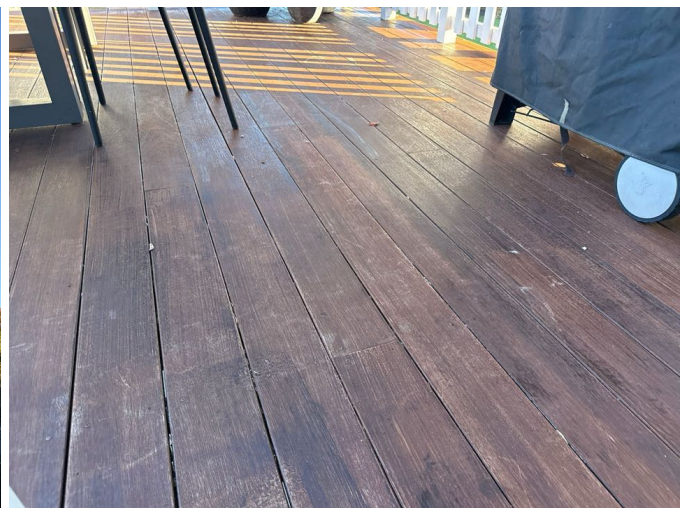
The timber decking is in good condition

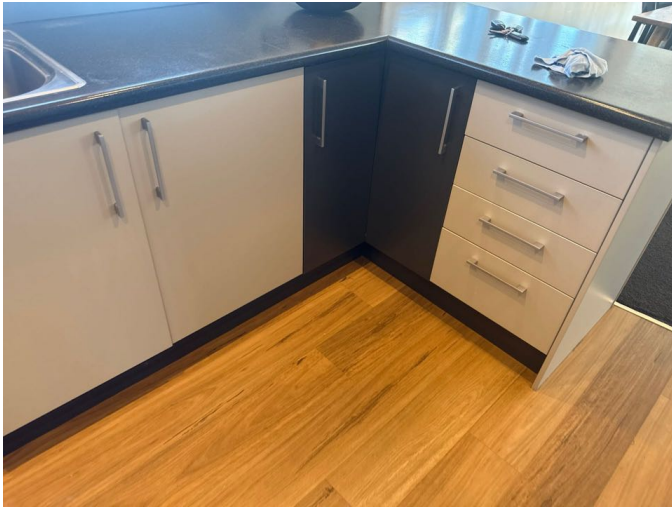
The kitchen cabinetry and vinyl floor are in good condition

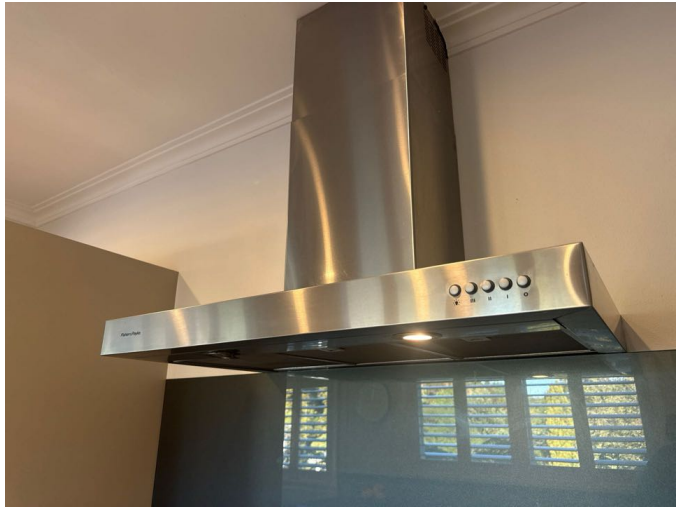
The range hood extraction unit is functioning

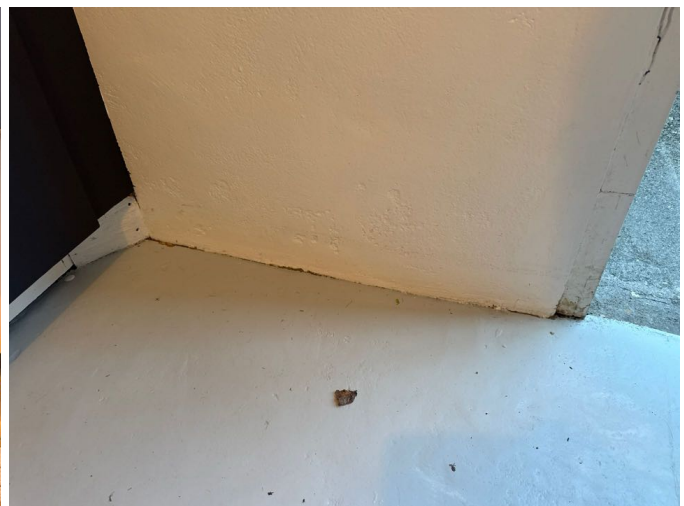
Concrete walls and floor noted. These areas could not be moisture scanned. The painted interior is tidy.

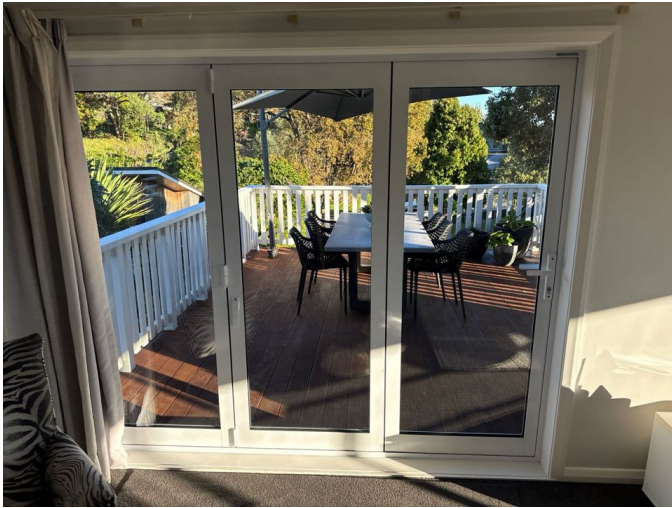
Doors and windows are functional

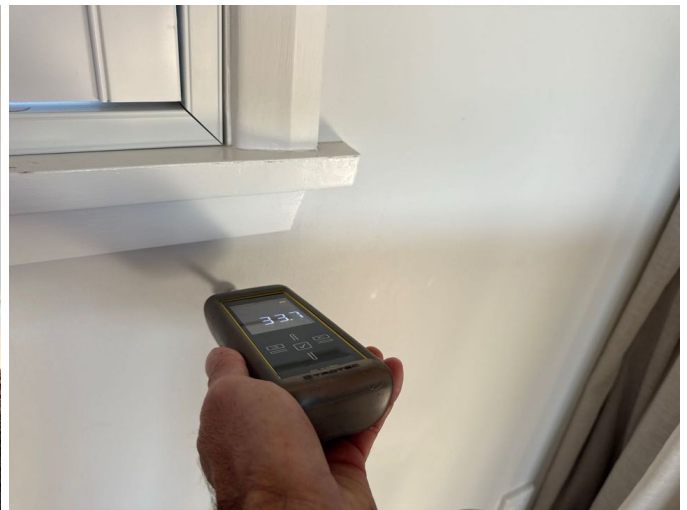
Moisture levels to the external walls were within the normal range at the time of inspection

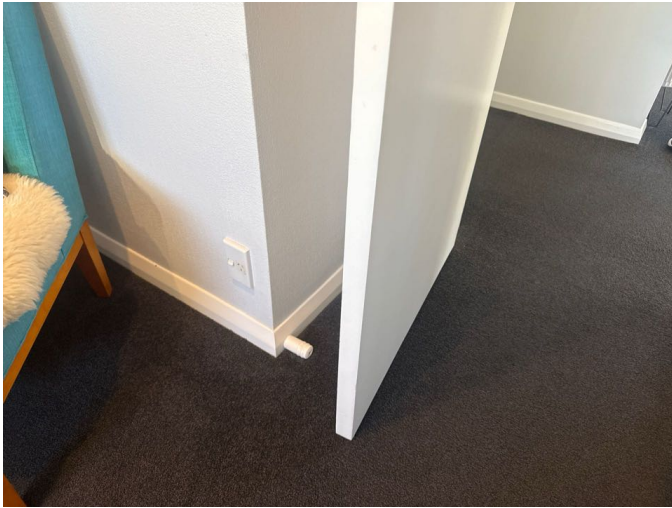
The internal doors are functioning well. Door stops installed behind the doors.

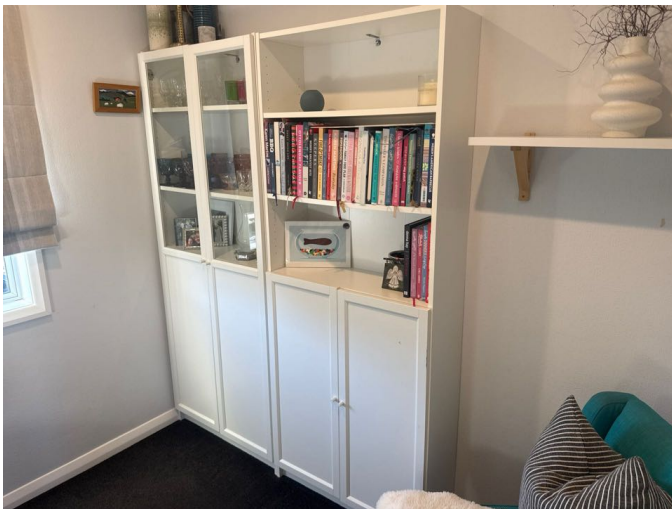
Fixed cabinet noted

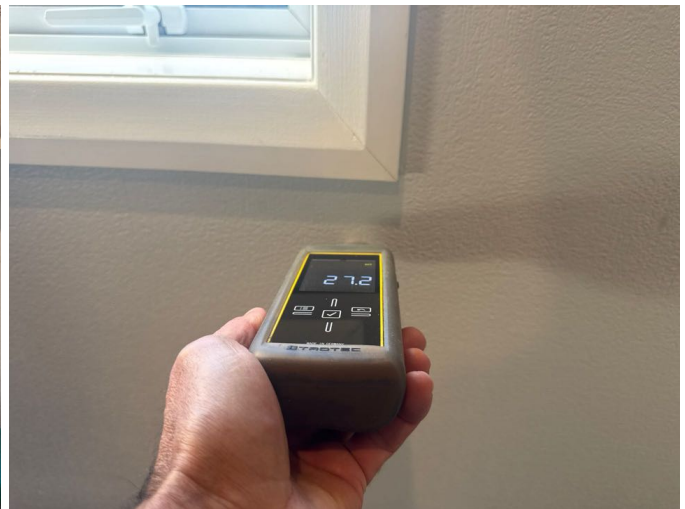
Moisture levels to the external walls were within the normal range at the time of inspection

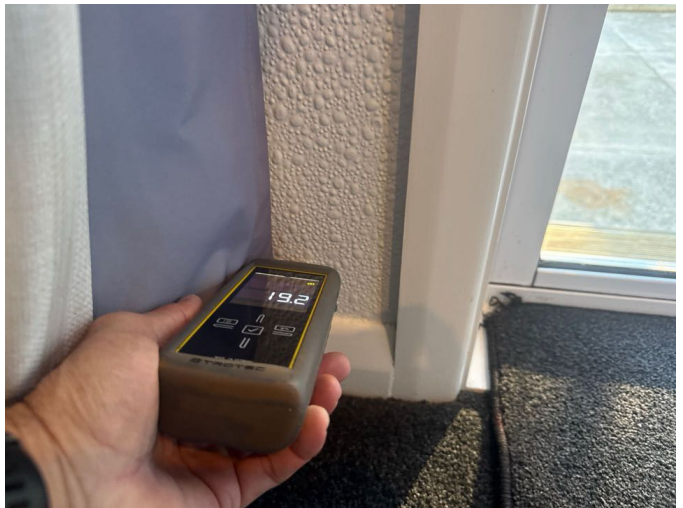
Moisture levels to the external walls were within the normal range at the time of inspection

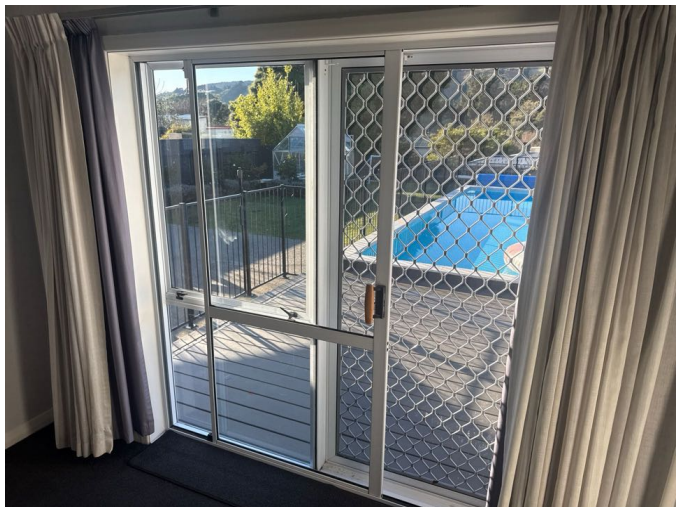
The sliding door is functioning. Security door noted.

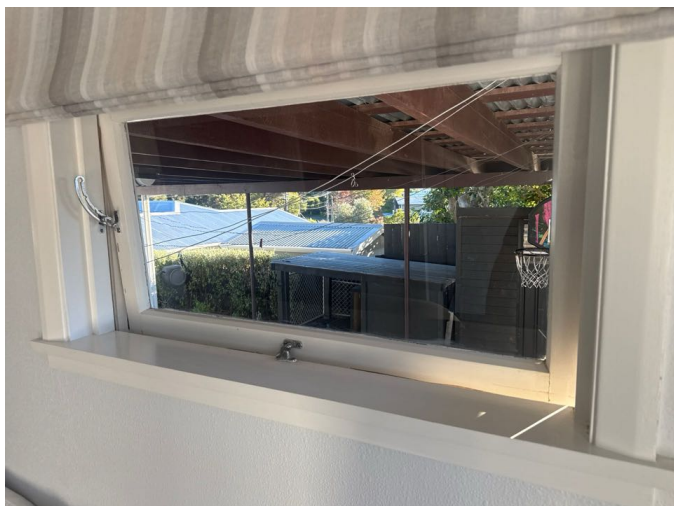
The timber windows are functional

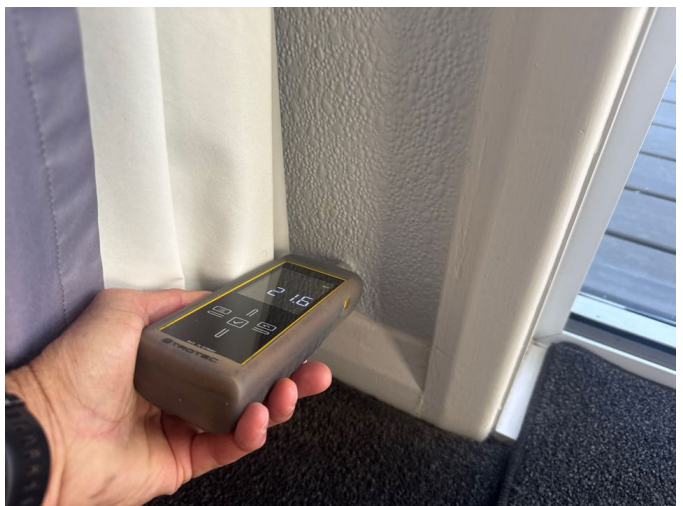
Moisture levels to the external walls were within the normal range at the time of inspection

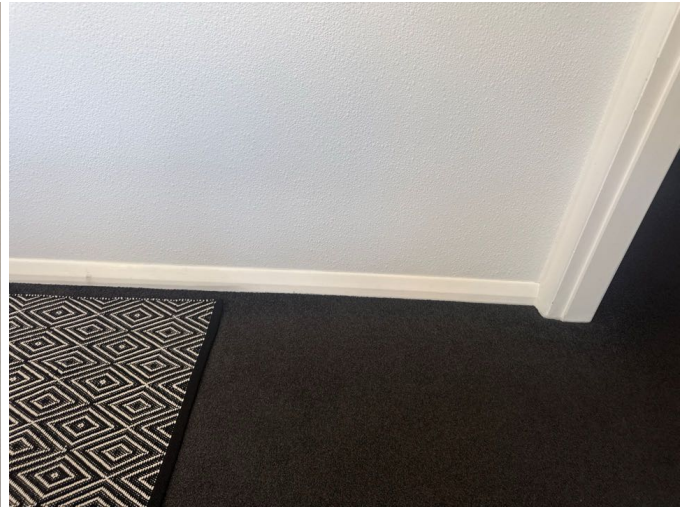
The wall and ceiling linings and carpet are in good condition

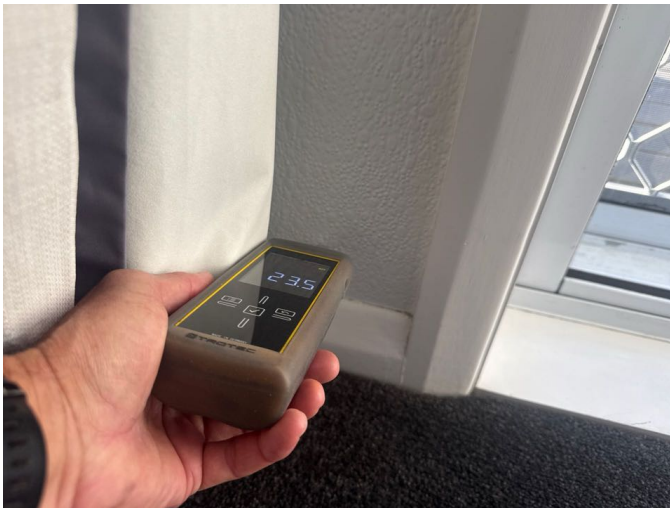
Moisture levels to the external walls were within the normal range at the time of inspection
