THERMOGRAPHY REPORT 2.

**151 Durham Dr,
Havelock North.**

Report Information

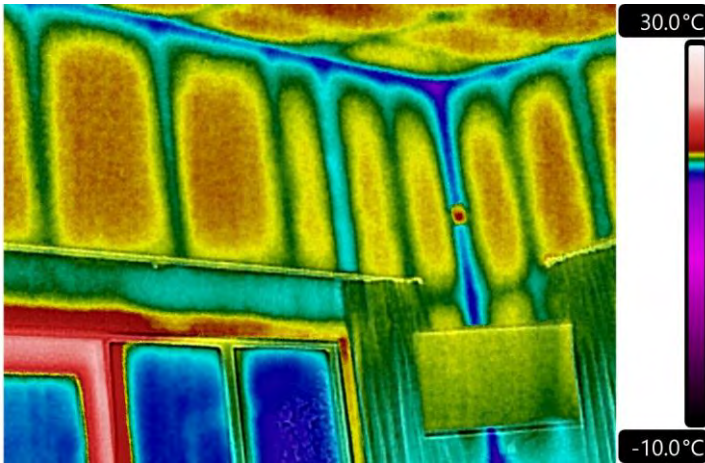
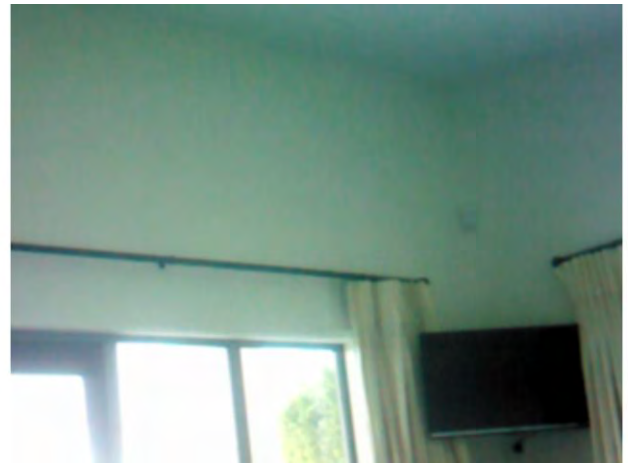
IR_19928.jpg | 20/05/2026 | 1:02 am

Building Information	
Location	Ground floor
Room	Master bedroom
Area	Ceiling / wall
Area Summary

No infrared anomaly was seen in this image at the time of inspection.

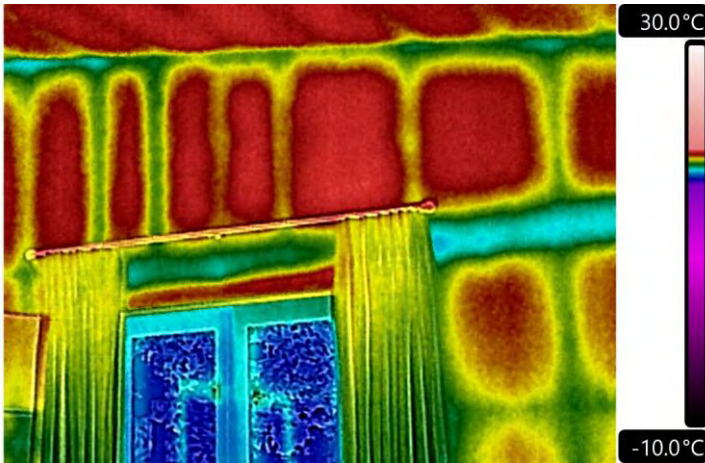
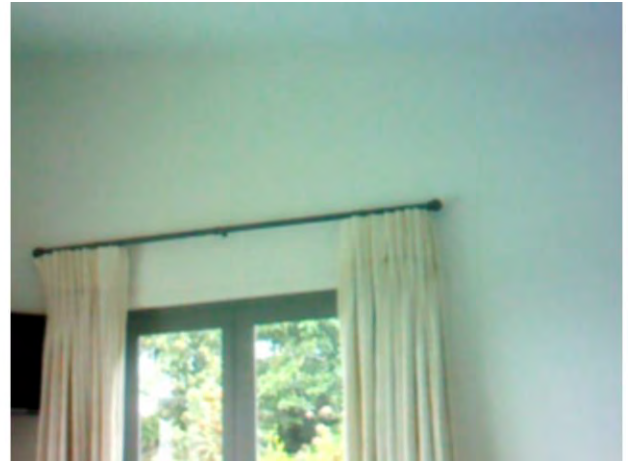
IR_19929.jpg | 20/05/2026 | 1:03 am

Building Information	
Location	Ground floor
Room	Master bedroom
Area	Ceiling / wall
Area Summary

No infrared anomaly was seen in this image at the time of inspection.

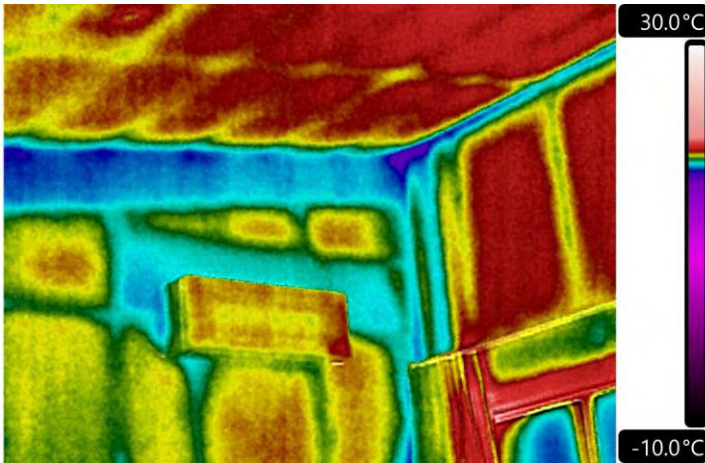
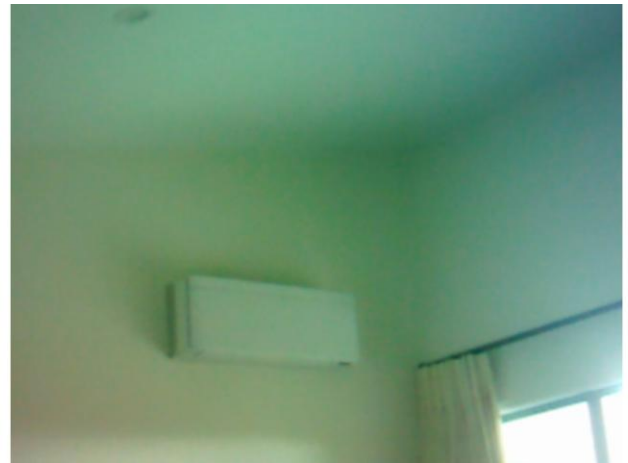
IR_19930.jpg | 20/05/2026 | 1:04 am

Building Information	
Location	Ground floor
Room	Master bedroom
Area	Ceiling / wall
Area Summary

No infrared anomaly was seen in this image at the time of inspection.

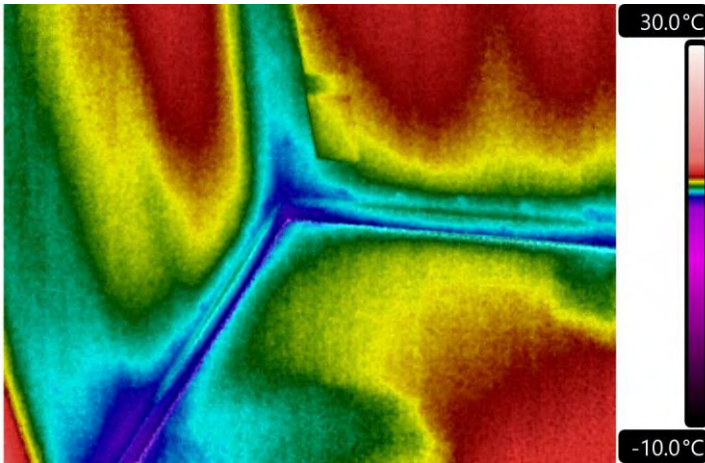
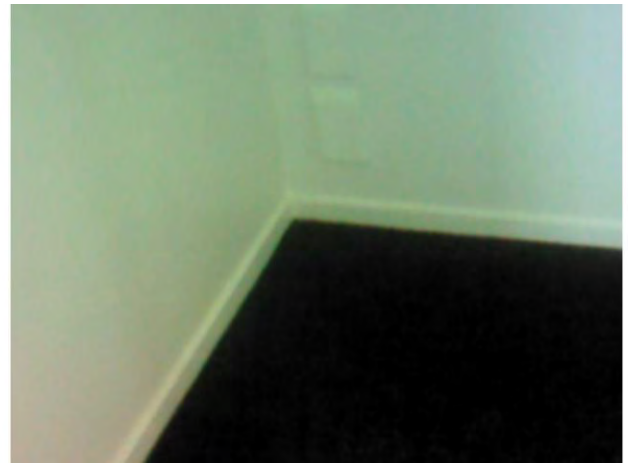
IR_19931.jpg | 20/05/2026 | 1:04 am

Building Information	
Location	Ground floor
Room	Master bedroom
Area	Wall / floor
Area Summary

No infrared anomaly was seen in this image at the time of inspection.

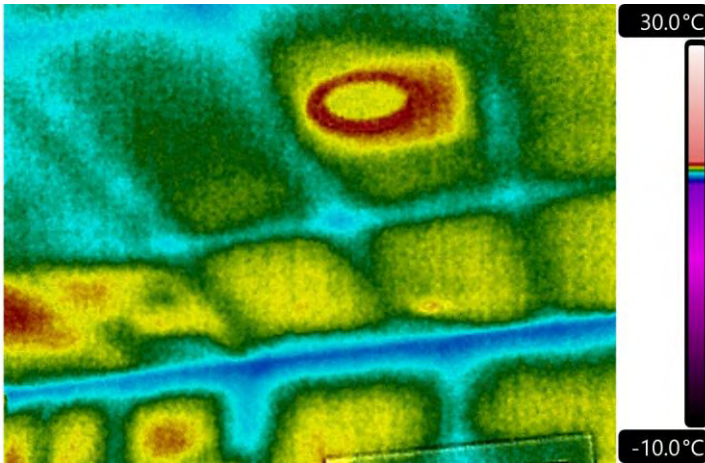
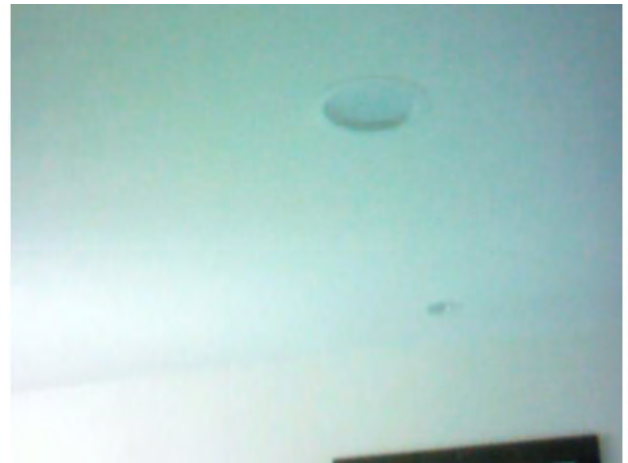
IR_19935.jpg | 20/05/2026 | 1:06 am

Building Information	
Location	Ground floor
Room	Master bedroom - walkin closet
Area	Window / wall
Area Summary

No infrared anomaly was seen in this image at the time of inspection.

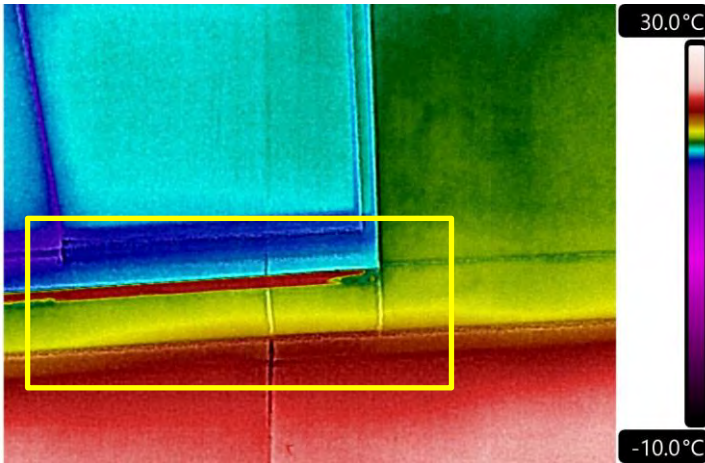
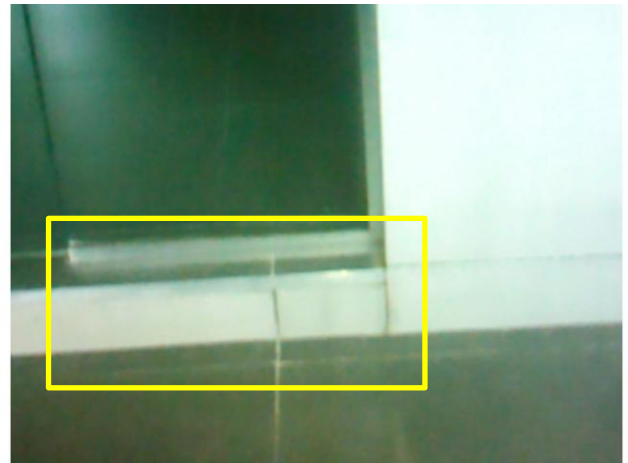
IR_19940.jpg | 20/05/2026 | 1:08 am

Building Information	
Location	Ground floor
Room	Master bedroom - ensuite
Area	Wall / floor
Area Summary

Infrared and or moderate moisture meter readings suggest a possible moisture issue.

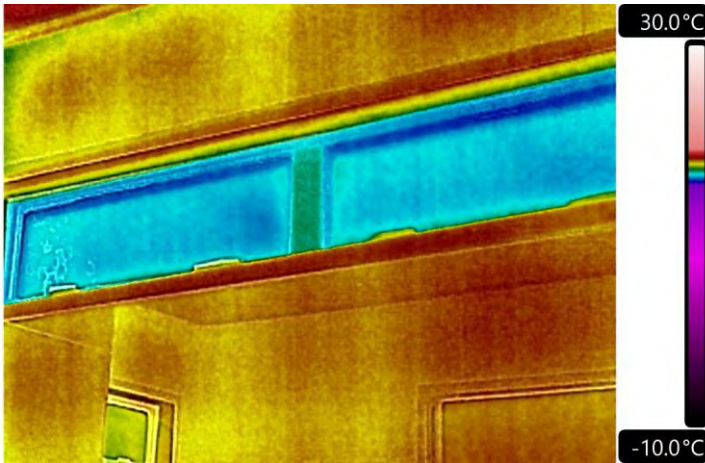
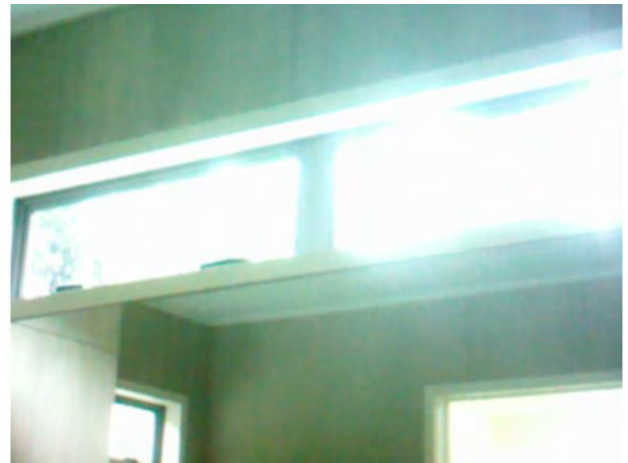
IR_19943.jpg | 20/05/2026 | 1:09 am

Building Information	
Location	Ground floor
Room	Master bedroom - ensuite
Area	Window / wall
Area Summary

No infrared anomaly was seen in this image at the time of inspection.

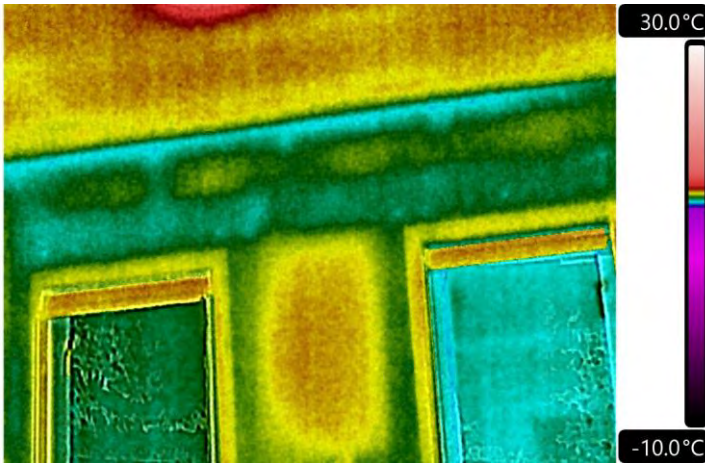
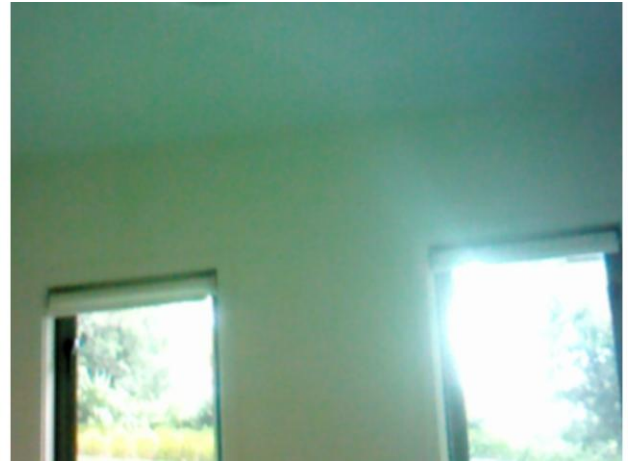
IR_19944.jpg | 20/05/2026 | 1:20 am

Building Information	
Location	Ground floor
Room	Office
Area	Window / wall
Area Summary

No infrared anomaly was seen in this image at the time of inspection.

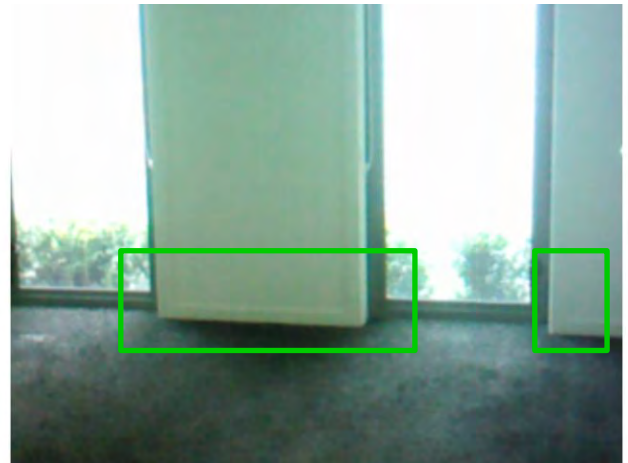
IR_19945.jpg | 20/05/2026 | 1:21 am

Building Information	
Location	Ground floor
Room	Office
Area	Wall / floor
Area Summary

A slight infrared anomaly was seen in this image it was investigated further with a Trotec moisture meter and readings were found to be an acceptable level under the threshold of 50 and similar to the surrounding area at the time of inspection.

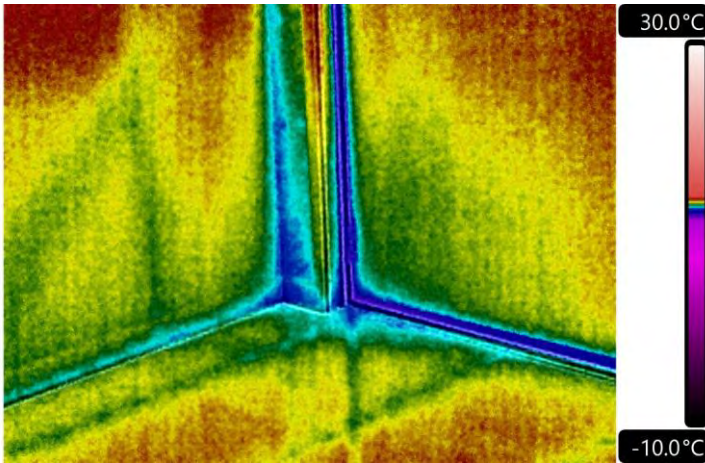
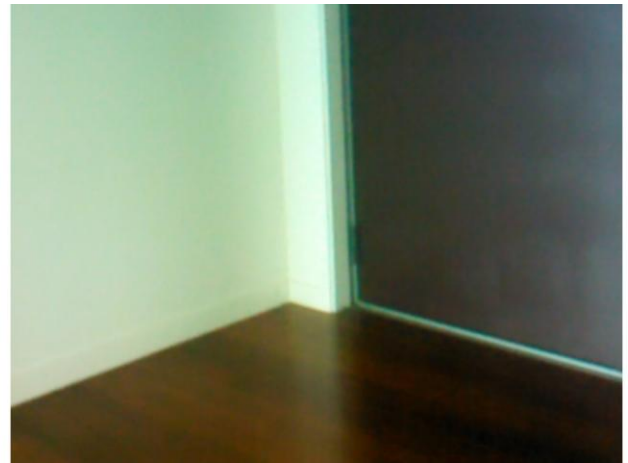
IR_19948.jpg | 20/05/2026 | 1:22 am

Building Information	
Location	Ground floor
Room	Foyer
Area	Ceiling / wall
Area Summary

No infrared anomaly was seen in this image at the time of inspection.

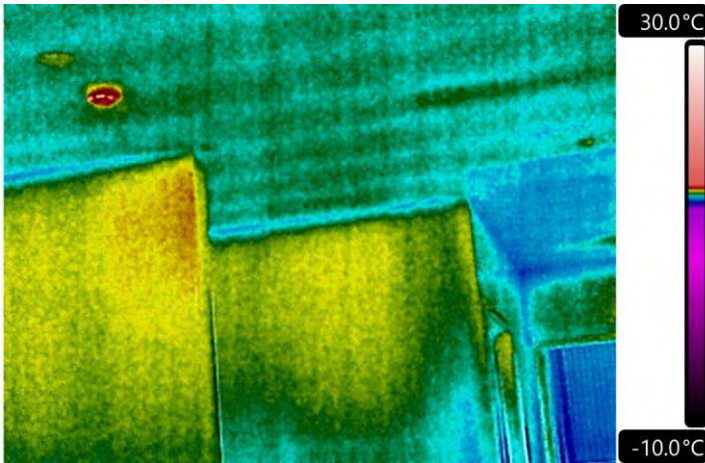
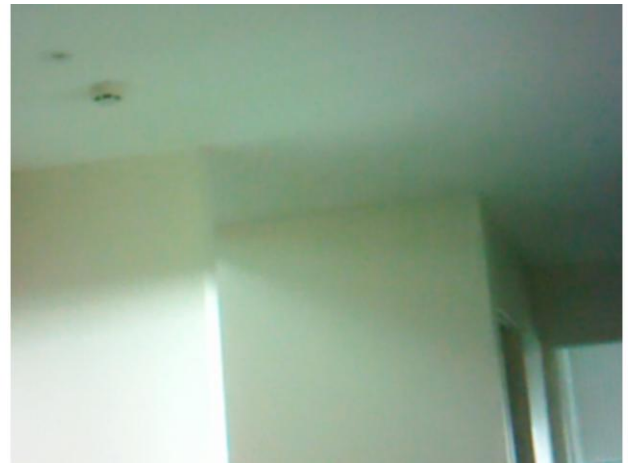
IR_19949.jpg | 20/05/2026 | 1:22 am

Building Information	
Location	Ground floor
Room	Foyer
Area	Ceiling / wall
Area Summary

No infrared anomaly was seen in this image at the time of inspection.

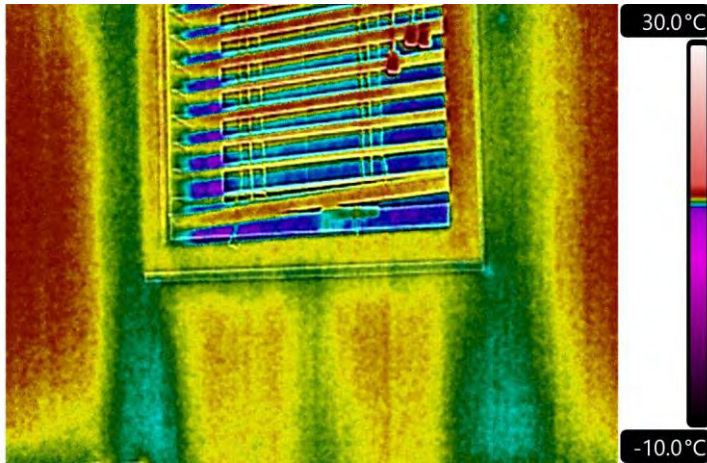
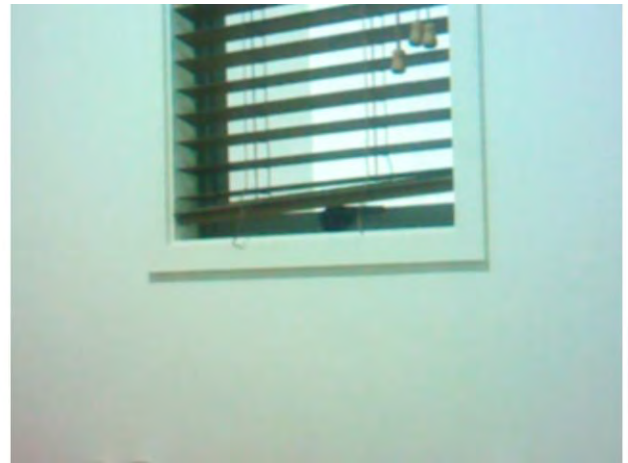
IR_19951.jpg | 20/05/2026 | 1:24 am

Building Information	
Location	First floor
Room	Toilet
Area	Window / wall
Area Summary

No infrared anomaly was seen in this image at the time of inspection.

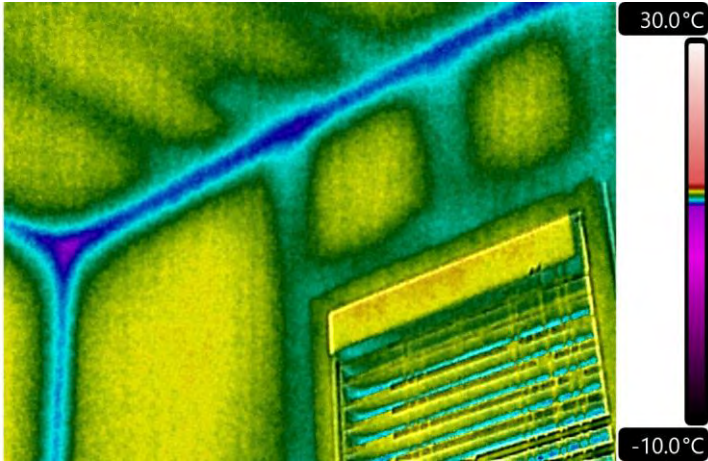
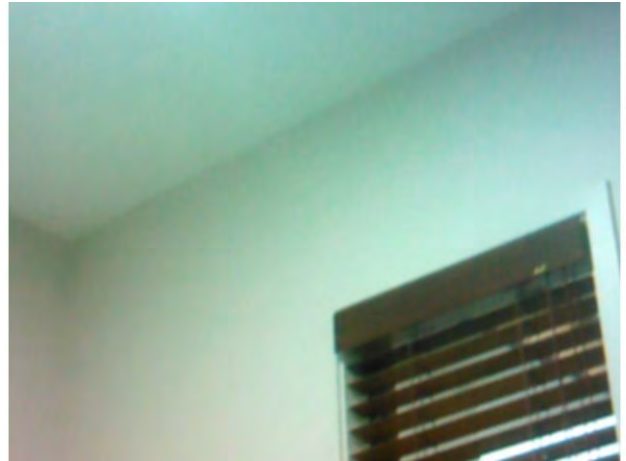
IR_19952.jpg | 20/05/2026 | 1:25 am

Building Information	
Location	First floor
Room	Toilet
Area	Window / wall
Area Summary

No infrared anomaly was seen in this image at the time of inspection.

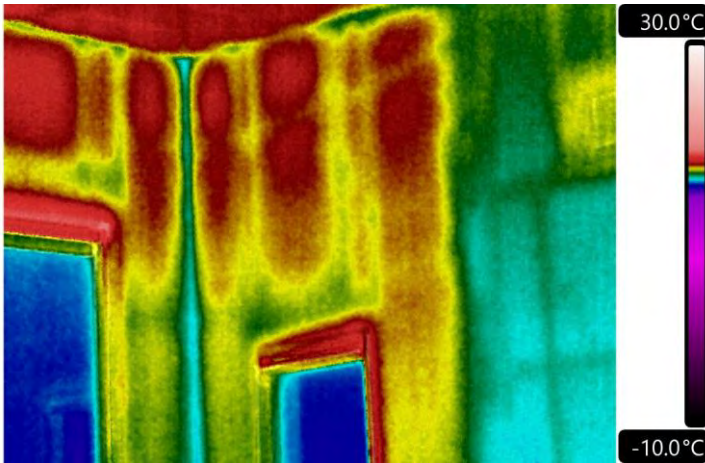
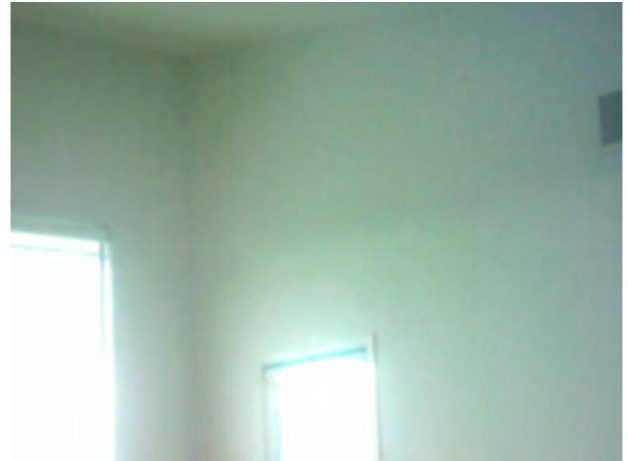
IR_19954.jpg | 20/05/2026 | 1:29 am

Building Information	
Location	Ground floor
Room	Lounge
Area	Ceiling / wall
Area Summary

No infrared anomaly was seen in this image at the time of inspection.

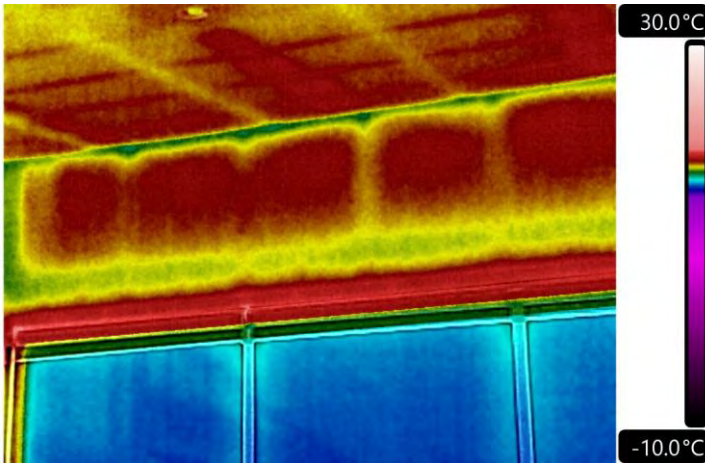
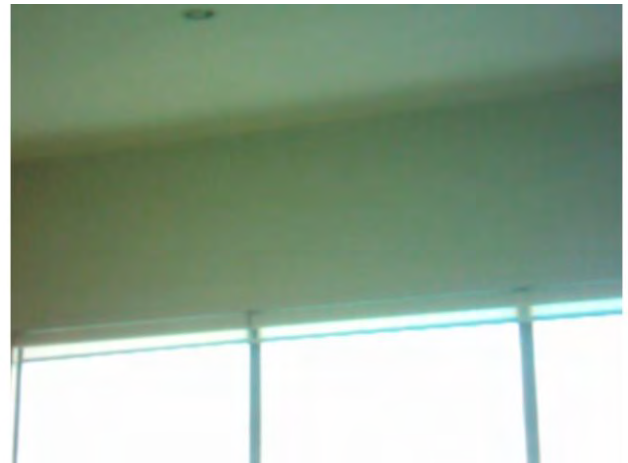
IR_19955.jpg | 20/05/2026 | 1:30 am

Building Information	
Location	Ground floor
Room	Lounge
Area	Ceiling / wall
Area Summary

No infrared anomaly was seen in this image at the time of inspection.

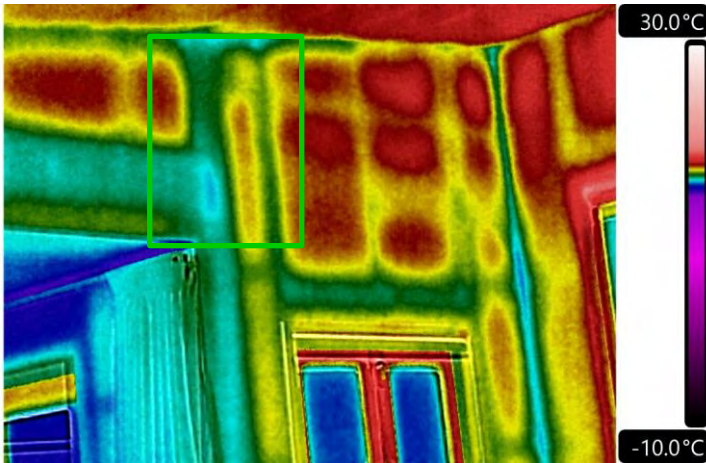
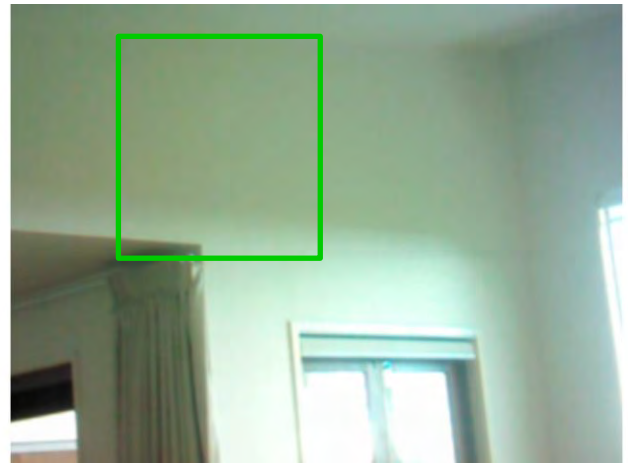
IR_19956.jpg | 20/05/2026 | 1:30 am

Building Information	
Location	Ground floor
Room	Lounge
Area	Ceiling / wall
Area Summary

A slight infrared anomaly was seen in this image it was investigated further with a Trotec moisture meter and readings were found to be an acceptable level under the threshold of 50 and similar to the surrounding area at the time of inspection.

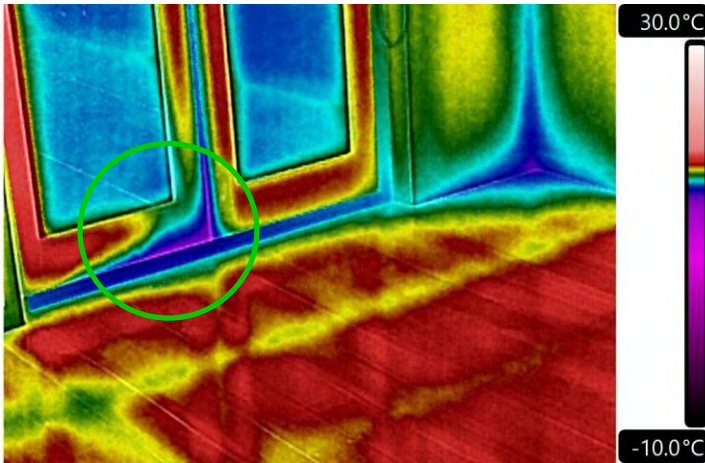
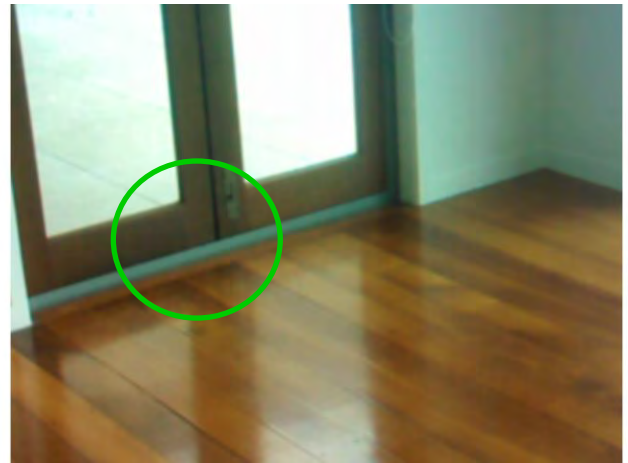
IR_19958.jpg | 20/05/2026 | 1:31 am

Building Information	
Location	Ground floor
Room	Lounge
Area	Wall / floor
Area Summary

A slight infrared anomaly was seen in this image it was investigated further visually and the door seal may be failing.

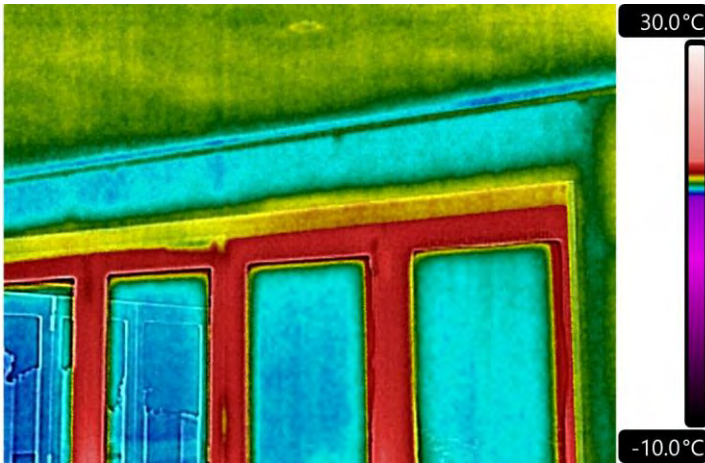
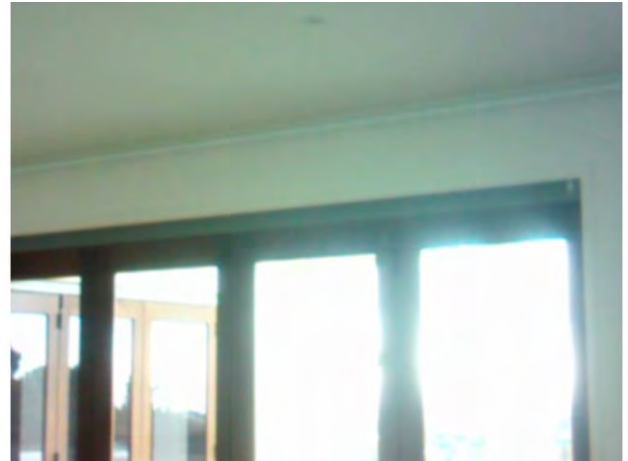
IR_19959.jpg | 20/05/2026 | 1:32 am

Building Information	
Location	Ground floor
Room	Lounge
Area	Window / wall
Area Summary

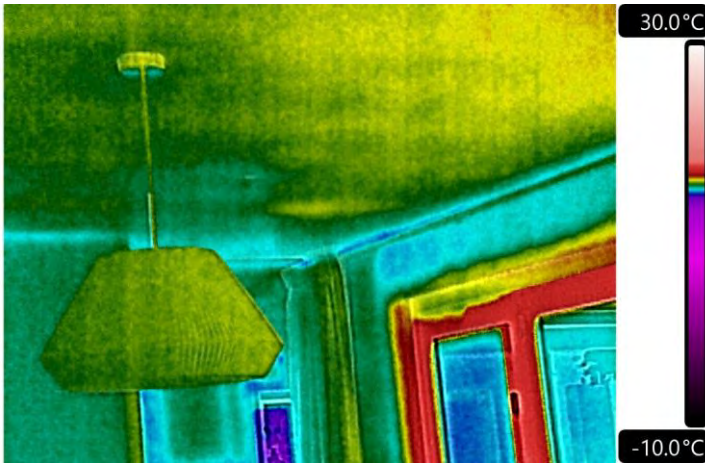
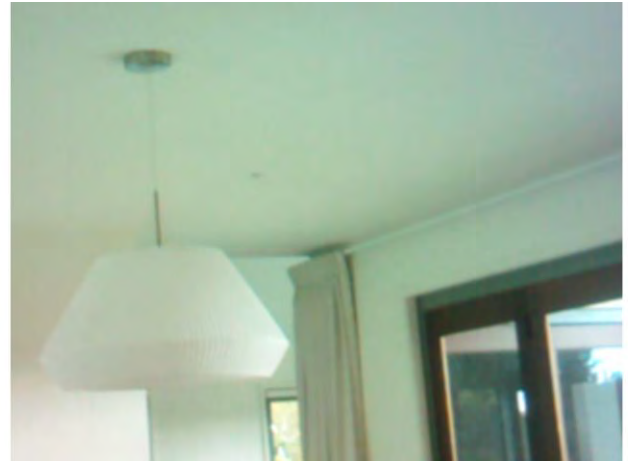
IR_19960.jpg | 20/05/2026 | 1:33 am

Building Information	
Location	Ground floor
Room	Lounge
Area	Window / wall
Area Summary

No infrared anomaly was seen in this image at the time of inspection.

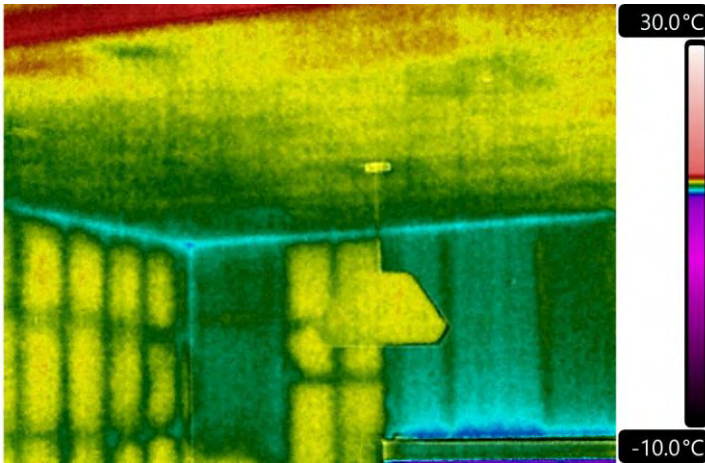
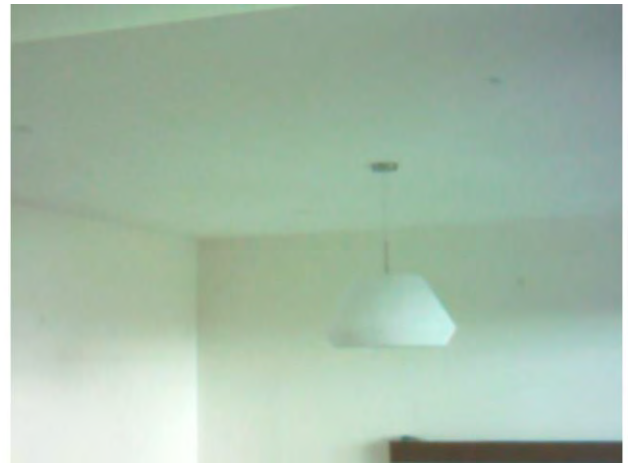
IR_19962.jpg | 20/05/2026 | 1:33 am

Building Information	
Location	Ground floor
Room	Lounge
Area	Ceiling / wall
Area Summary

No infrared anomaly was seen in this image at the time of inspection.

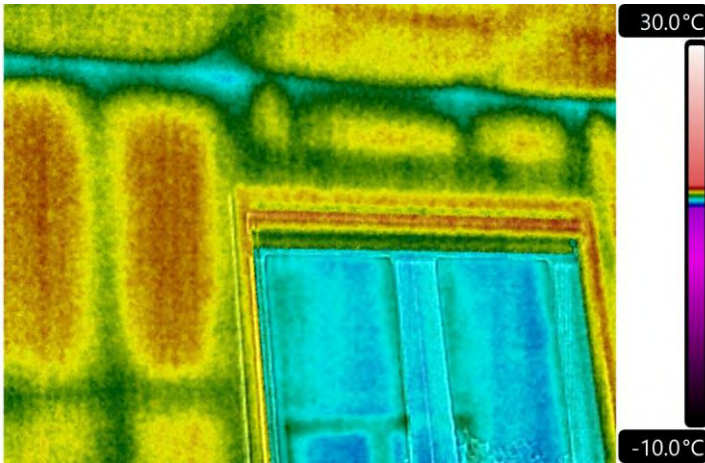
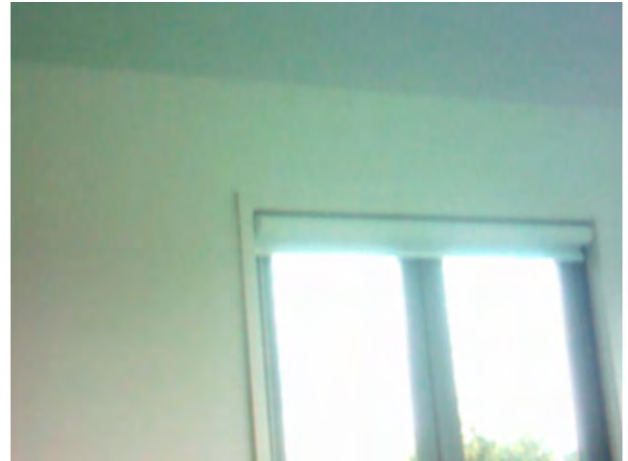
IR_19963.jpg | 20/05/2026 | 1:38 am

Building Information	
Location	Ground floor
Room	Dining room
Area	Ceiling / wall
Area Summary

No infrared anomaly was seen in this image at the time of inspection.

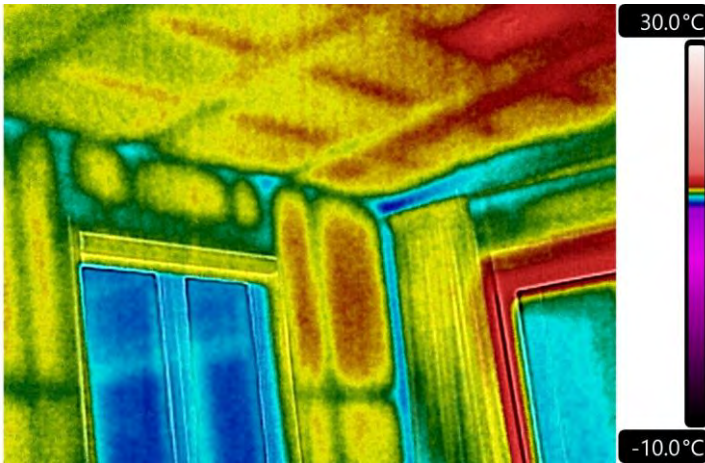
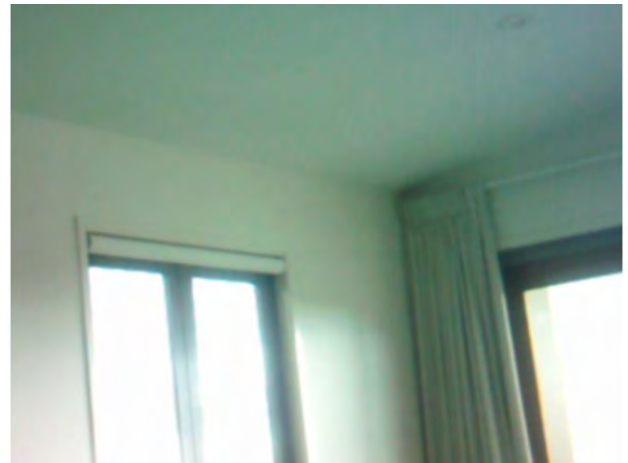
IR_19964.jpg | 20/05/2026 | 1:39 am

Building Information	
Location	Ground floor
Room	Dining room
Area	Ceiling / wall
Area Summary

No infrared anomaly was seen in this image at the time of inspection.

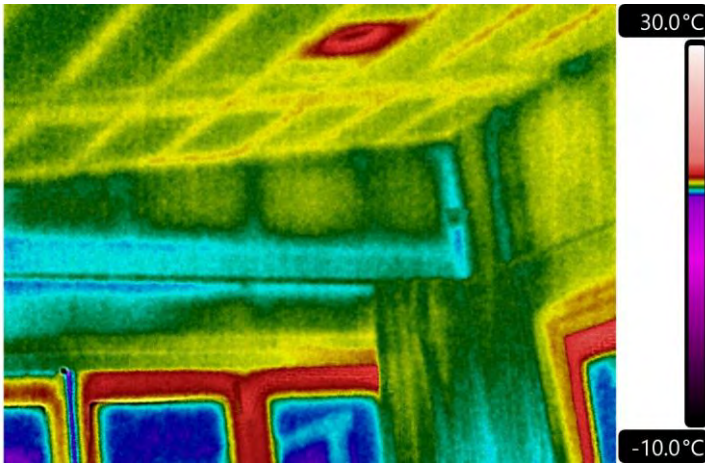
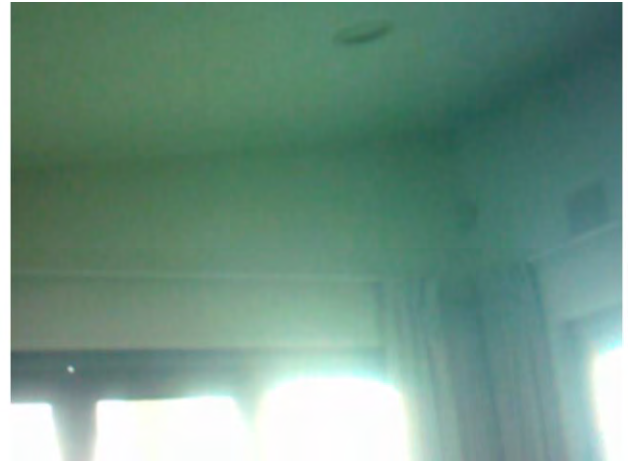
IR_19965.jpg | 20/05/2026 | 1:39 am

Building Information	
Location	Ground floor
Room	Dining room
Area	Ceiling / wall
Area Summary

No infrared anomaly was seen in this image at the time of inspection.

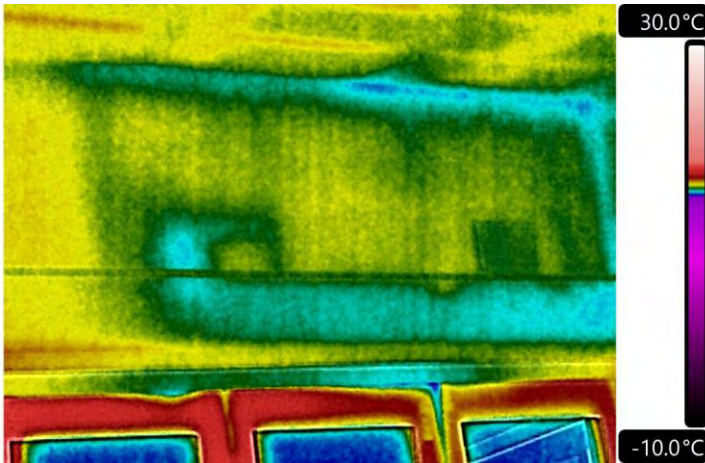
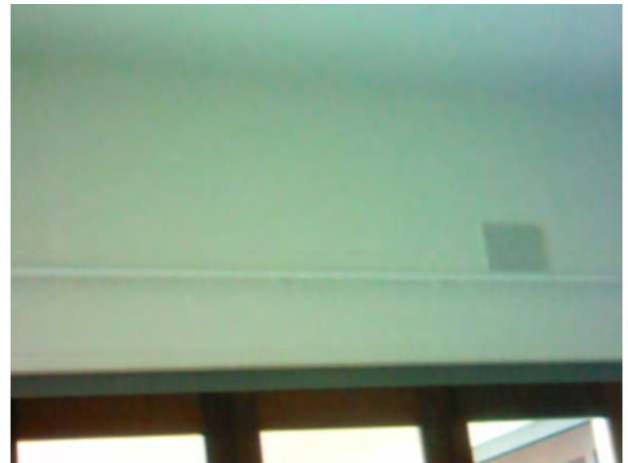
IR_19966.jpg | 20/05/2026 | 1:39 am

Building Information	
Location	Ground floor
Room	Dining room
Area	Ceiling / wall
Area Summary

No infrared anomaly was seen in this image at the time of inspection.

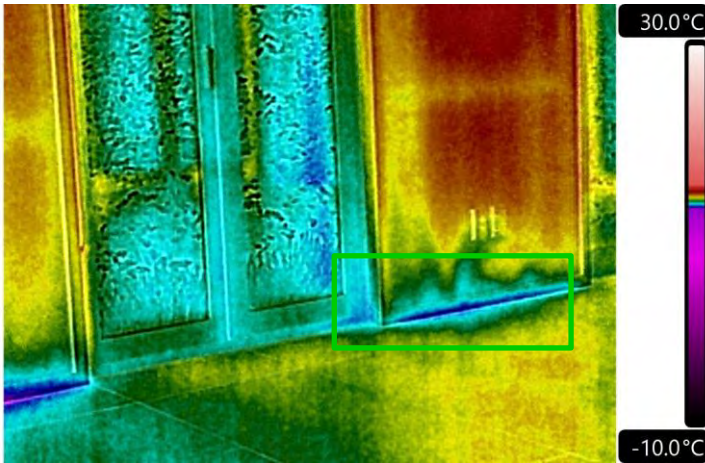
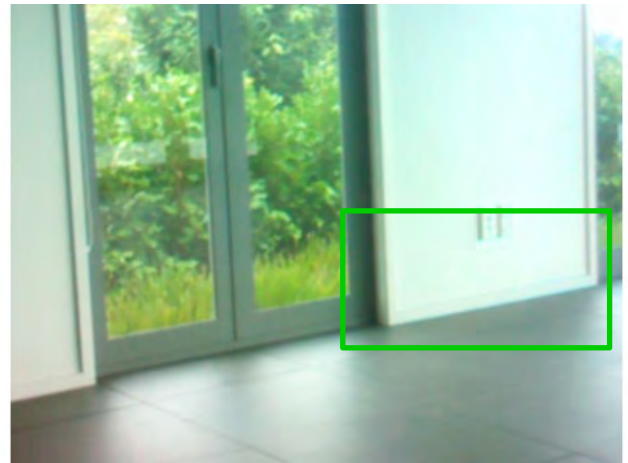
IR_19967.jpg | 20/05/2026 | 1:40 am

Building Information	
Location	Ground floor
Room	Dining room
Area	Wall / floor
Area Summary

A slight infrared anomaly was seen in this image it was investigated further with a Trotec moisture meter and readings were found to be an acceptable level under the threshold of 50 and similar to the surrounding area at the time of inspection.

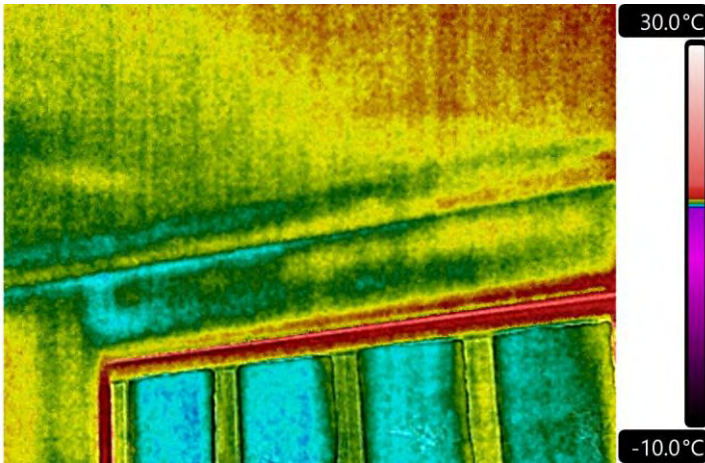
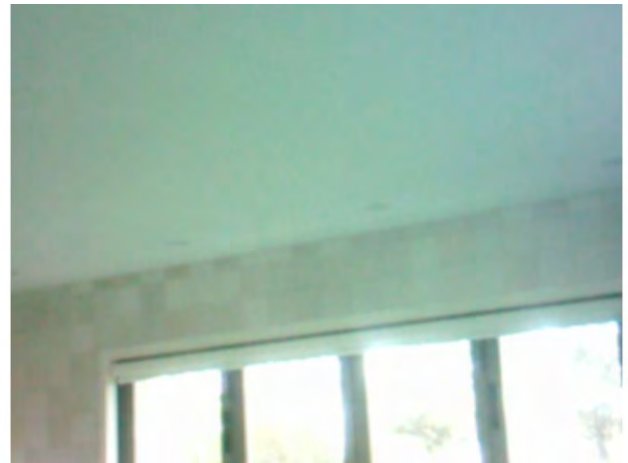
IR_19969.jpg | 20/05/2026 | 1:44 am

Building Information	
Location	Ground floor
Room	Kitchen
Area	Ceiling / wall
Area Summary

No infrared anomaly was seen in this image at the time of inspection.

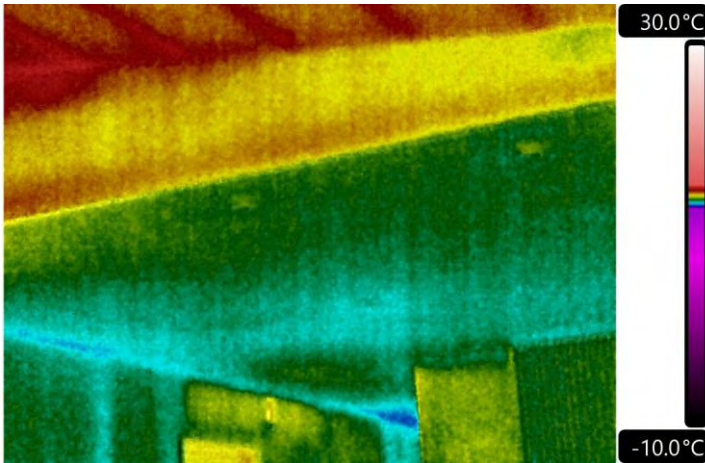
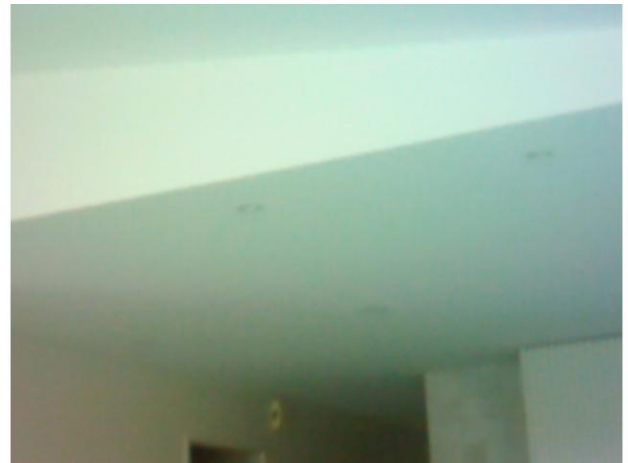
IR_19970.jpg | 20/05/2026 | 1:44 am

Building Information	
Location	Ground floor
Room	Kitchen
Area	Ceiling
Area Summary

No infrared anomaly was seen in this image at the time of inspection.

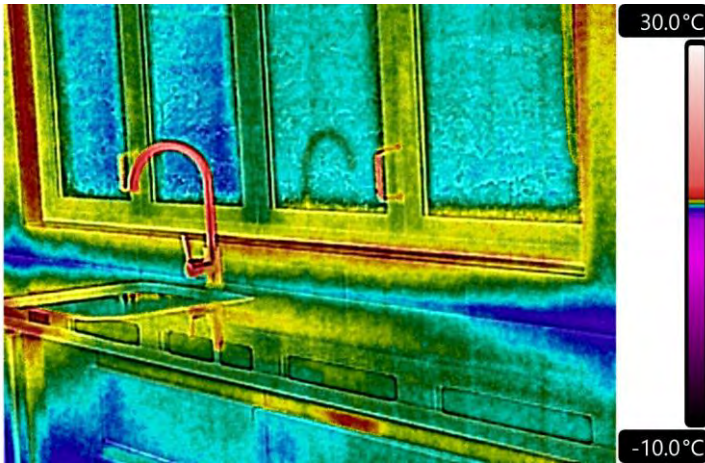
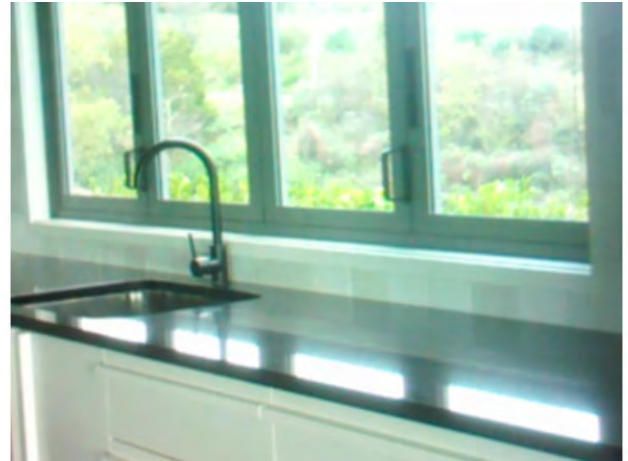
IR_19971.jpg | 20/05/2026 | 1:45 am

Building Information	
Location	Ground floor
Room	Kitchen
Area	Window / wall
Area Summary

No infrared anomaly was seen in this image at the time of inspection.

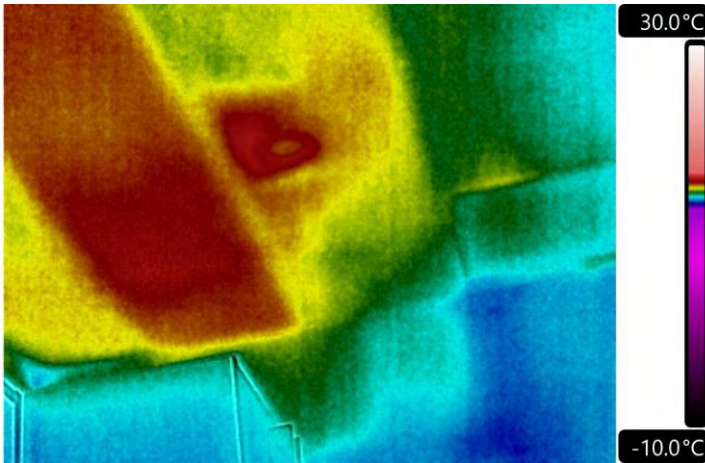
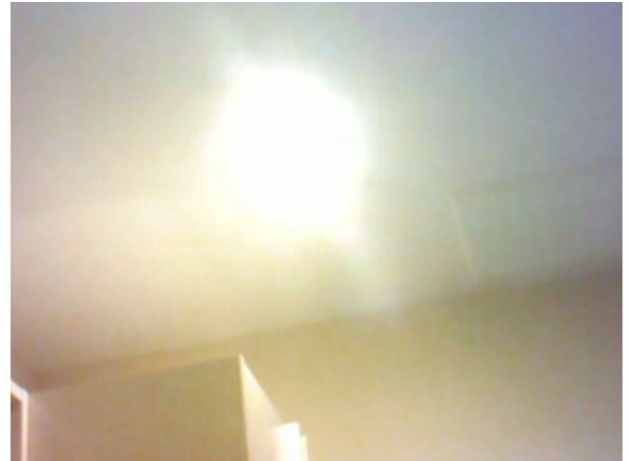
IR_19973.jpg | 20/05/2026 | 1:46 am

Building Information	
Location	Ground floor
Room	Pantry
Area	Ceiling
Area Summary

No infrared anomaly was seen in this image at the time of inspection.

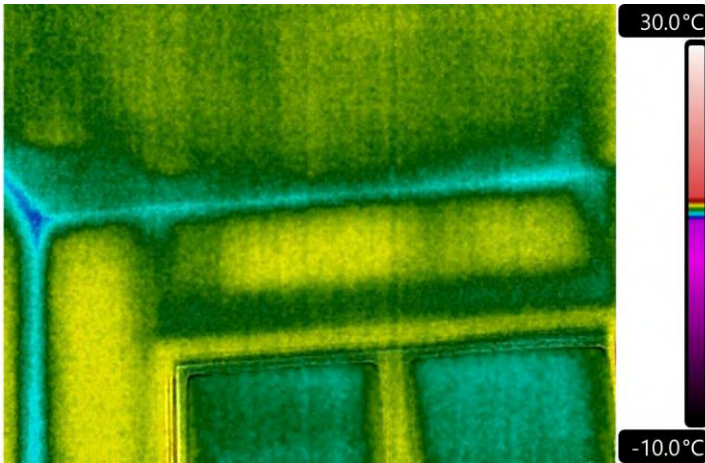
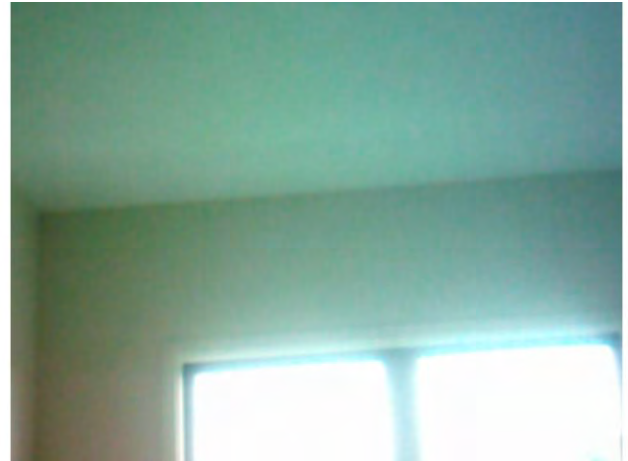
IR_19974.jpg | 20/05/2026 | 1:46 am

Building Information	
Location	Ground floor
Room	Laundry
Area	Ceiling / wall
Area Summary

No infrared anomaly was seen in this image at the time of inspection.

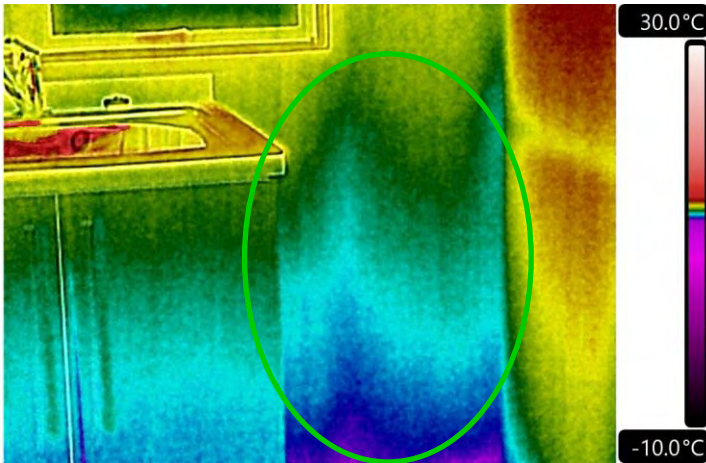
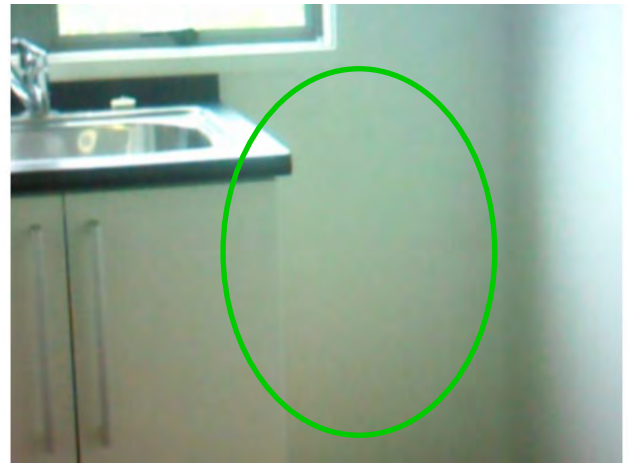
IR_19975.jpg | 20/05/2026 | 1:47 am

Building Information	
Location	Ground floor
Room	Laundry
Area	Window / wall
Area Summary

A slight infrared anomaly was seen in this image it was investigated further with a Trotec moisture meter and readings were found to be an acceptable level under the threshold of 50 and similar to the surrounding area at the time of inspection.

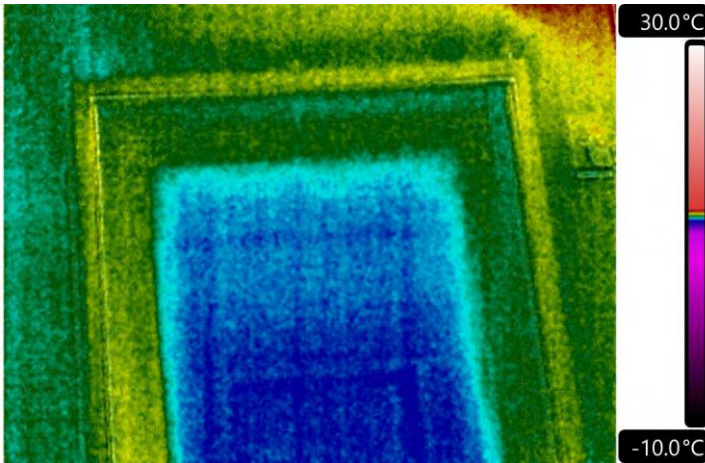
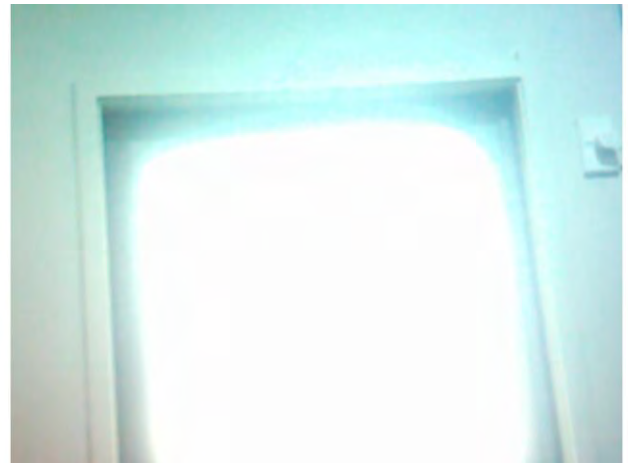
IR_19976.jpg | 20/05/2026 | 1:52 am

Building Information	
Location	Ground floor
Room	Garage
Area	Door
Area Summary

No infrared anomaly was seen in this image at the time of inspection.

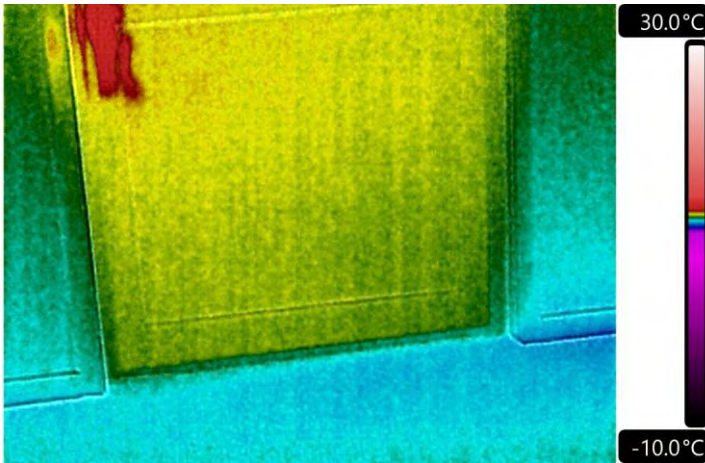
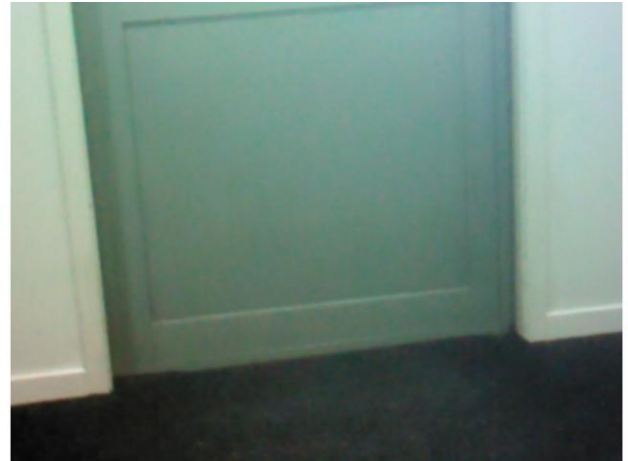
IR_19977.jpg | 20/05/2026 | 1:52 am

Building Information	
Location	Ground floor
Room	Garage
Area	Door
Area Summary

No infrared anomaly was seen in this image at the time of inspection.

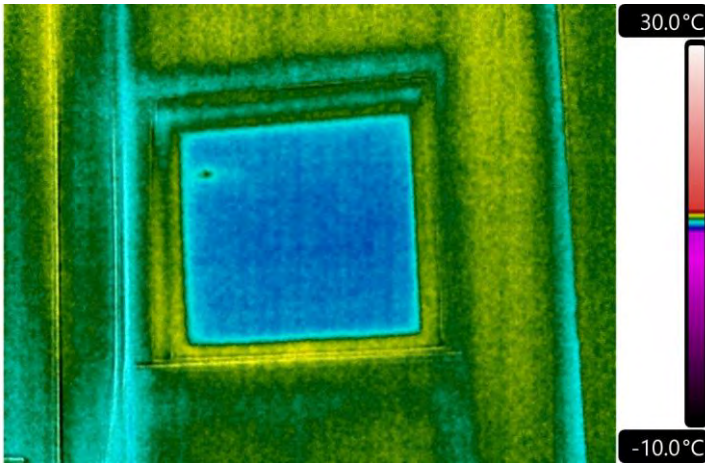
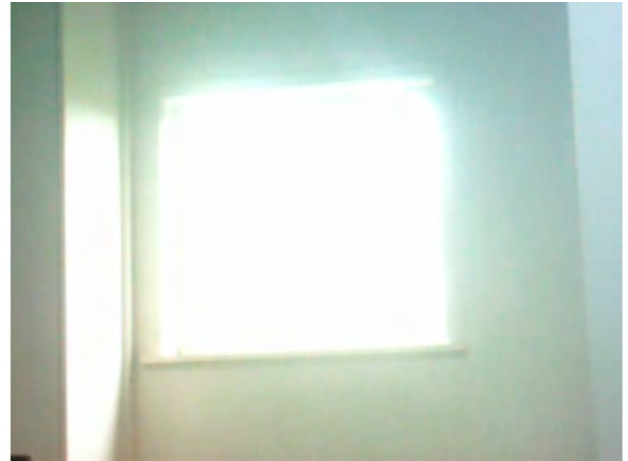
IR_19978.jpg | 20/05/2026 | 1:52 am

Building Information	
Location	Ground floor
Room	Garage
Area	Window / wall
Area Summary

No infrared anomaly was seen in this image at the time of inspection.
