THERMOGRAPHY REPORT 2.

**151 Durham Dr,
Havelock North.**

Report Information

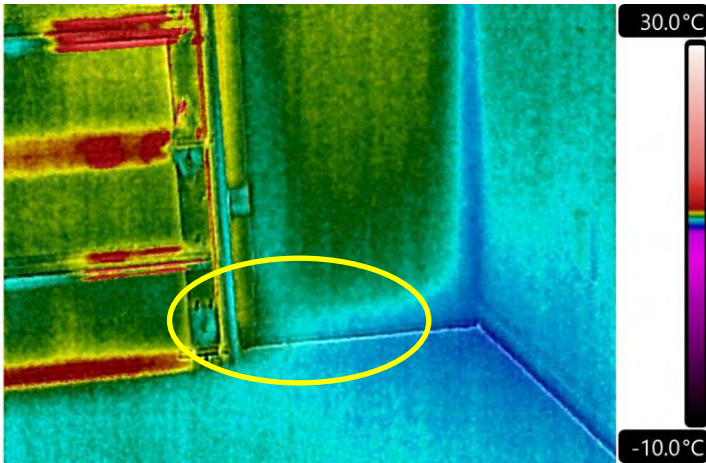
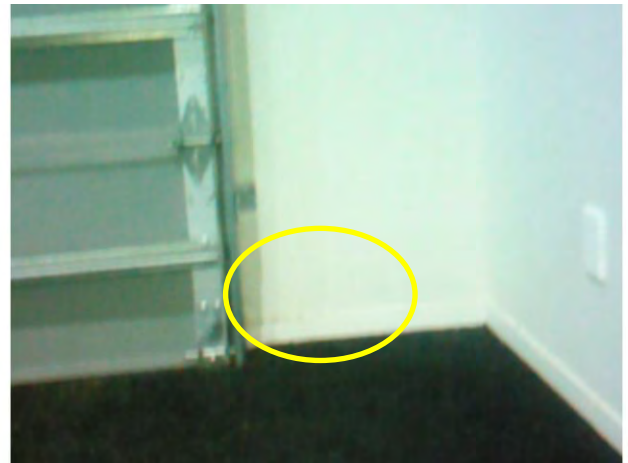
IR_19980.jpg | 20/05/2026 | 1:53 am

Building Information	
Location	Ground floor
Room	Garage
Area	Garage door
Area Summary

Infrared and or moderate moisture meter readings suggest a possible moisture issue.

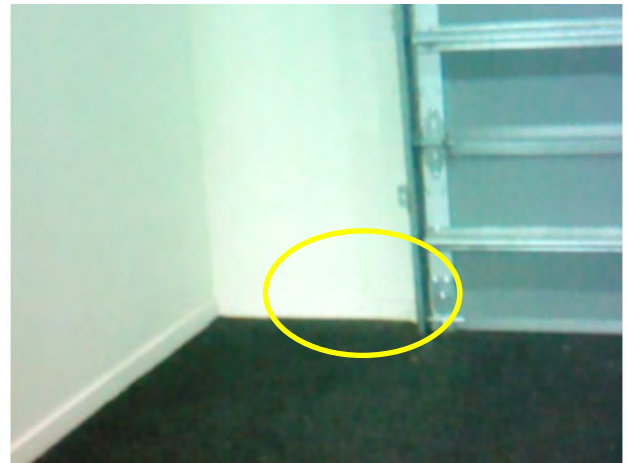
IR_19981.jpg | 20/05/2026 | 1:54 am

Building Information	
Location	Ground floor
Room	Garage
Area	Garage door
Area Summary

Infrared and or moderate moisture meter readings suggest a possible moisture issue.

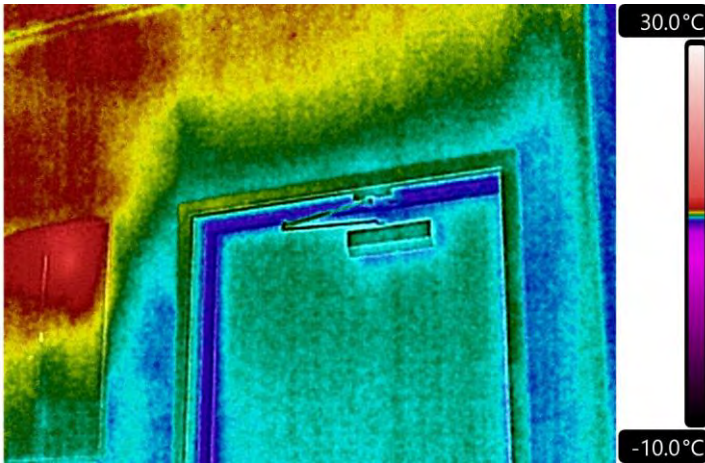
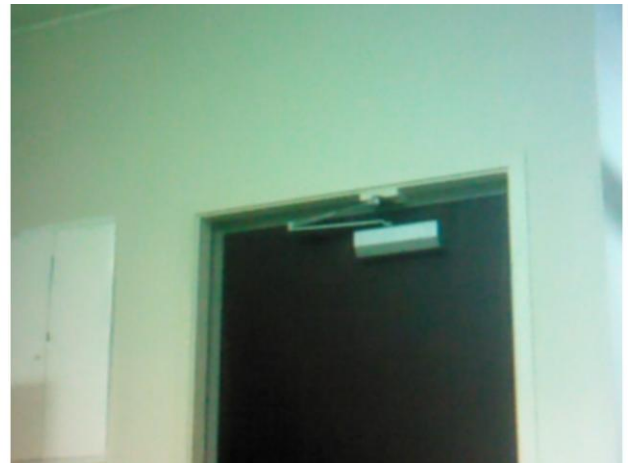
IR_19982.jpg | 20/05/2026 | 1:55 am

Building Information	
Location	Ground floor
Room	Garage
Area	Door
Area Summary

No infrared anomaly was seen in this image at the time of inspection.

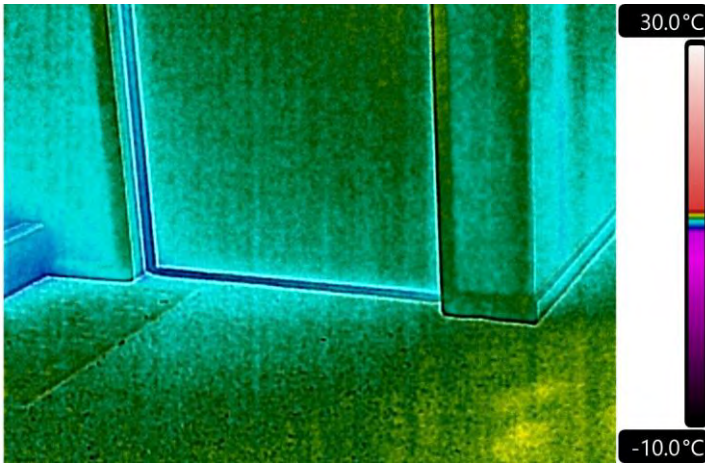
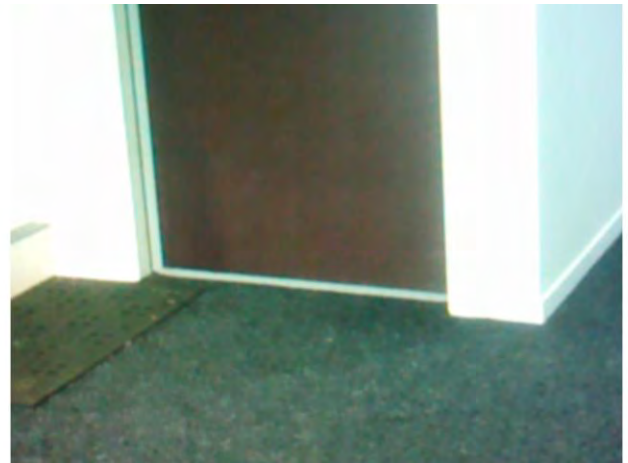
IR_19983.jpg | 20/05/2026 | 1:55 am

Building Information	
Location	Ground floor
Room	Garage
Area	Door
Area Summary

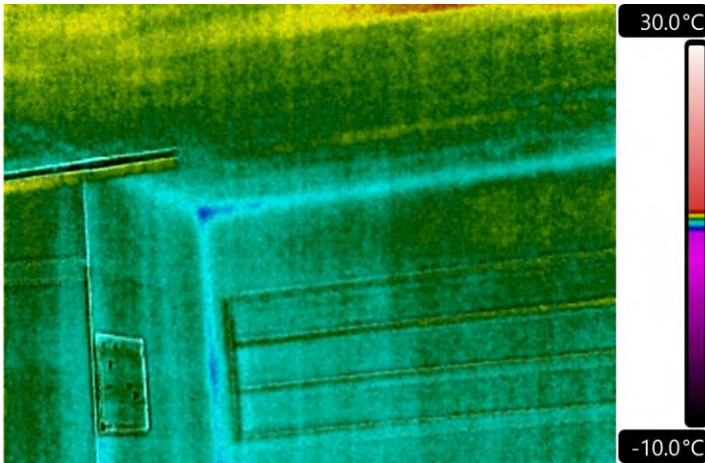
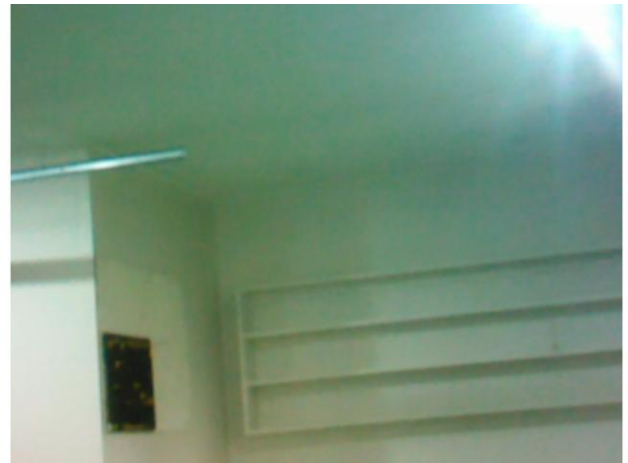
IR_19984.jpg | 20/05/2026 | 1:55 am

Building Information	
Location	Ground floor
Room	Garage
Area	Ceiling / wall
Area Summary

No infrared anomaly was seen in this image at the time of inspection.

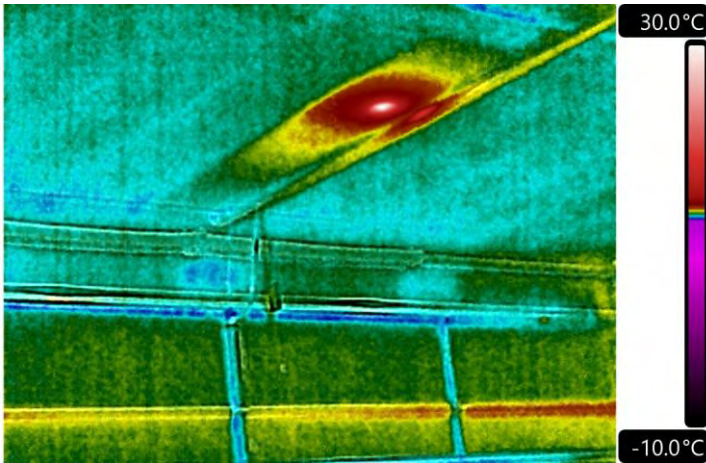
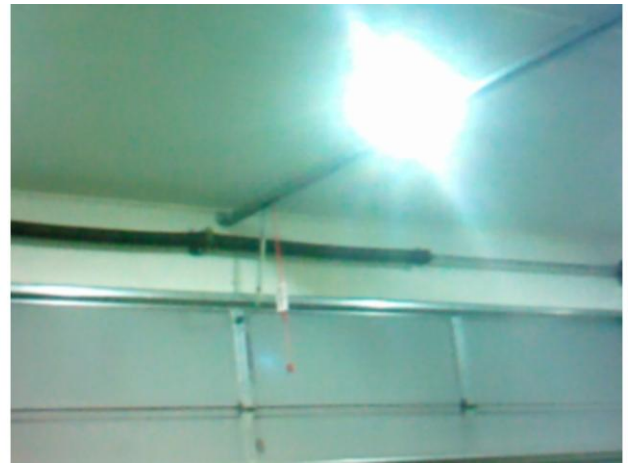
IR_19985.jpg | 20/05/2026 | 1:56 am

Building Information	
Location	Ground floor
Room	Garage
Area	Ceiling / wall
Area Summary

No infrared anomaly was seen in this image at the time of inspection.

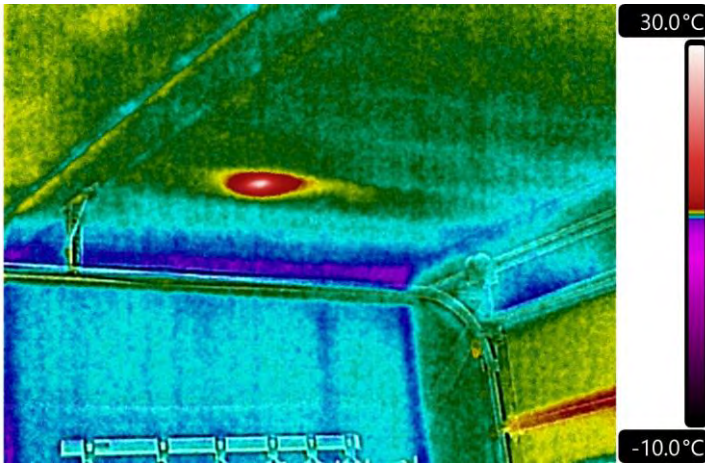
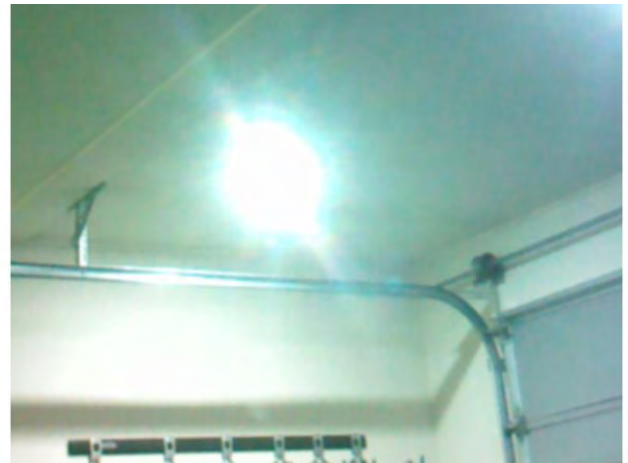
IR_19986.jpg | 20/05/2026 | 1:56 am

Building Information	
Location	Ground floor
Room	Garage
Area	Ceiling / wall
Area Summary

No infrared anomaly was seen in this image at the time of inspection.

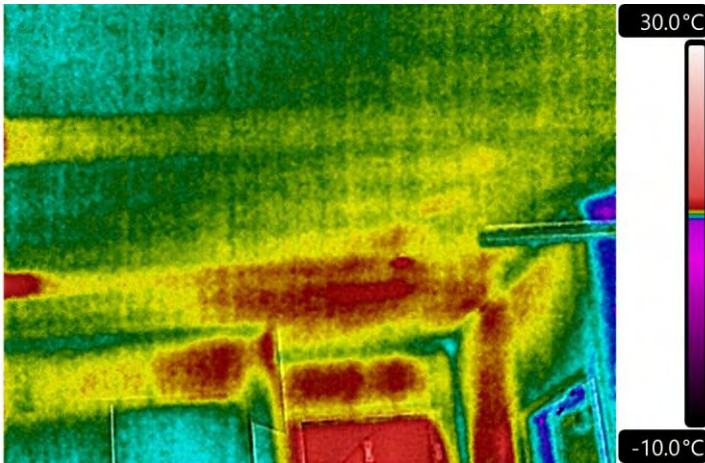
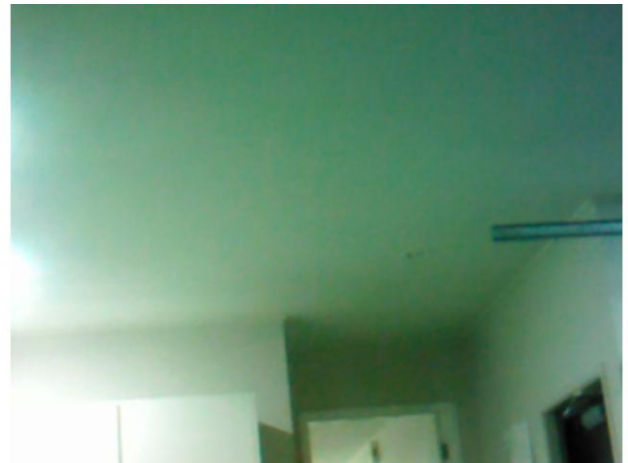
IR_19987.jpg | 20/05/2026 | 1:56 am

Building Information	
Location	Ground floor
Room	Garage
Area	Ceiling / wall
Area Summary

No infrared anomaly was seen in this image at the time of inspection.

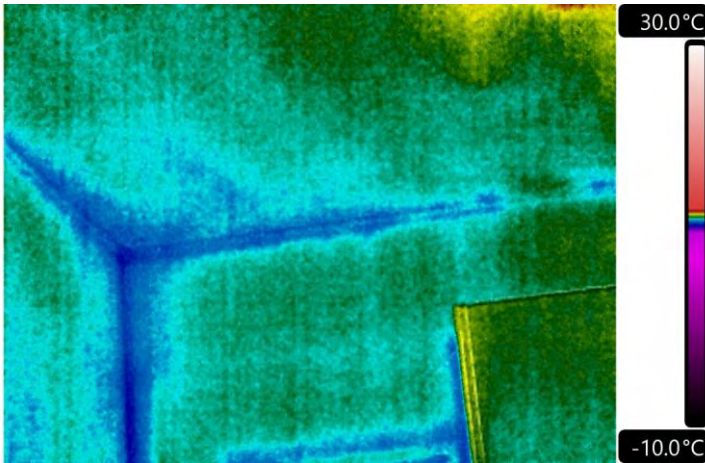
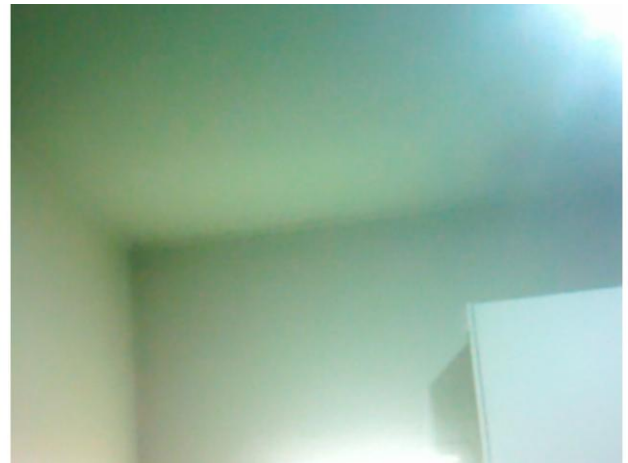
IR_19988.jpg | 20/05/2026 | 1:57 am

Building Information	
Location	Ground floor
Room	Garage
Area	Ceiling / wall
Area Summary

No infrared anomaly was seen in this image at the time of inspection.

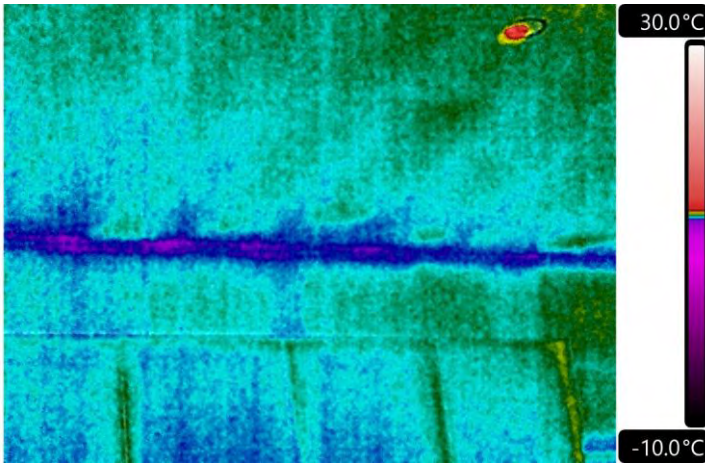
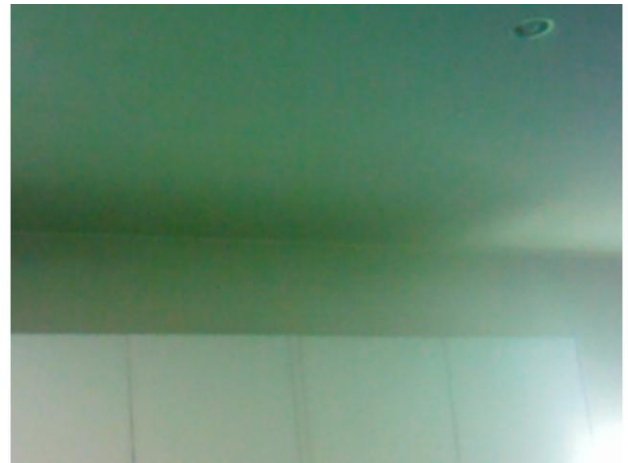
IR_19989.jpg | 20/05/2026 | 1:57 am

Building Information	
Location	Ground floor
Room	Garage
Area	Ceiling / wall
Area Summary

No infrared anomaly was seen in this image at the time of inspection.

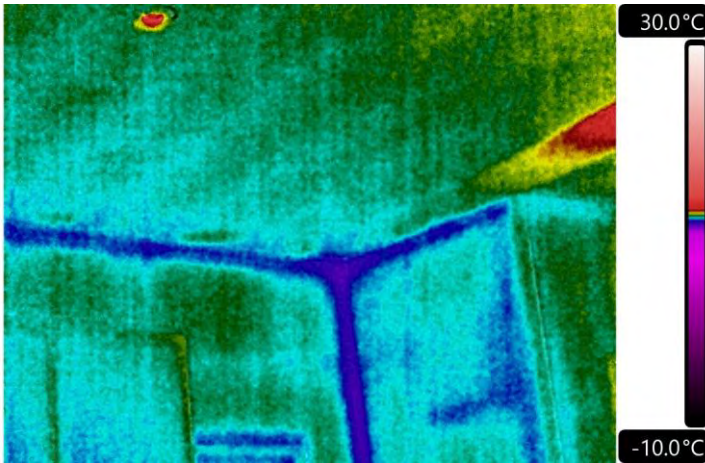
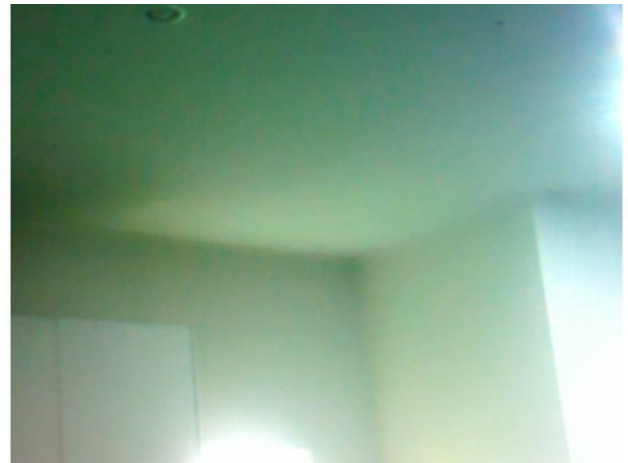
IR_19990.jpg | 20/05/2026 | 1:57 am

Building Information	
Location	Ground floor
Room	Garage
Area	Ceiling / wall
Area Summary

No infrared anomaly was seen in this image at the time of inspection.

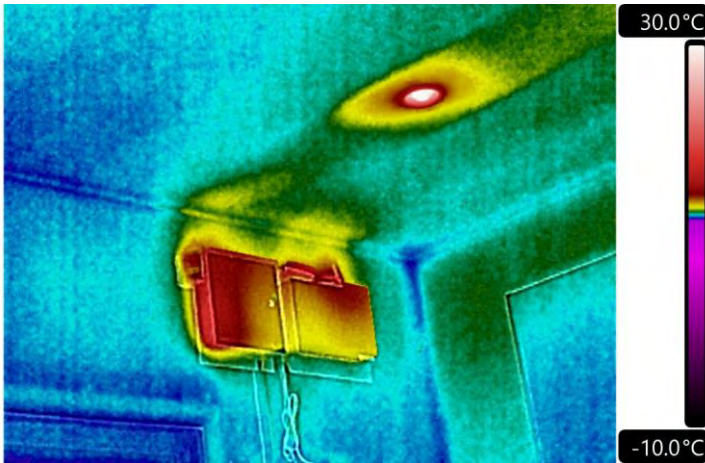
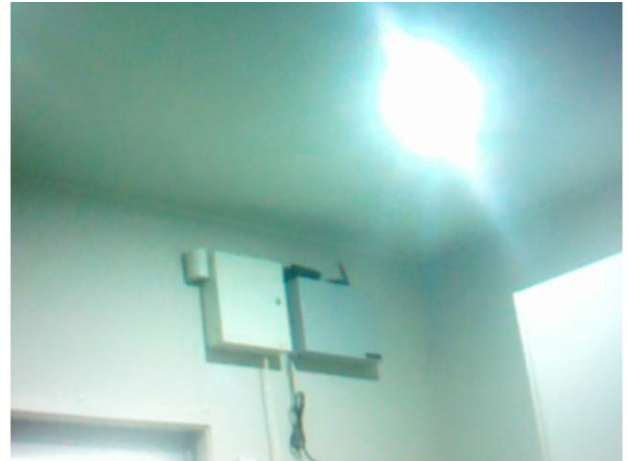
IR_19991.jpg | 20/05/2026 | 1:57 am

Building Information	
Location	Ground floor
Room	Garage
Area	Ceiling / wall
Area Summary

No infrared anomaly was seen in this image at the time of inspection.

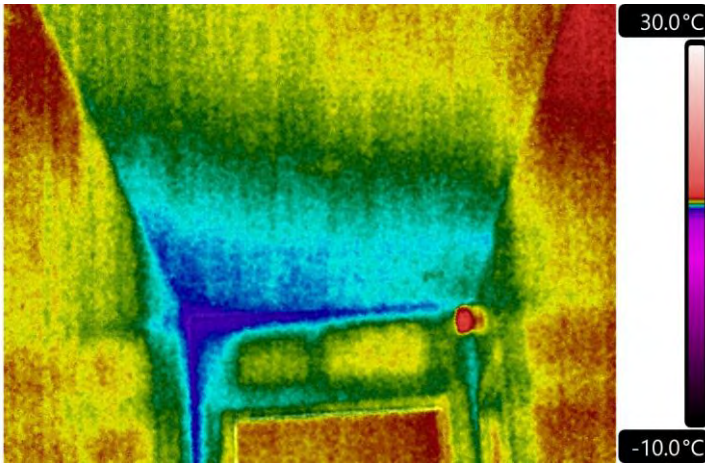
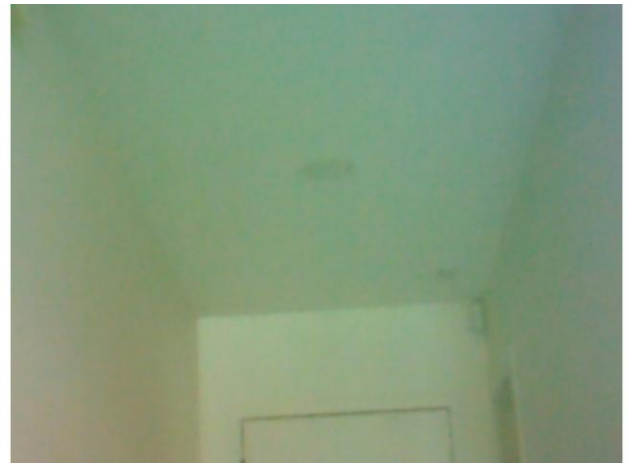
IR_19992.jpg | 20/05/2026 | 2:08 am

Building Information	
Location	Ground floor
Room	Hallway
Area	Ceiling / wall
Area Summary

No infrared anomaly was seen in this image at the time of inspection.

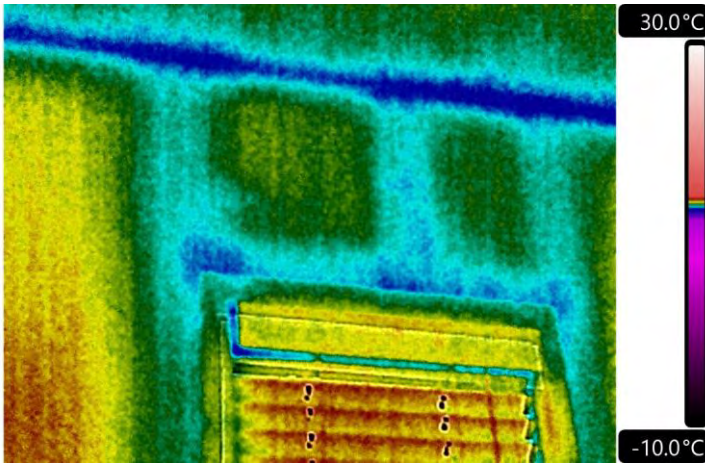
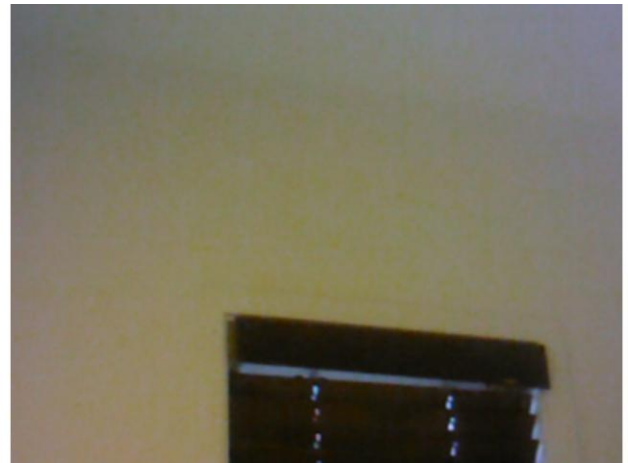
IR_19993.jpg | 20/05/2026 | 2:09 am

Building Information	
Location	Ground floor
Room	Powder room
Area	Ceiling / wall
Area Summary

No infrared anomaly was seen in this image at the time of inspection.

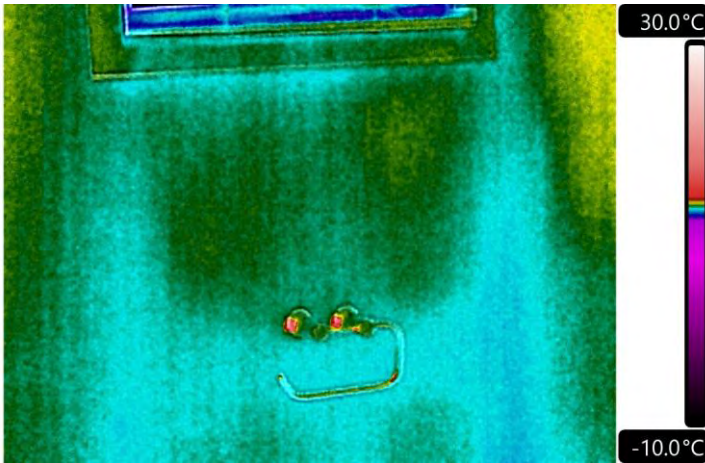
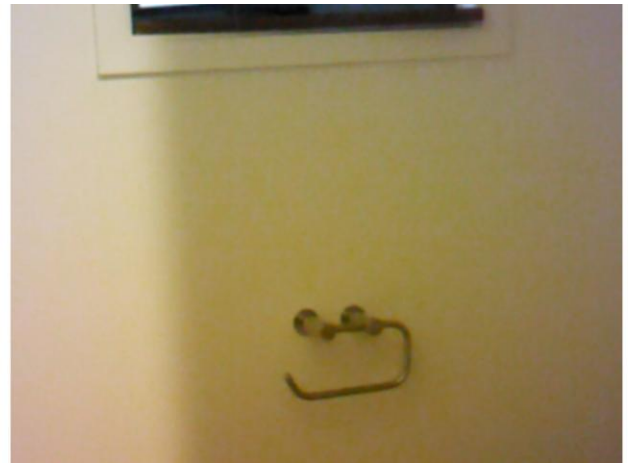
IR_19994.jpg | 20/05/2026 | 2:10 am

Building Information	
Location	Ground floor
Room	Powder room
Area	Window / wall
Area Summary
