THERMOGRAPHY REPORT 1

**151 Durham Dr,
Havelock North.**

Customer	Whistle Trustee Ltd
Site Address	151 Durham Dr, Havelock North
Contact Person	Nic Goodman
Phone Number	+64 21980545
Thermographer	Aaron Bryant
Weather	Overcast - med to heavy rain during the last 5 days.
Date	19 th May 2026

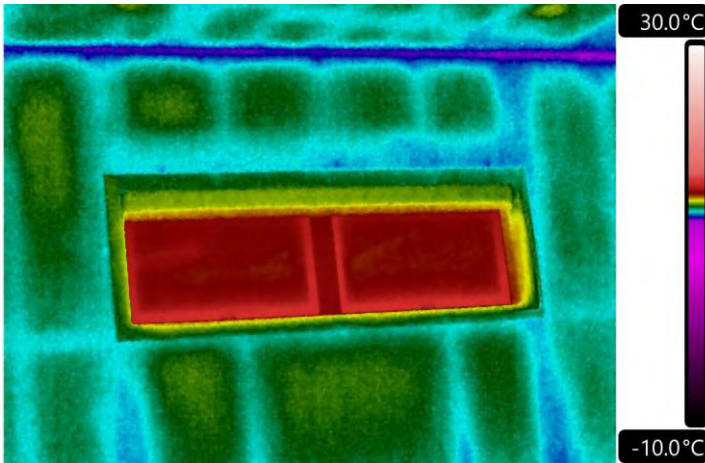
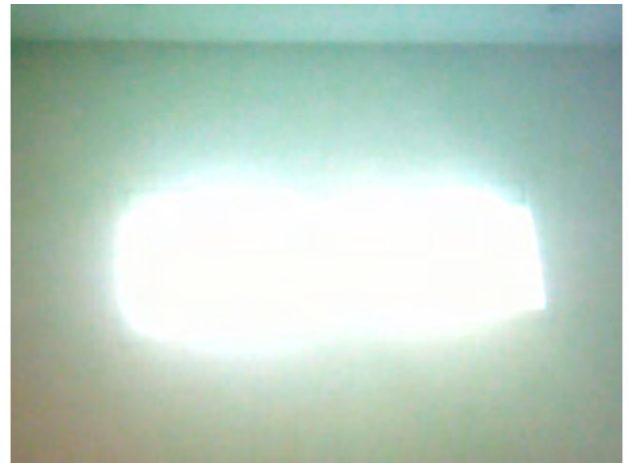
IR_19884.jpg | 20/05/2026 | 12:14 am

Building Information	
Location	First floor
Room	Bedroom 5
Area	Window / wall
Area Summary

No infrared anomaly was seen in this image at the time of inspection.

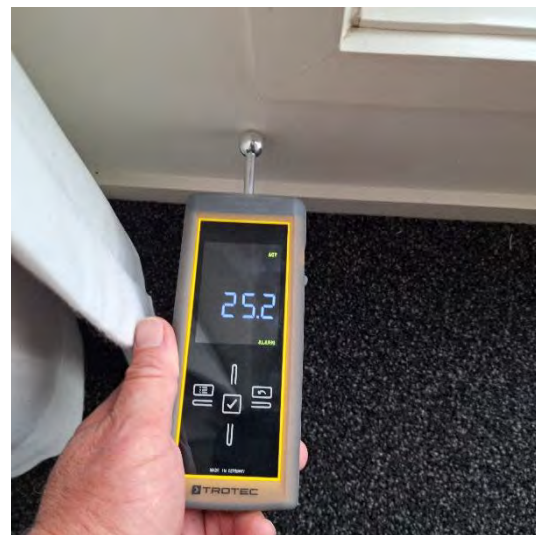
IR_19886.jpg | 20/05/2026 | 12:16 am

Building Information	
Location	First floor
Room	Bedroom 5
Area	Wall / floor
Area Summary

A slight infrared anomaly was seen in this image it was investigated further with a Trotec moisture meter and readings were found to be an acceptable level under the threshold of 50 and similar to the surrounding area at the time of inspection.

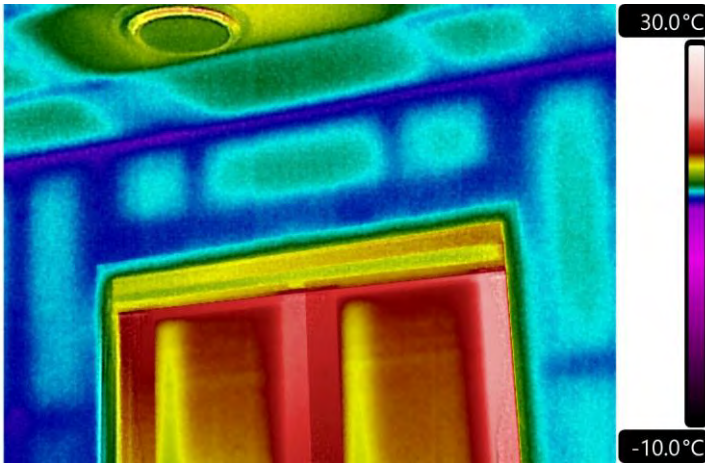
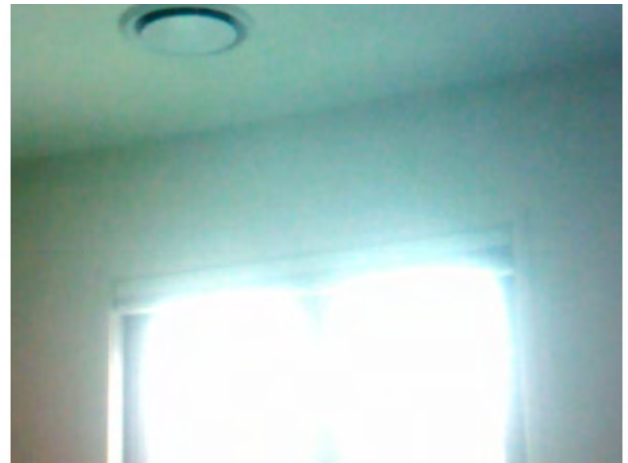
IR_19888.jpg | 20/05/2026 | 12:22 am

Building Information	
Location	First floor
Room	Sitting room
Area	Window / wall
Area Summary

No infrared anomaly was seen in this image at the time of inspection.

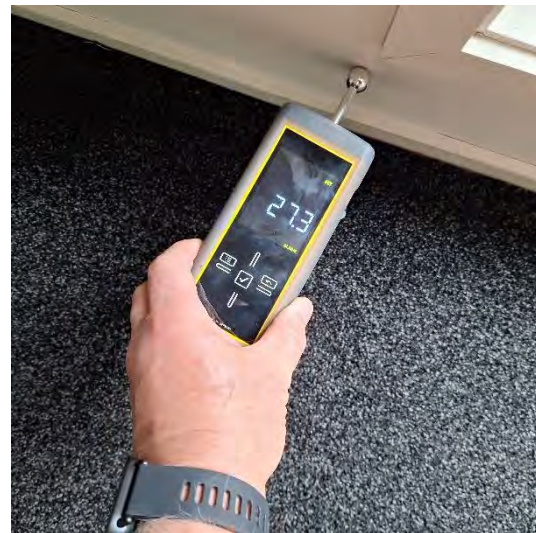
IR_19889.jpg | 20/05/2026 | 12:23 am

Building Information	
Location	First floor
Room	Sitting room
Area	Wall / floor
Area Summary

A slight infrared anomaly was seen in this image it was investigated further with a Trotec moisture meter and readings were found to be an acceptable level under the threshold of 50 and similar to the surrounding area at the time of inspection.

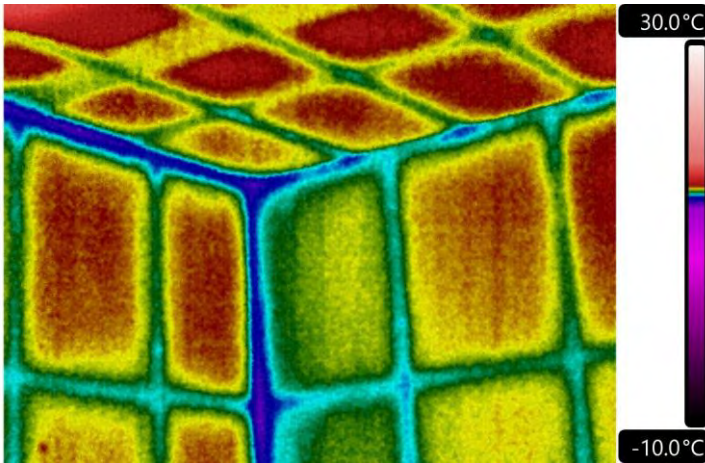
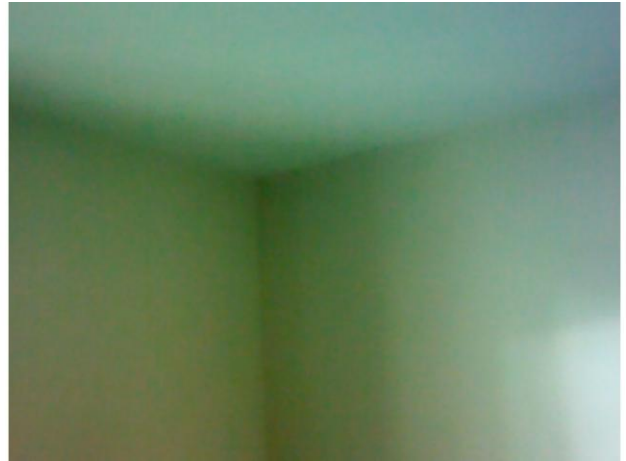
IR_19891.jpg | 20/05/2026 | 12:24 am

Building Information	
Location	First floor
Room	Sitting room
Area	Ceiling / wall
Area Summary

No infrared anomaly was seen in this image at the time of inspection.

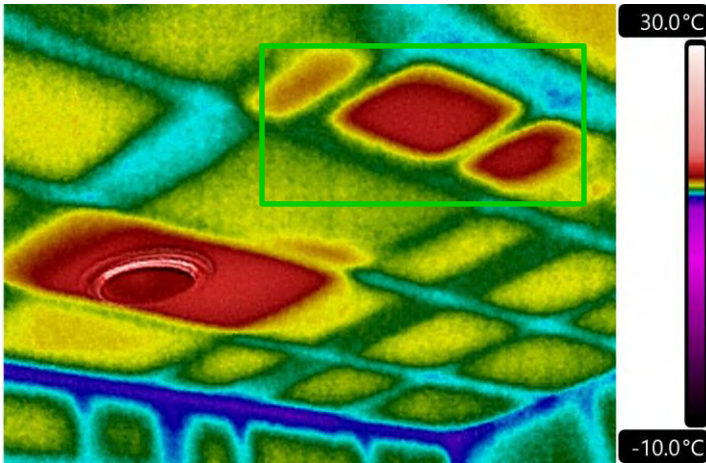
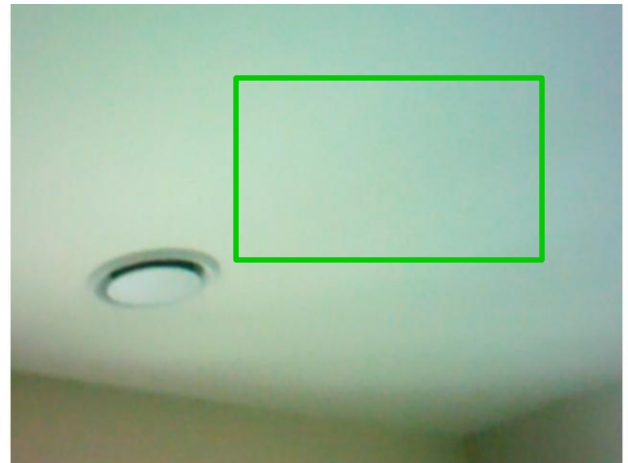
IR_19892.jpg | 20/05/2026 | 12:24 am

Building Information	
Location	First floor
Room	Sitting room
Area	Ceiling
Area Summary

A slight infrared anomaly was seen in this image it was investigated further with a Trotec moisture meter and readings were found to be an acceptable level under the threshold of 50 and similar to the surrounding area at the time of inspection.

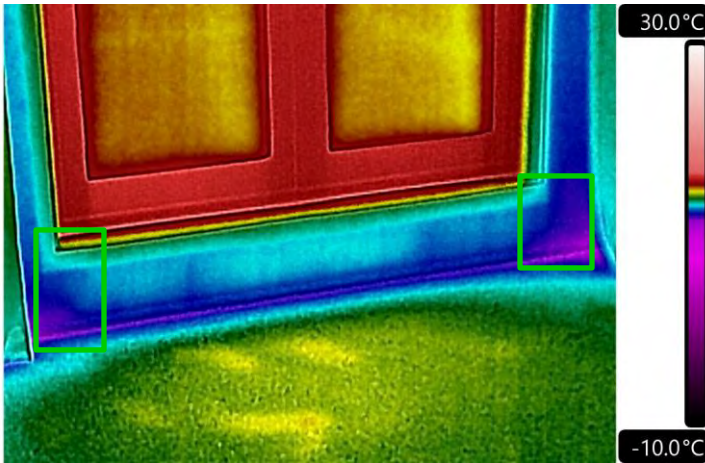
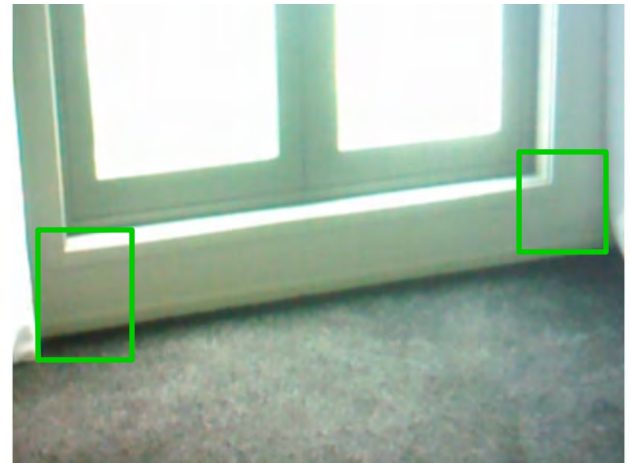
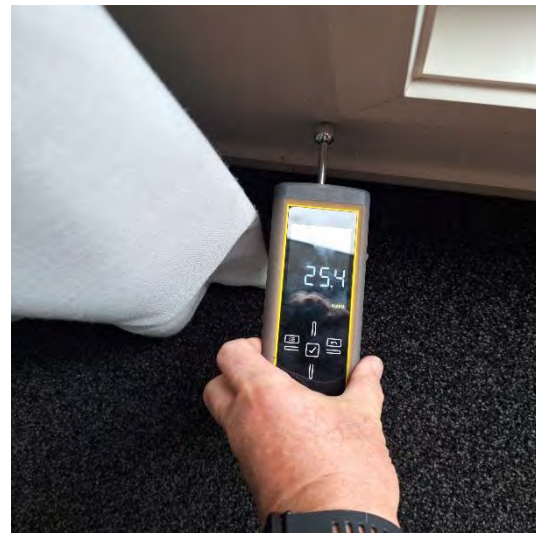
IR_19894.jpg | 20/05/2026 | 12:28 am

Building Information	
Location	First floor
Room	Bedroom 4
Area	Wall / floor
Area Summary

A slight infrared anomaly was seen in this image it was investigated further with a Trotec moisture meter and readings were found to be an acceptable level under the threshold of 50 and similar to the surrounding area at the time of inspection.

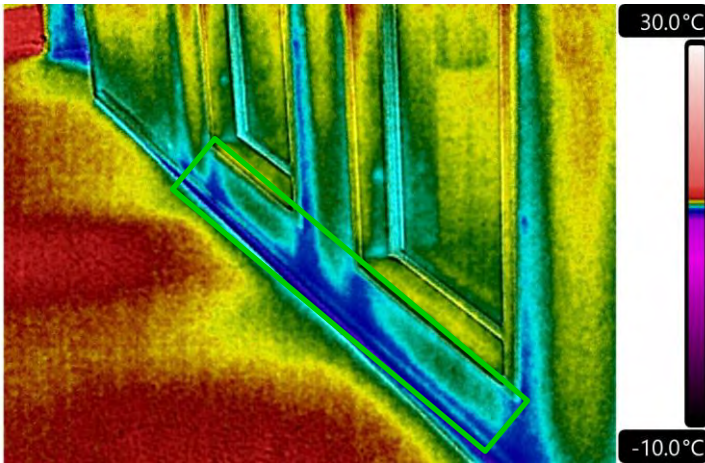
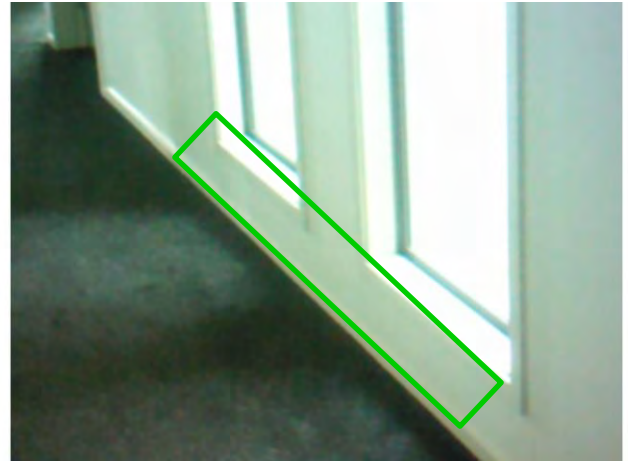
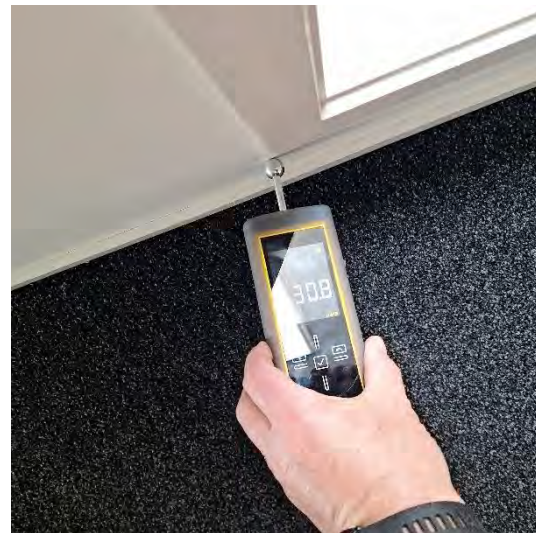
IR_19896.jpg | 20/05/2026 | 12:29 am

Building Information	
Location	First floor
Room	Hallway
Area	Wall / floor
Area Summary

A slight infrared anomaly was seen in this image it was investigated further with a Trotec moisture meter and readings were found to be an acceptable level under the threshold of 50 and similar to the surrounding area at the time of inspection.

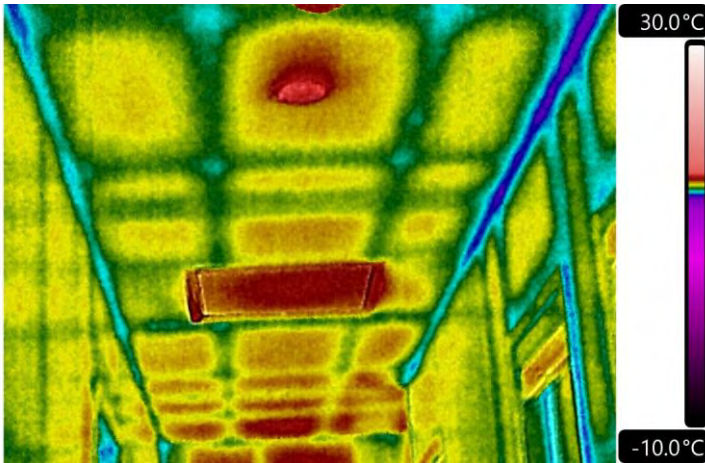
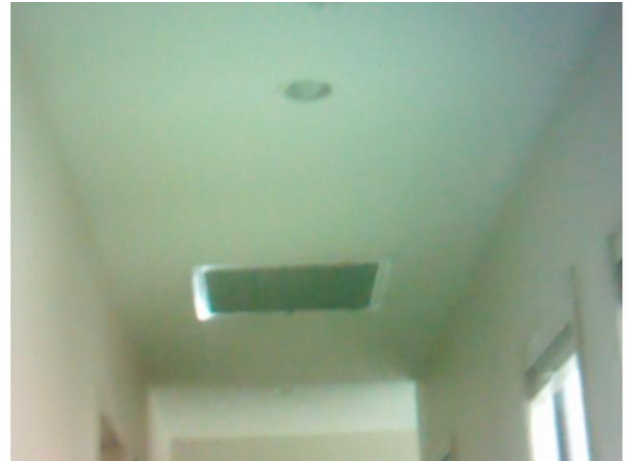
IR_19898.jpg | 20/05/2026 | 12:30 am

Building Information	
Location	First floor
Room	Hallway
Area	Ceiling / wall
Area Summary

No infrared anomaly was seen in this image at the time of inspection.

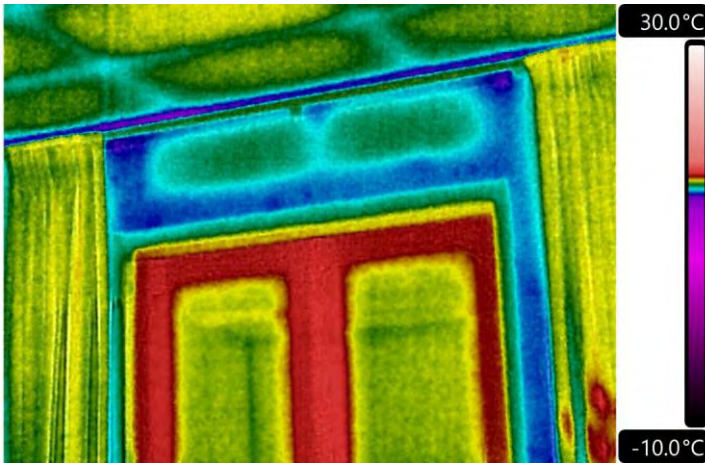
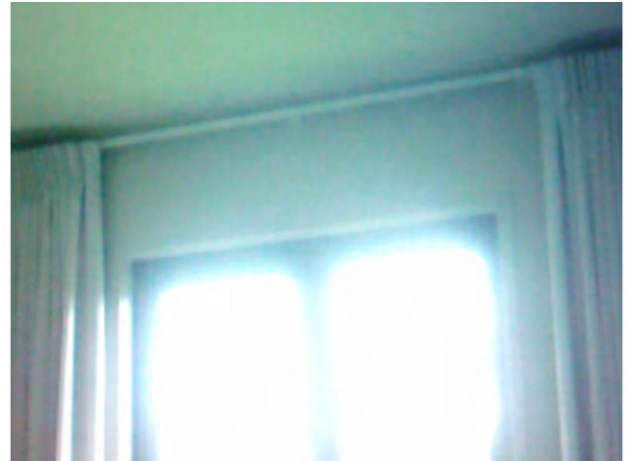
IR_19899.jpg | 20/05/2026 | 12:33 am

Building Information	
Location	First floor
Room	Bedroom 3
Area	Window / wall
Area Summary

No infrared anomaly was seen in this image at the time of inspection.

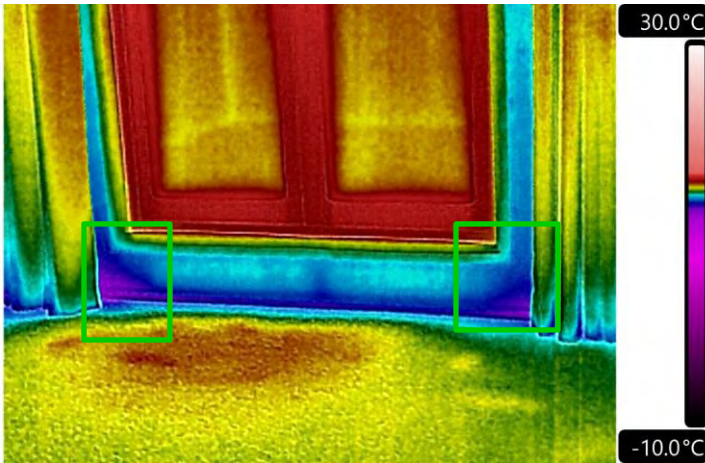
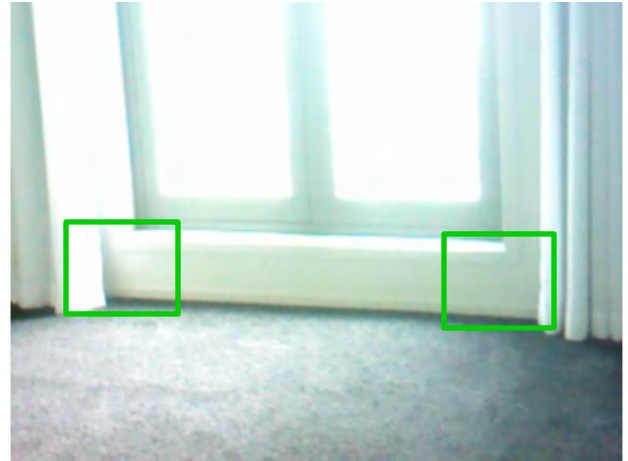
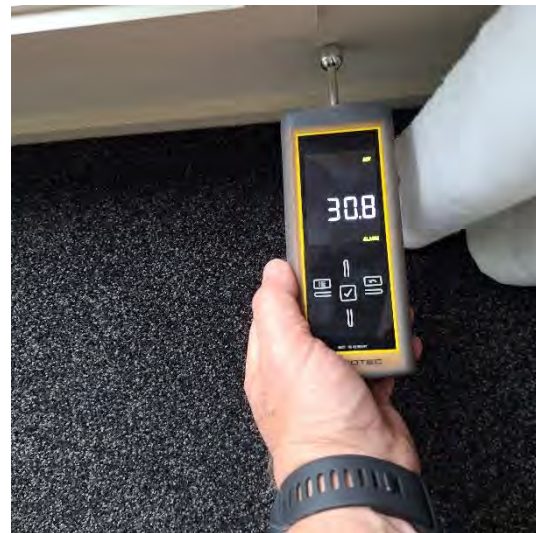
IR_19900.jpg | 20/05/2026 | 12:34 am

Building Information	
Location	First floor
Room	Bedroom 3
Area	Wall / floor
Area Summary

A slight infrared anomaly was seen in this image it was investigated further with a Trotec moisture meter and readings were found to be an acceptable level under the threshold of 50 and similar to the surrounding area at the time of inspection.

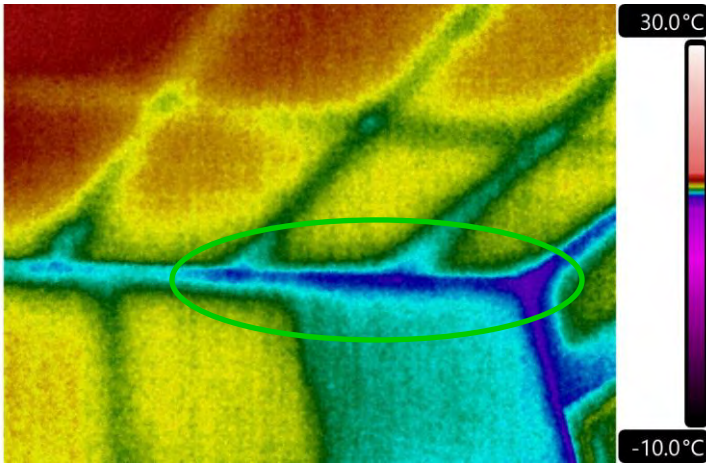
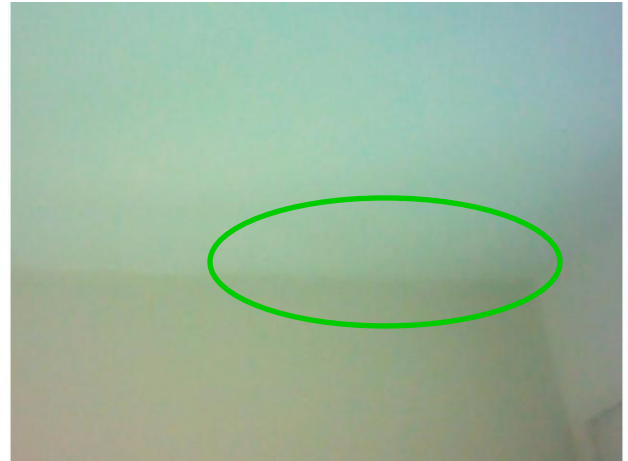
IR_19902.jpg | 20/05/2026 | 12:35 am

Building Information	
Location	First floor
Room	Bedroom 3
Area	Ceiling / wall
Area Summary

A slight infrared anomaly was seen in this image it was investigated further with a Trotec moisture meter and readings were found to be an acceptable level under the threshold of 50 and similar to the surrounding area at the time of inspection.

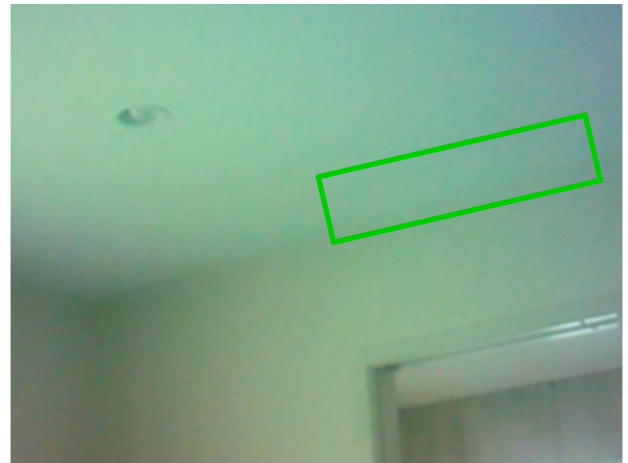
IR_19903.jpg | 20/05/2026 | 12:35 am

Building Information	
Location	First floor
Room	Bedroom 3
Area	Ceiling / wall
Area Summary

No infrared anomaly was seen in this image at the time of inspection.

However as there was evidence of a previous repair, moisture meter readings were therefore taken and found to be within an acceptable range.

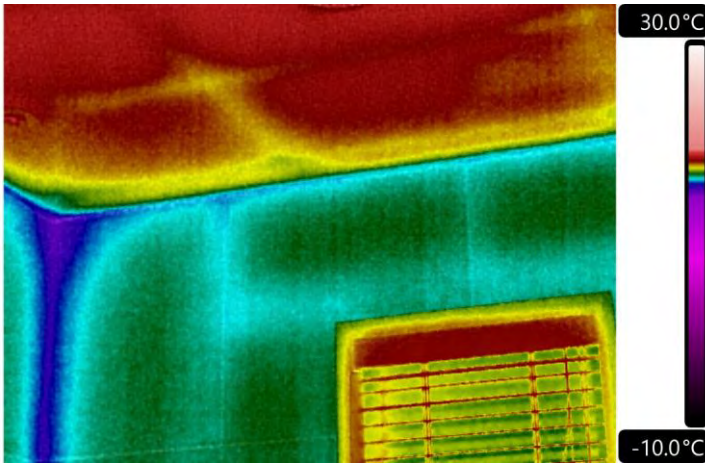
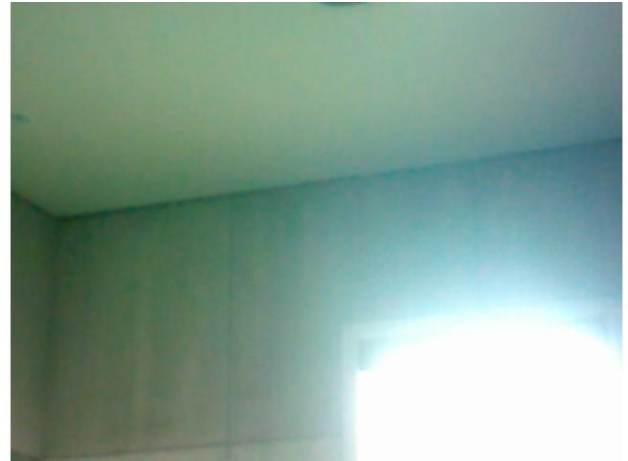
IR_19905.jpg | 20/05/2026 | 12:41 am

Building Information	
Location	First floor
Room	Shared Bathroom
Area	Window / wall
Area Summary

No infrared anomaly was seen in this image at the time of inspection.

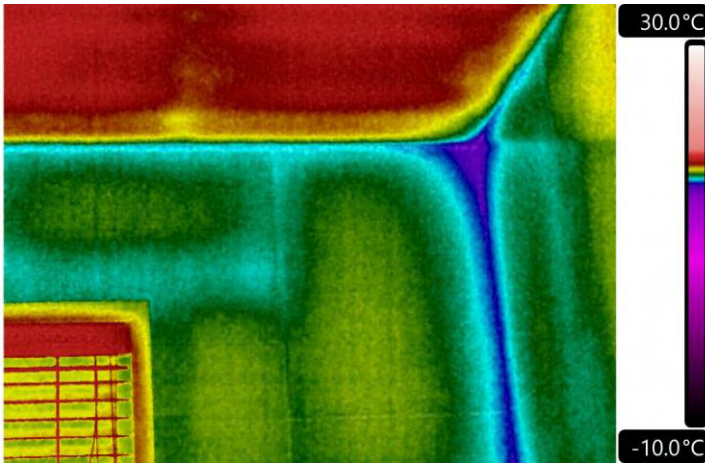
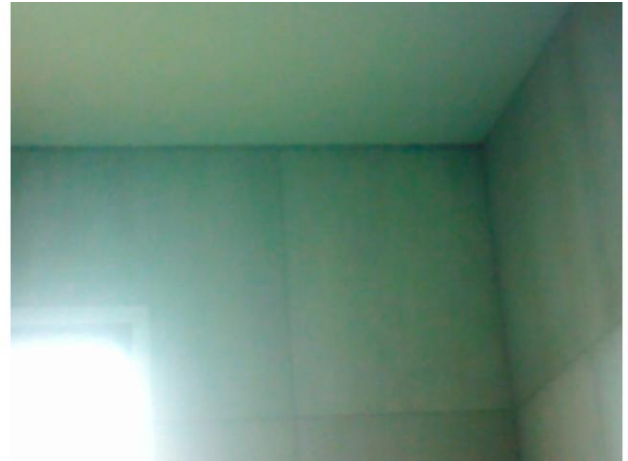
IR_19906.jpg | 20/05/2026 | 12:41 am

Building Information	
Location	First floor
Room	Shared Bathroom
Area	Window / wall
Area Summary

No infrared anomaly was seen in this image at the time of inspection.

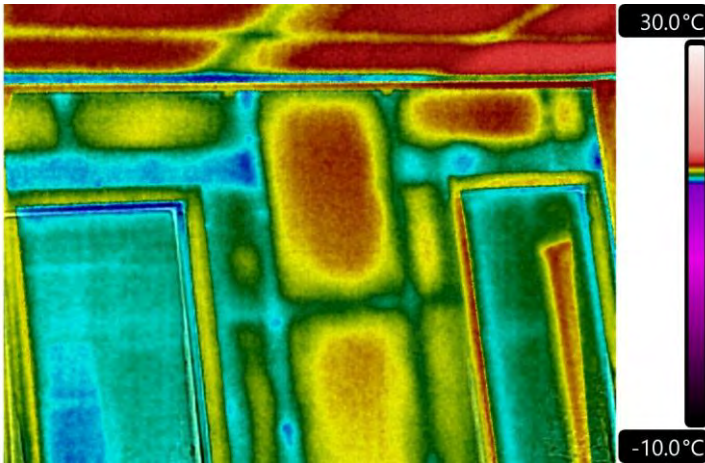
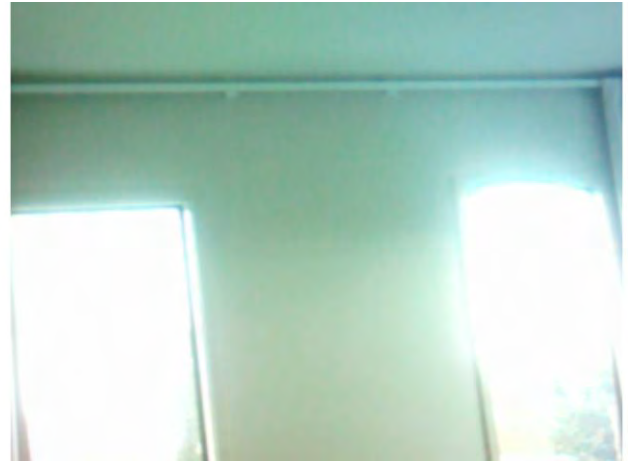
IR_19908.jpg | 20/05/2026 | 12:43 am

Building Information	
Location	First floor
Room	Bedroom 2
Area	Window / wall
Area Summary

No infrared anomaly was seen in this image at the time of inspection.

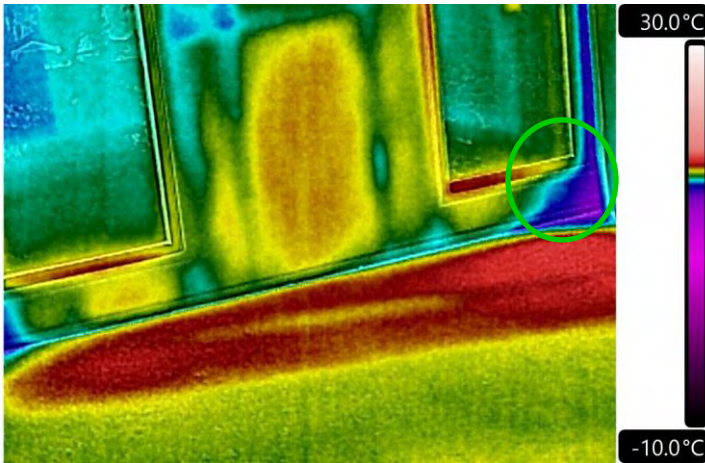
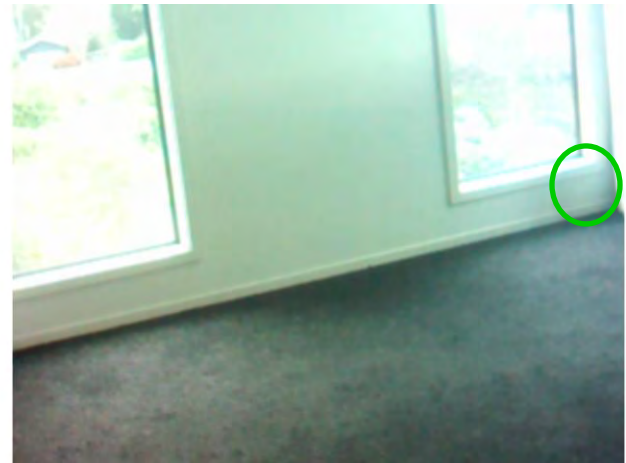
IR_19909.jpg | 20/05/2026 | 12:44 am

Building Information	
Location	First floor
Room	Bedroom 2
Area	Window / wall
Area Summary

A slight infrared anomaly was seen in this image it was investigated further with a Trotec moisture meter and readings were found to be an acceptable level under the threshold of 50 and similar to the surrounding area at the time of inspection.

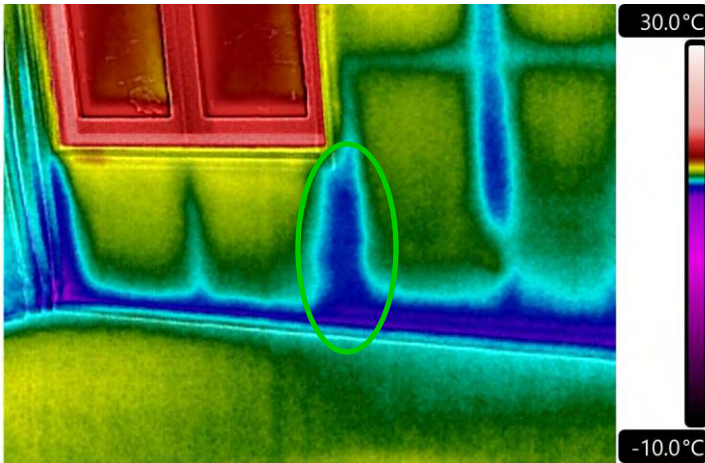
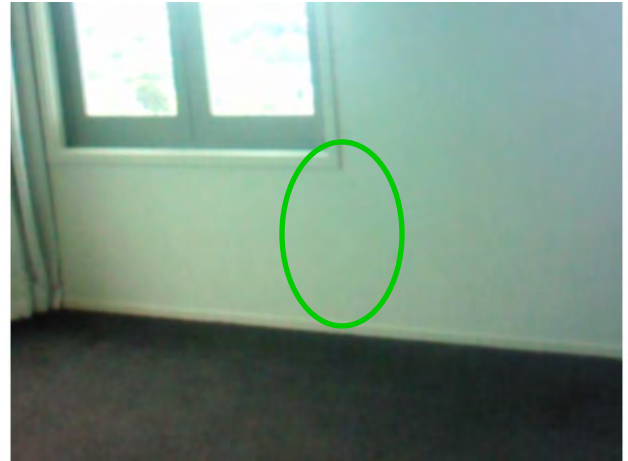
IR_19911.jpg | 20/05/2026 | 12:44 am

Building Information	
Location	First floor
Room	Bedroom 2
Area	Window / wall
Area Summary

A slight infrared anomaly was seen in this image it was investigated further with a Trotec moisture meter and readings were found to be an acceptable level under the threshold of 50 and similar to the surrounding area at the time of inspection.

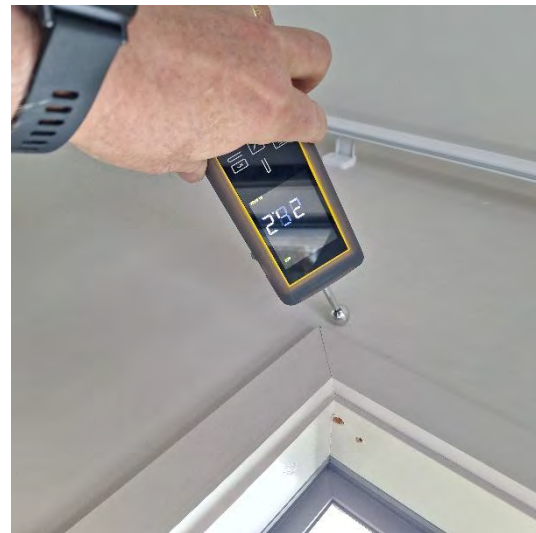
IR_19912.jpg | 20/05/2026 | 12:44 am

Building Information	
Location	First floor
Room	Bedroom 2
Area	Window / wall
Area Summary

A slight infrared anomaly was seen in this image it was investigated further with a Trotec moisture meter and readings were found to be an acceptable level under the threshold of 50 and similar to the surrounding area at the time of inspection.

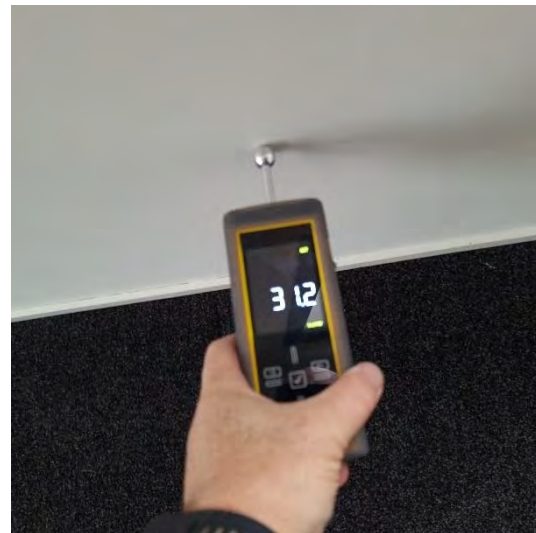
IR_19913.jpg | 20/05/2026 | 12:45 am

Building Information	
Location	First floor
Room	Bedroom 2
Area	Window / wall
Area Summary

A slight infrared anomaly was seen in this image it was investigated further with a Trotec moisture meter and readings were found to be an acceptable level under the threshold of 50 and similar to the surrounding area at the time of inspection.

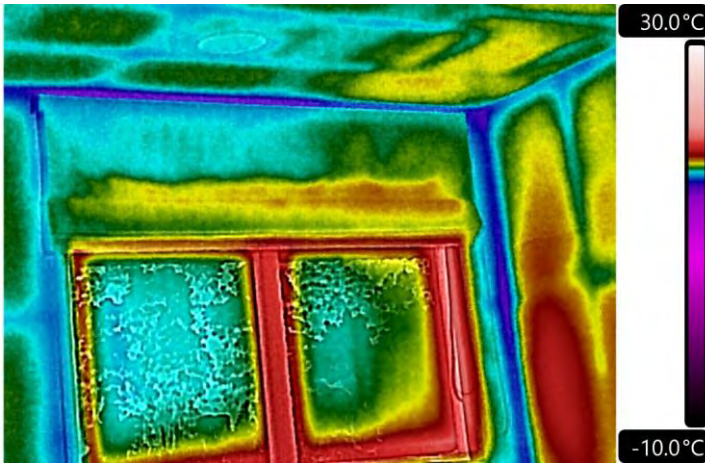
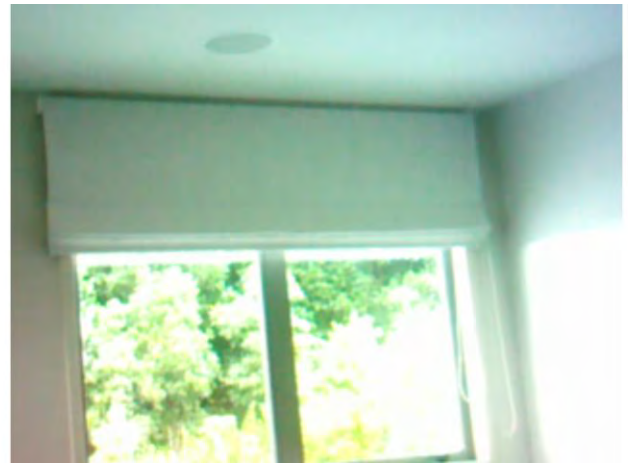
IR_19915.jpg | 20/05/2026 | 12:51 am

Building Information	
Location	First floor
Room	Lounge
Area	Ceiling / wall
Area Summary

No infrared anomaly was seen in this image at the time of inspection.

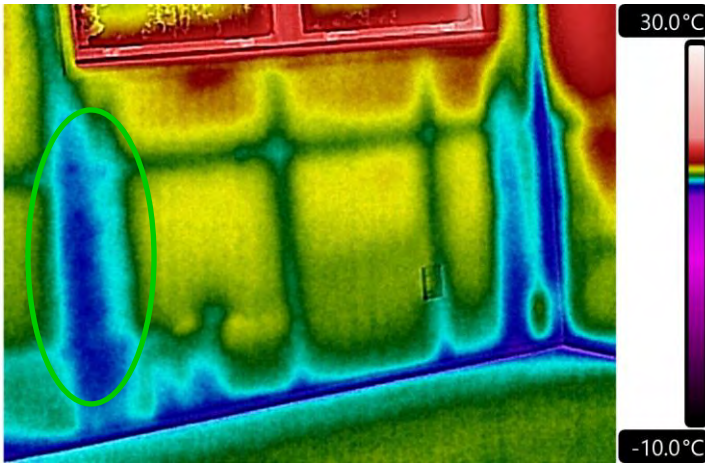
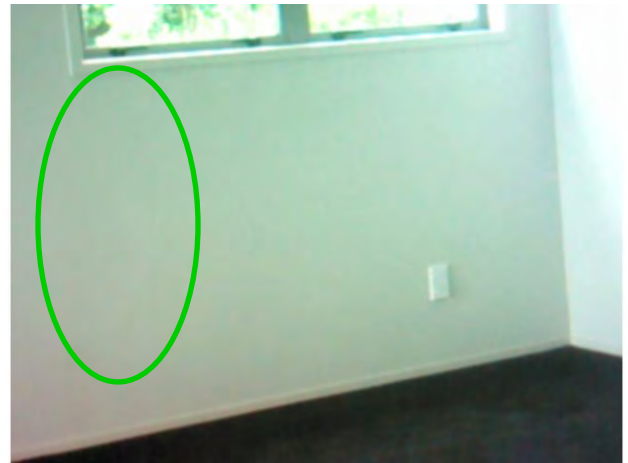
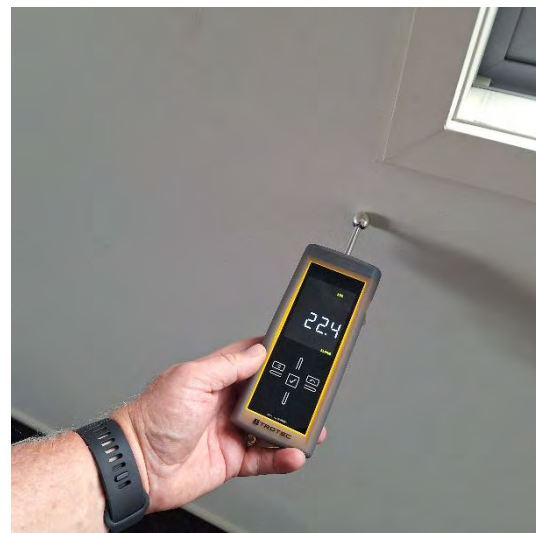
IR_19916.jpg | 20/05/2026 | 12:52 am

Building Information	
Location	First floor
Room	Lounge
Area	Ceiling / wall
Area Summary

A slight infrared anomaly was seen in this image it was investigated further with a Trotec moisture meter and readings were found to be an acceptable level under the threshold of 50 and similar to the surrounding area at the time of inspection.

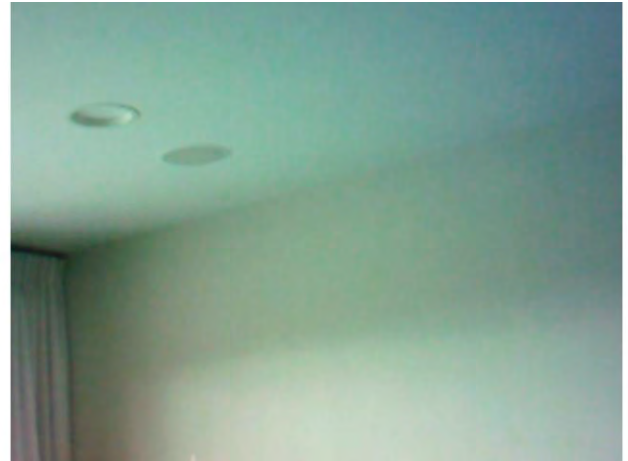
IR_19917.jpg | 20/05/2026 | 12:52 am

Building Information	
Location	First floor
Room	Lounge
Area	Ceiling / wall
Area Summary

No infrared anomaly was seen in this image at the time of inspection.

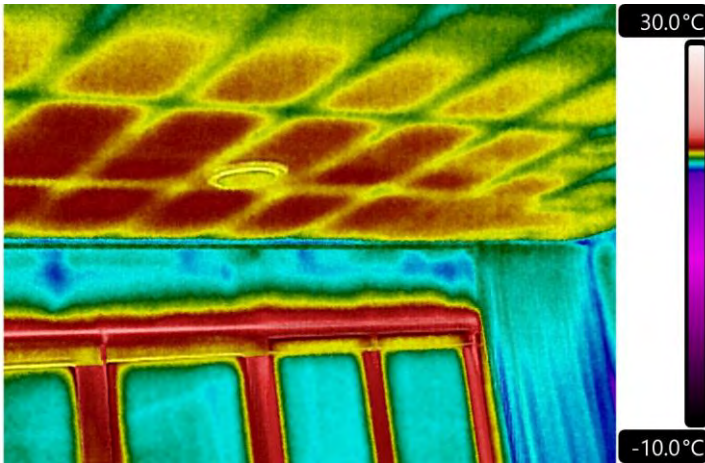
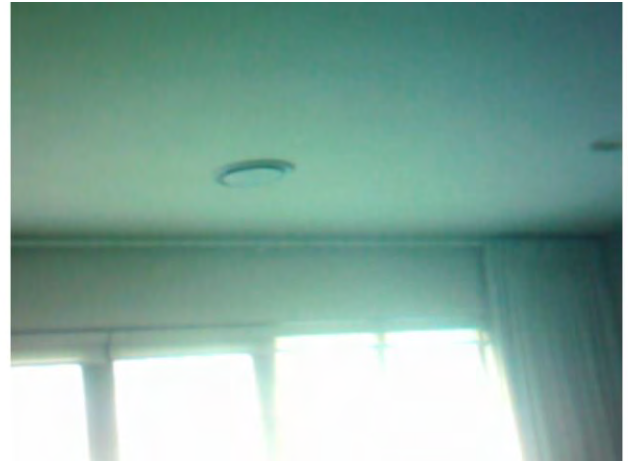
IR_19918.jpg | 20/05/2026 | 12:52 am

Building Information	
Location	First floor
Room	Lounge
Area	Ceiling / wall
Area Summary

No infrared anomaly was seen in this image at the time of inspection.

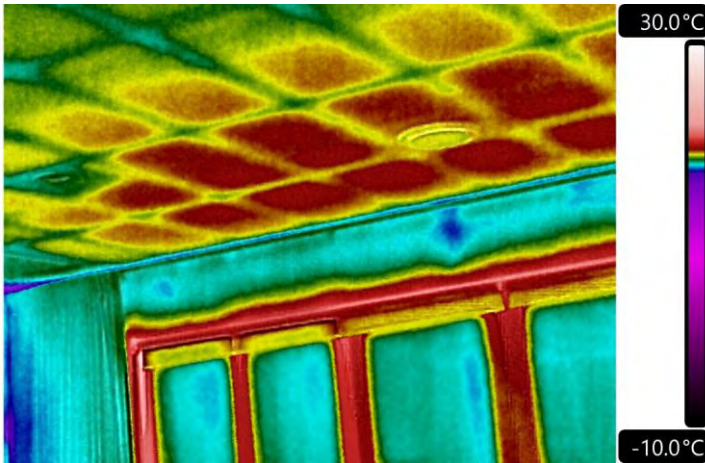
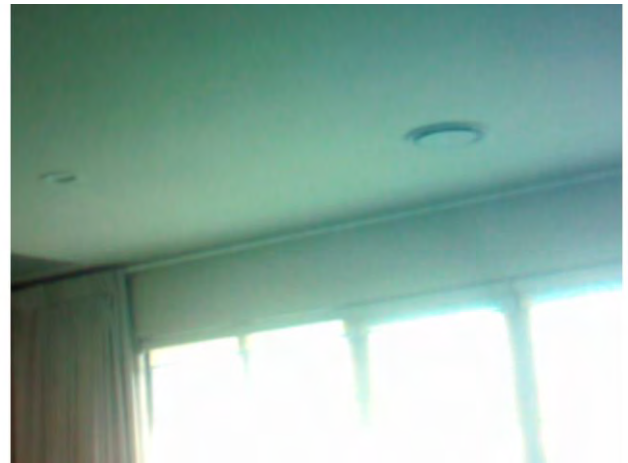
IR_19919.jpg | 20/05/2026 | 12:53 am

Building Information	
Location	First floor
Room	Lounge
Area	Ceiling / wall
Area Summary

No infrared anomaly was seen in this image at the time of inspection.

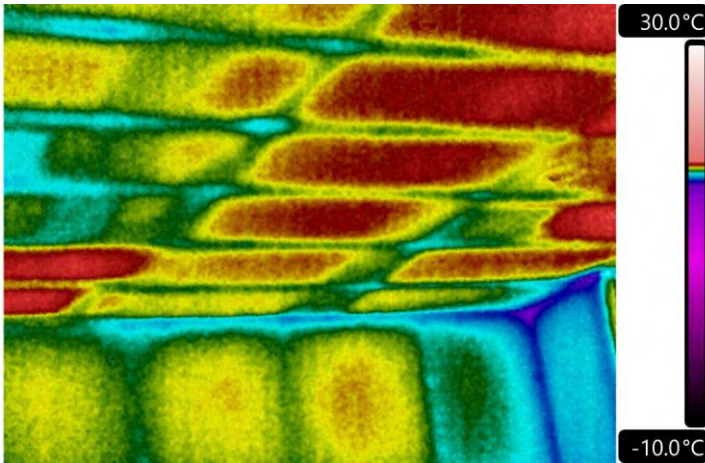
IR_19920.jpg | 20/05/2026 | 12:53 am

Building Information	
Location	First floor
Room	Lounge
Area	Ceiling / wall
Area Summary

No infrared anomaly was seen in this image at the time of inspection.

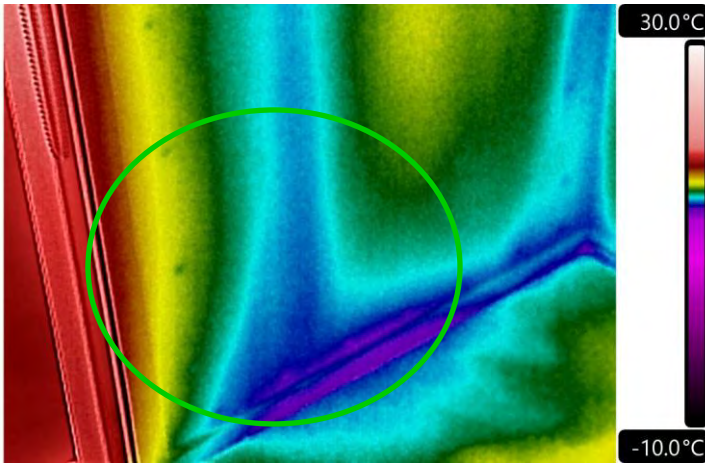
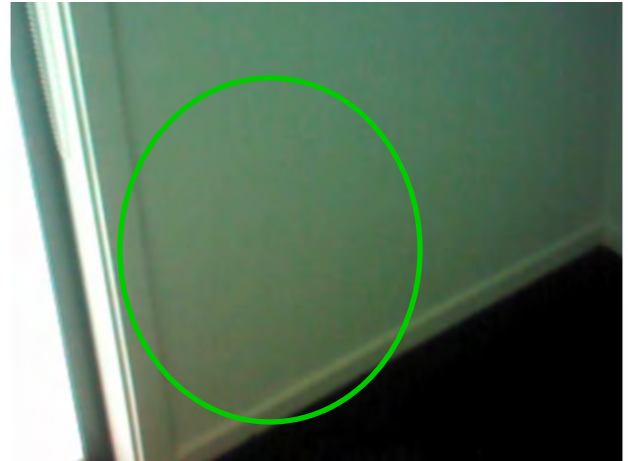
IR_19921.jpg | 20/05/2026 | 12:54 am

Building Information	
Location	First floor
Room	Lounge
Area	Wall / floor
Area Summary

A slight infrared anomaly was seen in this image it was investigated further with a Trotec moisture meter and readings were found to be an acceptable level under the threshold of 50 and similar to the surrounding area at the time of inspection.

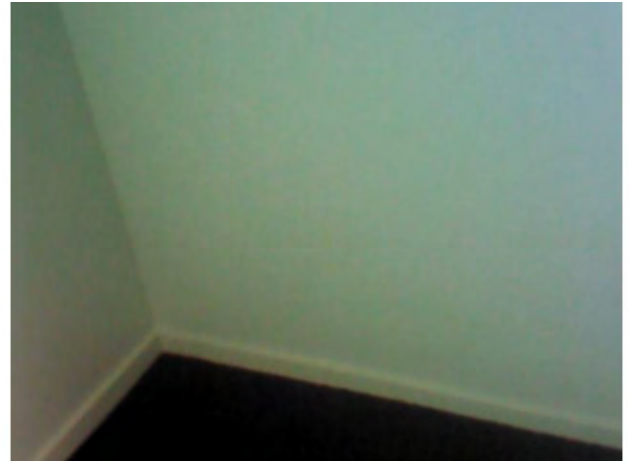
IR_19922.jpg | 20/05/2026 | 12:55 am

Building Information	
Location	First floor
Room	Lounge
Area	Wall / floor
Area Summary

No infrared anomaly was seen in this image at the time of inspection.

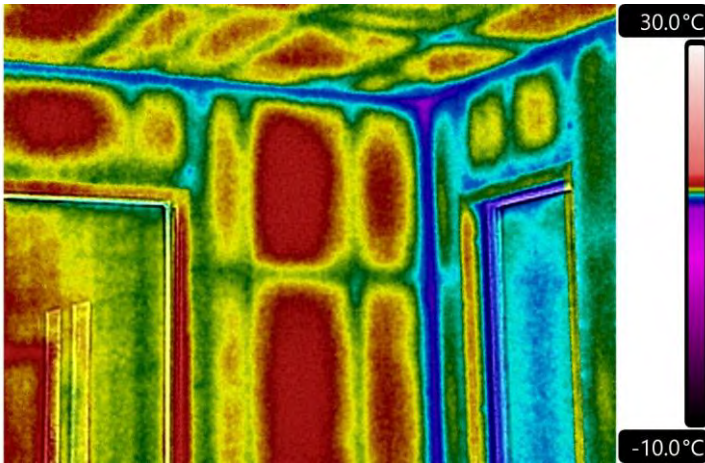
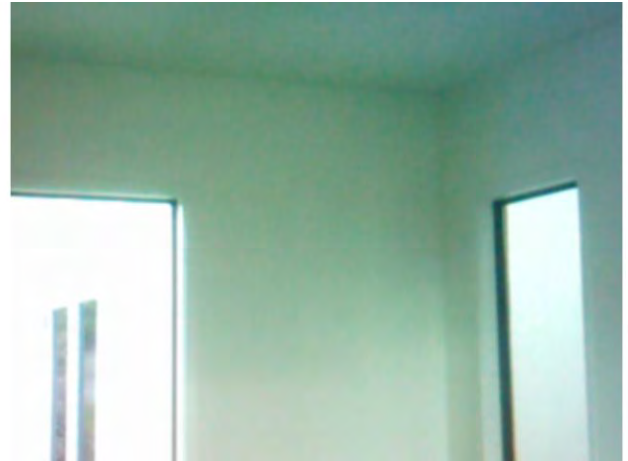
IR_19923.jpg | 20/05/2026 | 12:58 am

Building Information	
Location	First floor
Room	Staircase
Area	Window / wall
Area Summary

No infrared anomaly was seen in this image at the time of inspection.

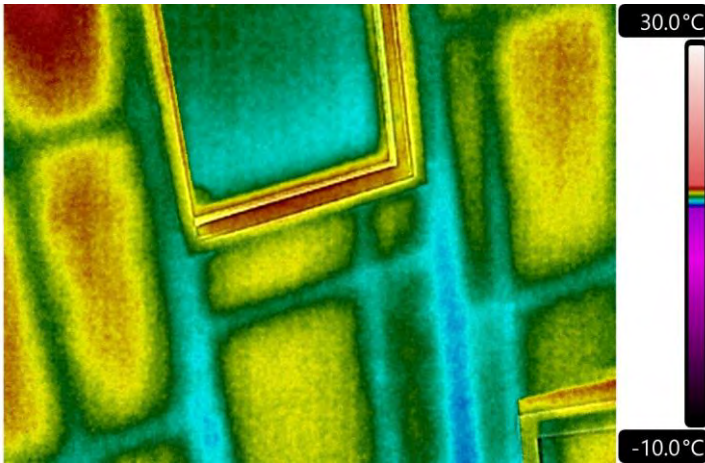
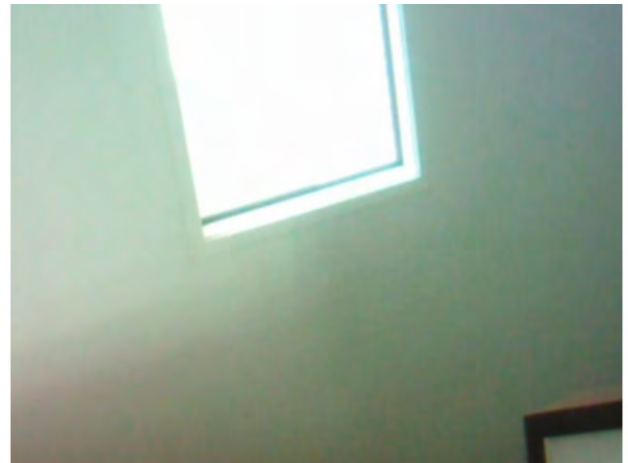
IR_19924.jpg | 20/05/2026 | 12:58 am

Building Information	
Location	First floor
Room	Staircase
Area	Window / wall
Area Summary

No infrared anomaly was seen in this image at the time of inspection.

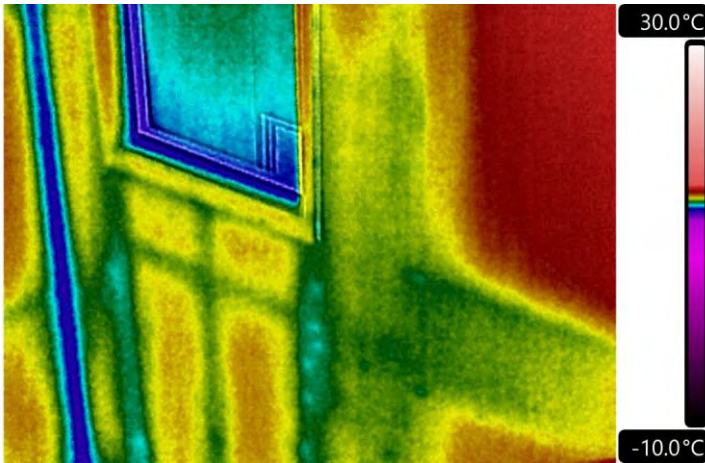
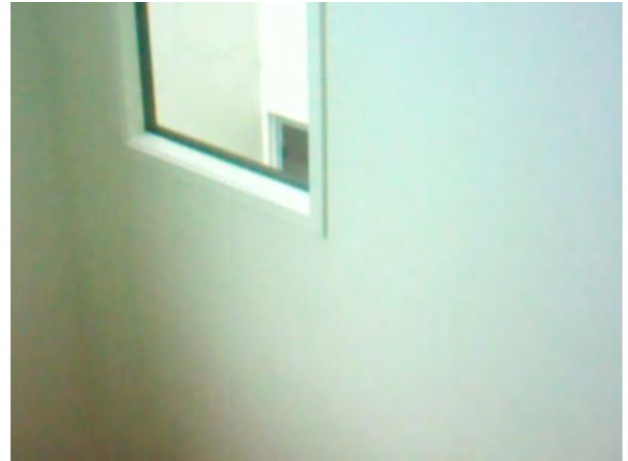
IR_19925.jpg | 20/05/2026 | 12:59 am

Building Information	
Location	First floor
Room	Staircase
Area	Window / wall
Area Summary

No infrared anomaly was seen in this image at the time of inspection.

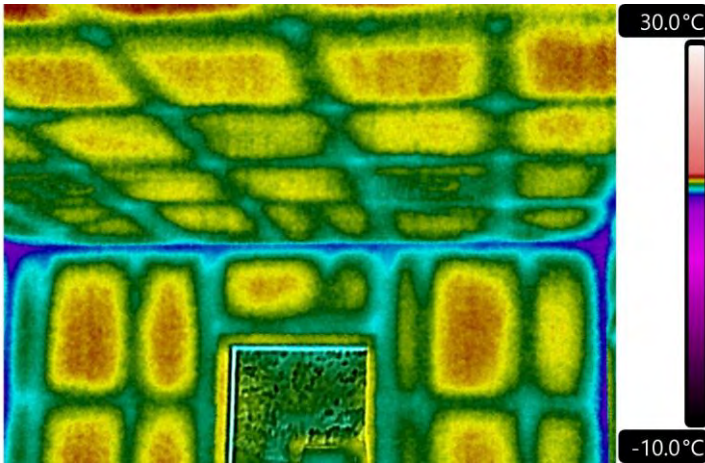
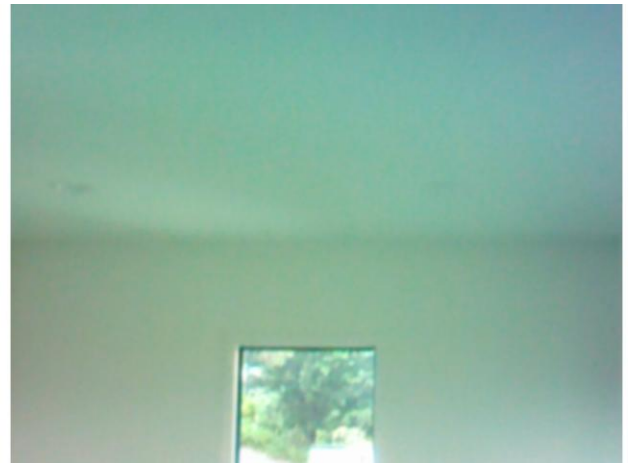
IR_19926.jpg | 20/05/2026 | 12:59 am

Building Information	
Location	First floor
Room	Staircase
Area	Ceiling / wall
Area Summary

No infrared anomaly was seen in this image at the time of inspection.

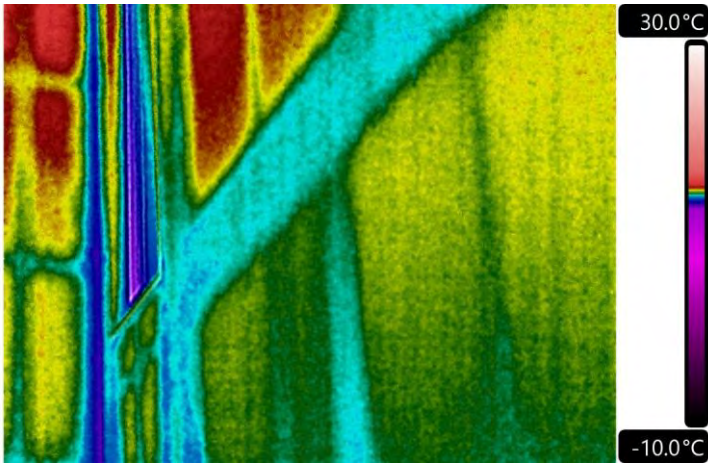
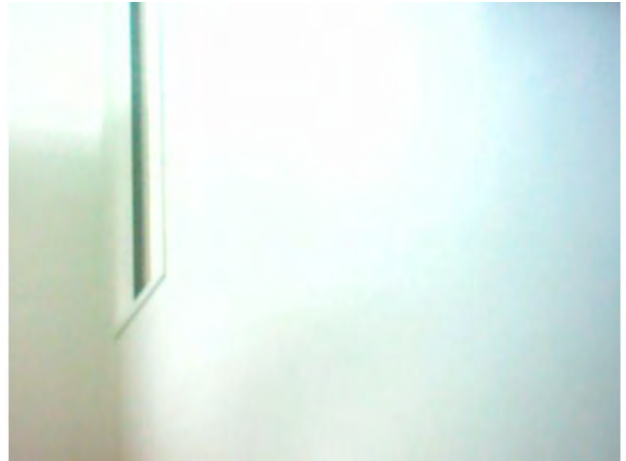
IR_19927.jpg | 20/05/2026 | 1:02 am

Building Information	
Location	First floor
Room	Staircase
Area	Wall
Area Summary
