## BUILDING INSPECTION REPORT

## RESIDENTIAL HOUSE INSPECTION

191 Westminster St 1  
Christchurch, Canterbury Region 8013

28/05/2026

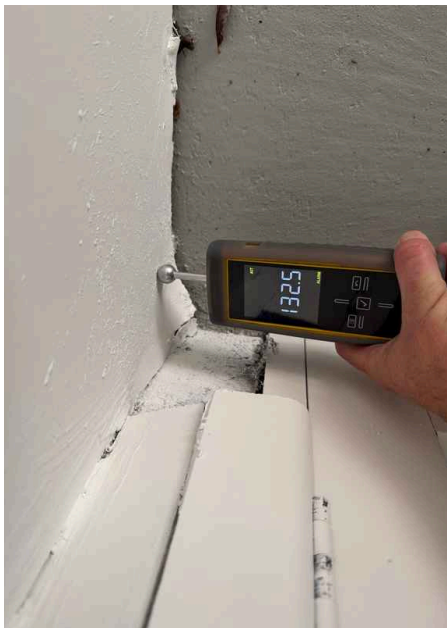
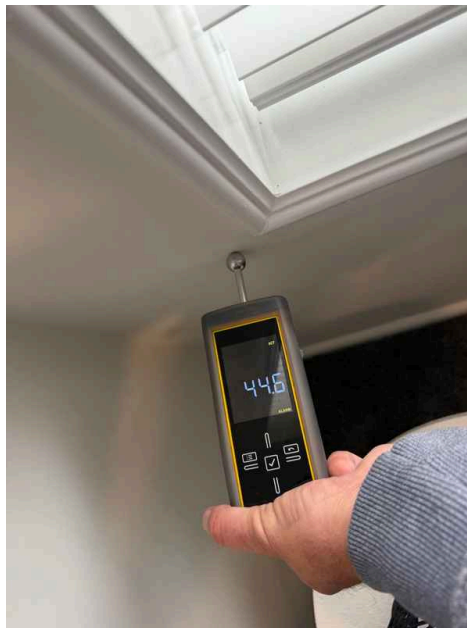
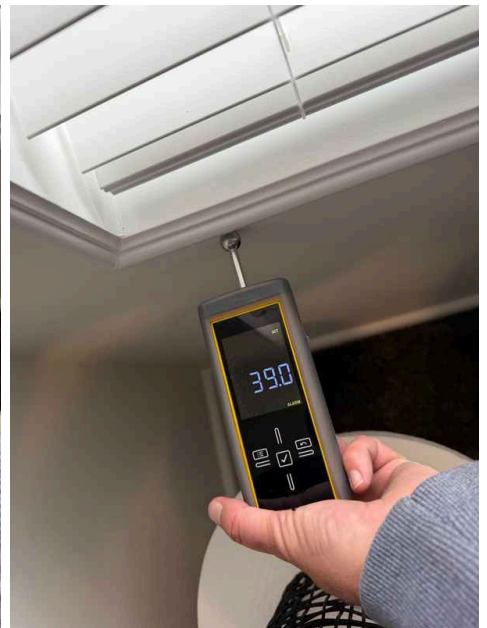
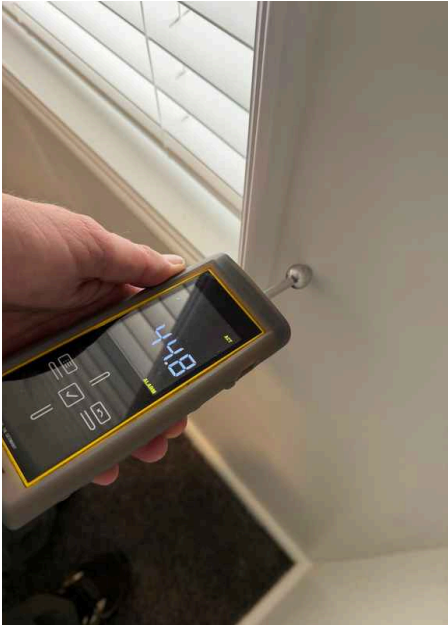
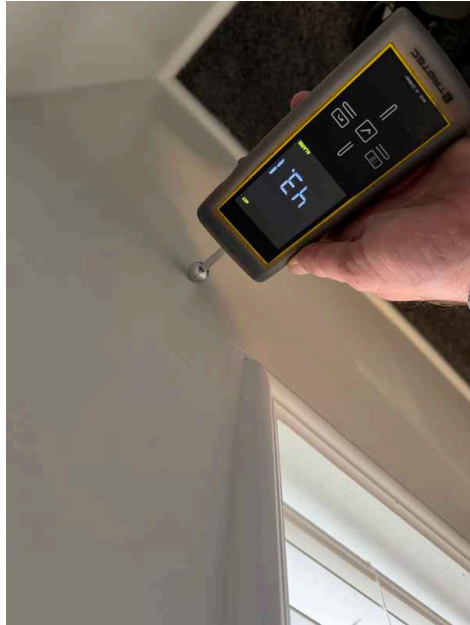
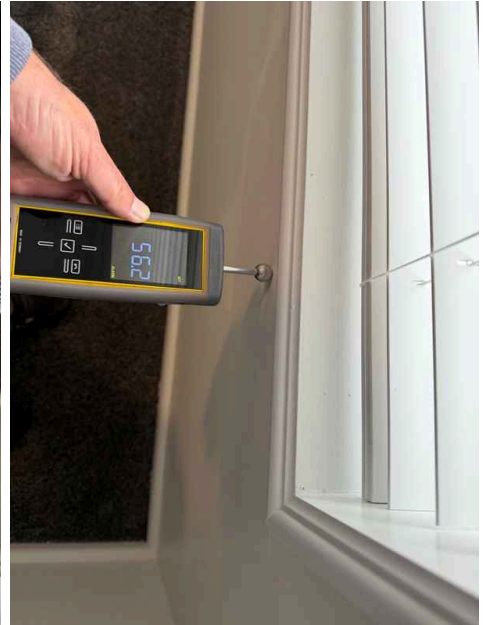
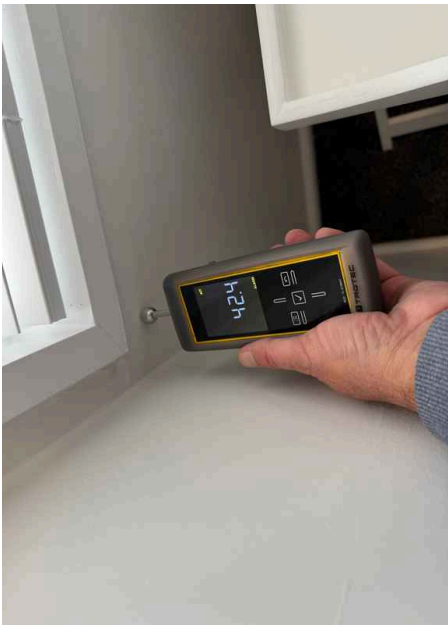
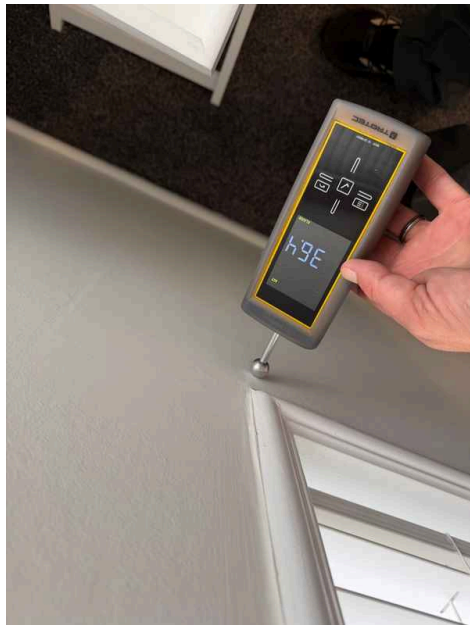
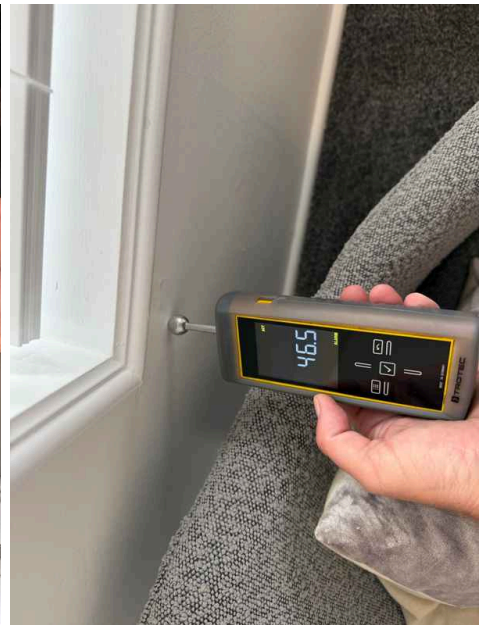
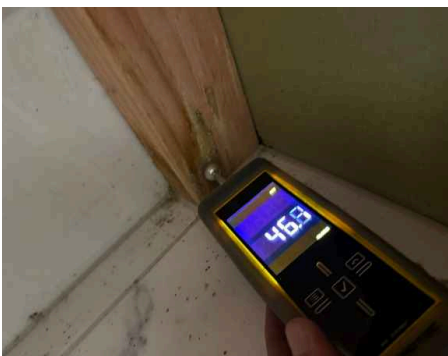
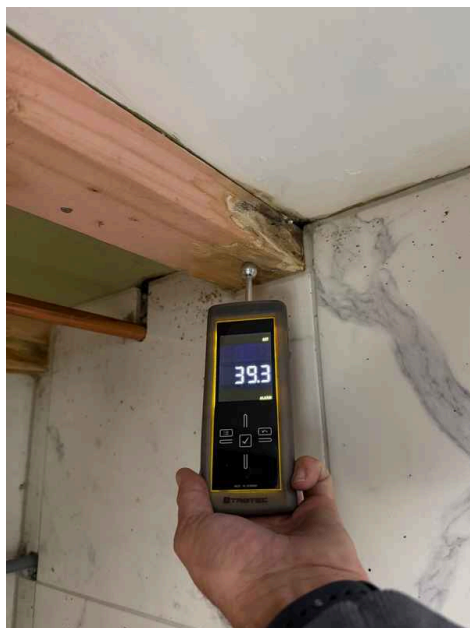
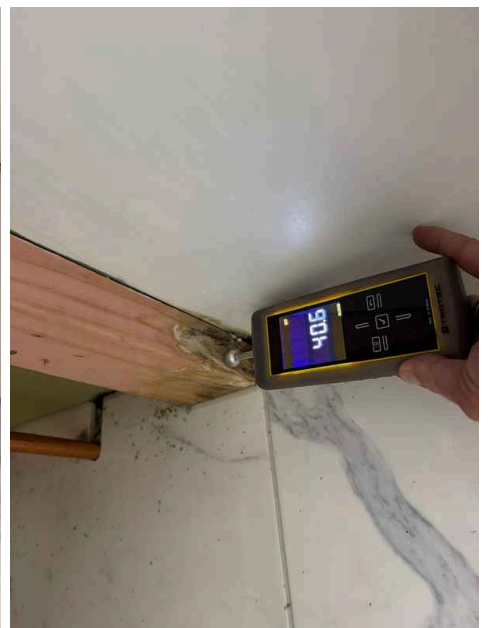
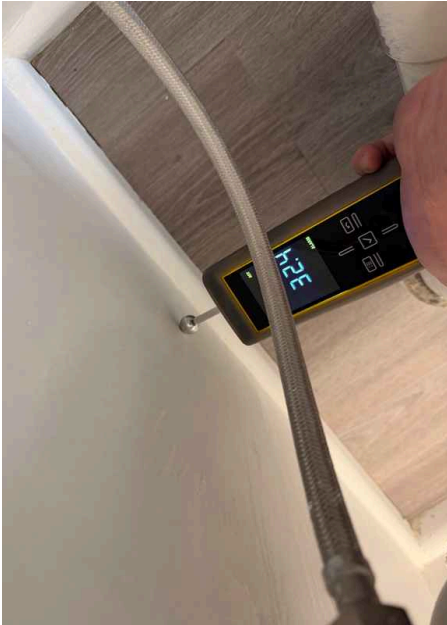
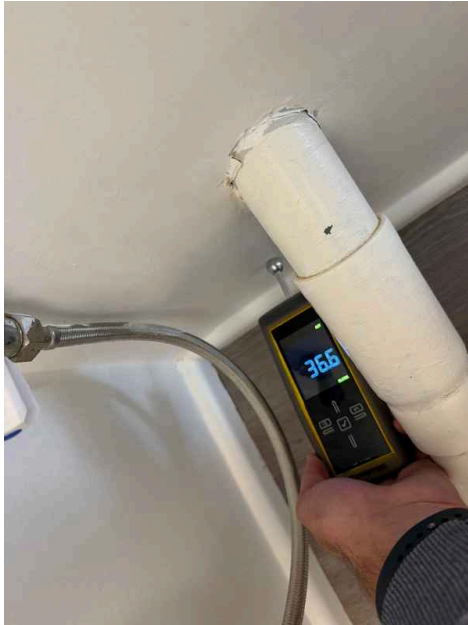
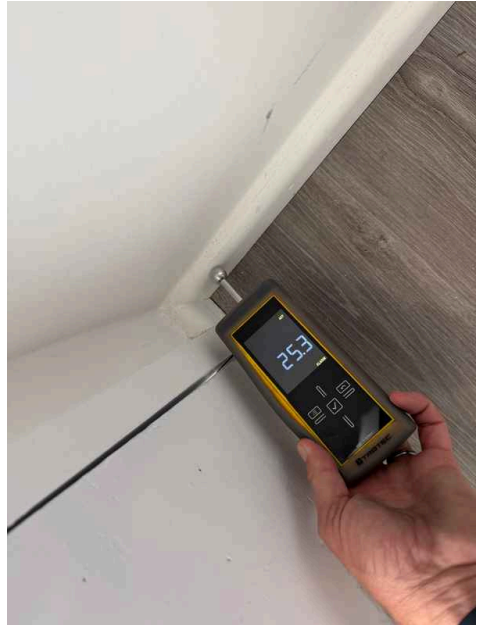
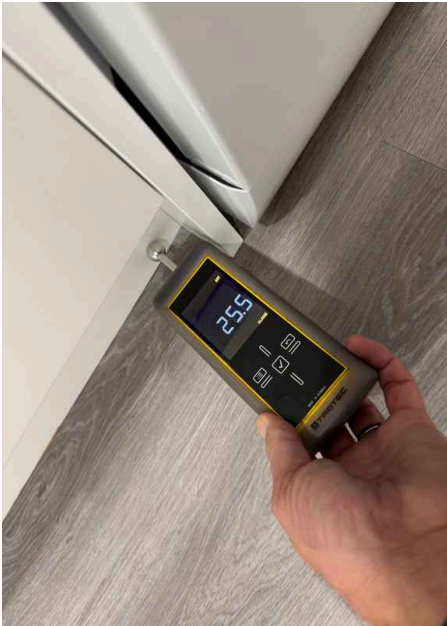
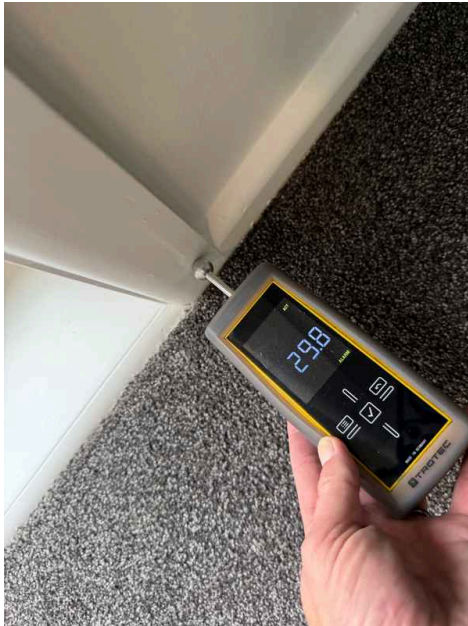
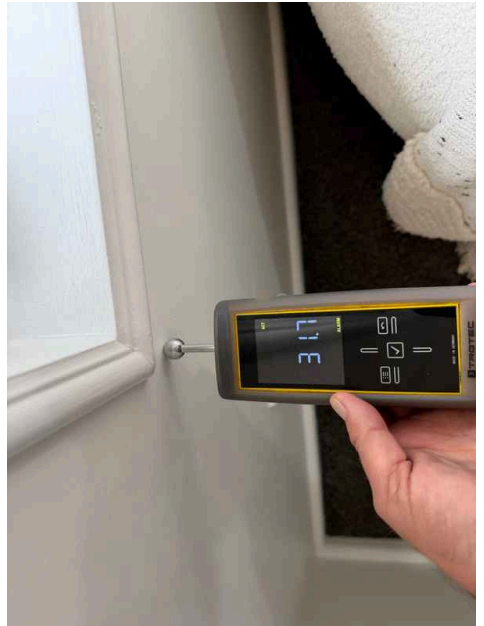
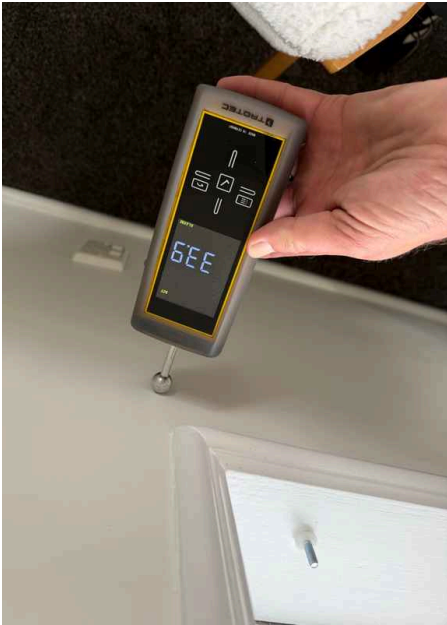
#### Moisture : Sample Of Readings

Photos are samples of readings taking around the dwelling. Instrument may be tilted to allow image to be taken.
