BUILDING INSPECTION REPORT

RESIDENTIAL HOUSE INSPECTION

191 Westminster St 2
Christchurch, Canterbury Region 8013

28/05/2026

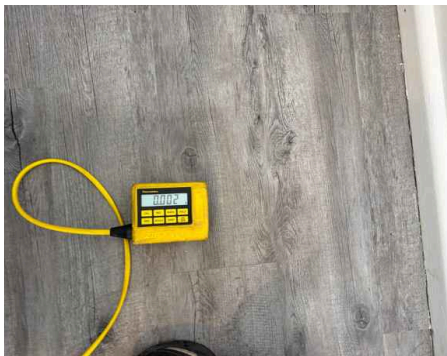
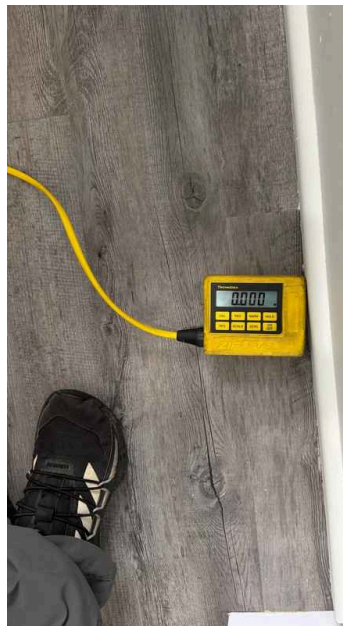
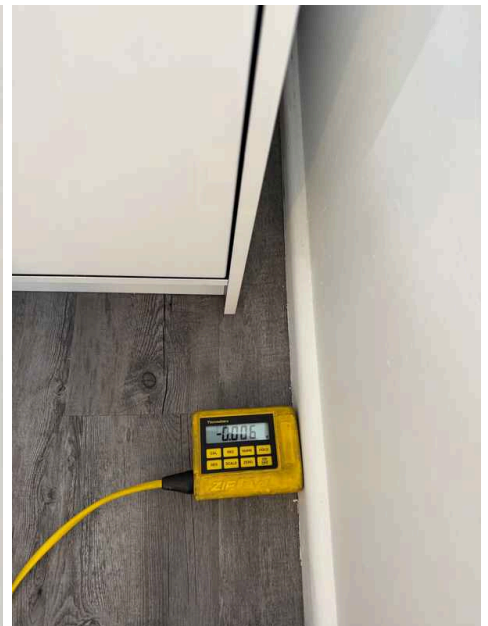
Floor Levels: Floor Levels

Floor levels were randomly checked with a zip level in various locations throughout the dwelling, the dwelling appears to be within the Ministry of Business, Innovation and employment guidelines, variation in level over the floor plan is <50 mm, please note this is not a floor level survey, tolerances in measuring devices and benchmarks may occur.

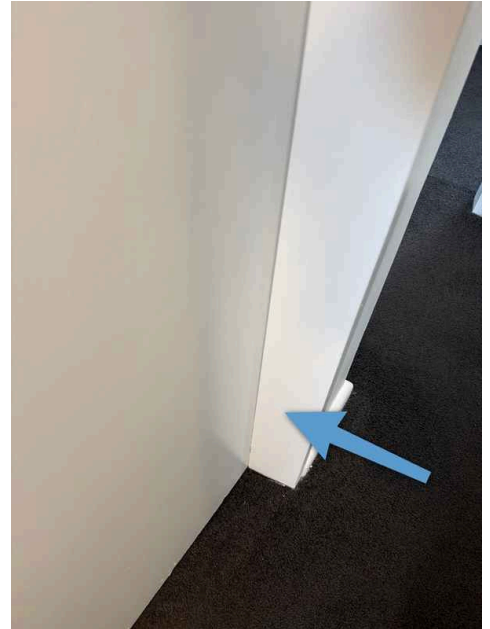
20.4.1 Floor Coverings

MINOR DEVIATION OF FLOOR LEVEL

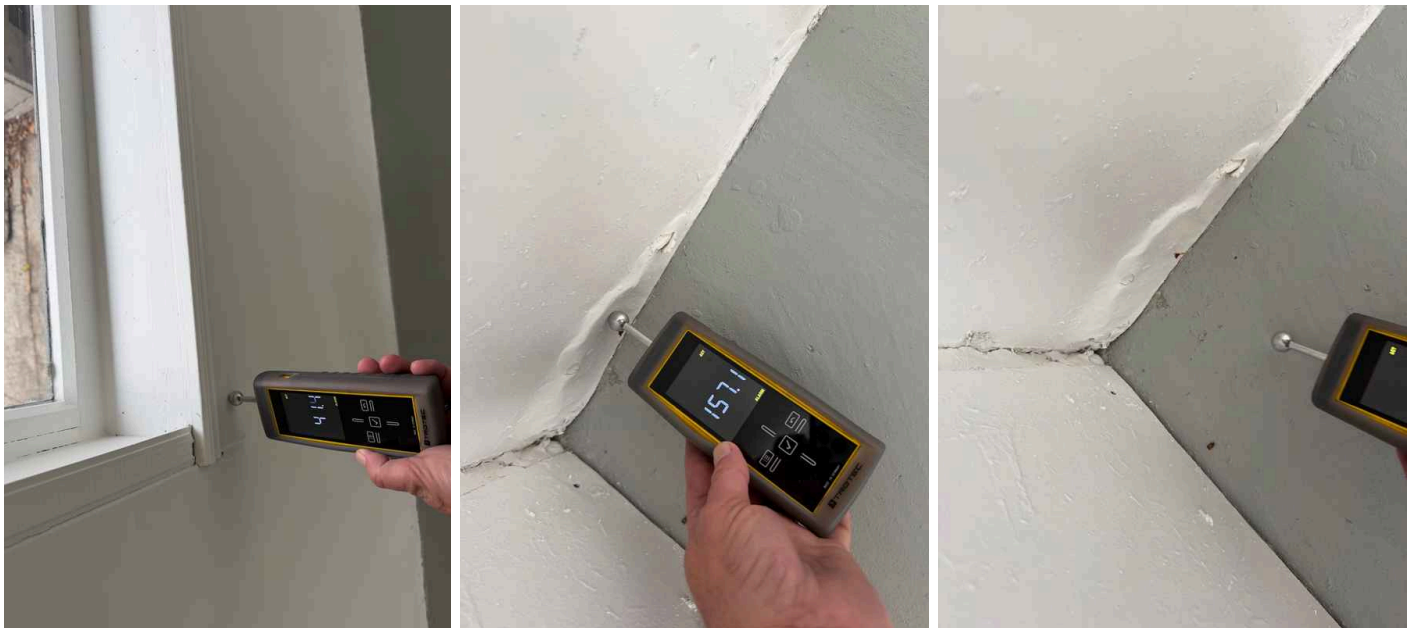
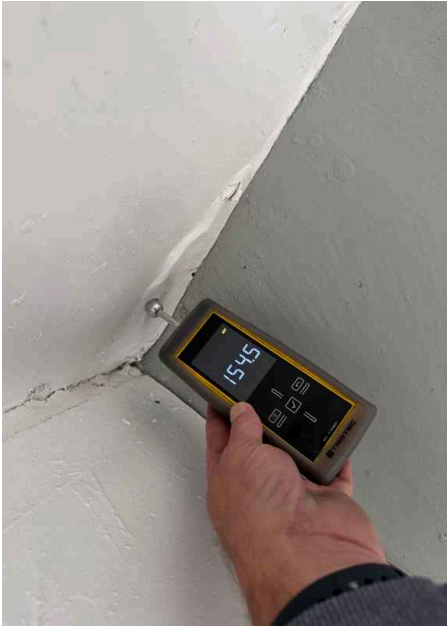
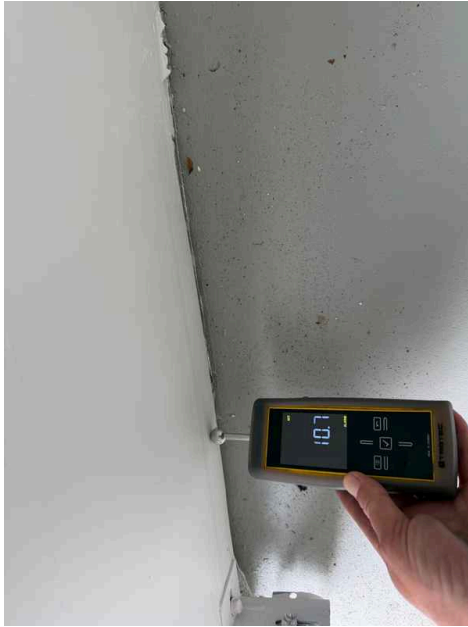
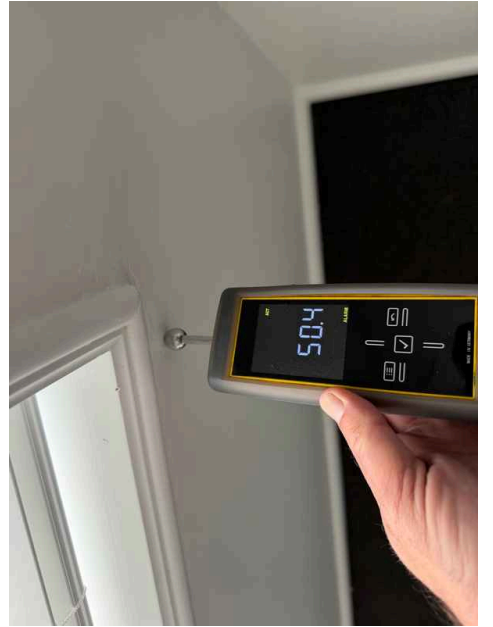
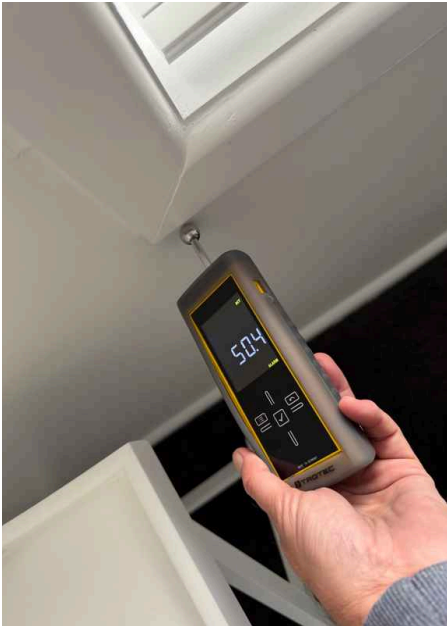
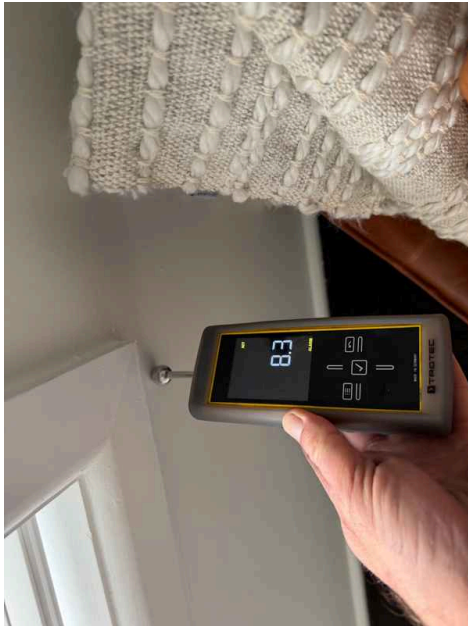
Moisture : Sample Of Readings

Photos are samples of readings taking around the dwelling. Instrument may be tilted to allow image to be taken.
