EQC CLAIM DOCUMENTATION CAVITY CRITTER REPORT

Under floor Inspections

Property address: 191 Westminster Street

Property address: 191A Westminster Street

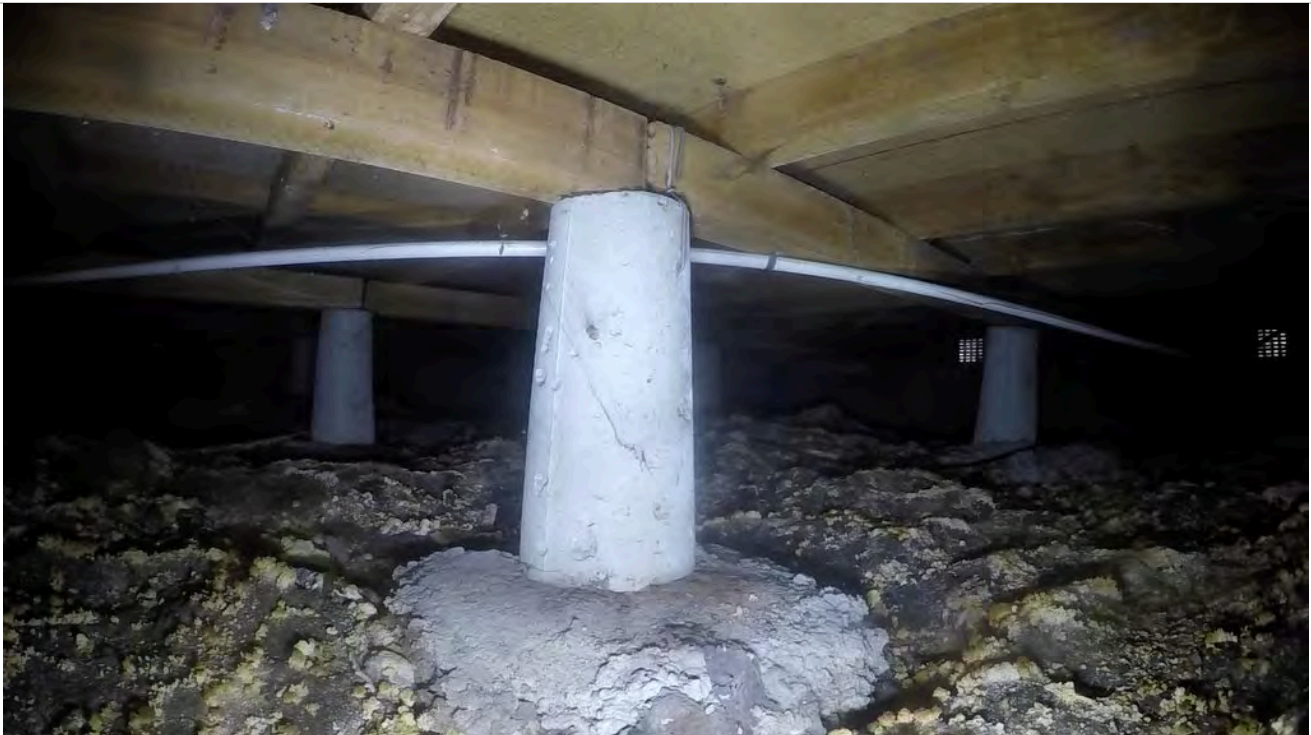
28: Pile with bearer join. There is significant yellow mold growing beneath this home.

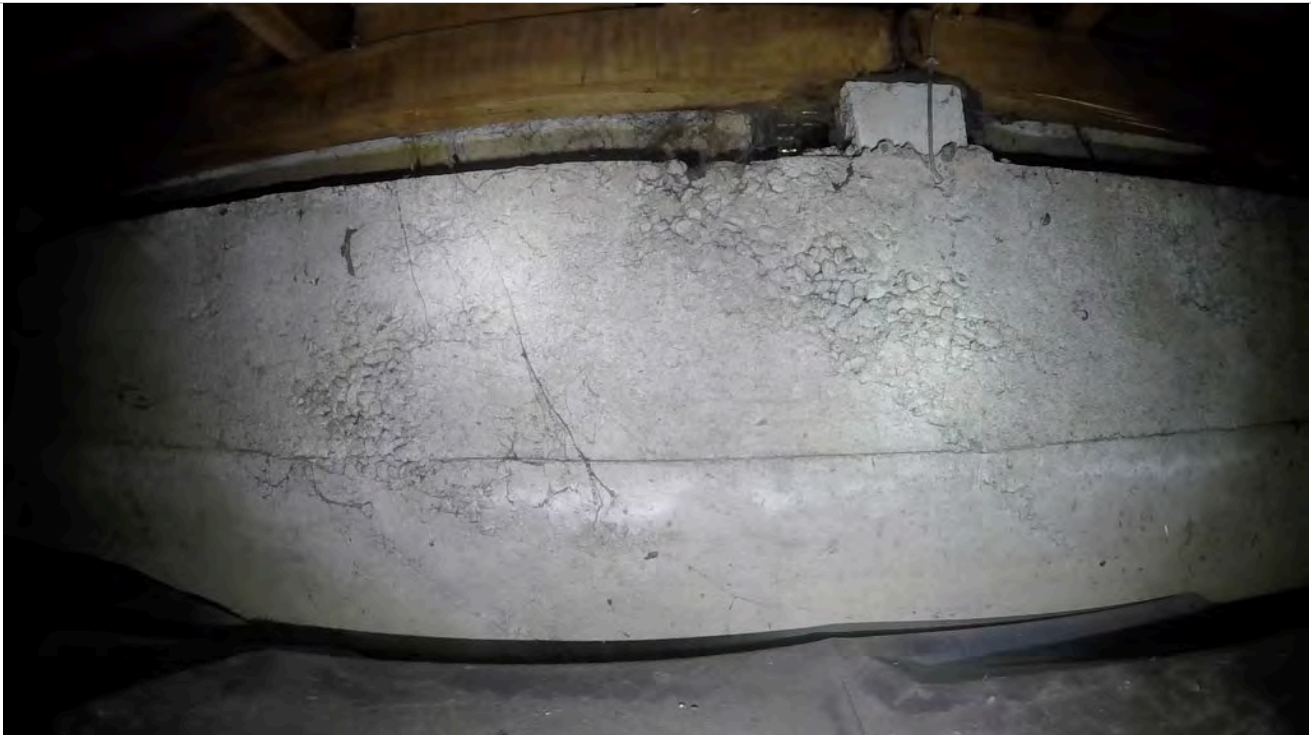
4: View of ring foundation.

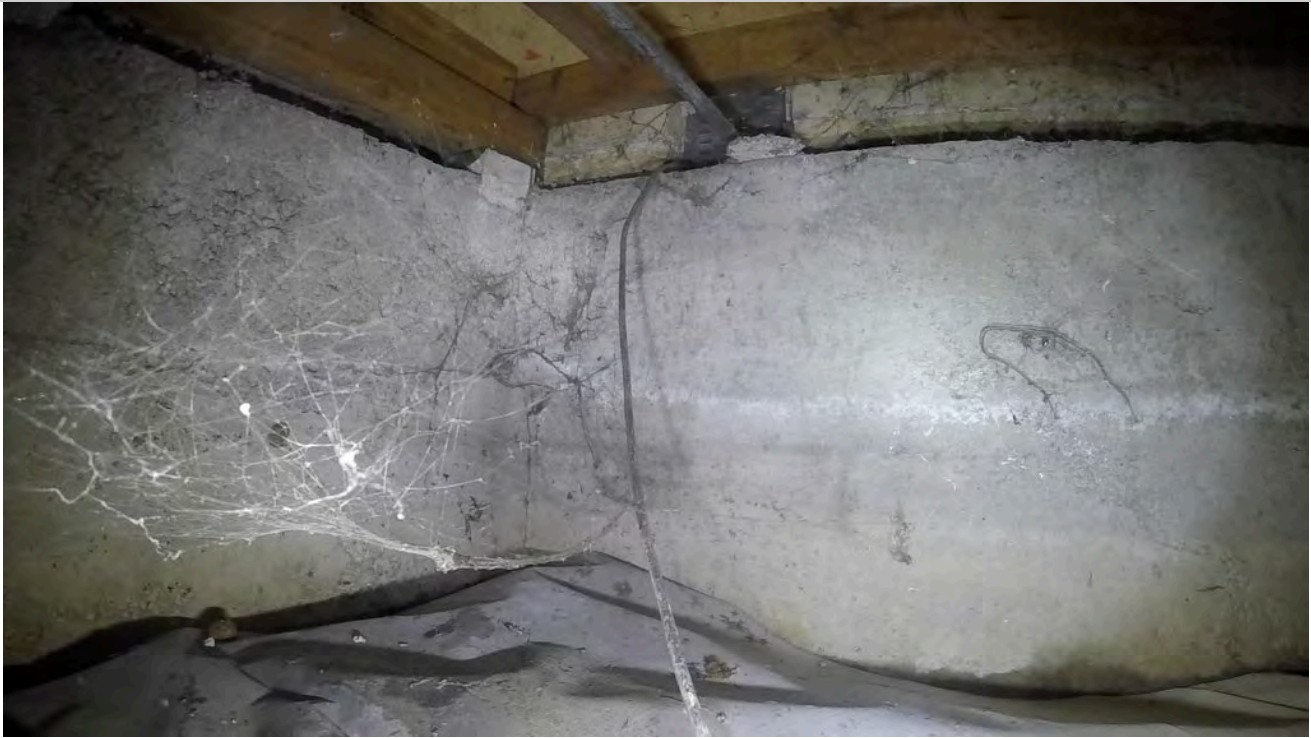
5: View of ring foundation.

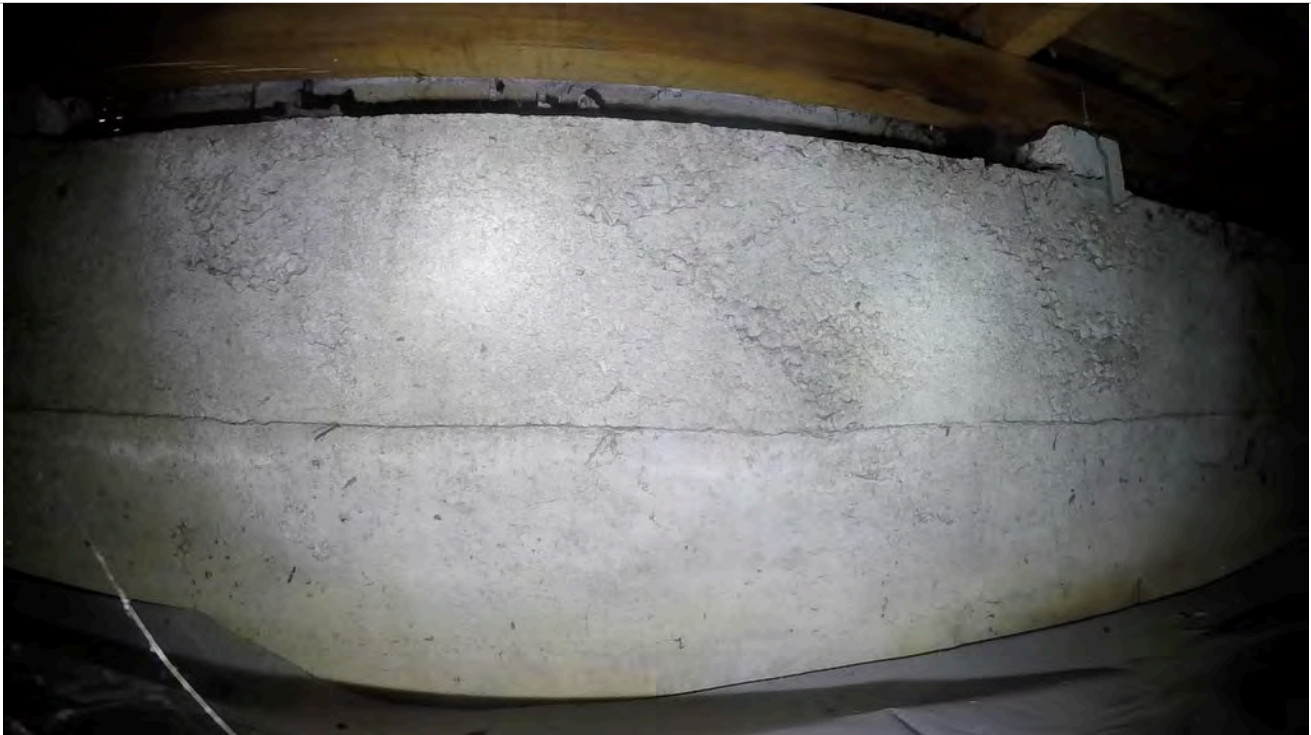
6: View of ring foundation.

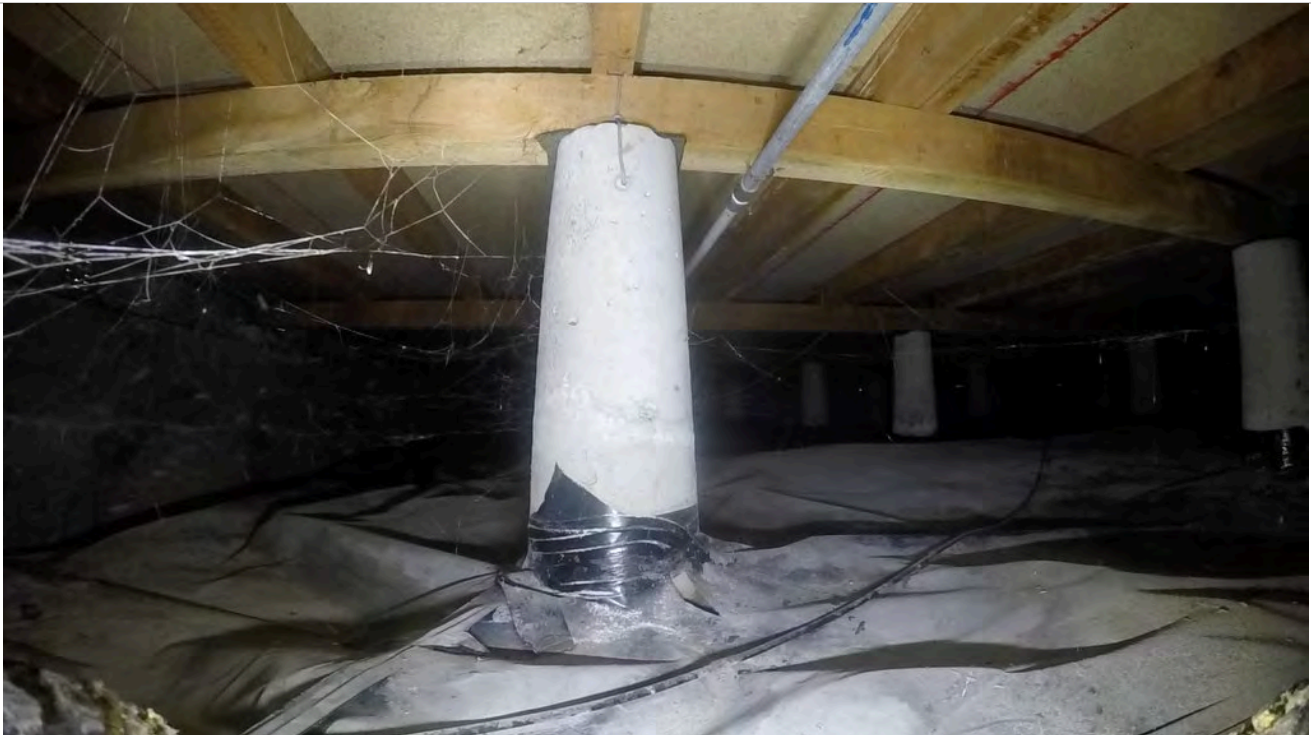
8: All piles appear to have their original connections, however there are several piles that the stapling has not been carried out correctly.

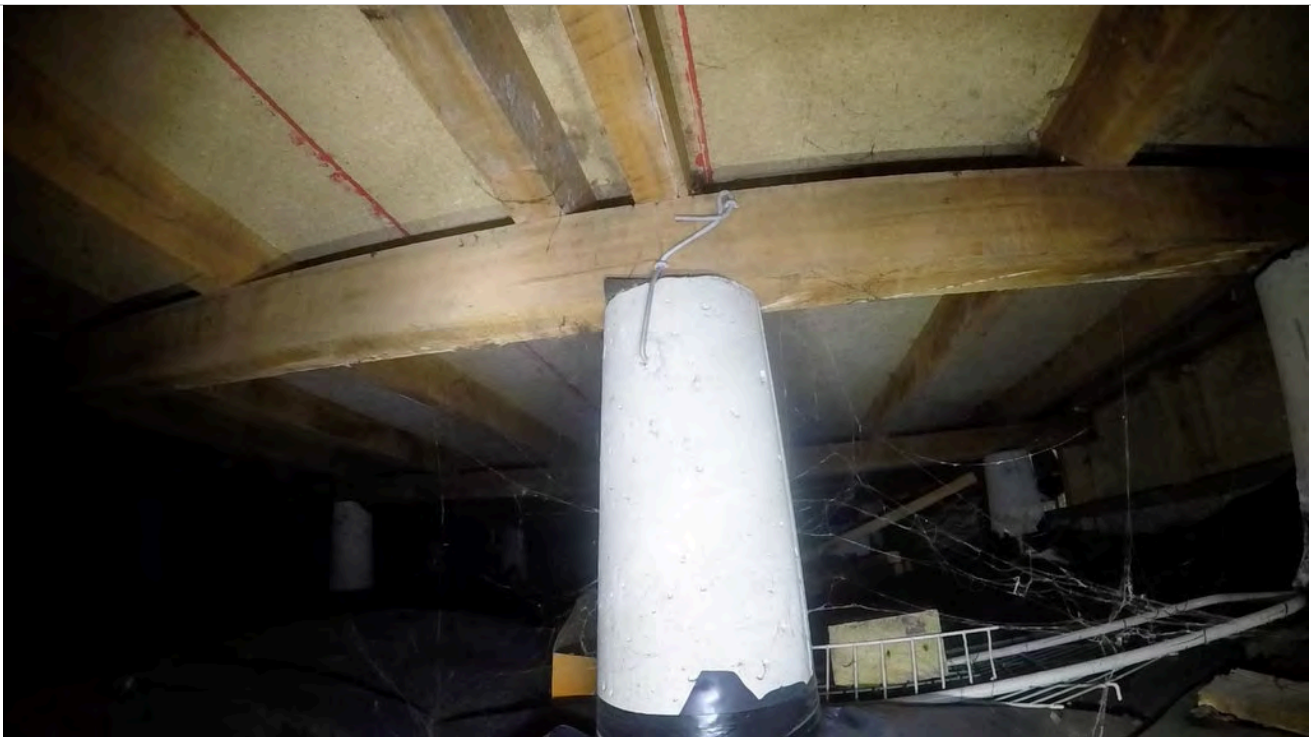
14: Pile with connection.

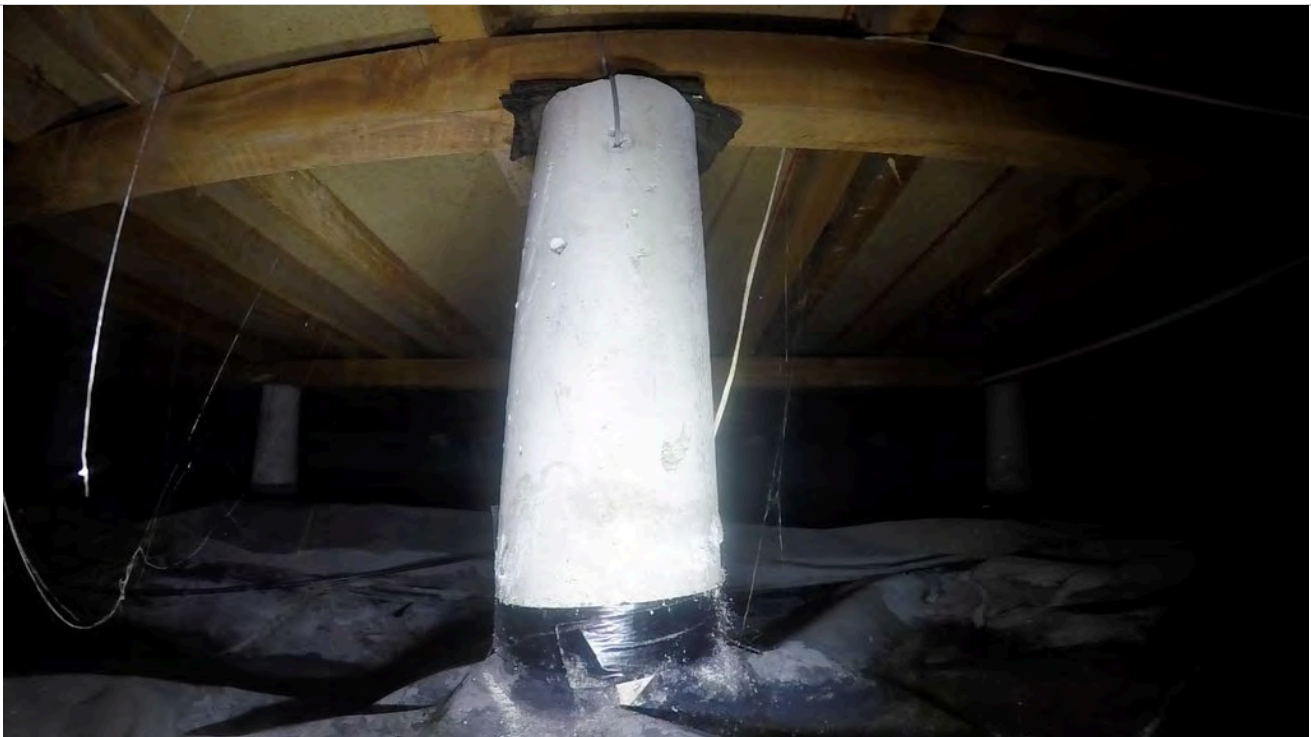
22: Pile with connection.

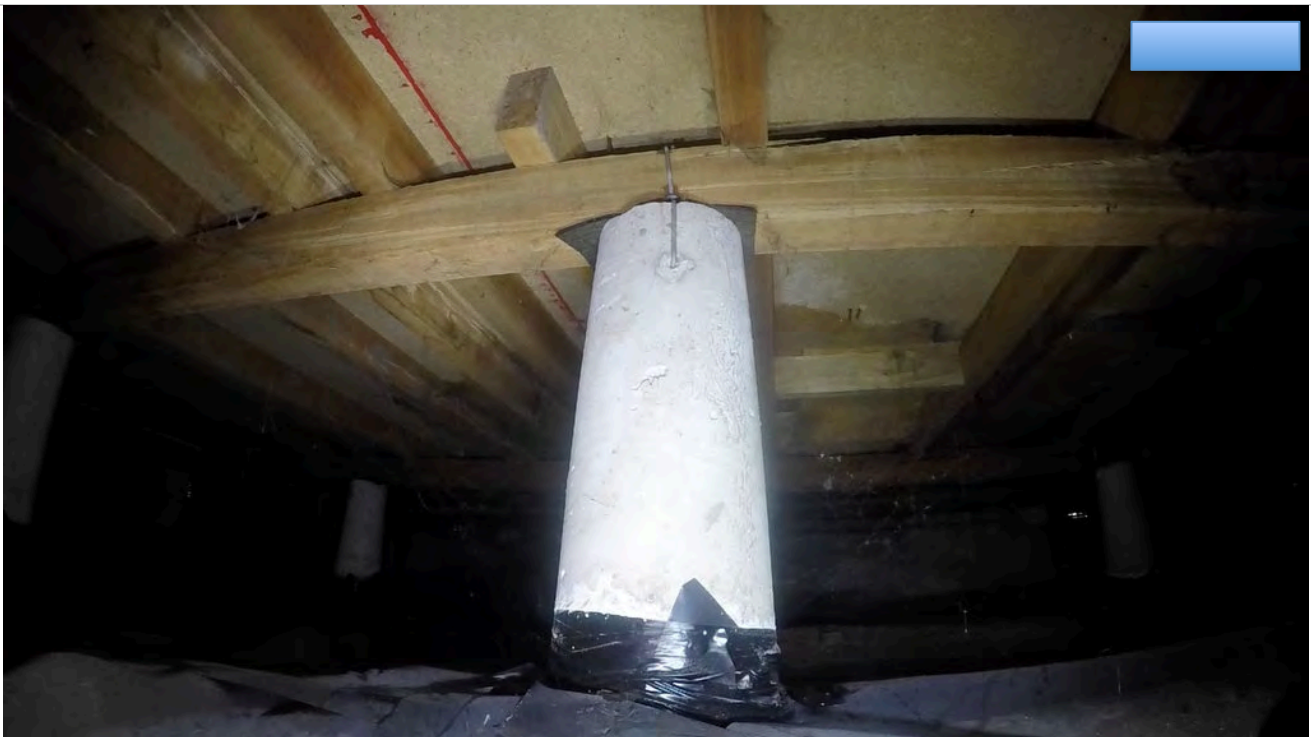
28: Pile with connection.

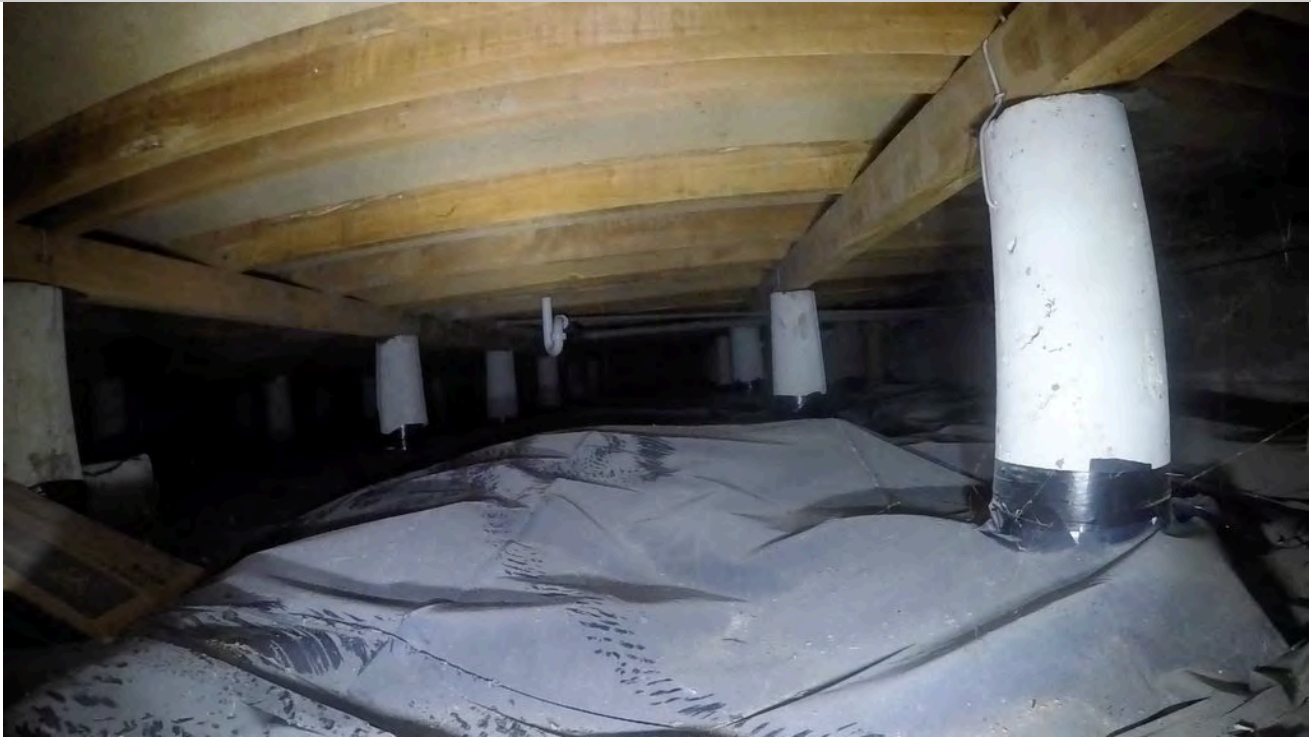
35: View along piles.

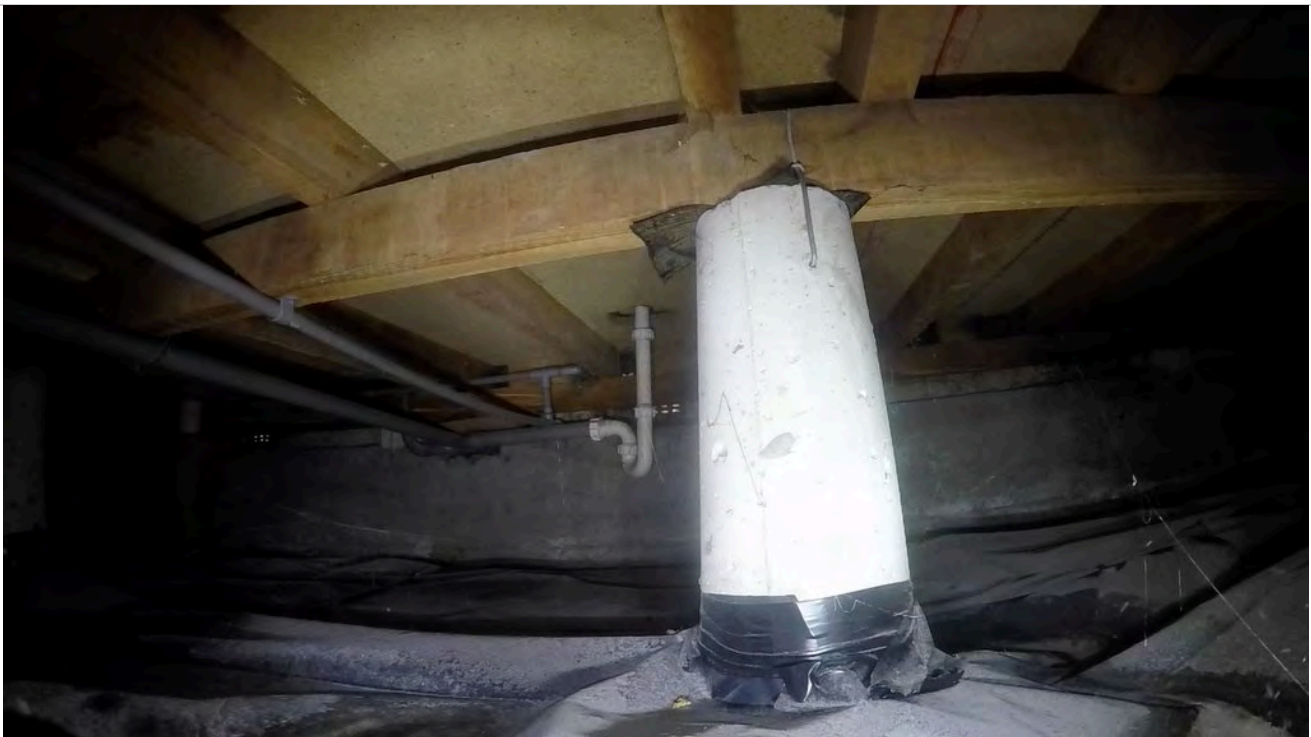
36: Pile with connection.

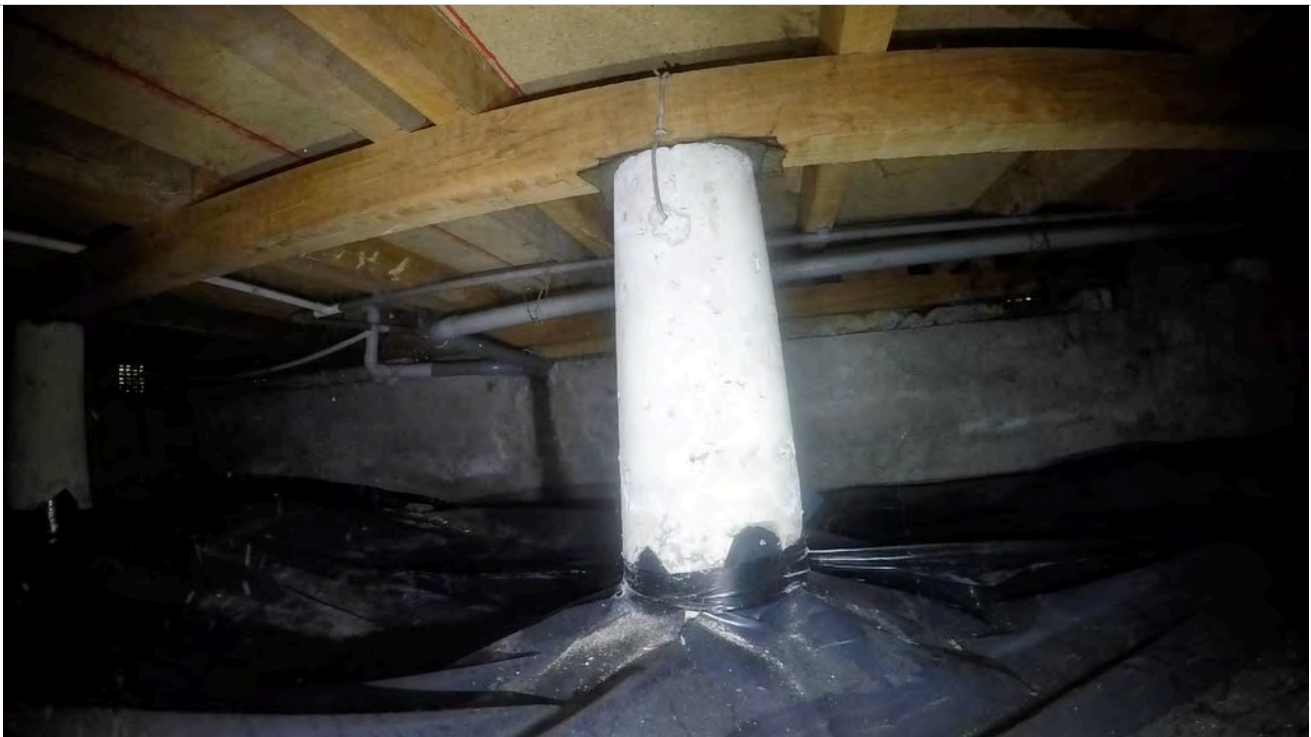
40: Pile with connection.

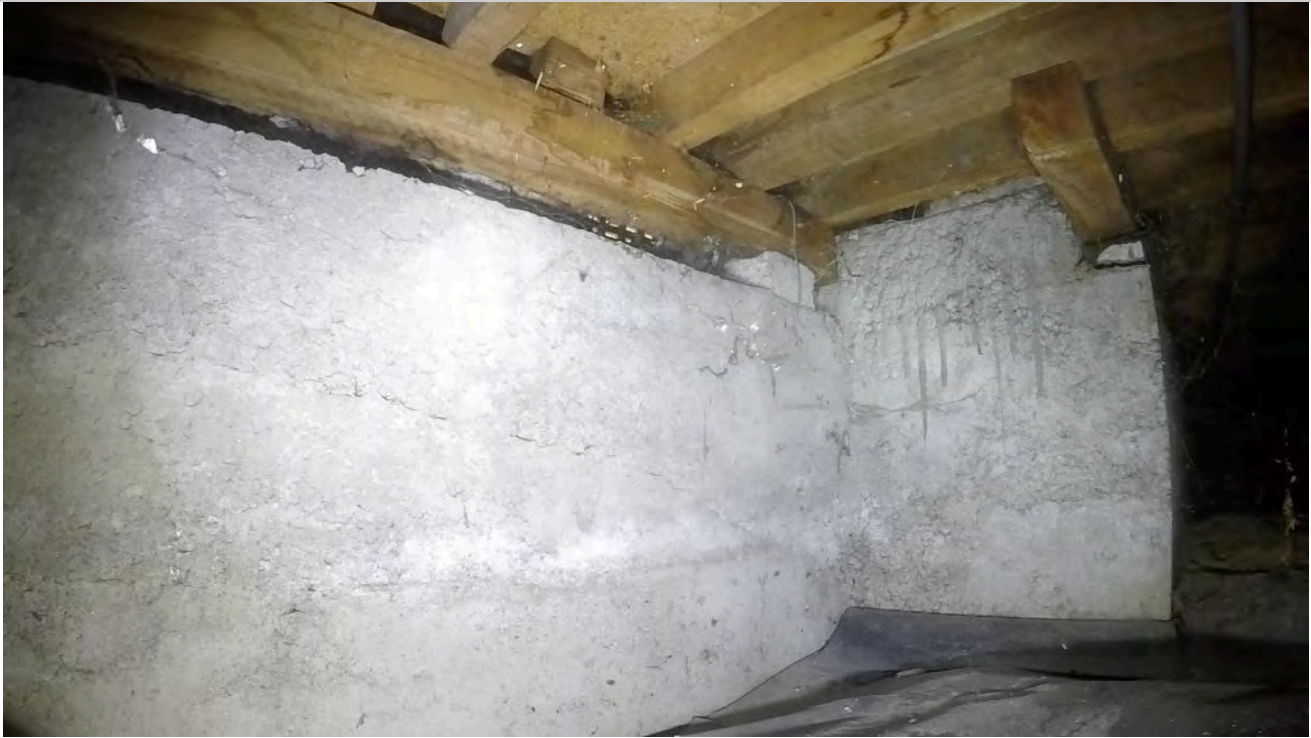
45: View of ring foundation.

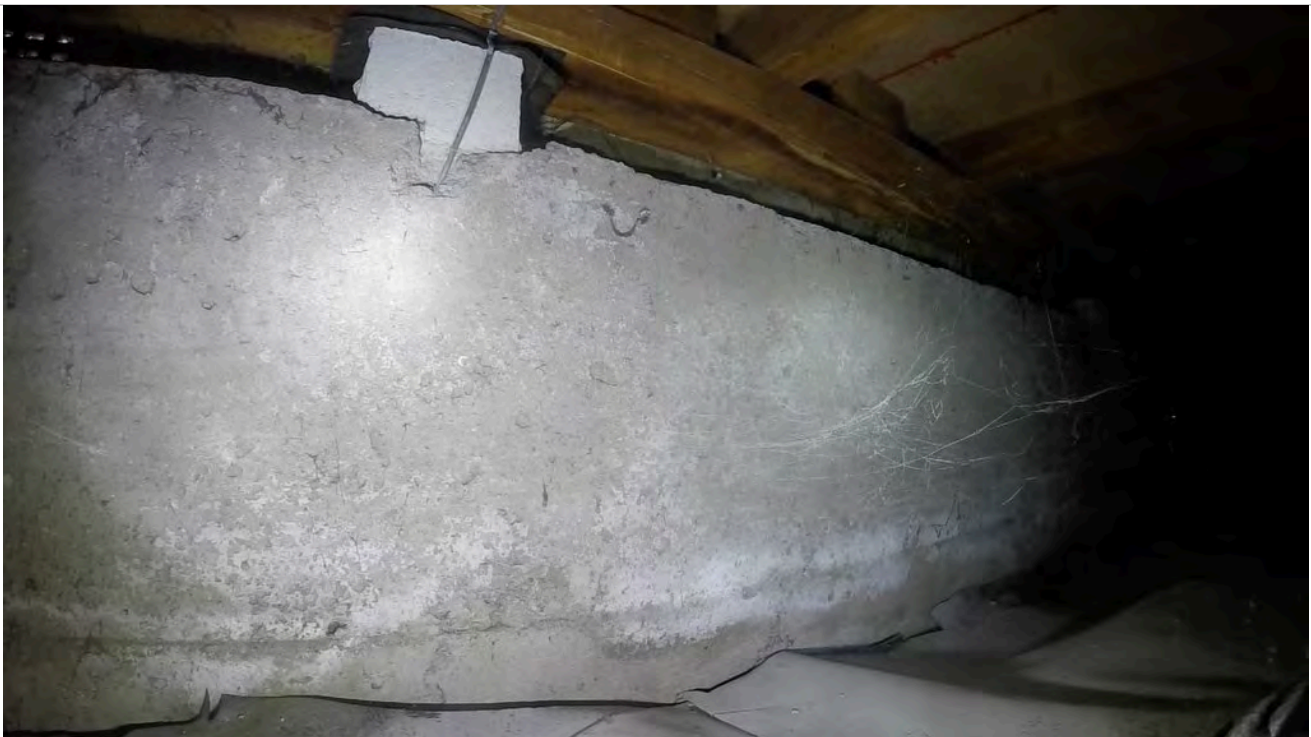
47: View of ring foundation.
