EQC CLAIM DOCUMENTATION CAVITY CRITTER REPORT

Under floor Inspections

Property address: 191 Westminster Street

Date: 26 July 2017

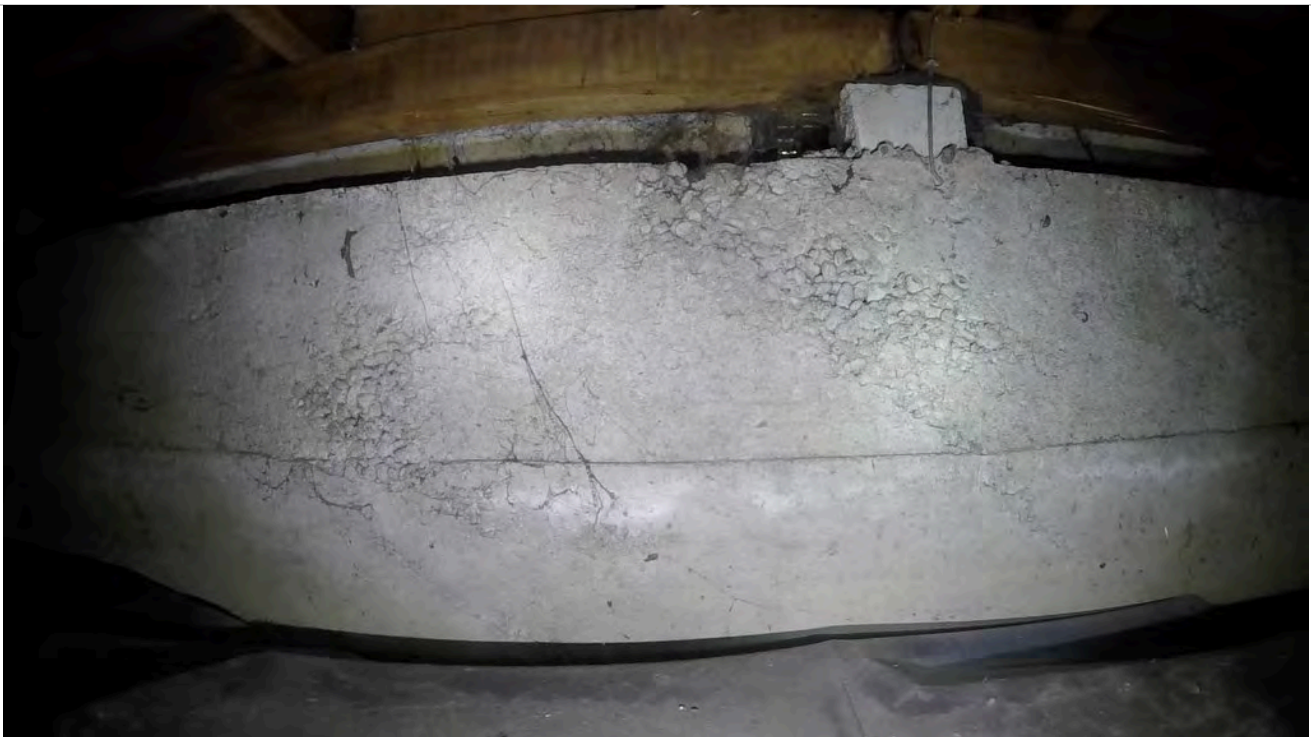
4: View of ring foundation.

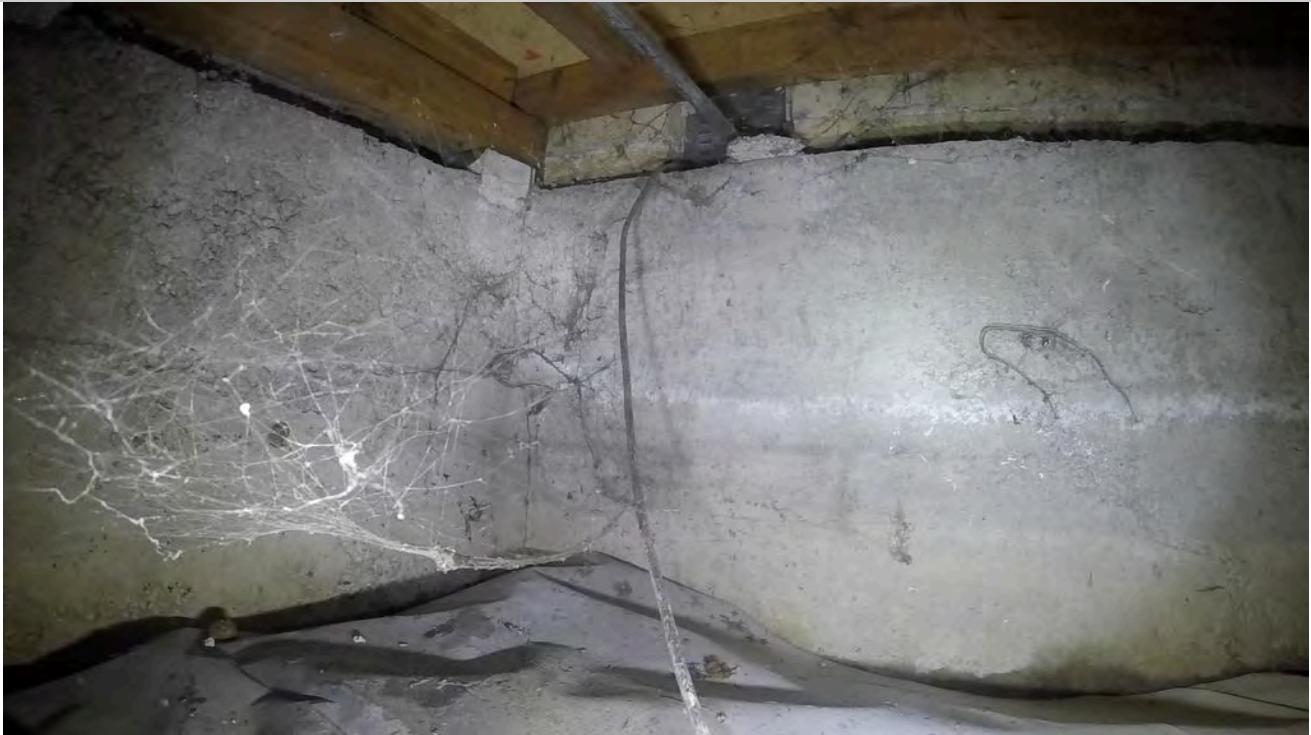
5: View of ring foundation.

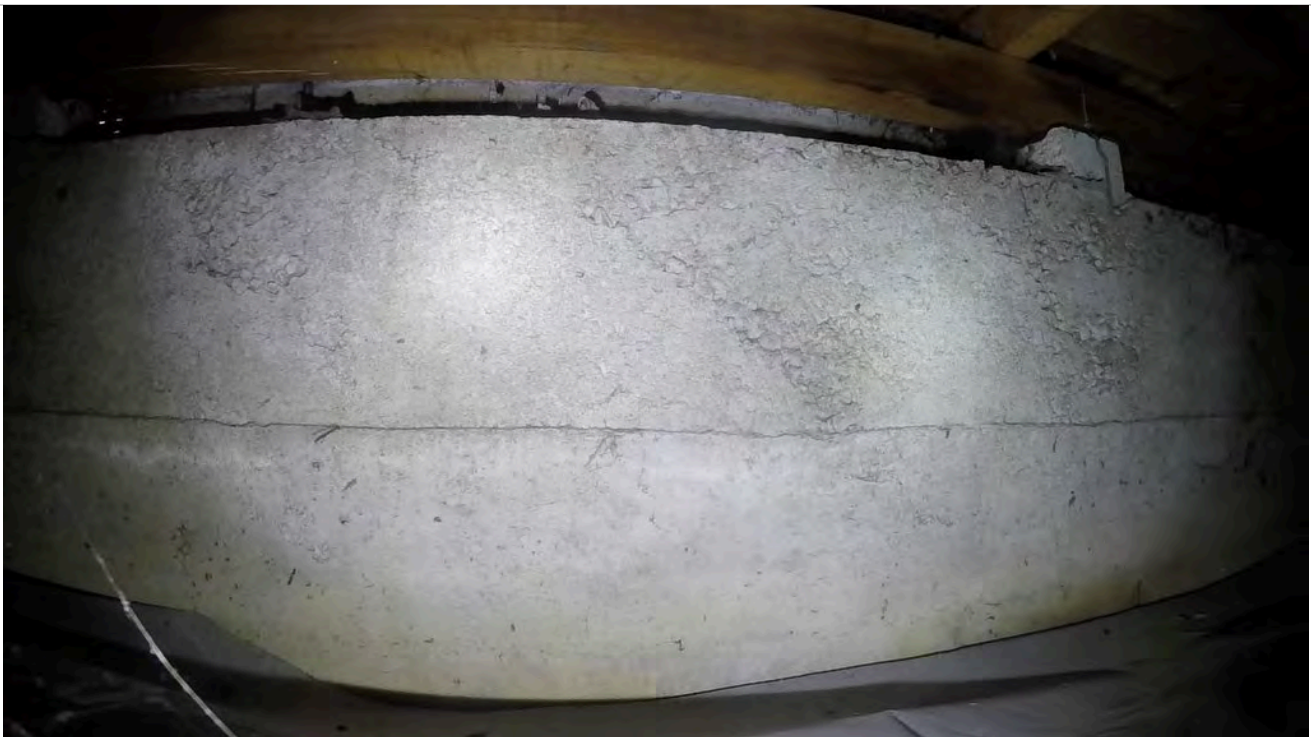
6: View of ring foundation.

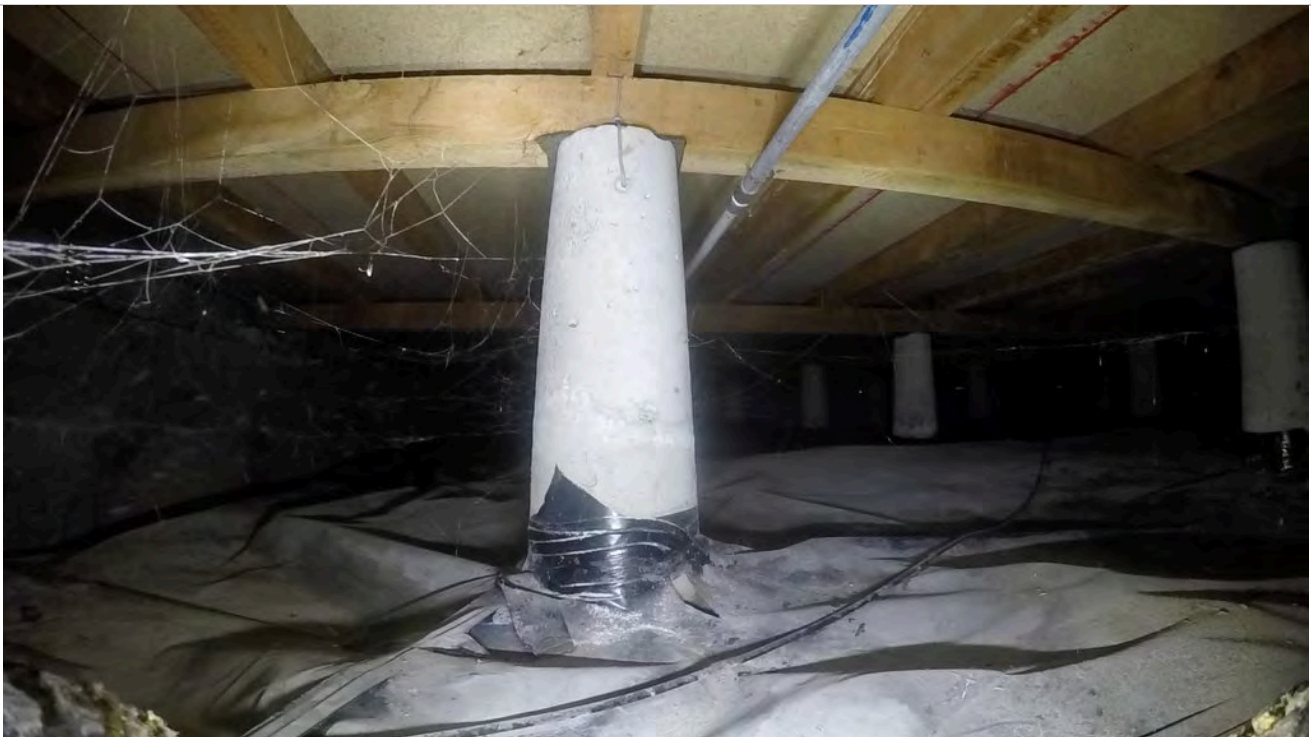
8: All piles appear to have their original connections, however there are several piles that the stapling has not been carried out correctly.

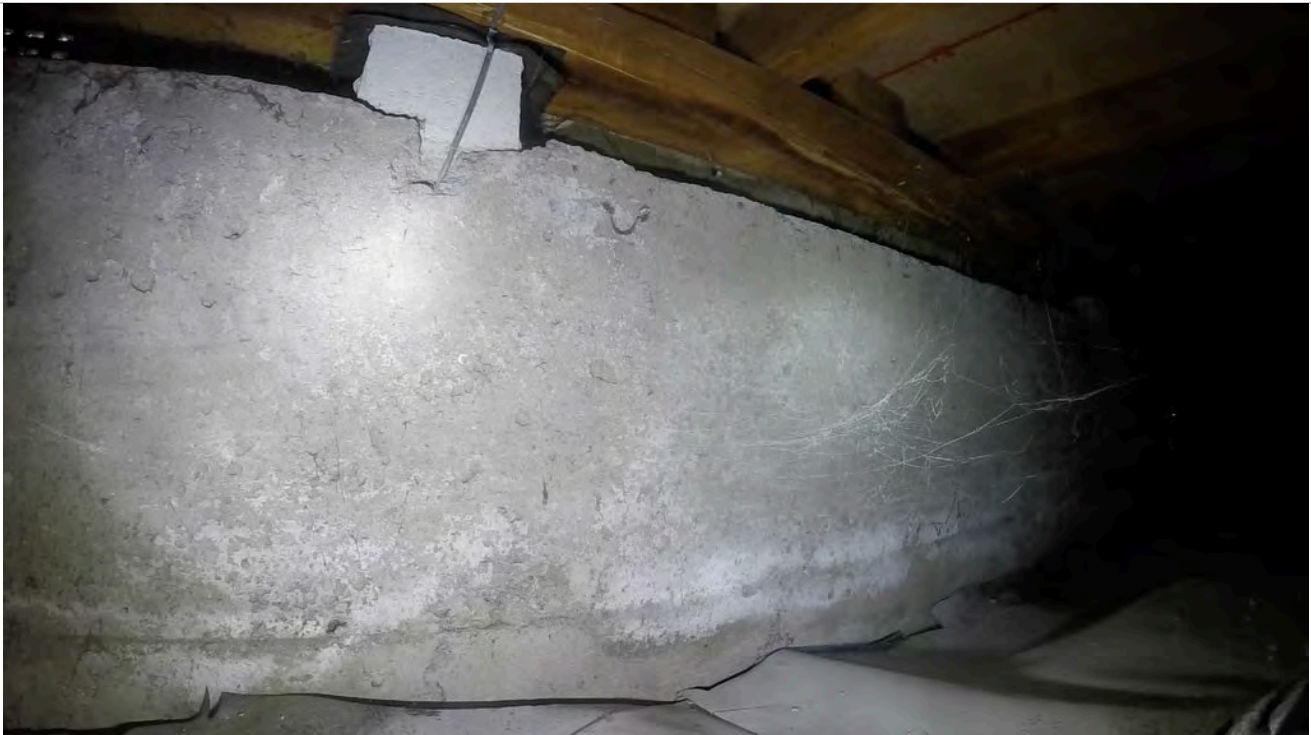
47: View of ring foundation.
