## Building Report

21 Kanawa Street  
Waikanae

| <b>Date/s of inspection:</b> | 30-Apr-2026 |
| <b>Type of inspection:</b> | Building Inspection |

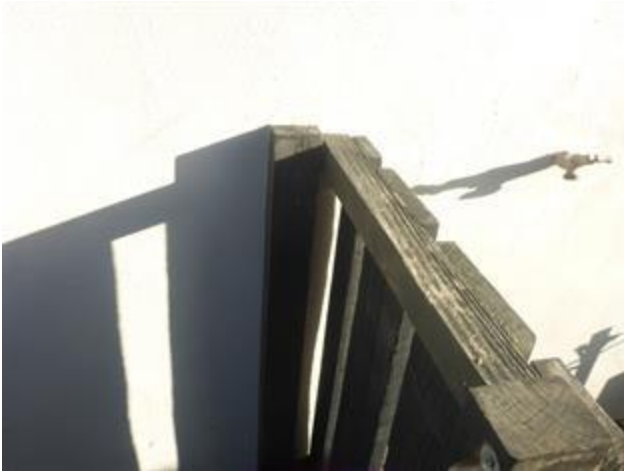
The gatepost to the fencing to the side of the dwelling and the clothesline have been direct fixed through the cladding, which is not recommended as it can be a weather tightness issue. Any wall penetrations can be a higher-risk area for ingress as moisture can find its way into the cladding through fixing penetrations. Post fixings can be modified.

Direct fixed post

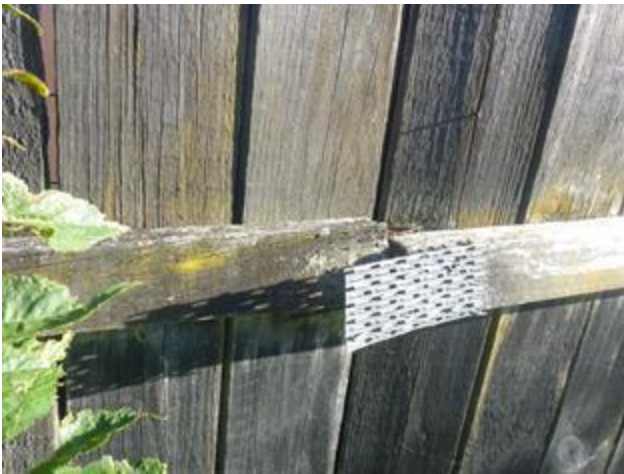
The property has a variety of fence types, which were generally in reasonable condition where visible and in terms of maintenance planning, areas would benefit from a coat of paint or stain to protect the integrity of the timber. Some post repair is required to the eastern side with railing repair to the western side of the dwelling as part of the maintenance planning.

Railing repair

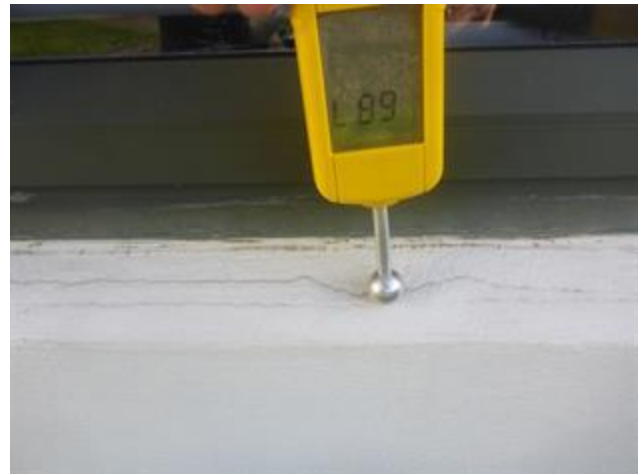
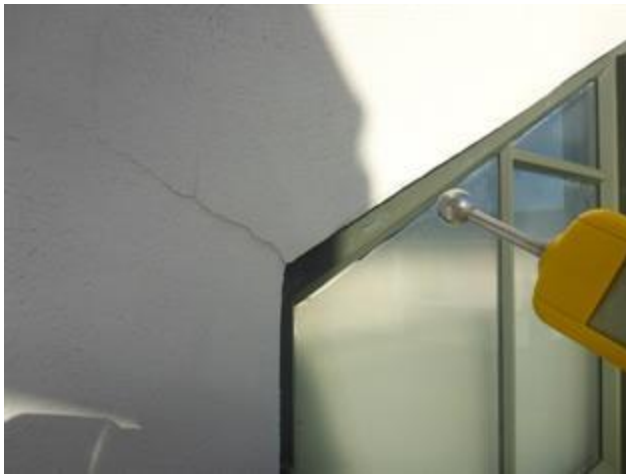
Hairline cracks were sighted to the cladding to the front and side of the dwelling and impact damage was sighted to the western side and to the front, with two hole penetrations sighted to the rear.

Front window

My recommendation is that the EIFS now have further specialist invasive appraisal to give you advice about the cracks, hole penetrations, and impact damage repair requirements, for the installation of kick out flashings, for the area with indications of moisture retention, and for an indication of costs.

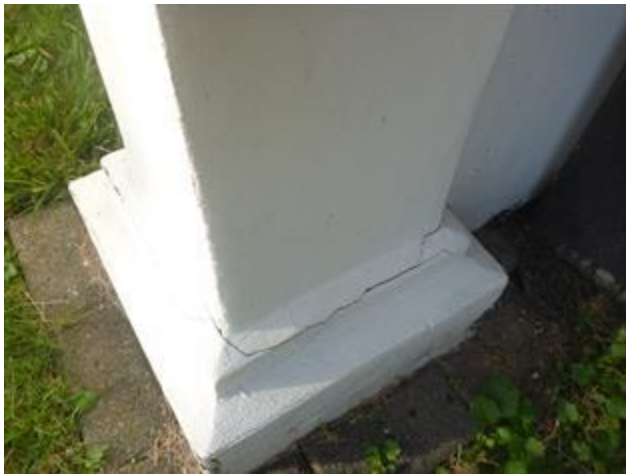
Impact damage front

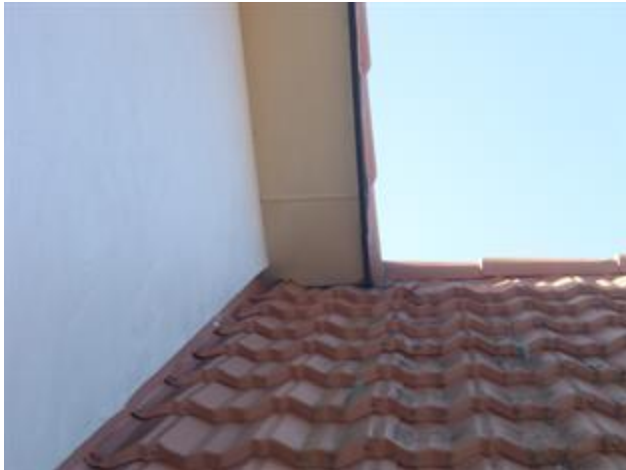
End-grain decay was sighted to the fascia where in contact.

Fascia and soffit in contact

I recommend further investigation for repair to prevent progressive damage.

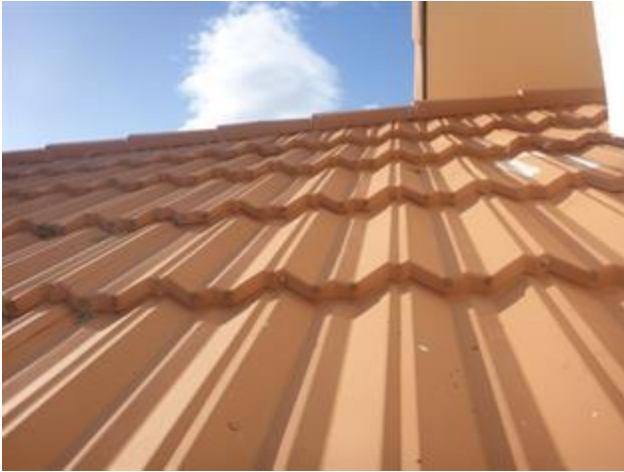
Direct fixed fastener

I did note that the tiles of the lower run above the spouting have been fixed through the tops of the tiles without rubber washers. This would have been compliant at the time of construction but does not meet today's standards as this can allow moisture ingress issues.

I recommend that the roofing material have further appraisal by a licensed roofer to give you advice on the degree of fastener / butynol / washer upgrades and potential costs.

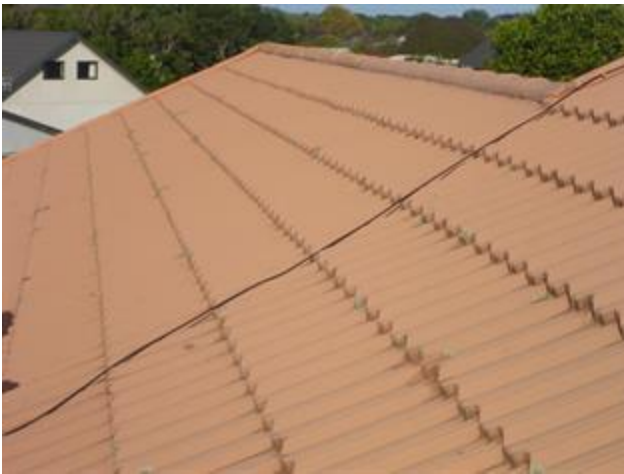
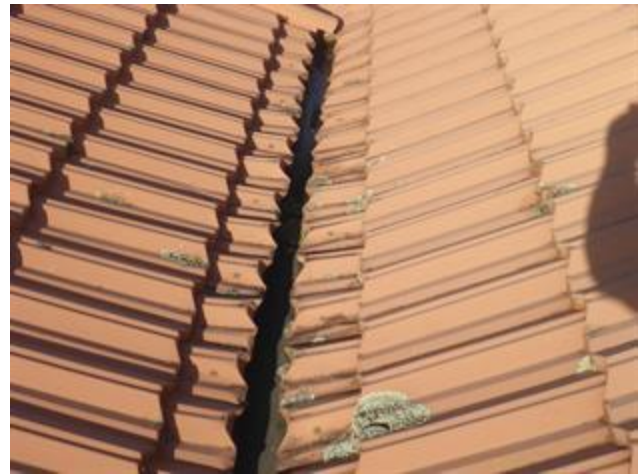
Butynol

The butynol appeared aged and I recommend this now have further specialist appraisal.

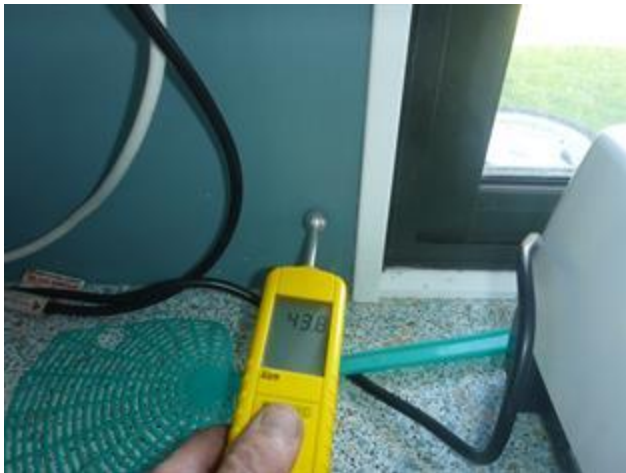
Moisture levels acceptable parameters

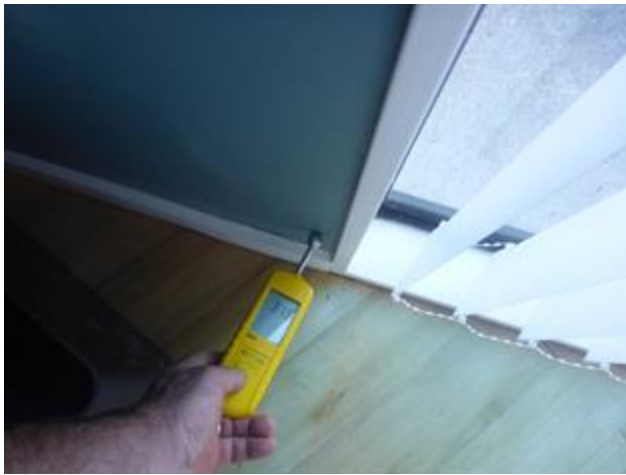
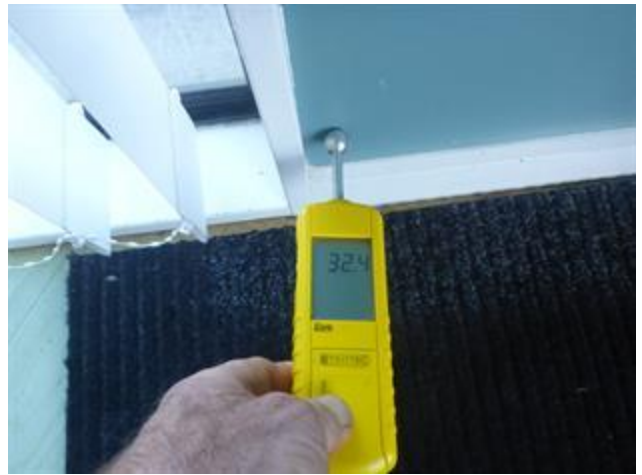
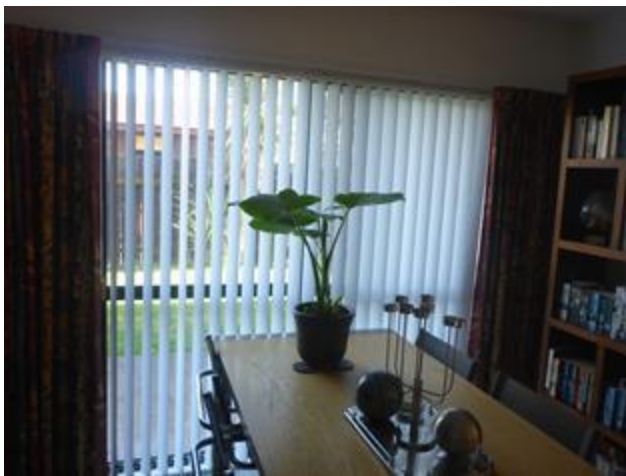
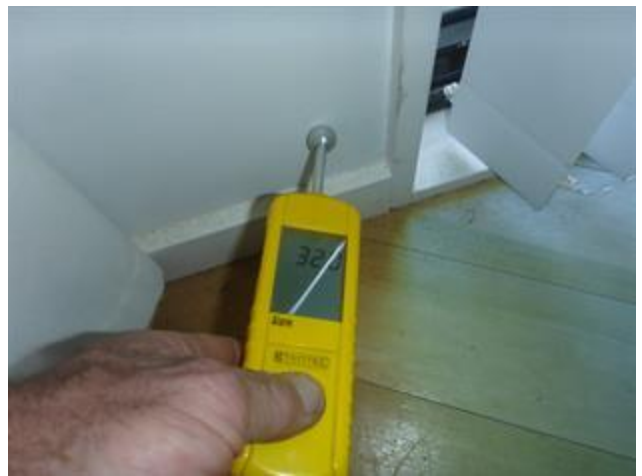
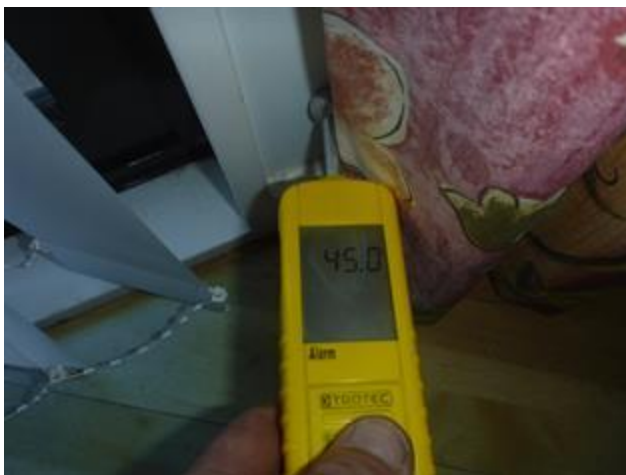
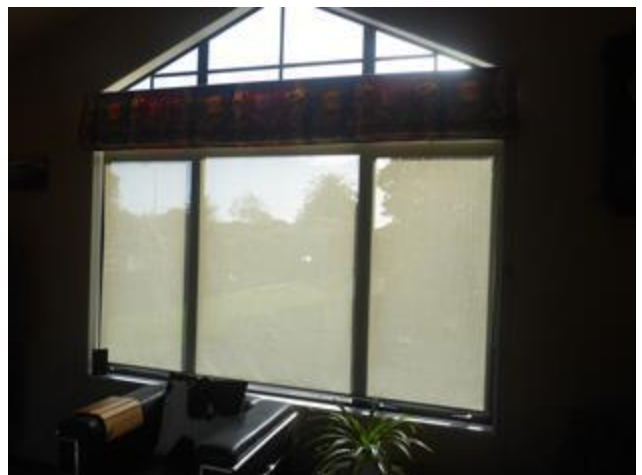
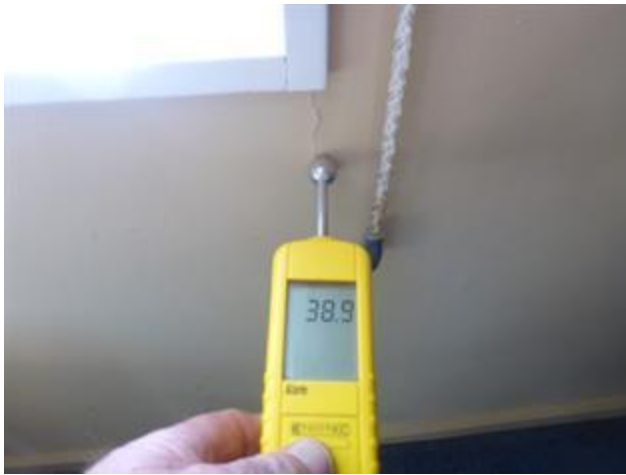
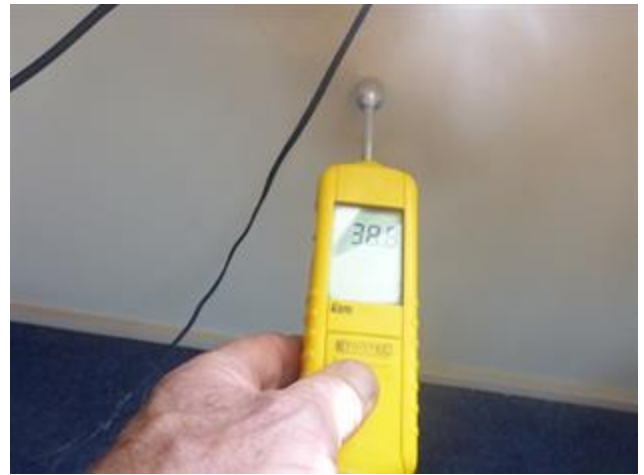
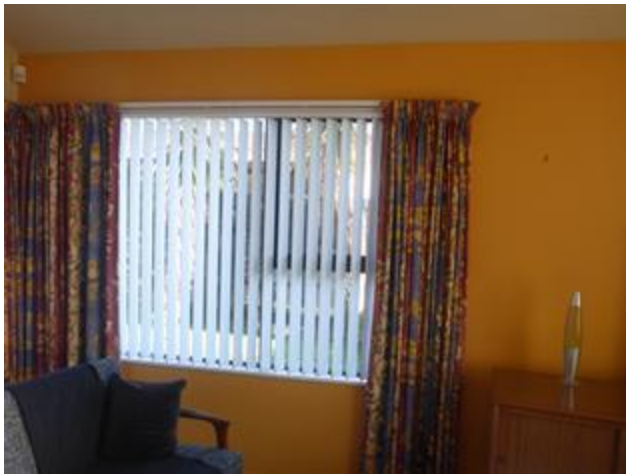
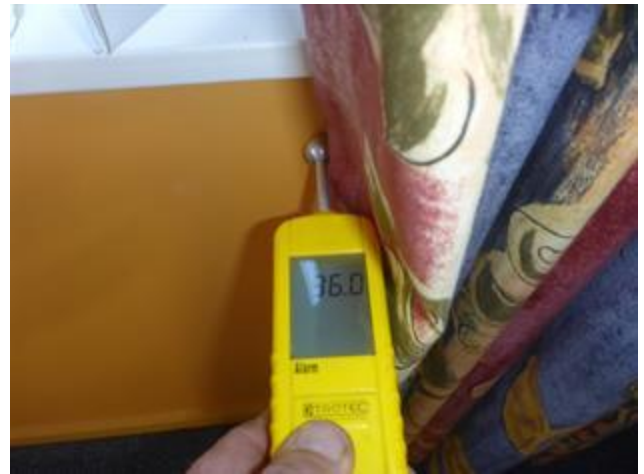
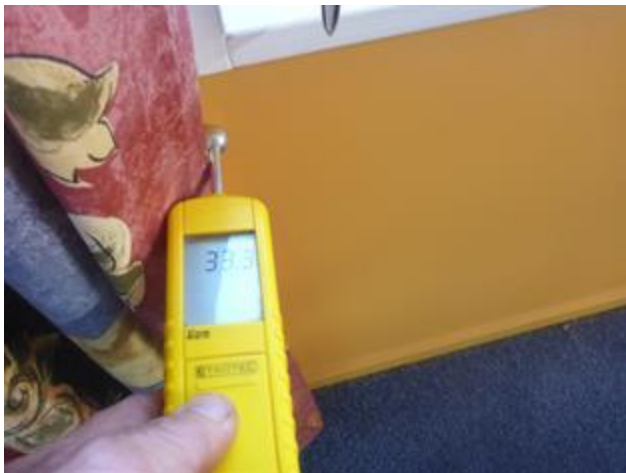
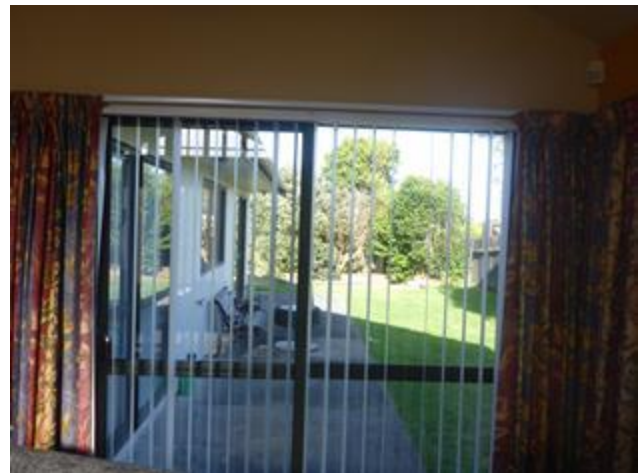
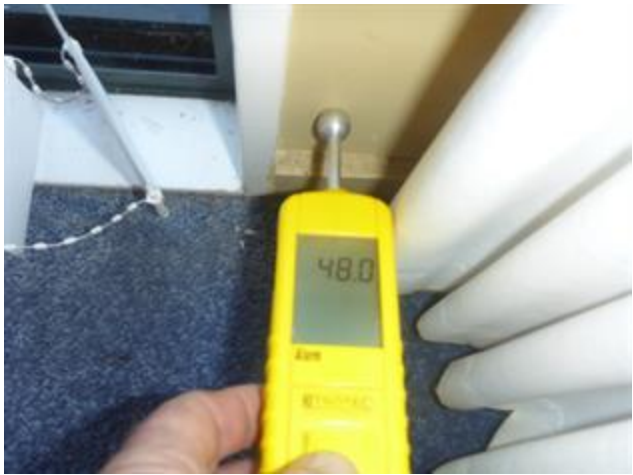
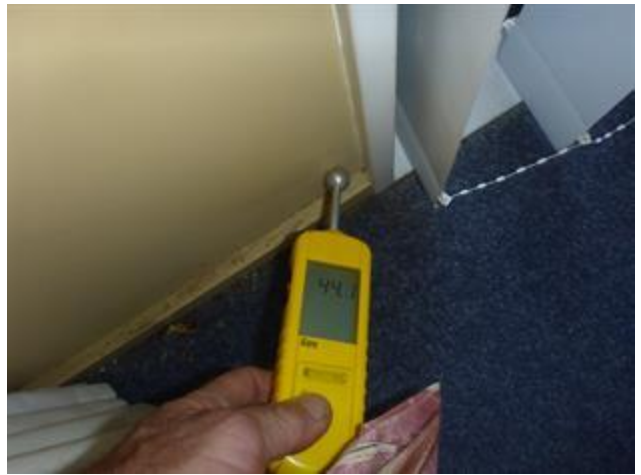
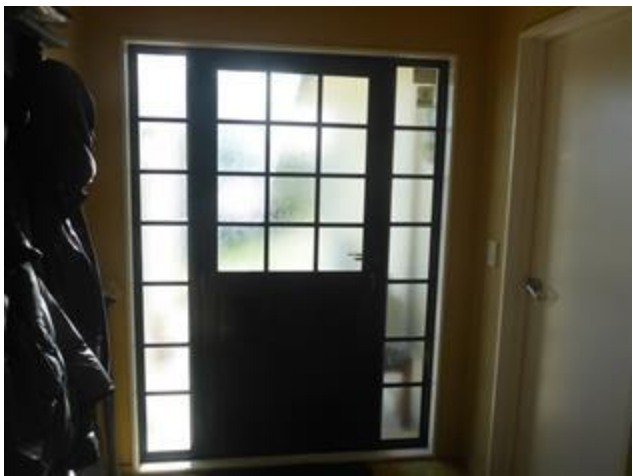
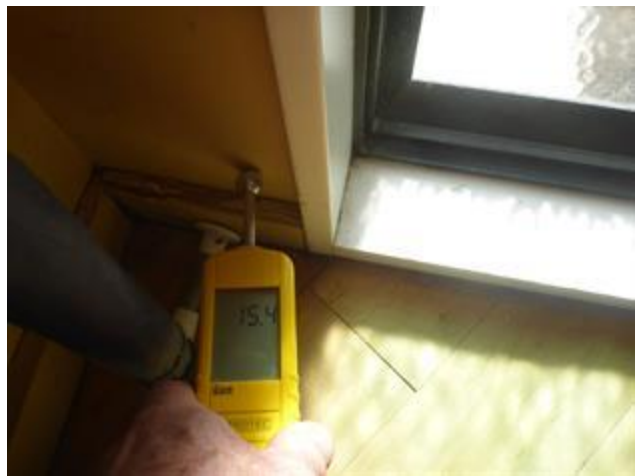
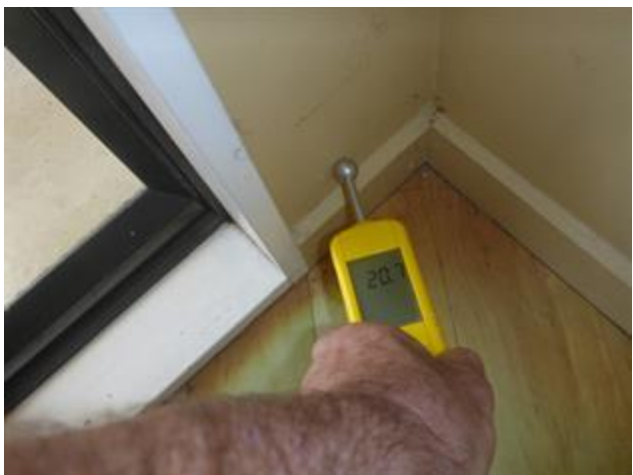
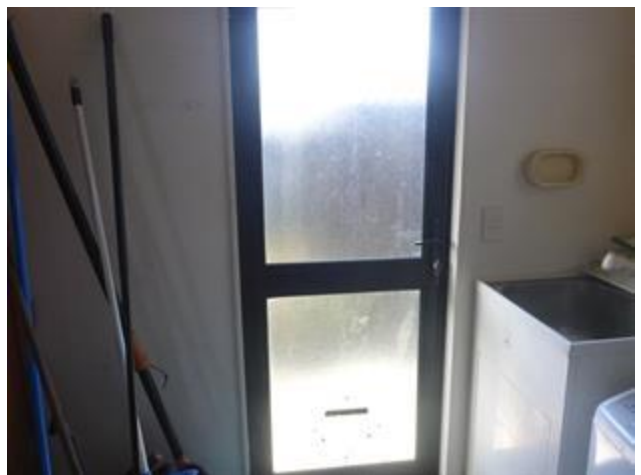
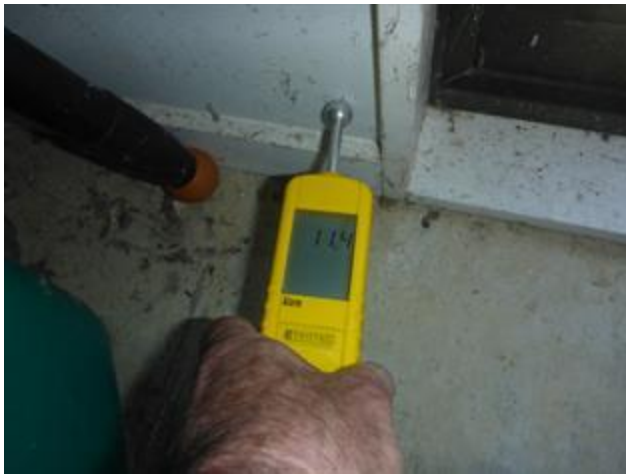
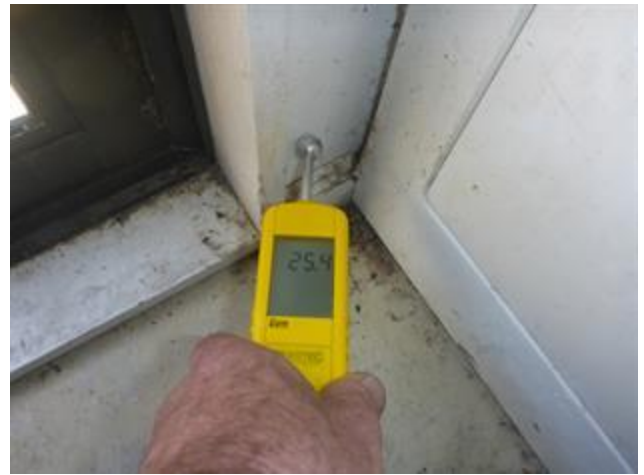
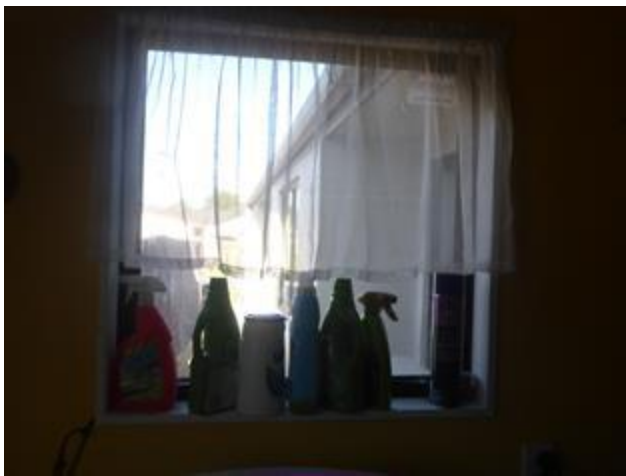
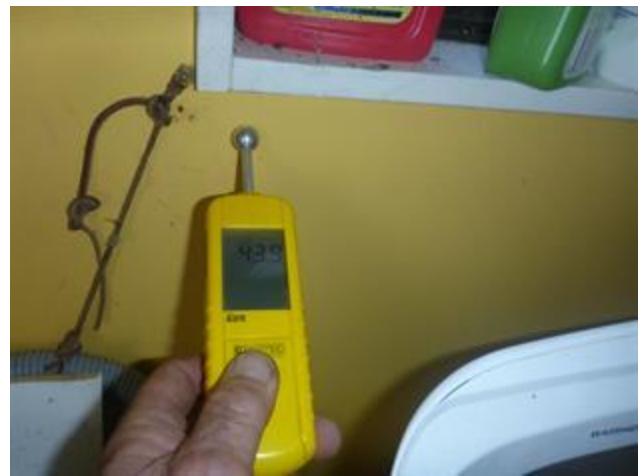
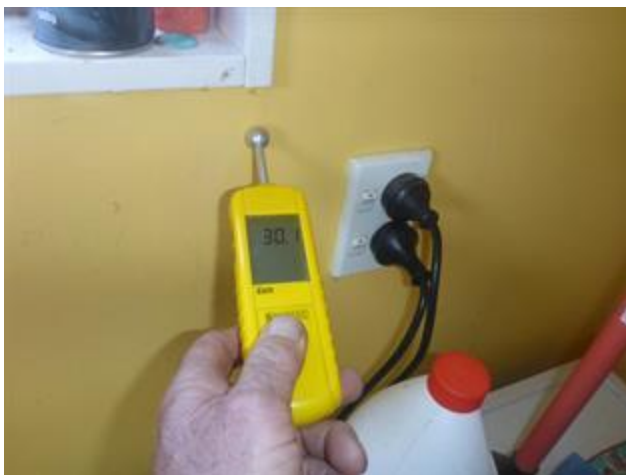
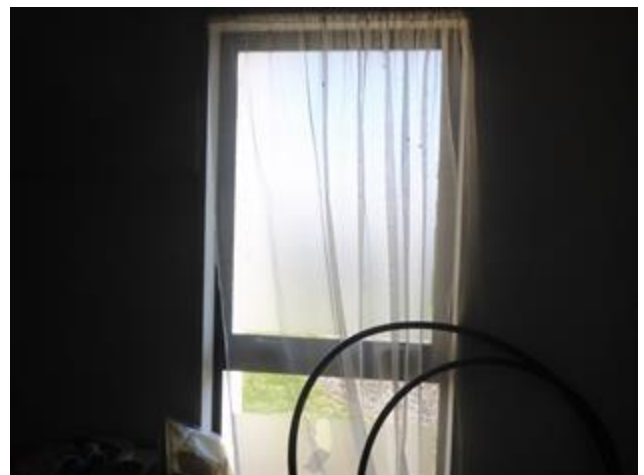
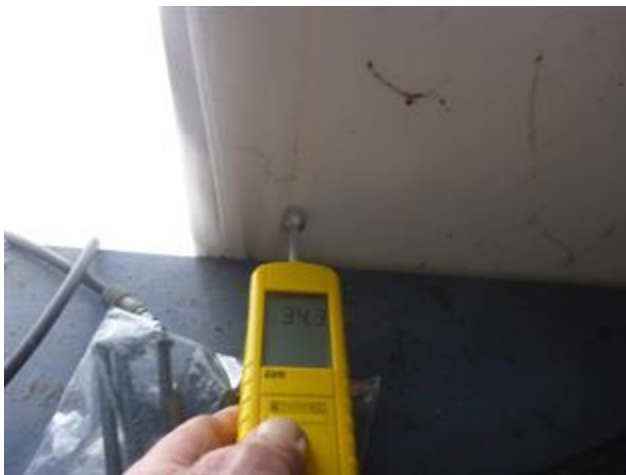
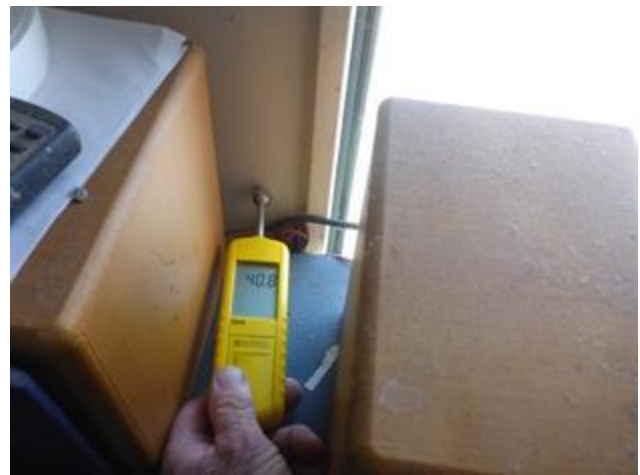
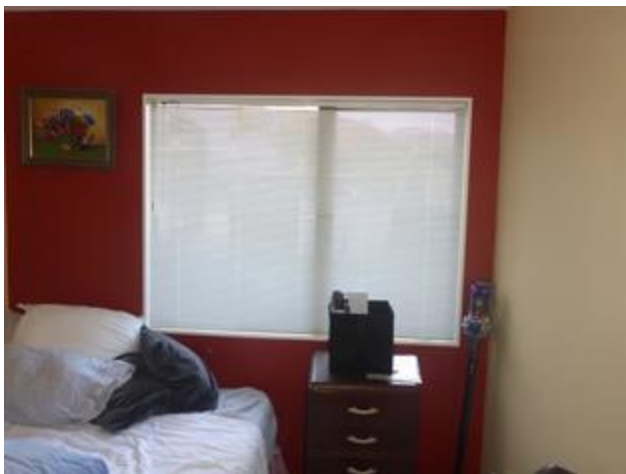
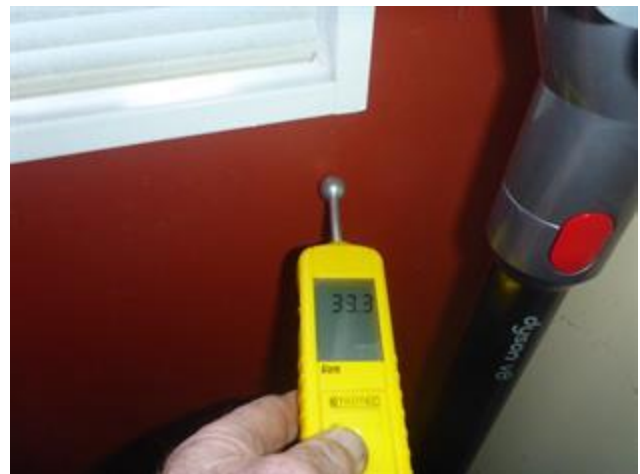
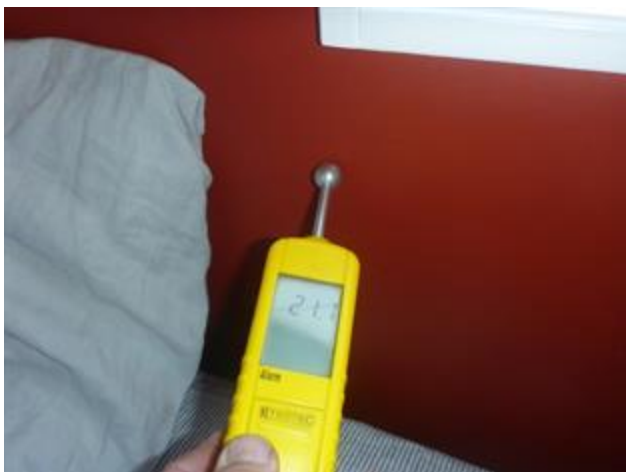
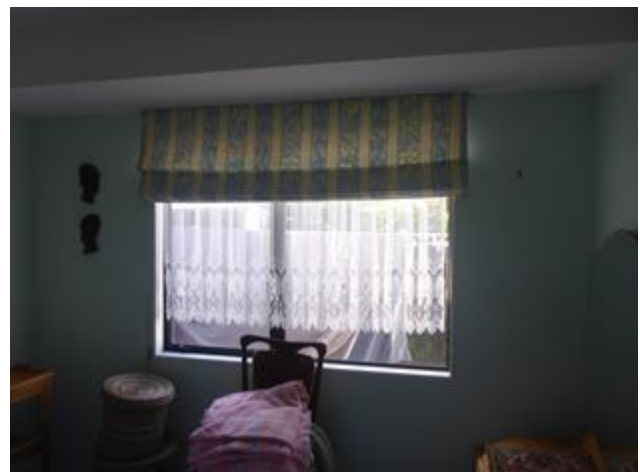
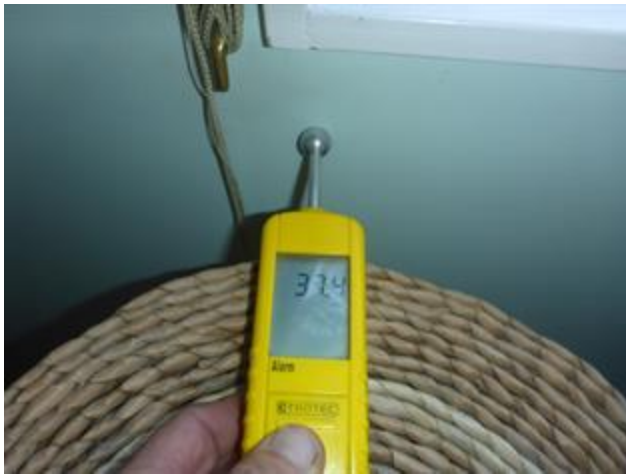
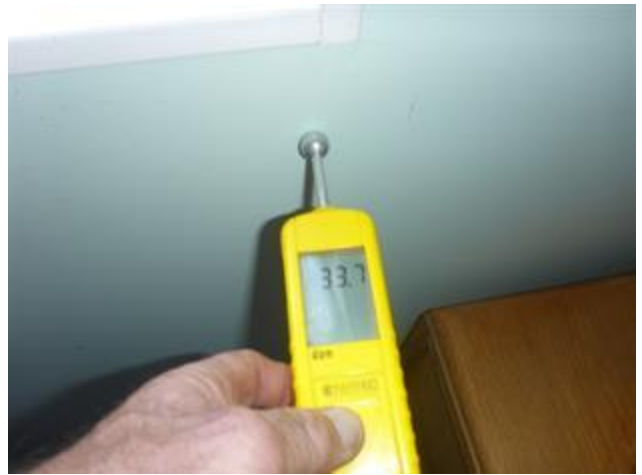
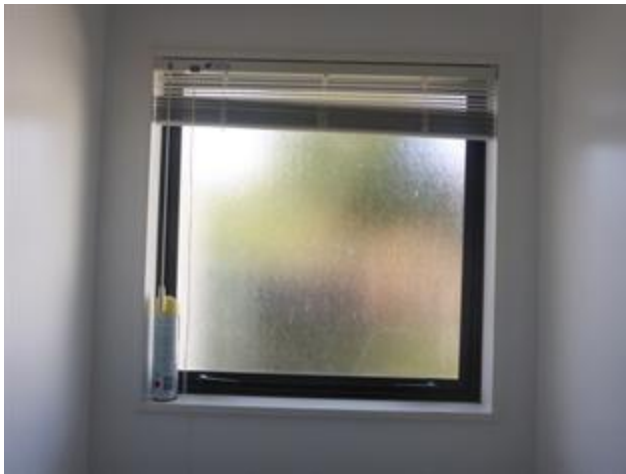
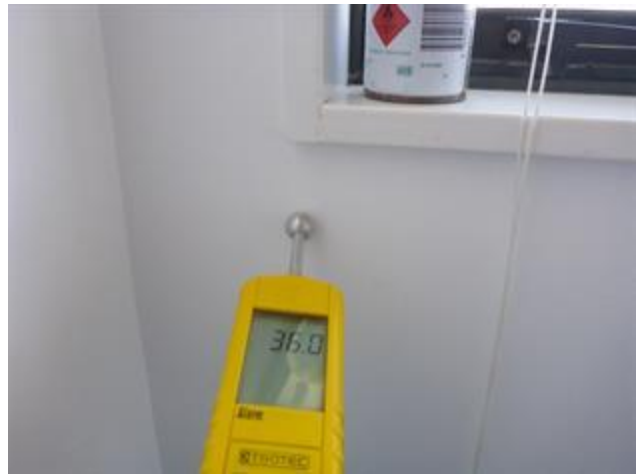
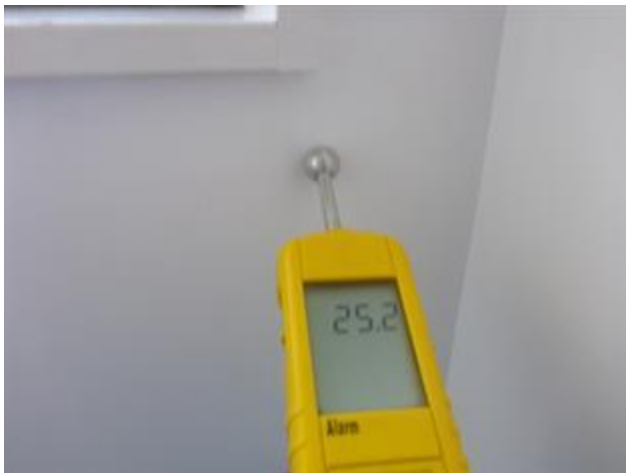
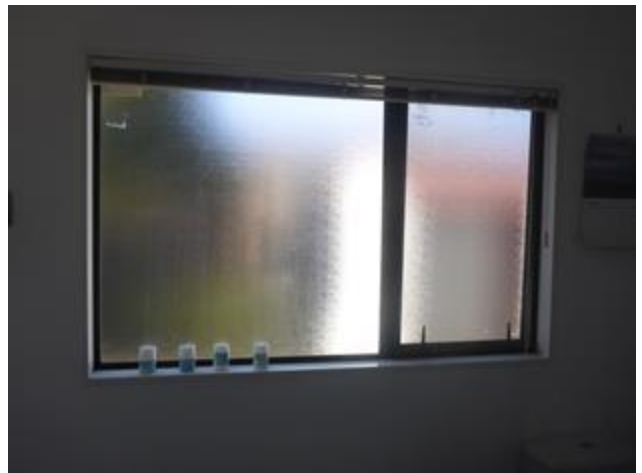
All moisture readings were within acceptable parameters at the time of inspection. I was unable to access the corresponding interior area of the outside tap due to the furniture in place.

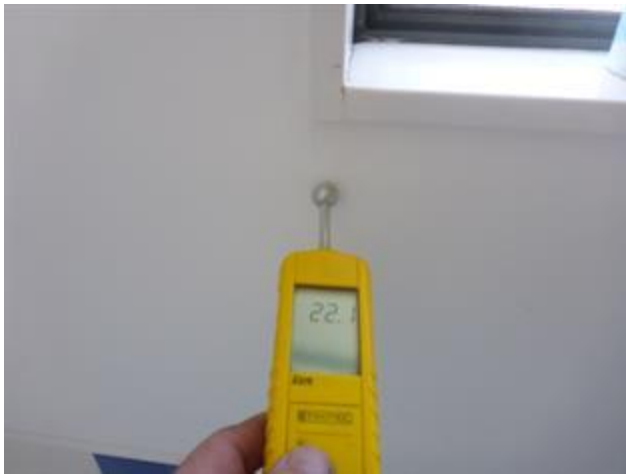
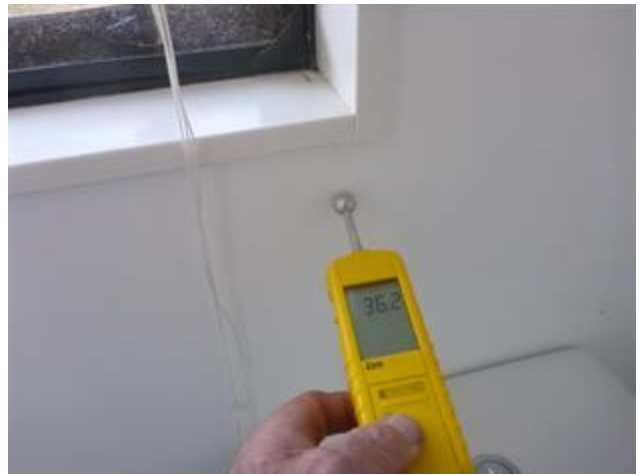
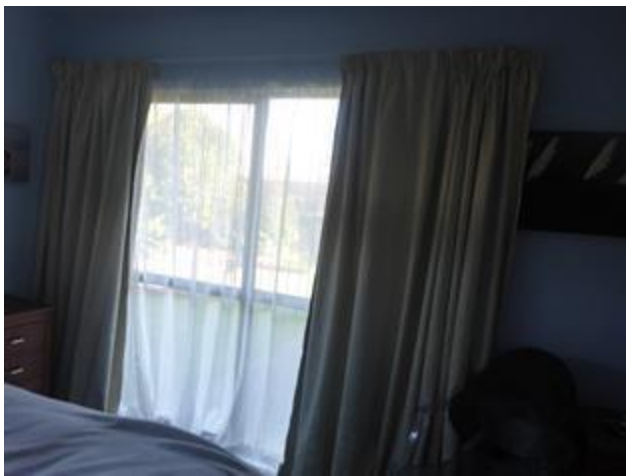
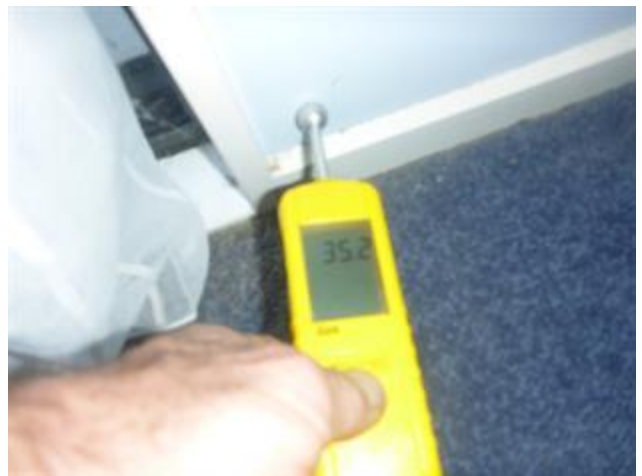
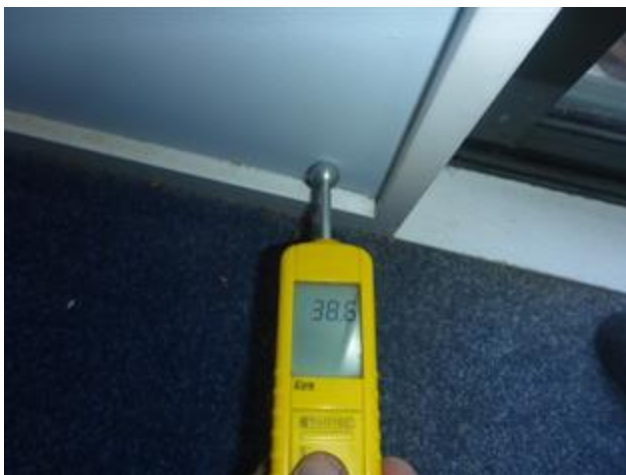
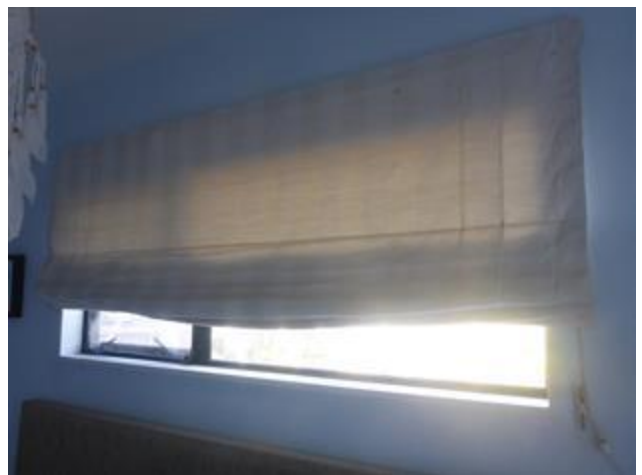
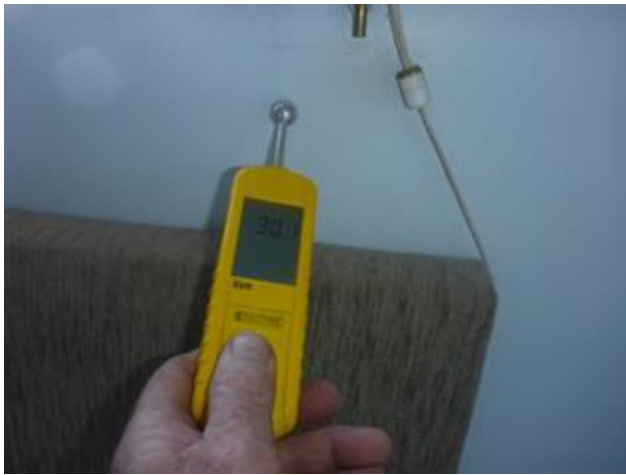
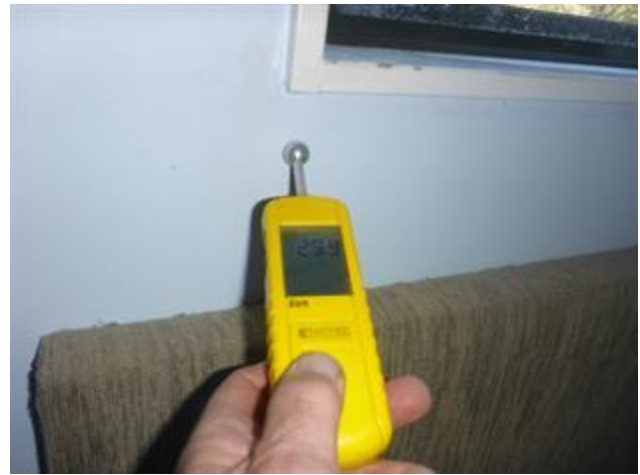
The ceilings appeared to be in good condition with no signs of sagging. Dampness and moisture damage were not seen in the ceilings or walls.

There were a few cracks noted to the plasterboard (gib board) wall linings due to the inevitable movement or setting of the dwelling. Gib board tends to crack at the sheet joins

on ceilings and around the window and door openings. This type of cracking is not uncommon and could be addressed the next time the dwelling is to be redecorated. Mechanical ventilation was fitted to the kitchen and the bathroom.

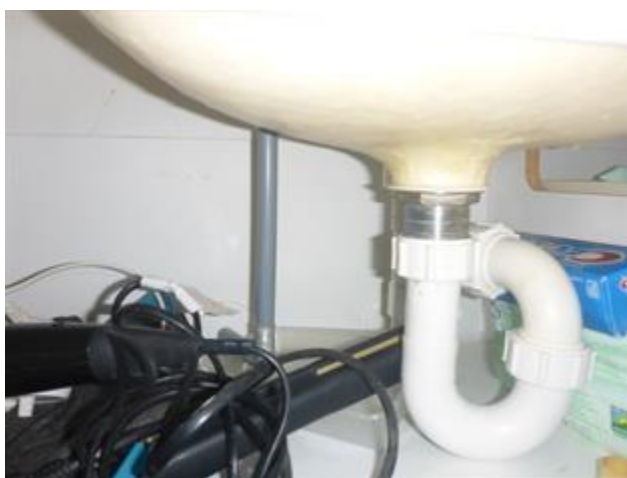
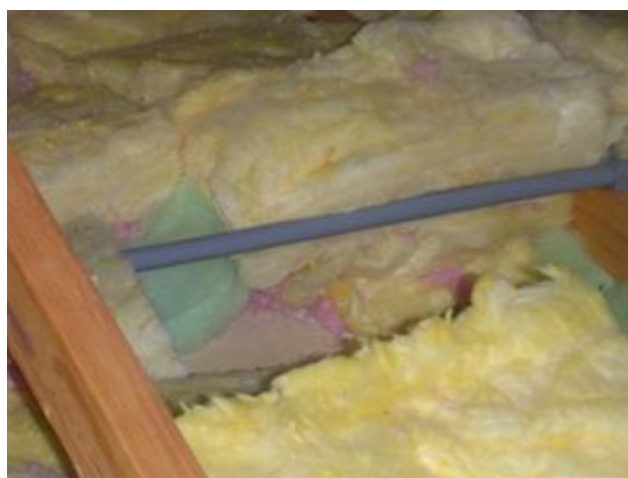
Some copper water piping was also present and supplying the hot water cylinder.

Where the plumbing was visible, there were no indications of any issues to report.

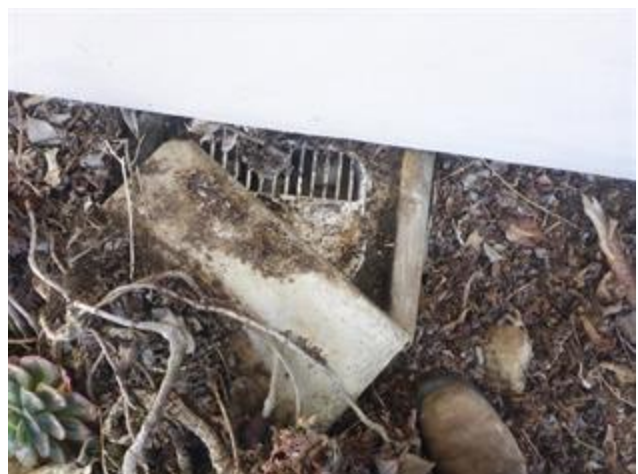
## Drainage

The gully traps appeared clear and clean at the time of inspection.
