# Independent Builders Report

Total Home Inspection Services Porirua City Ltd

Fri 29 May 2026

**75B Paremata Haywards Hill Rd, Pāuatahanui, Porirua,**  
**5381, New Zealand**

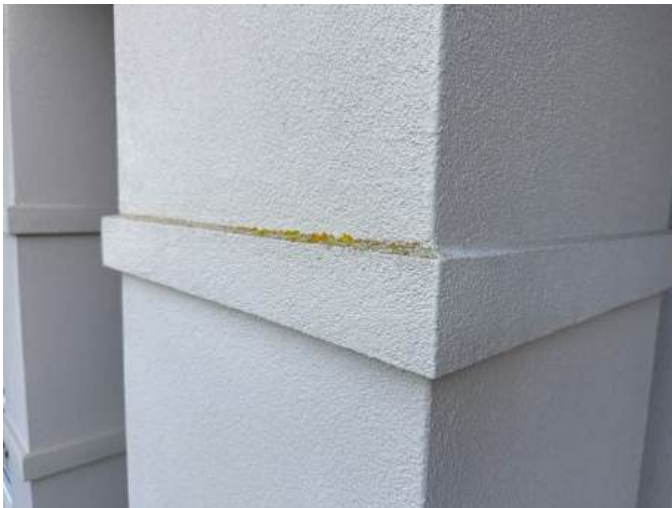
Lichen should be removed for the cladding surface to prevent the risk of premature deterioration

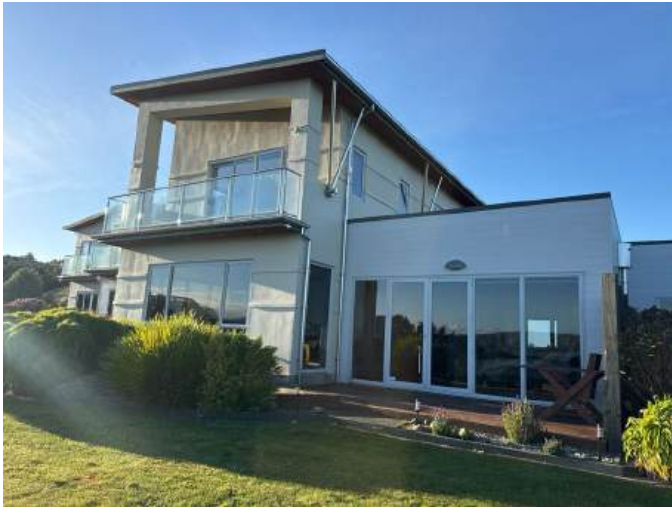
Plants in close contact with the cladding should be trimmed back to prevent the risk of premature deterioration

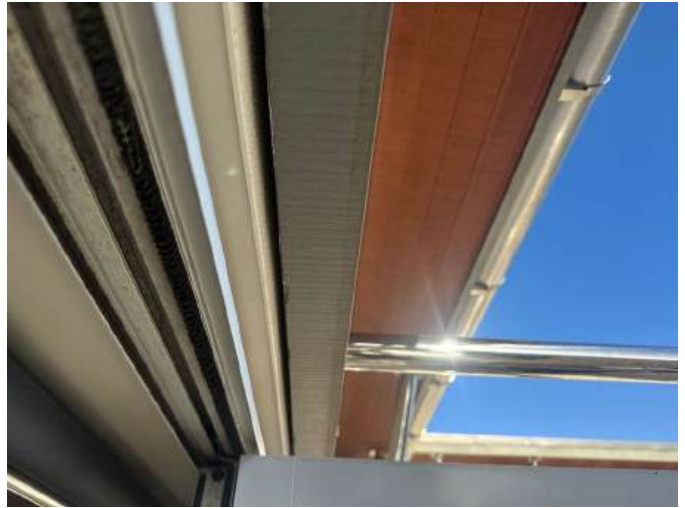
Vented cavity system identified beneath the parapets

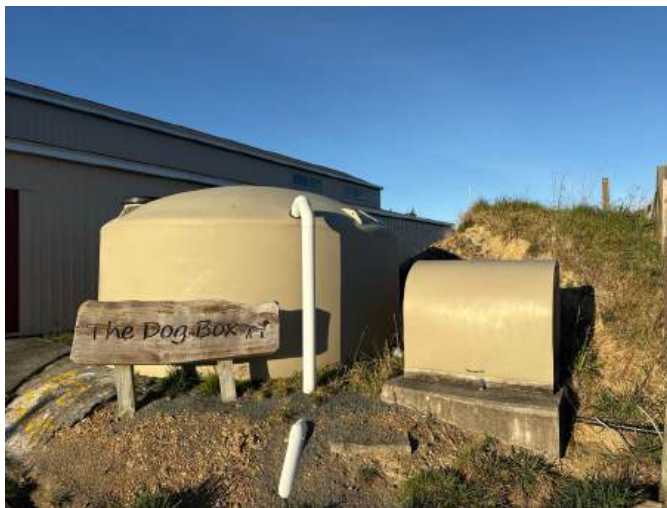
Fire fighting tank and generator installed by shed. The generator, water pumps and condition of the tanks were not checked as part of the inspection process.

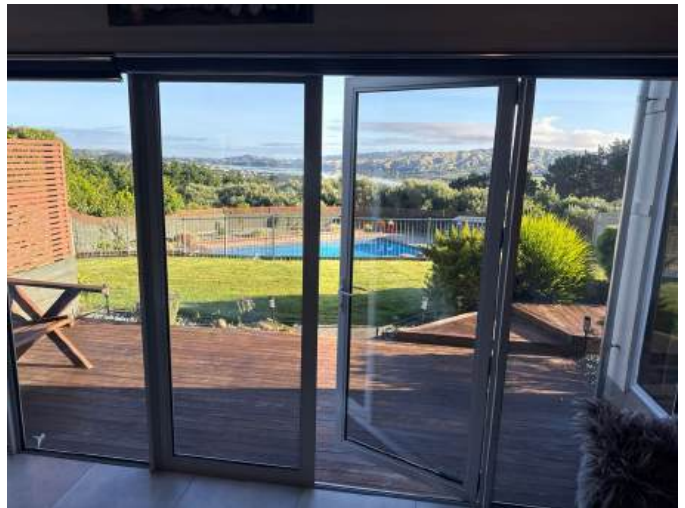
The external doors are functioning well

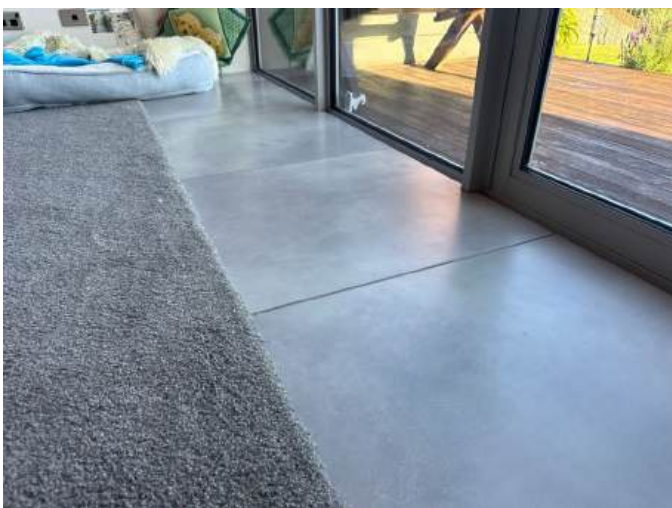
The tiles are intact and are well adhered to the floor beneath

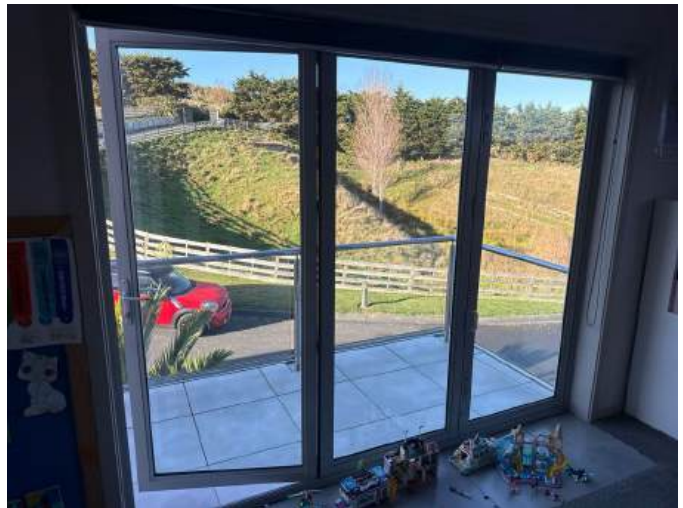
The bifold door is functioning

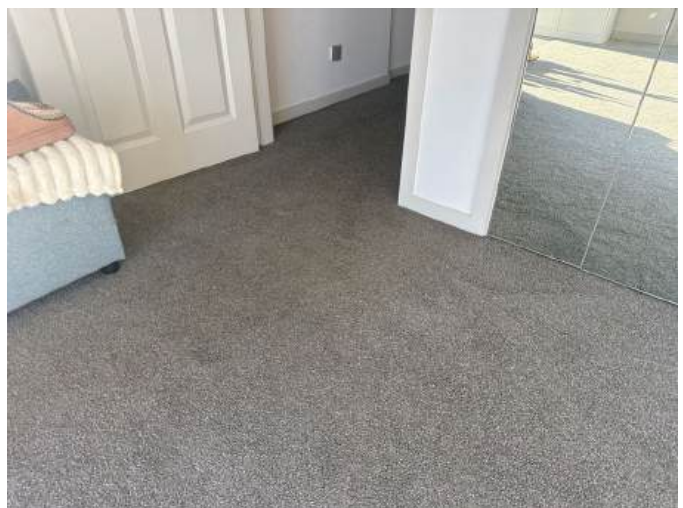
The condition of the internal linings and carpet is good

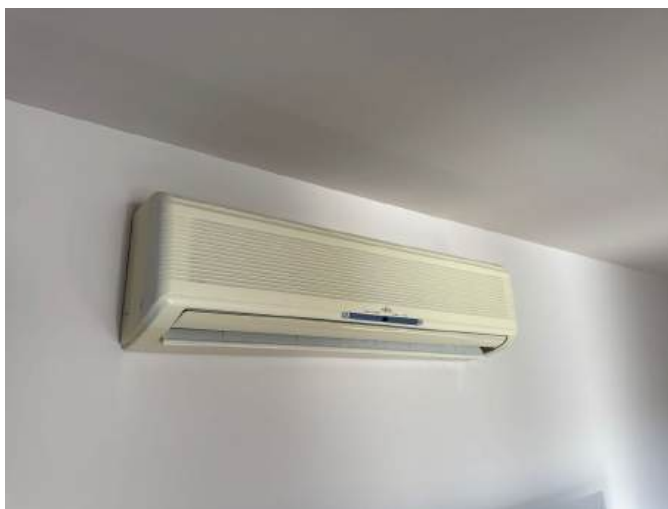
Heatpump installed. Untested.

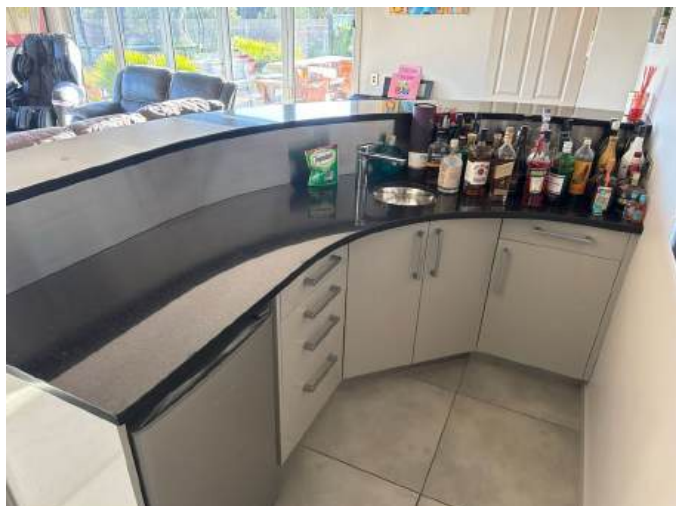
The plumbed bar area is in very good condition.

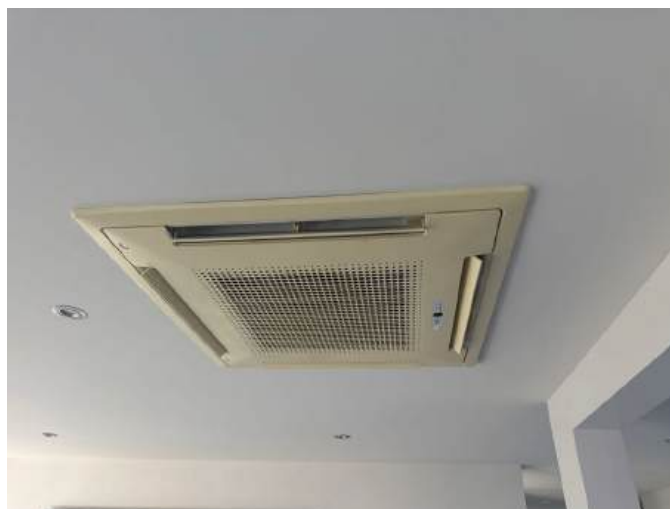
Ceiling Heatpump installed.

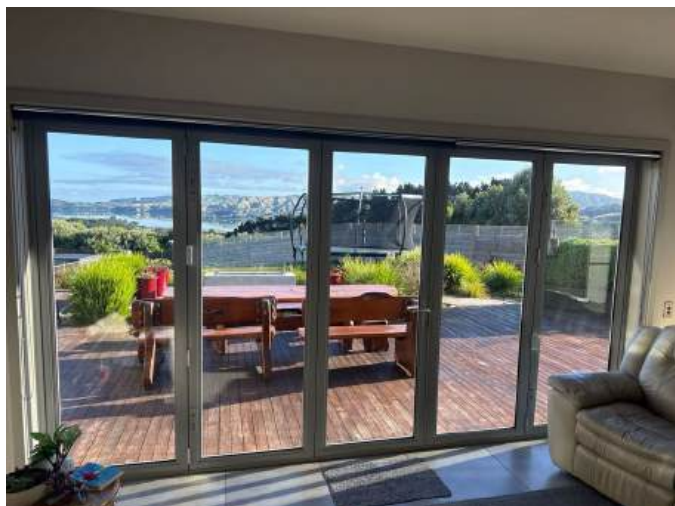
The external doors and windows are functioning

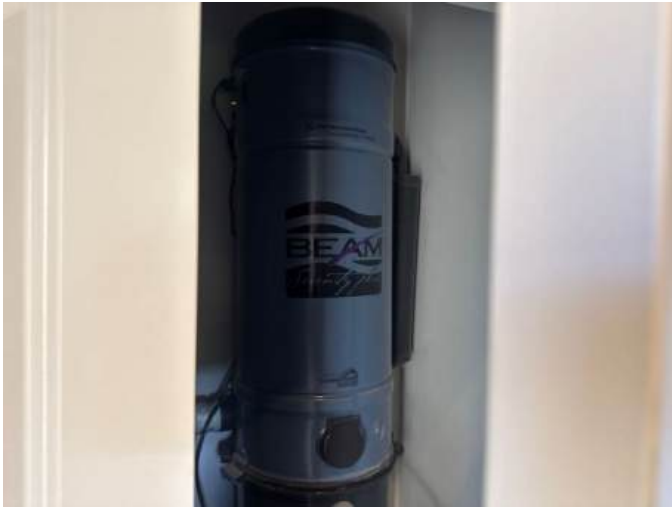
A central vacuum system is located inside the laundry cupboard. Untested.

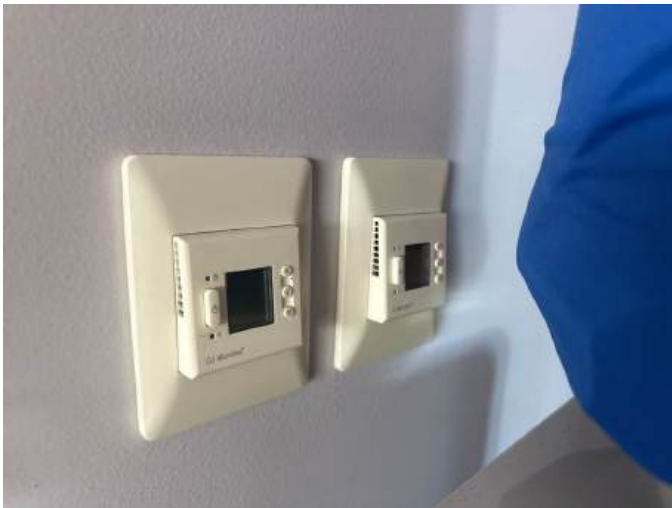
Control panels for the under tile heating are located in the kitchen and bathrooms

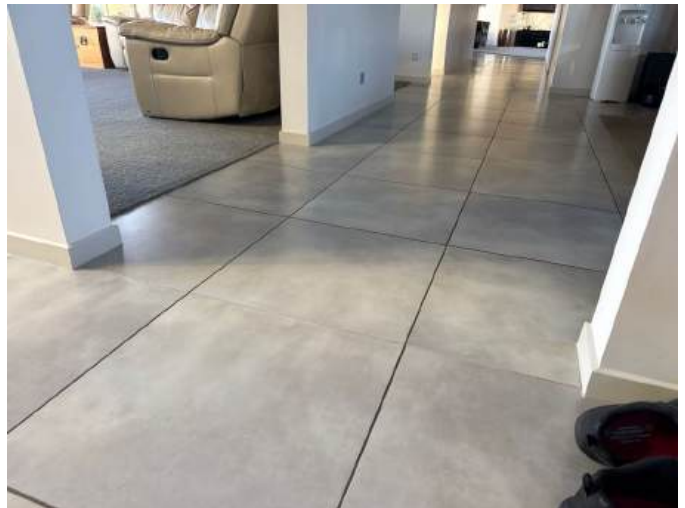
The tiles to the entrance and hallway are intact and are well adhered to the floor

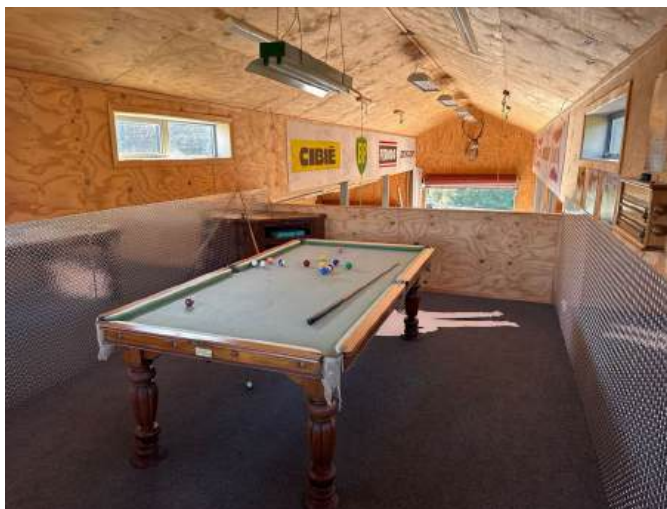
The mezzanine floor area is in good condition
